ANALOG DEVICES

2 ADC, 8 DAC, 96 kHz, 24-Bit Σ-Δ Codec

Silicon Anomaly Sheet   AD1835

This document details known bugs in the current version of the AD1835.

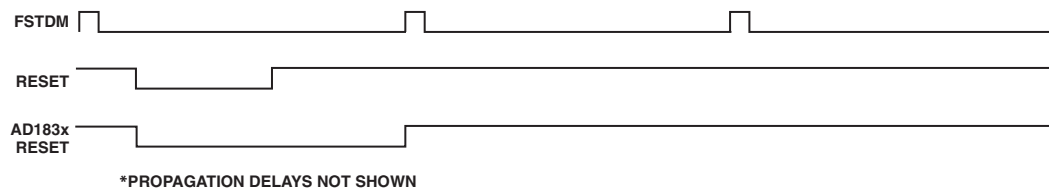
Figure 3. Synchronization Circuit for Falling Edges

The ADC engine used in the AD1835 loads the serial port with the results of the last conversion periodically at the sample rate. The loading operation is initially determined by where the $\overline{PD}/\overline{RST}$ pin goes high. For slave mode operation, the loading operation and LRCLK or FSTDM signal have no fixed relationship so it is possible that the loading operation can occur in the middle of a data transfer. This results in the right ADC sample being one sample ahead of the left ADC sample, which presents itself as a phase shift. See Figure 1.

Synchronizing the rising edge of $\overline{PD}/\overline{RST}$ with the appropriate LRCLK (for I^{2}S, left or right justified modes) or FSTDM (for TDM256 mode) edge will ensure that the ADC result updates occur in a safe region and the phase shift will not occur. Figure 2 shows a synchronization circuit using a single flip-flop that latches the reset signal on the rising edge of FSTDM/ALRCLK. Figure 3 shows an alternate circuit for latching the reset on the falling edge of ALRCLK. Figure 4 shows a timing diagram associated with Figure 2. Table I lists the ADC modes affected by this issue and which circuit should be used to prevent it occurring.

Table I. Safe Regions for $\overline{PD}/\overline{RST}$ Rising Edge

ADC Mode	Safe Region	Recommended Circuit
I^{2}S	On rising edge of ALRCLK	Figure 2
Left Justified	On falling edge of ALRCLK	Figure 3
Right Justified	On rising edge of ALRCLK	Figure 2
TDM256	On rising edge of FSTDM	Figure 2
