Nokia Customer Care
2255 (RM-97)
Mobile Terminal

Antenna Description and Troubleshooting

ISSUE 1 10/2005

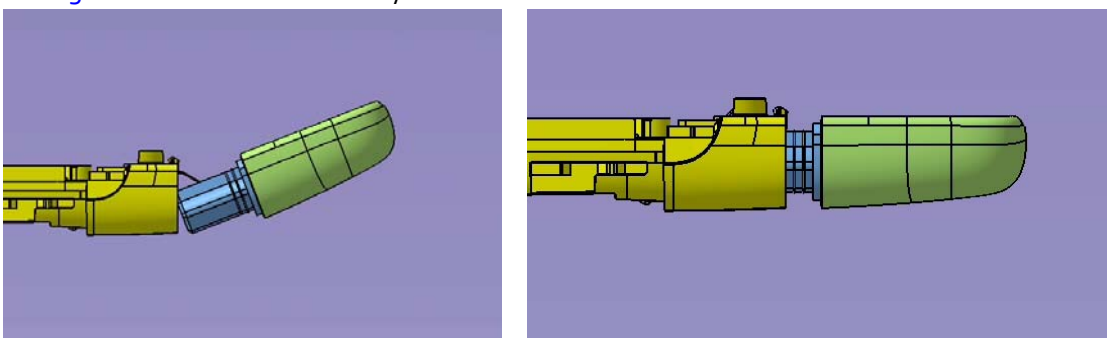
Figure 2: Installing a stub antenna

If no stub antenna is installed, the antenna gain will be degraded by more than 25 dB.

The stub antenna has a spring clip feed contact that should properly touch the PWB. Positioning of this pin is shown in Figure 2.

- If the RF feed pin is broken or bent the pin will not touch the PWB and the stub antenna must be replaced. If the spring for the RF feed pin damaged, replace the stub antenna.
- If the RF feed pin of the stub antenna does not touch the PWB, the antenna gain will degrade by more than 25 dB.

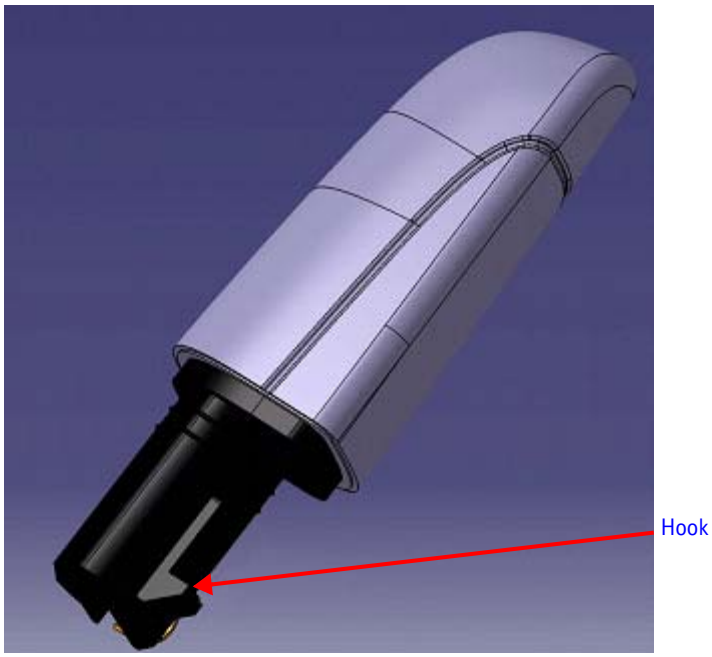
Figure 3: Locking mechanism on antenna anchor

The stub has a hook on the antenna anchor which locks the antenna into the D-cover when installed. See Figure 3.

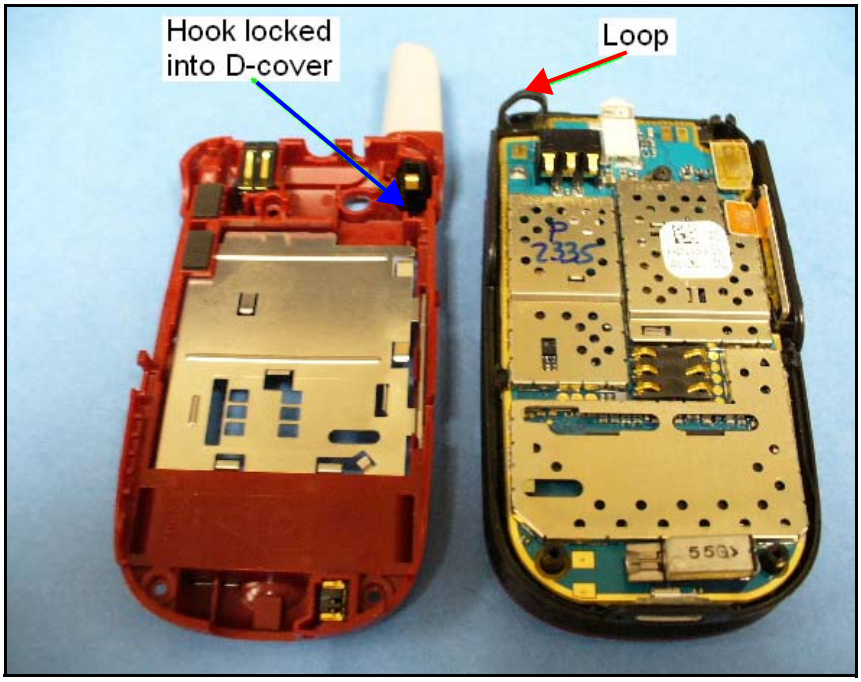
Figure 4: Antenna locked into D-cover and plastic loop in C-cover

During antenna installation, the antenna anchor passes through a plastic loop in the C-cover (See Figure 4). The antenna is the last item to be installed during assembly of the mobile terminal.

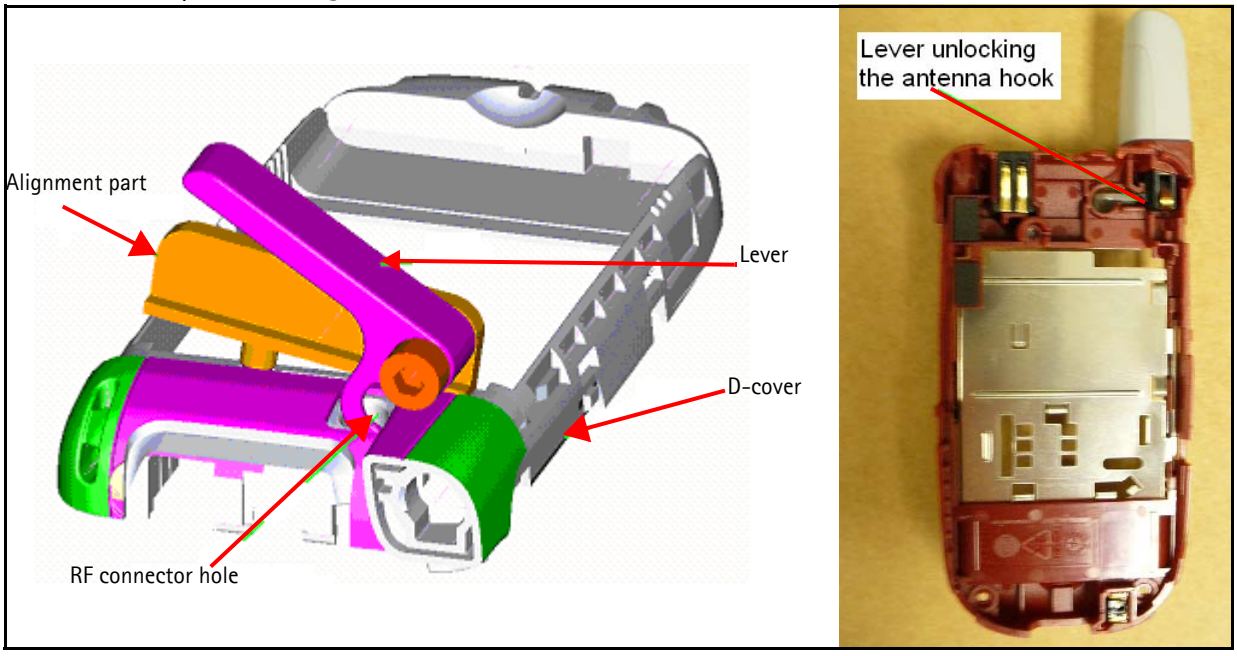
Figure 5: Position of antenna extraction tool onto D-cover

During disassembly of the mobile terminal, the antenna needs to be uninstalled first. To uninstall an antenna, a special extraction tool is needed. The antenna should never be extracted by force as the antenna and/or the D/C-covers may brake or be damaged.

Use the static portion of the extraction tool to align the tool onto the D-cover. A moving lever passes though the RF connector hole and releases the hook from D-cover.

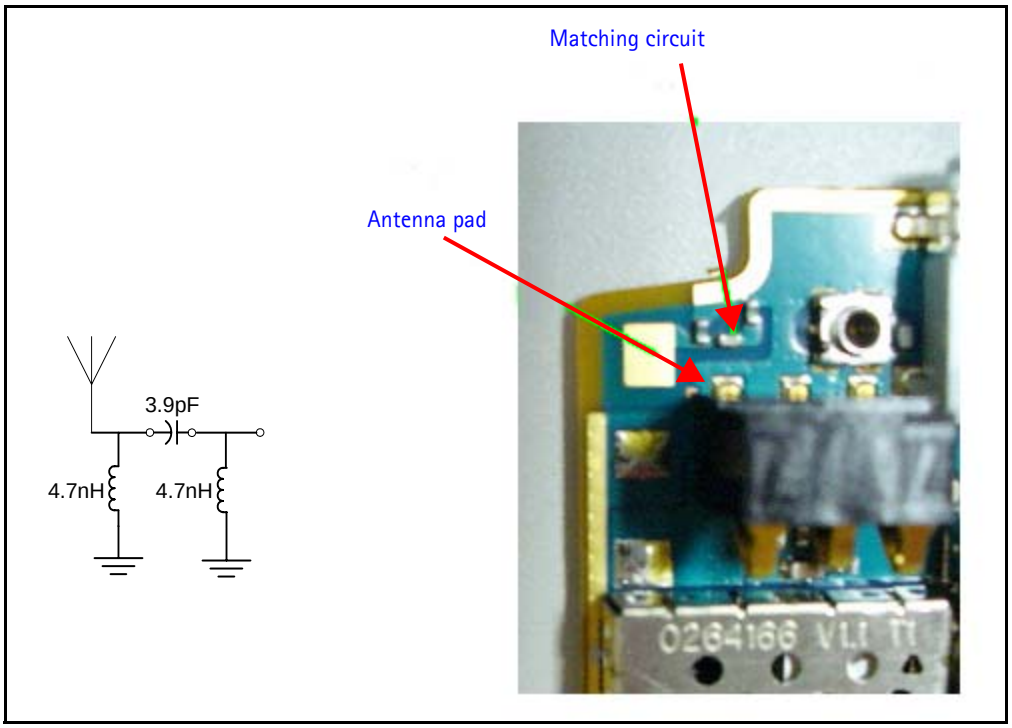
Figure 6: PWB layout of RF feed pad and matching circuit

If the RF feed pin is obstructed, removed or covered, the RF pin will not touch the PWB and then the antenna performance will degrade.

The antenna matching circuit is positioned next to the RF feed pad. If the matching circuit is improperly installed or any of the components are missing, the antenna gain will be degraded by about 25dB.

- If corrosion is present or the pad is missing, replace the PWB and the mobile terminal.
- If either pad is obstructed or covered, clean and/or clear the pad.
