Hi-Fi Products
Service Bulletin

Model: STR-AV970X/AV1070X

No. 232

Subject: Unit Goes Into Protection With High Volume On Rear Amp

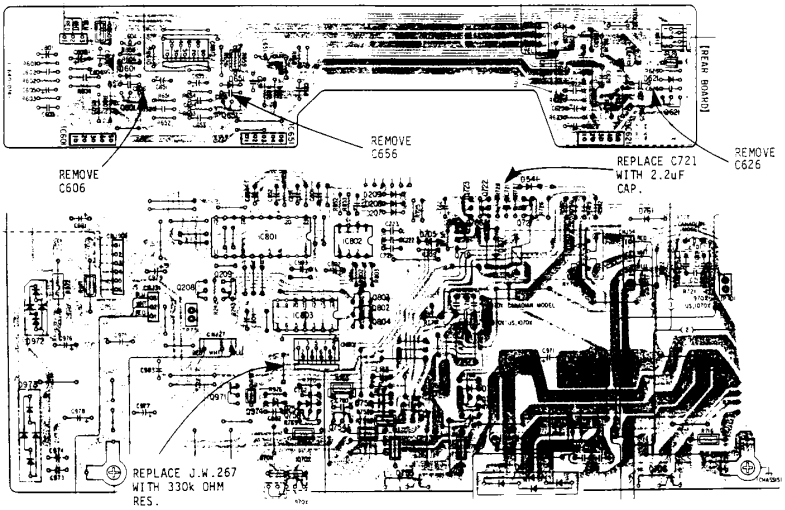
Symptom:
(12) Setting the rear amp volume too high causes the protection circuit to activate.

Solution:
1. Replace C721 from a 0.1μF to a 2.2μF.
2. Replace jumper JW267 with a 330K ohms resistor.

3. Remove C606, C656 and 626.
