The Experiment of Flow Induced Vibration in PWR RCCAs

Sang-Nyung Kim[*][†], **Cheol Shin**

Department of Nuclear Engineering, Kyunghee University

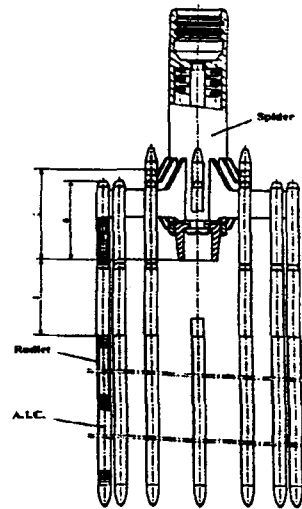
**Fig. 1** RCCA spider diagram

In Ulchin Nuclear Power Plant #1, 2 and Framatome's plants which have 17×17 fuel assembly, RCCA has 24 rodlets brazed to a spider (Fig. 1) (Kim and Shin, 1998). The rodlet consists of a thin 304S. S. tube filled with a silver-indium-cadmium (Ag-In-Cd) cylindrical bar. The rod is long(3.8m), thin and very flexible.

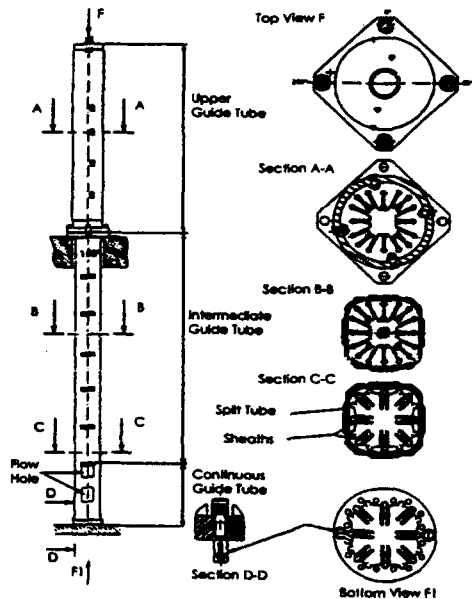
Fig. 2 RCCA guide tube and guide plate geometry along elevation

Figure 2 shows a 17×17 RCCA guide tube. In the upper plenum locates the lower guide tube assembly, consisting of an enclosure with intermediate plates and a continuous support assembly used to guide and support the RCCA control rods. The lower guide tube assembly has a square cross-section member, and it is divided into intermediate and continuous assembly. The assembly is made up of sheaths and C-tube supports, so-called cards shown in the cross section C-C (Fig. 2). In the intermediate and upper guide tube, the guide plates are equipped but the continuous section has no guide plate except for its bottom and has some flow holes on its surface.

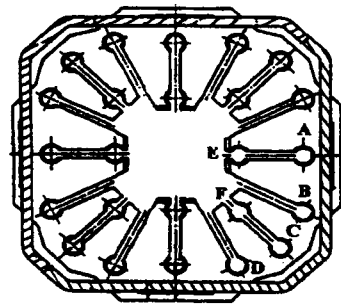
Fig. 3 Rodlet position in guide tube

B. The inside face (position E in Fig. 3) rodlet wear was the greatest, while the inside corner (F) rodlet wear was 40% to 65% as much, and the outer (A, B, C, D) rodlet wear was significantly lower (Fig. 4).

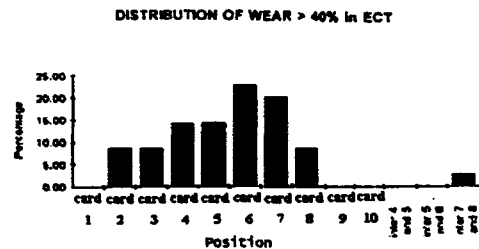
Fig. 4 The distribution of RCCA fretting wear in guide plate

D. The most severe wear occurred on the intermediate flange plate No. 6.

DISTRIBUTION OF WEAR > 40% in ECT

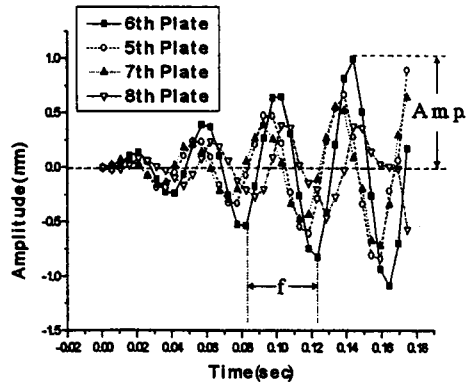
Fig. 10   The displacement variation for the most dominant four plates at fixed flow rate, 110 l/min (stage 1. exp.)

The results of the amplitude measurement along the plate position show that the largest amplitude occurred at the sixth plate. Also, the amplitude decreased as the distance from the sixth plate increased. Also the figure shows that the frequency of the vibration is 20 to 25 Hz since the period is about 0.05 sec. to 0.04 sec.

These measured results are exactly coincident with the Ulchin E. C. T. result and Framatome's report. This means that the design of the experimental rig, conditions, and method are quite adequate.

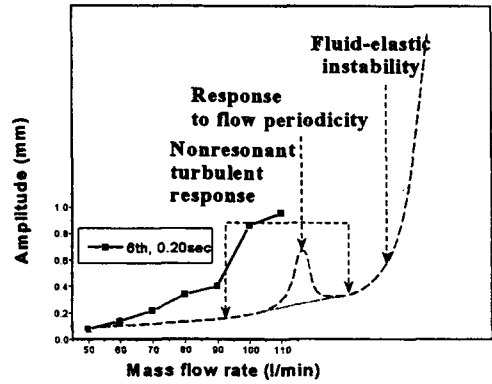
Fig. 11 The amplitude trend at 6th plate position with mass flow rate variation (stage 2. Exp.)

The results of the second stage experiment are shown in Fig. 11. The vibration amplitude steadily increases as the flow rate increases from 50l/min to 90l/min. After this steady increase stage, the amplitude increases drastically with the flow

rate. In this experiment(Fig. 7), the amplitude was limited to about 1 mm since the gap between the hole and rod is about 1 mm. To show this sudden amplitude increase in more detail, the results were redrawn in Figure 12. Figure 12 shows that the F. I. V. characteristic curve for an idealized rod matches that of the experimental results. Governing mechanisms are divided into three parts according to fluid velocity. Turbulent excitation mechanism is dominant in the low mass flow rate range, periodic wake shedding mechanism occurs at a certain velocity in the medium range, and fluid-elastic instability mechanism is essential in the high range. In the range from 50 l/min to 90 l/min, the amplitude increases with the mass flow rate gradually. But at the moment of changing mass flow rate from 90l/min to 100l/min, the amplitude increases dramatically. This behaviour of the amplitude can be explained as the transition of governing mechanism. Turbulent excitation is dominant in the low flow range (50–90l/min), then as the flow rate approaches 100l/min, the governing flow-induced vibration mechanism is changed to periodic wake shedding.

(5) For the reduction of control rod fretting wear by F. I. V. the bypass flow reduction is strongly recommended by the redesign of upper support plate to narrow the gap.
