DEPARTMENT OF THE ARMY
U.S. Army Corps of Engineers
CECW-ED   Washington, DC 20314-1000   ETL 1110-2-533

Technical Letter
No. 1110-2-533   30 September 1994

Engineering and Design
LIFELINE REPORT NO. 1, SYSTEMS AT RISK FROM EARTHQUAKES,
HYDROELECTRIC POWER PLANT FACILITIES

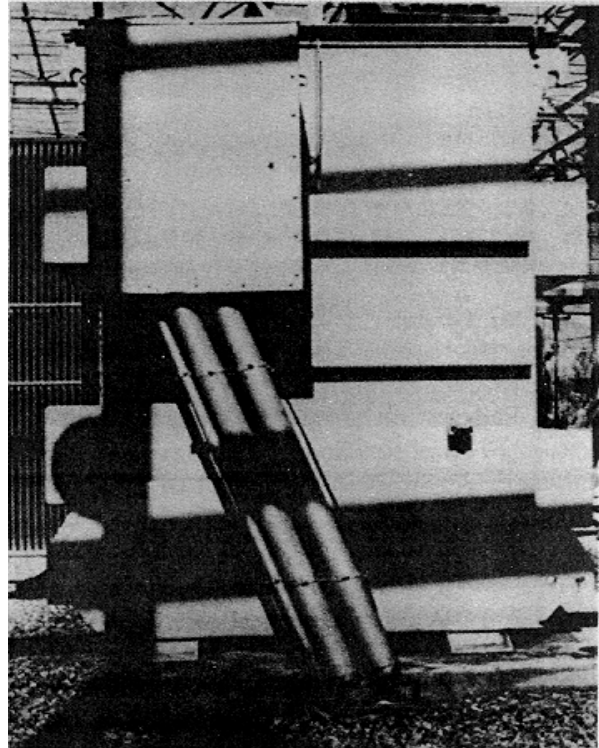
Figure B-1. Motion of unanchored transformer

(4) Vibration-induced sloshing of oil in transformers and motion of transformers frequently cause sudden pressure relays to trip, causing circuit breakers to isolate transformers. As a result, in moderate and strong earthquakes, busses are often de-energized so that there is a loss of offsite power. Massive objects, such as power transformers, require substantial anchorage to prevent movement relative to support structures when ground motions are imposed, as in earthquakes. The transformer shown in Figure B-1 moved over 3 ft in the 1971 San Fernando earthquake

(Richter magnitude 6.4). The motion of the transformer can cause bushings and surge arrestors to be damaged, particularly if rigid bus is used. Control cables can also be damaged.

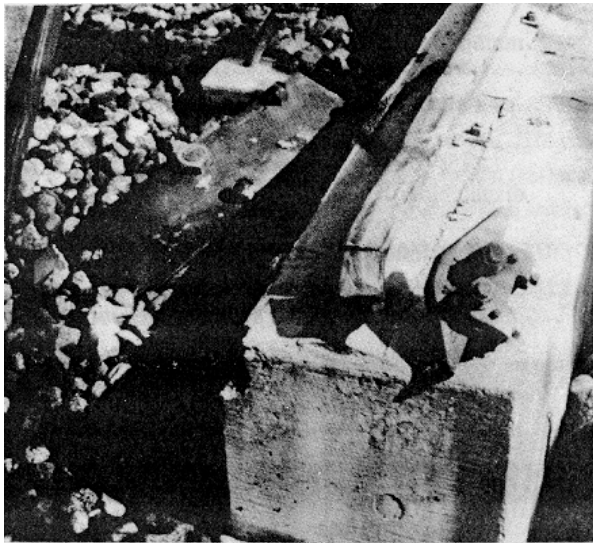
**Figure B-2. Failure of a rail-mounted transformer**

(1) Under certain conditions, when saturated soils experience vibrations, shear strength decreases and soil liquefaction can occur. Liquefied soil has been observed to flow on 1 percent grades. Surface-supported structures have settled several feet below grade, and buried tanks have floated to the surface. Lateral spreading associated with liquefaction can cause large horizontal motions, often several feet. Even when a rail-mounted transformer (Figure B-2) is secured by chocks, the chocks can slip, or the transformer can tip over damaging bushings, radiators, bus work, and internal parts and connections. In Figure B-3, the transformer pushed the chock off of the end of the rail and allowed the transformer to fall from its pedestal.

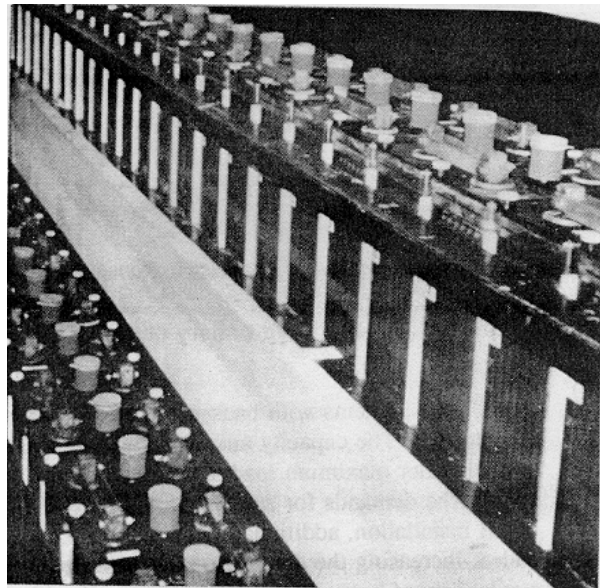
Figure B-4. Inadequate battery restraints

(3) The battery restraints in Figure B-4 are anchored with two 3/8-in. bolts at each end. Even if the anchorage does not fail, motion in the transverse direction would cause significant deformation in the long, end-supported lateral rail restraint. This would allow the batteries to impact the opposite rail when the motion reverses direction. Impacting can crack battery cases causing an acid spill or loss of power. Rail supports should be provided every three to four cells to ensure both strength and stiffness of the restraints.

(4) When batteries are unanchored, the need for anchorage is obvious. It is important to check situations where restraints and anchorage are present, but are inadequate. More stringent design criteria for batteries, as compared with other parts of the system, should be considered because of their importance to the operation and safety of the facility, and the fact that the incremental cost of conservative design is small.

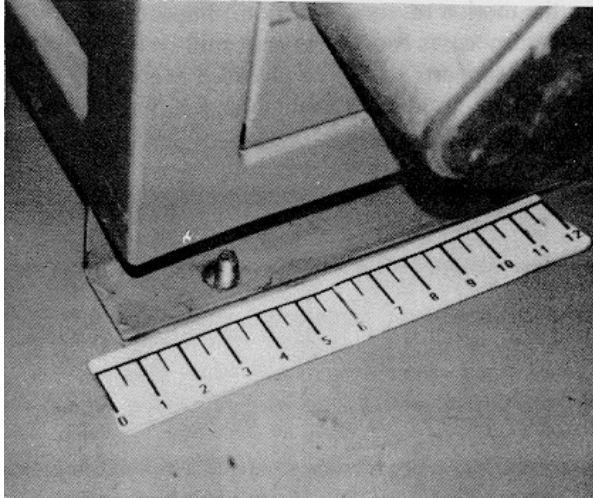
Figure B-5. Unanchored battery charger

(6) Figure B-5 shows an unanchored charger. Anchorage provisions are sometimes provided but not fully executed. The strength and stiffness of the fabricated channel used to form the anchorage should also be checked.

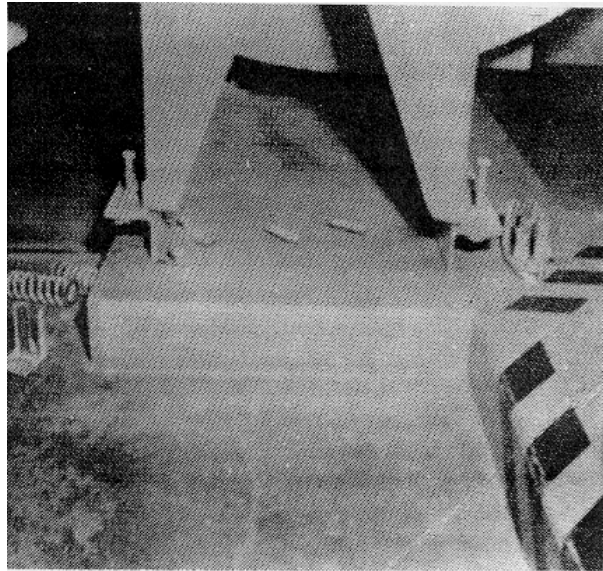
Figure B-6. Damaged vibration isolation system

(10) A damaged vibration isolation system is shown in Figure B-6. A cast iron retainer around the spring failed due to impacts from lateral earthquake-induced motions. In this example, the equipment shifted about 4 in. to the left. Snubbers restraining lateral motion should have been added to the system.

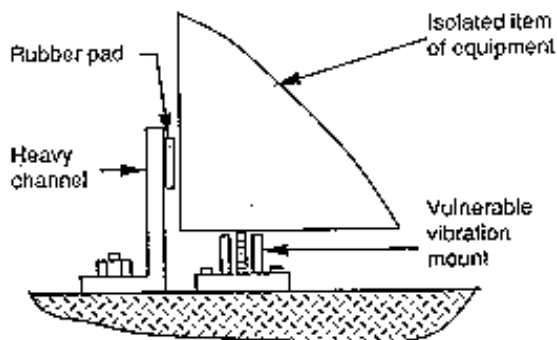
**Figure B-7. Vulnerable engine generator vibration isolation system**

(11) Figure B-7 shows a type of vibration isolator that frequently fails. The members enclosing the spring are made of cast iron, and there are no restraints to limit the motion of the unit if the isolators fail. Failure of the vibration isolators can cause the engine generator to move more than a foot. This may cause the failure of fuel, water, power, and control lines.

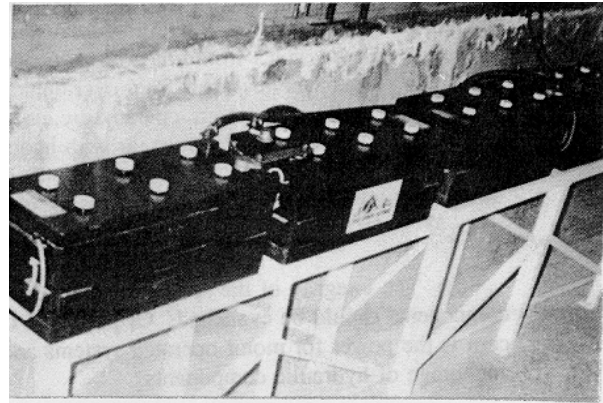
Figure B-9. An emergency generator with unsecured batteries

(13) The batteries used to start the engine and the daytank (small fuel tank near the engine) must be securely restrained. The integrity of the fuel line connecting the main fuel tank to the daytank should be evaluated. The engine generator control panel should be well anchored.

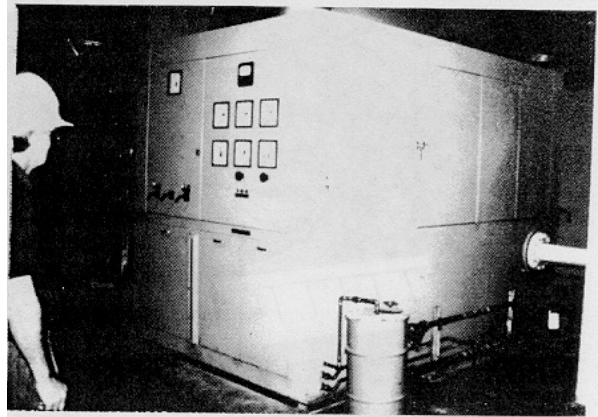
Figure B-10. An unanchored heavy item of equipment can cause a pipe failure. An unanchored pump and sump used to operate the wicket gates can cause a pipe or pipe flange failure. Loss of pressure would deactivate the hydraulic wicket gate system

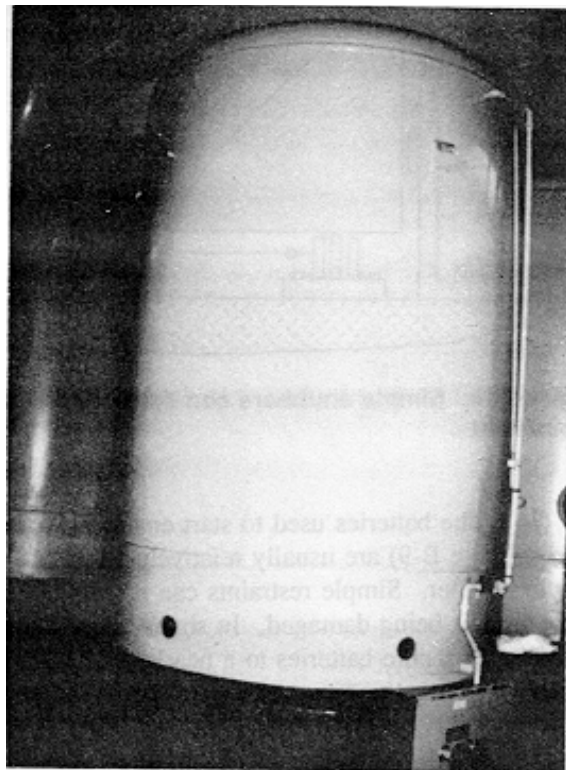
Figure B-11. An unanchored tank in the wicket gate hydraulic system. The unanchored tank in the wicket gate hydraulic system would cause the failure of the main piping system if the tank tips over, or break a smaller pipe if it moves slightly

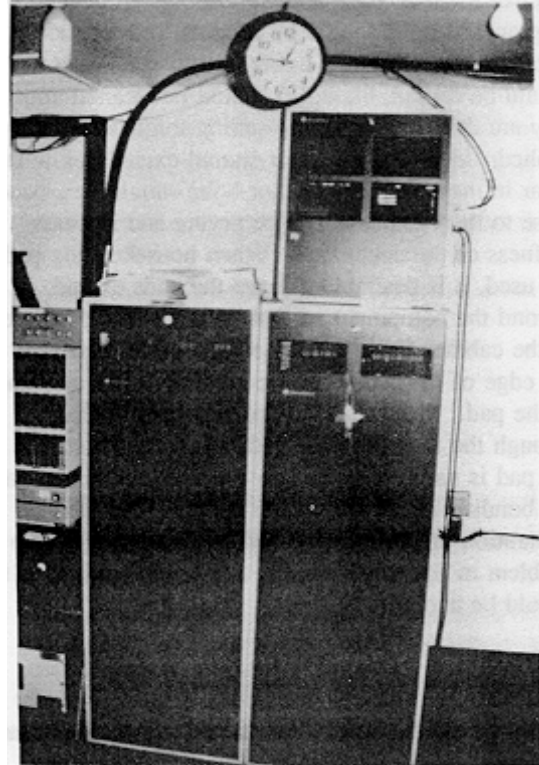
Figure B-12. Radio equipment cabinets must be anchored

be bolted to the floor adjacent to the ends of the inadequately anchored cabinet and then welded or bolted to the cabinet. The load path between the cabinet and the new anchor should be checked.

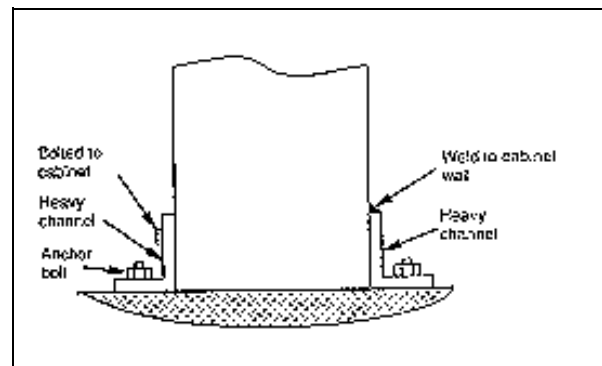
Figure B-13. Retrofitted anchorage to cabinet that is difficult to move

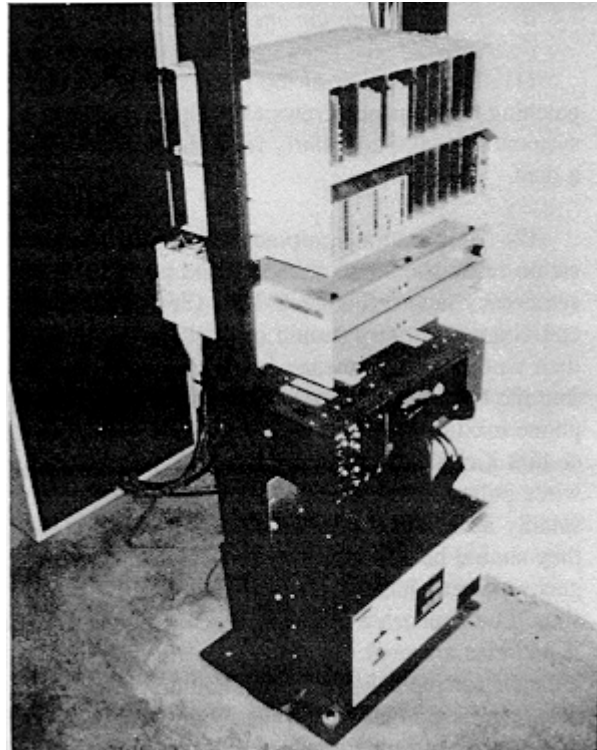
(6) Typically, communications equipment is installed in tall frames that have a narrow footprint so that large overturning moments and prying loads can be applied to the anchorage (Figure B-14). Even when provided with a strong anchorage, these frames tend to be very flexible, so that large amplification from earthquake-induced motion can be expected. In a few cases, cable connections have been pulled loose due to the motion of the equipment frame. Because of the flexibility of these frames, it is desirable to have them braced at the top to a structural wall by means of a brace or a cable tray that has structural integrity. This will reduce the motion of the frame and the loads applied to the anchorage. Frequently, frames of different heights are placed next to each other so that it is difficult to attach each frame to the overhead bracing system. Bolting adjacent frames together simplifies the bracing and adds redundancy (Figure B-15).

**Figure B-14. Base anchorage of a typical communication frame**

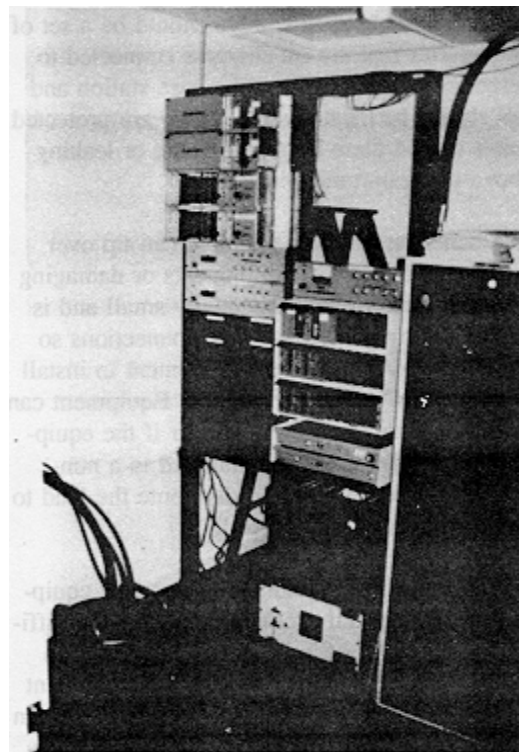
Figure B-15. Bolt adjacent racks together

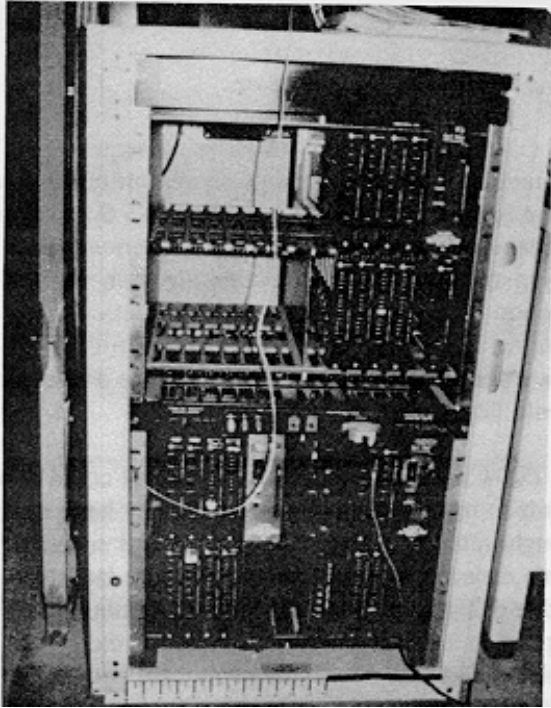
(7) Another problem that has frequently been observed in communication equipment is that circuit packs (circuit boards) vibrate loose (Figure B-16). Typically, card cages do not have doors, and circuit packs may be held only by the friction of the connector where they plug into the back plane of the card cage. Locking type card pullers are desirable, but

Figure B-16. Communication equipment with unre-strained circuit boards

typically not incorporated in older equipment. A rod placed across the front of the card cage through holes drilled in the ends of the cage can serve as a retaining bar to keep circuit packs from vibrating loose. A potential difficulty with this method of protection is that in the course of normal operations, restraining rods are removed and then not replaced.

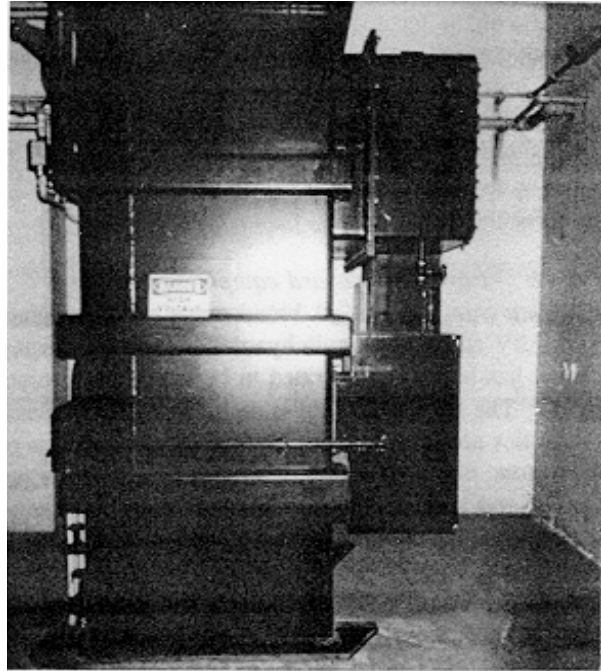
(2) All components including transformers providing house power and units substations should be anchored taking into account both strength and flexibility. Frequently, transformers providing house power are not anchored (Figure B-18). Transformers should be prevented from sliding and tipping. Some units can be tall and exert large overtuning moments. Frequently these units in dams are surrounded by structural walls so that restraints placed at the base and bracing to walls near the top of the unit can provide adequate seismic protection. Of particular concern, because the anchorage is concealed, are certain dry-type transformers in which some manufacturers do not positively anchor the transformer coil to its cabinet.

Figure B-18. House power transformers are frequently unanchored

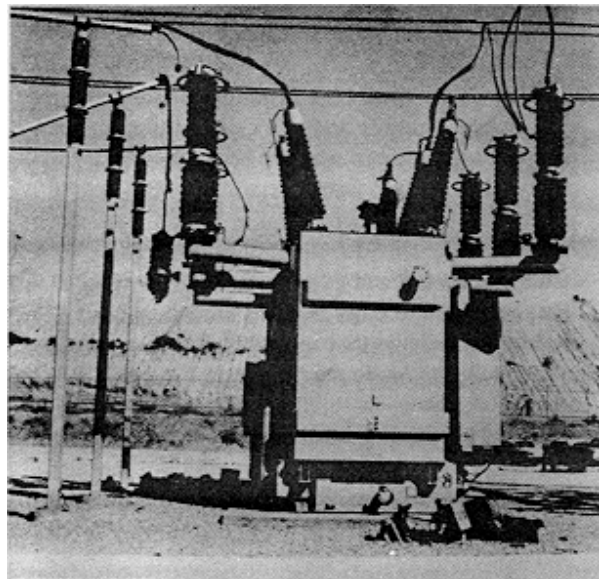
(c) An unanchored transformer (Figure B-19) can slide on its supporting pad as the pad vibrates back and forth in an earthquake. This is a means of base isolation. One of the advantages of this "anchorage" approach is that the transformer experiences lower horizontal accelerations than it would had it been fixed to its support pad. This would reduce inertial forces on bushings, radiators, and internal components.

Figure B-19. Unanchored transformer. Sliding of an unanchored transformer caused one surge arrestor to fail. Several bus connections to bushings and surge arrestors also failed. The failure of the bus connections probably prevented surge arrestor and bushing damage

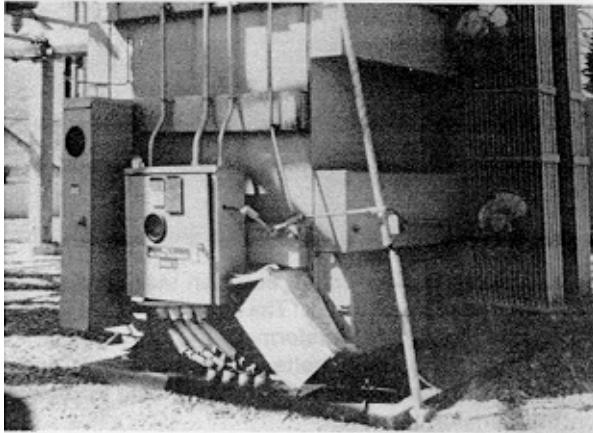
(e) Long vertical drops using flexible bus can accommodate relatively large displacements, but short flexible bus connections between equipment, rigid bus connections, and control cable connections to the transformer can only accommodate limited motions (Figure B-20).

Figure B-20. Transformer control cable damage. Sliding of an unanchored transformer has damaged control cables and piping penetration allowing transformer oil to leak

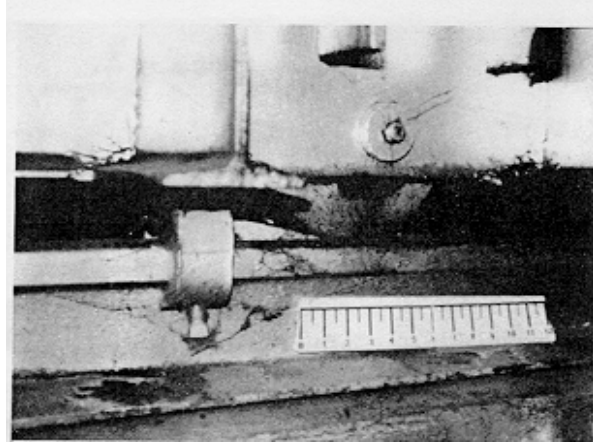
Figure B-21. Transformer restrained by chock at dam. A chock, clamped to a rail, restrains a pedestal-mounted step-up transformer at a dam. This type of restraint has repeatedly proven to be an inadequate anchorage

(h) The design of retrofits for rail-mounted transformers must carefully consider the load path. In general, it is desirable to anchor the transformer to

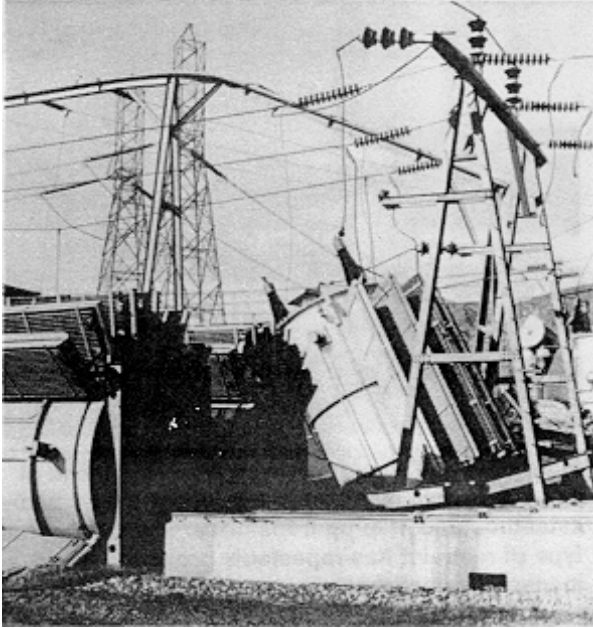
Figure B-22. Failure of rail-mounted transformers restrained by chocks. Five of the six single-phase transformers fell from their supports, damaging radiators, bushings, and the bus support structure. Chocks clamped to the rails could not restrain the transformers. Restoration is lengthy and expensive. Note that the carriages on the 2nd and 3rd transformers separated from their transformers

(j) The recommended method of transformer anchorage for new construction is to weld the transformer case to a steel embedment in the foundation pad. It is important that adequate weld length be provided to carry the maximum expected loads and that good weld penetration be achieved. The embedment must also be properly designed and installed.

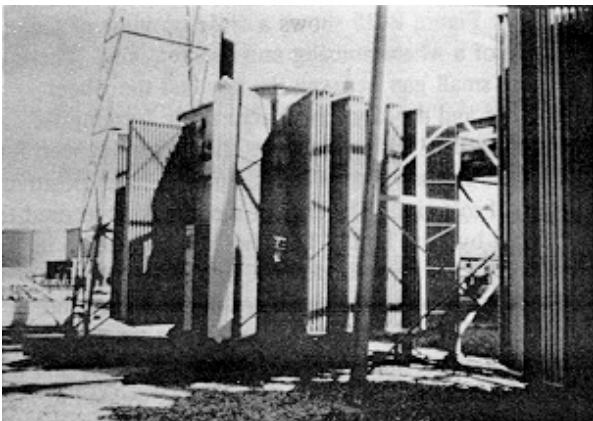
Figure B-23. Transformer restrained to rails. Overall view of rail-mounted transformer which is restrained by large chocks and concrete keys under the carriage. Note that the rails are mounted to a slab at grade; however, the transformer has no positive vertical restraint. Since the unit is not mounted on an elevated pedestal, it is less likely to fall over

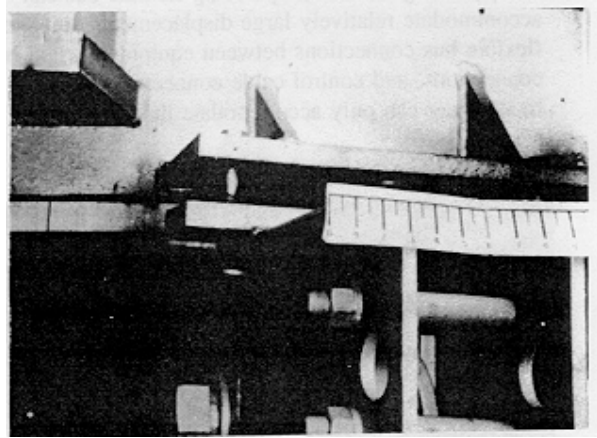
Figure B-24. Connection between step-up transformer and its carriage. The transformer carriage is attached to the transformer at four locations, each with two 1/2-in. bolts. If the carriage is not adequately anchored, it may not be able to restrain the transformer

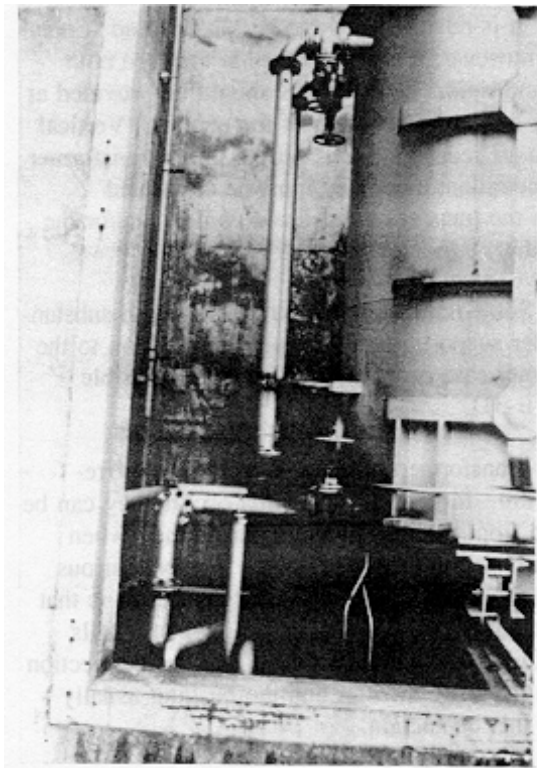
(l) Some step-up transformers at dams are water-cooled rather than air-cooled. Movement of the transformer can cause the failure to piping connections associated with the cooling system (Figure B-26).

Figure B-26. Piping connections of water-cooled transformers. Relatively rigid piping connections in water-cooled, chock-restrained transformers are one of the main restraints to transformer motion. Relatively small movement could cause pipe flanges to leak

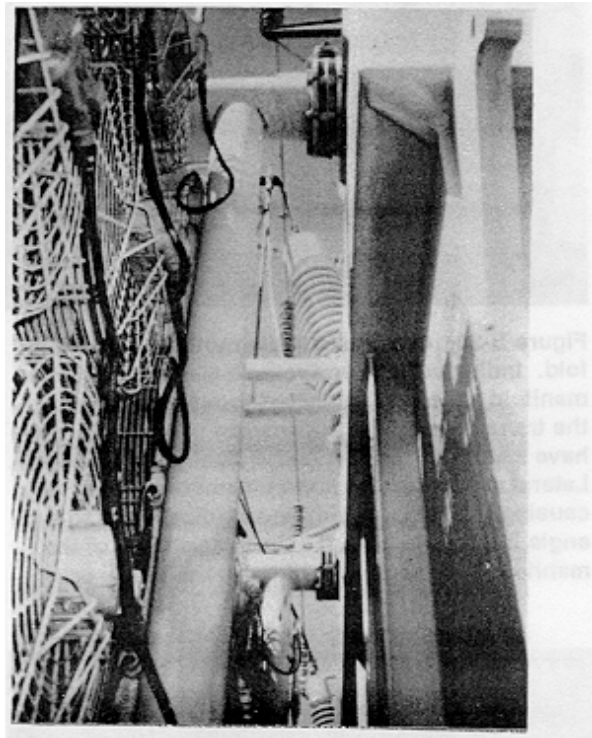
(m) Transformer coolers, depending on their design, are vulnerable to oil leaks. Large coolers that are manifold-mounted are the most vulnerable. Typically, the upper structural support of the cooler is the penetration through the transformer case (Figure B-27).

Figure B-27. Upper cooler support and transformer penetration. A large manifold-mounted cooler is supported by the pipe that also serves as the penetration to the transformer case. Lateral forces can cause large moments on the flange and oil leaks

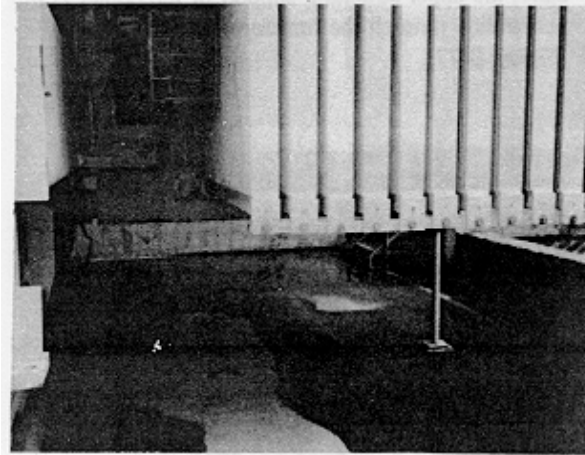
Figure B-28. Cooler elements mounted to a manifold. Individual cooler sections are mounted to a manifold which is connected to a flange forming the transformer case penetration. The cooler does have a vertical support and a small diagonal brace. Lateral motion exerts large moments on the flange causing oil leaks. A simple modification is to add angle iron brace between the outside end of the manifold and the corner of the transformer case

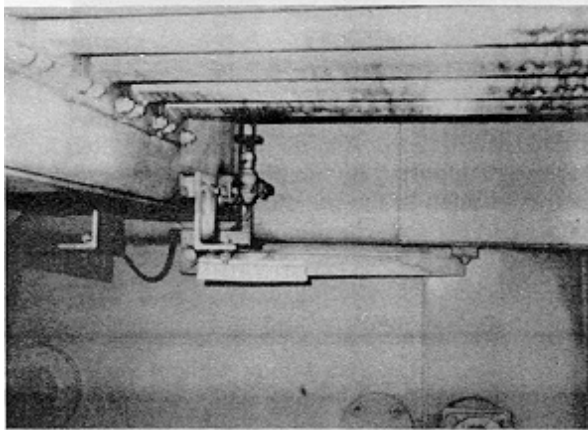
Figure B-29. Bracing of lower cooler manifold. A diagonal angle iron serves as a brace between the transformer body and the cooler manifold. Note that the connection to the manifold is through an angle. While this may be strong, it is very flexible so that the cooler assembly is not adequately restrained, and large moments can be applied to the flange on the transformer case penetration

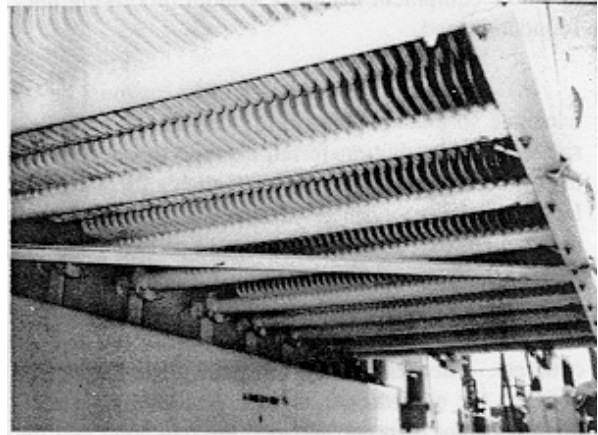
(p) Coolers which are individually connected to the transformer by their own penetrations have not developed leaks (Figure B-30).

Figure B-30. Individually supported cooler elements. Each cooler element has its own transformer case penetration which also serves to support the cooler. Flange leaks have not been observed for this type of configuration. The end of the coolers which is most distant from the transformer body is also restrained by a small angle iron brace

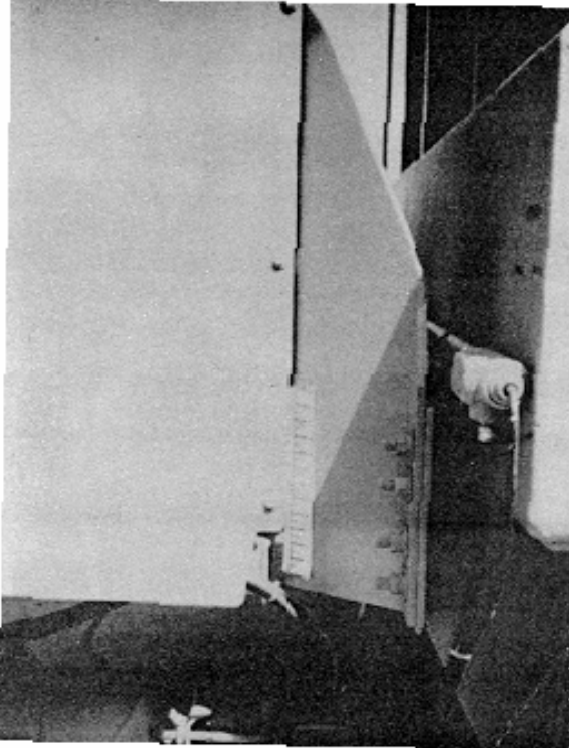
Figure B-31. Manifold-mounted cooler with support structure. The cooler lower support is substantial and separate from the piping penetration. The connection to the transformer case penetration is relatively flexible to reduce moments applied to the pipe flanges

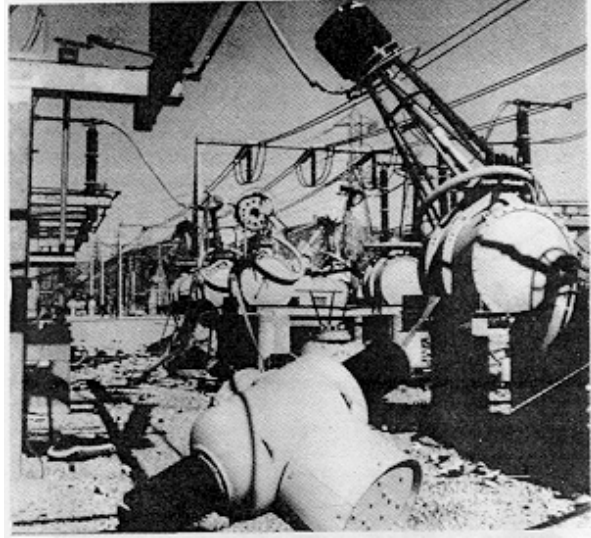
(a) Switchyard circuit breakers play an important role in system protection. They can be bypassed if desired but with reduced system protection then provided by other circuit breakers. Their seismic shock integrity depends upon design. First, existing oil circuit breakers are seismically rugged. However, they are being replaced with SF_6 circuit breakers which need less maintenance and are less of an environmental hazard. Live-tank SF_6 circuit breakers are seismically very vulnerable (Figure B-32). If used, they should be designed for seismic forces. Dead-tank SF_6 circuit breakers should be considered for

Figure B-32. Earthquake damage, live-tank circuit breakers. The porcelain columns that support the interrupter heads on life-tank circuit breakers are very vulnerable

replacements because of their inherent seismic ruggedness.

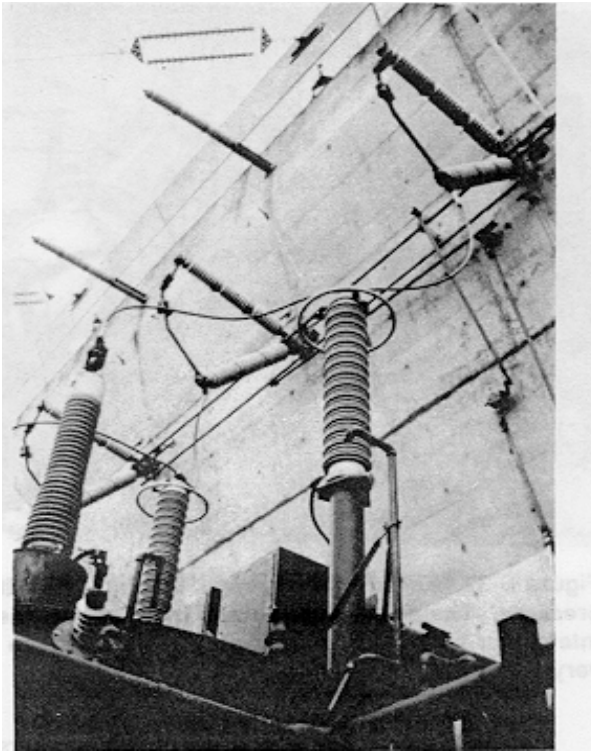
(b) Post insulators used to fabricate disconnect switches have failed. Their failure can cause more severe problems after they fail when they are located on bus structures or otherwise supported above circuit breakers or transformers, as falling parts from the switch can damage bushings (Figure B-33). The risk of these failures is relatively small so that retrofitting is probably not justified. For units that present an unacceptable risk, the post insulators can be replaced with units made of high strength porcelain. In new

Figure B-33. Disconnect switches located above transformer bushings

construction, good system layout can reduce the risk of secondary failures.

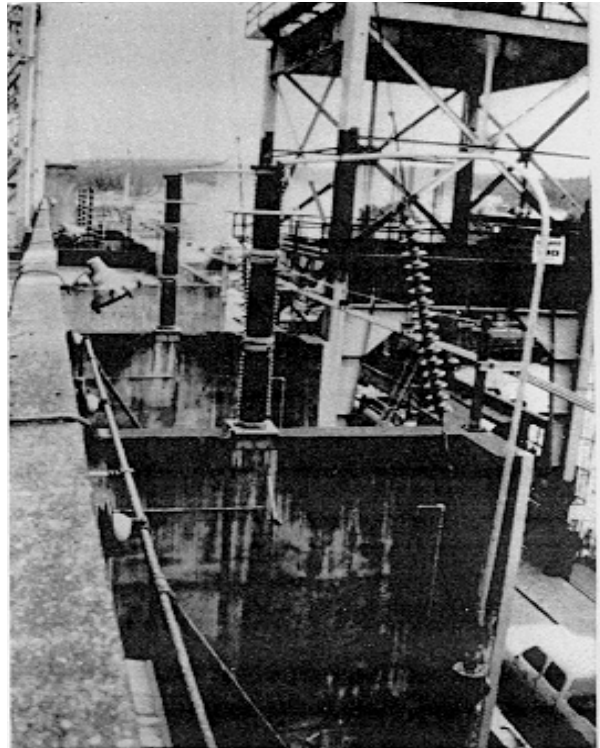
Figure B-34. Vulnerable bus runs

(b) Bus configurations may be vulnerable to earthquake damage. In one case, a taut bus from near the step-up transformers to the top of the bus support structure on top of the power house could be subjected to high loads if the bus support structure moves (Figure B-34). A small amount of slack would eliminate the problem.

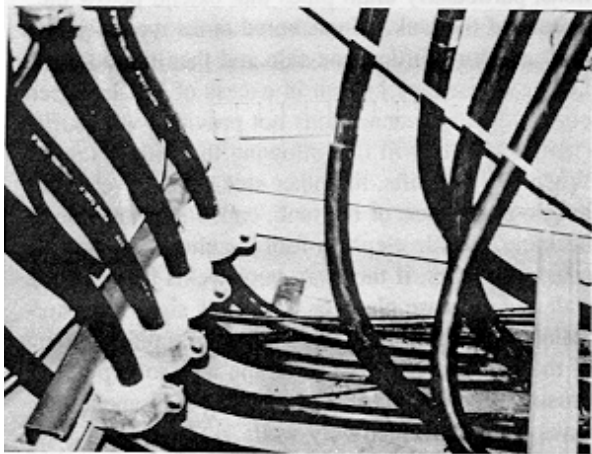
Figure B-35. Control console anchorage. Control consoles should be securely anchored. This console in a dam is anchored with friction clips, which can slip

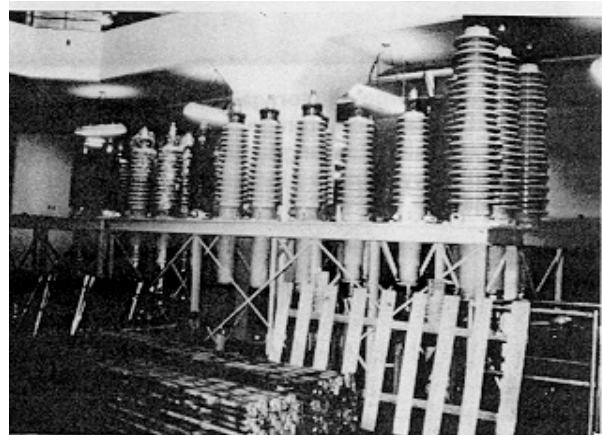
Figure B-36. Storage of critical spare parts

(5) Critical spare parts, such as bushings, should be anchored to substantial racks that are anchored and safe from secondary damage (Figure B-36).

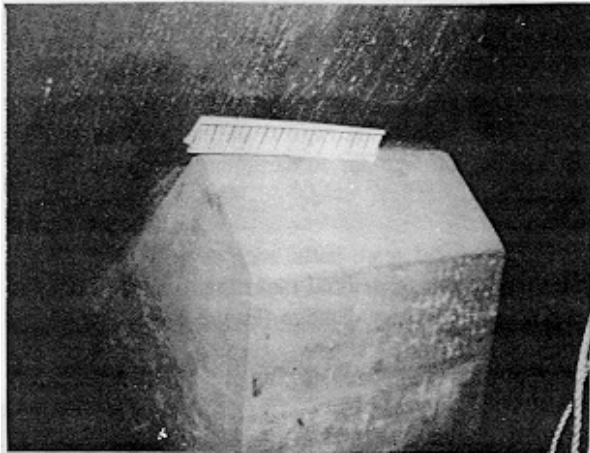
Figure B-37. Large oil storage tank inadequately anchored. A large oil storage tank does not have positive restraints for longitudinal motion. Motion of the tank may damage pipe connections and cause a leak

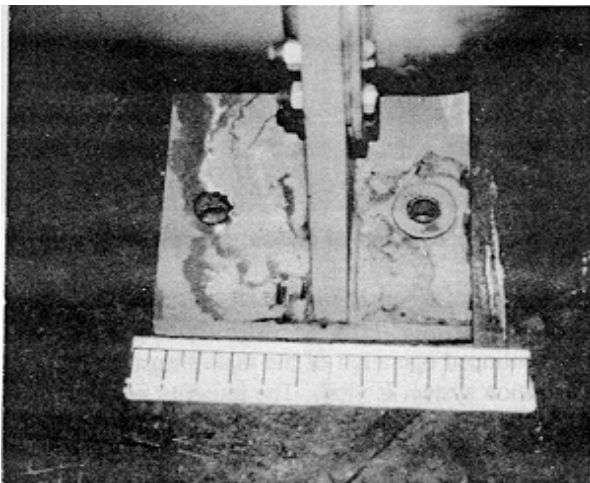
Figure B-38. Unanchored chiller. In large facilities, such as a dam, when some equipment was initially installed, modified, or replaced, it may not have been adequately anchored. A walk-through of facilities will usually find unanchored equipment

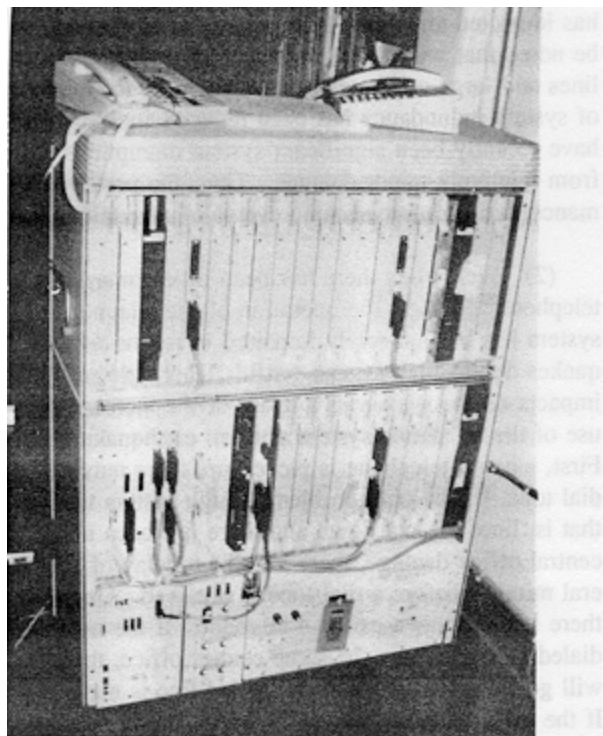
Figure B-39. Unanchored PBX used in a dam. This PBX has been designed to resist earthquakes. The circuit cards are latched in their card cages, and the power supply, which is relatively heavy, is located at the bottom of the unit to keep the center of gravity low. The unit is unanchored so that connecting cables can be damaged if it moves in an earthquake
