AFRRI TECHNICAL REPORT

AFRRI TR88-1

Cleanup of Johnston Atoll missile launch facility

THE DAMASCUS MISSILE MISHAP

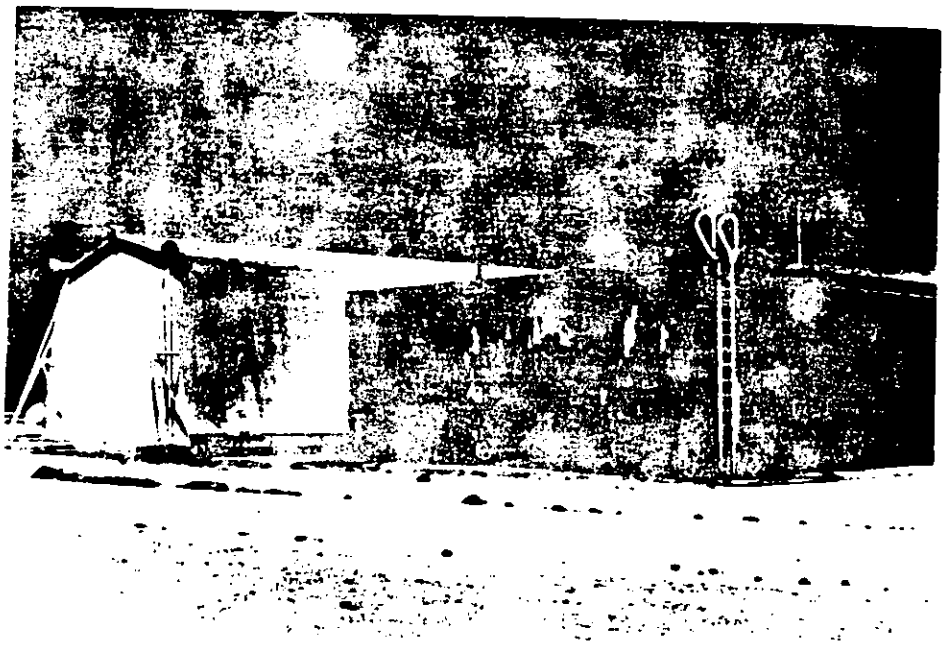
Figure 3. Missile shelter building (background) and steel blast revetments (foreground)

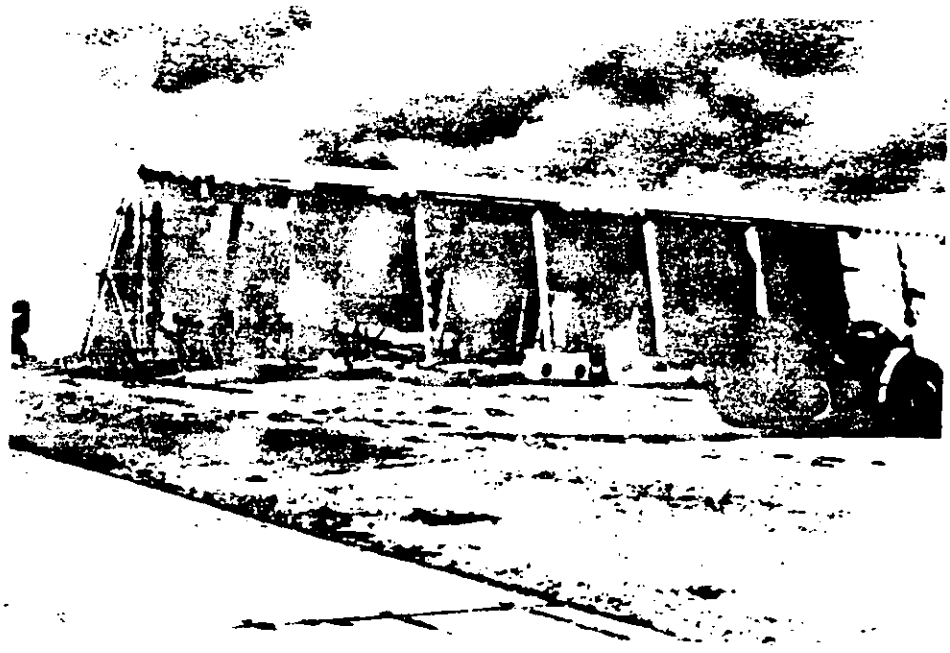
Figure 7. Missile shelter building with panels removed

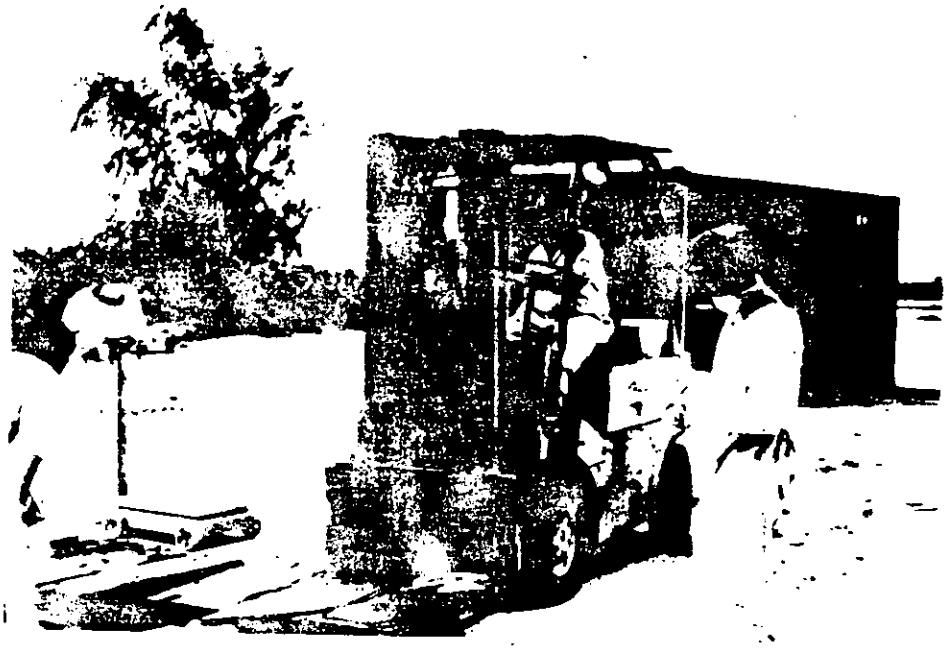
Figure 8. Debris being weighed before loaded into freight container at rear

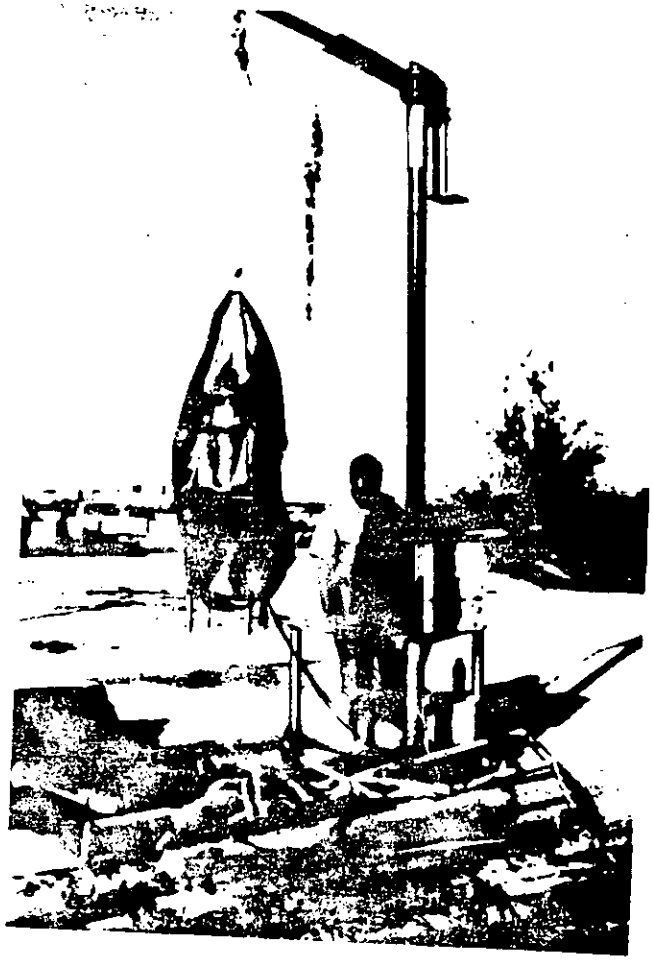
Figure 14. Monitoring pallet of debris with germanium detector system

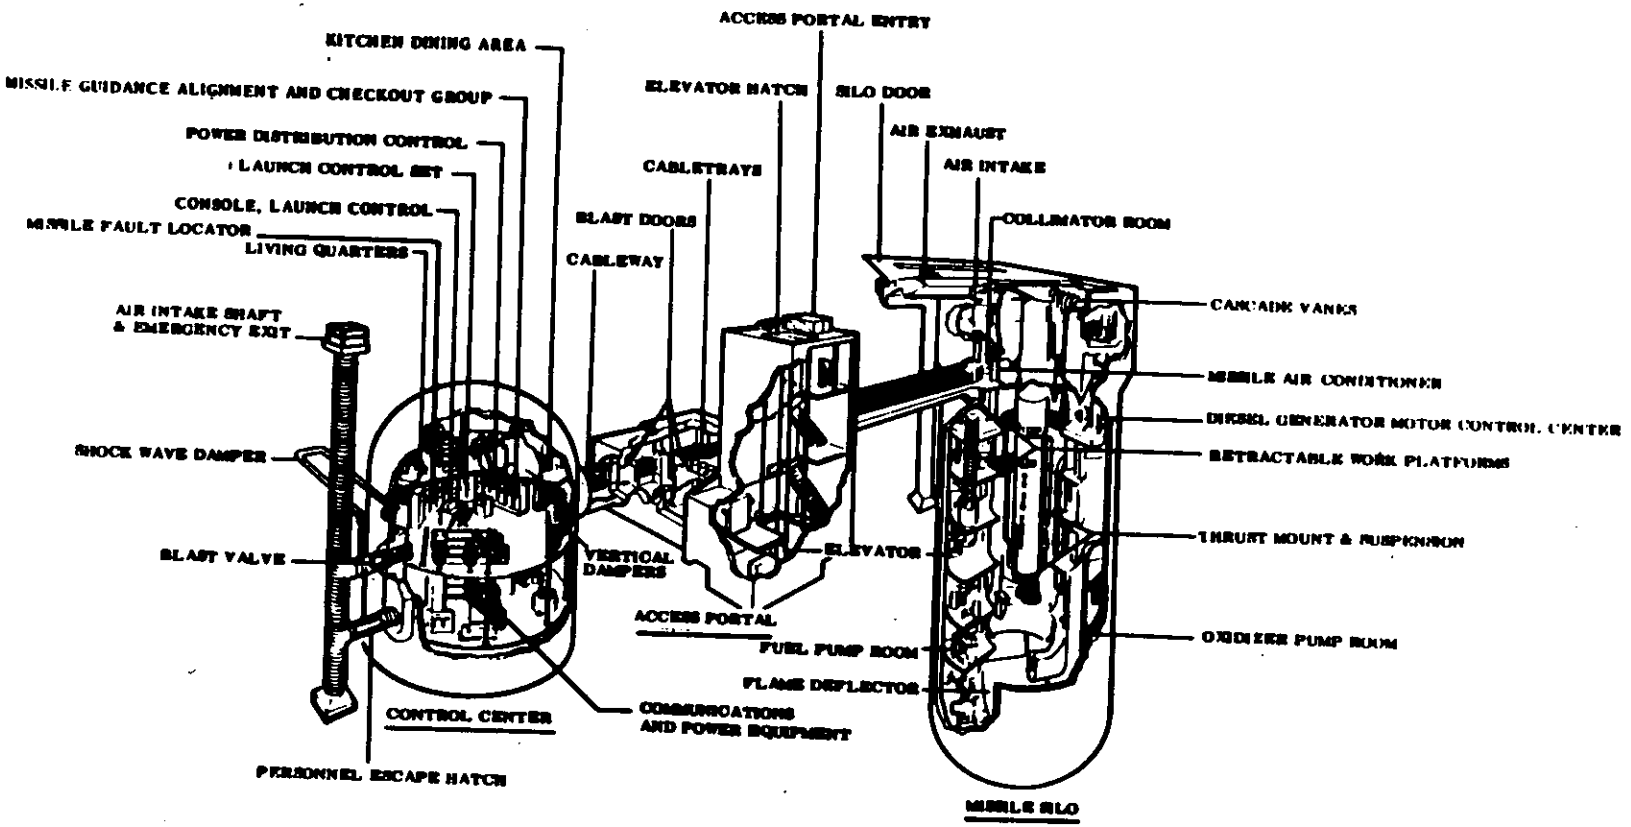
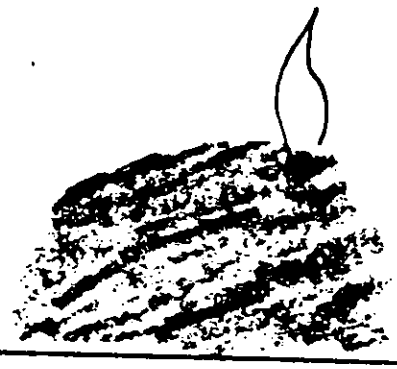
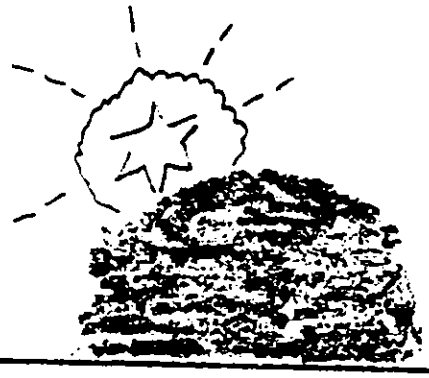
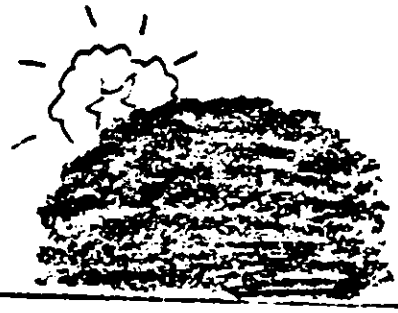
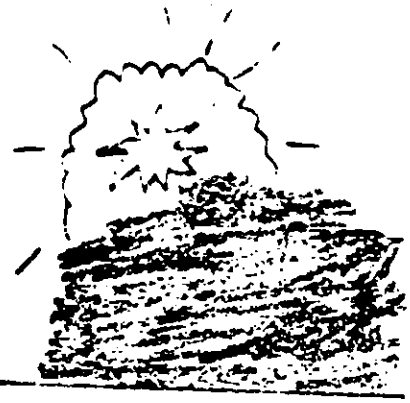
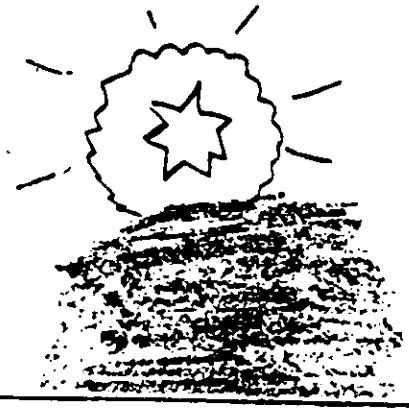
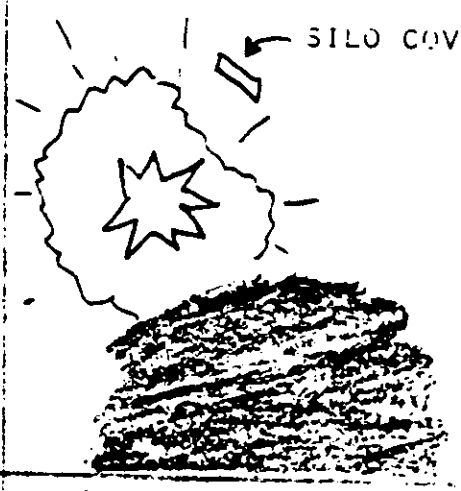
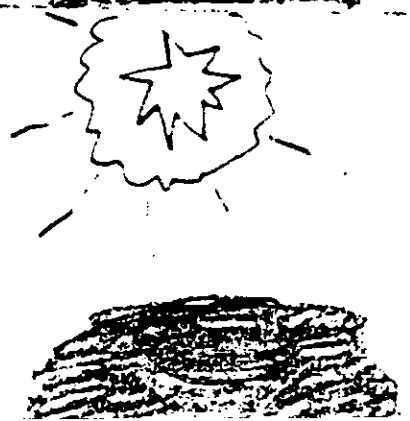
TITAN II LAUNCH COMPLEX

CAMERA GROUND LEVEL VIDEO TAPE SEQUENCE

T+0 SEC
DIFFUSION FIRE

T+3 SEC
JETTING FIRE

T+4 SEC
SMALL EXPLOSION

T+4.5 SEC
SECOND LARGE EXPLOSION

T+4.6 SEC FIREBALL

FLAME AND
THIRD
EXPLOSION
T+6.0 SEC

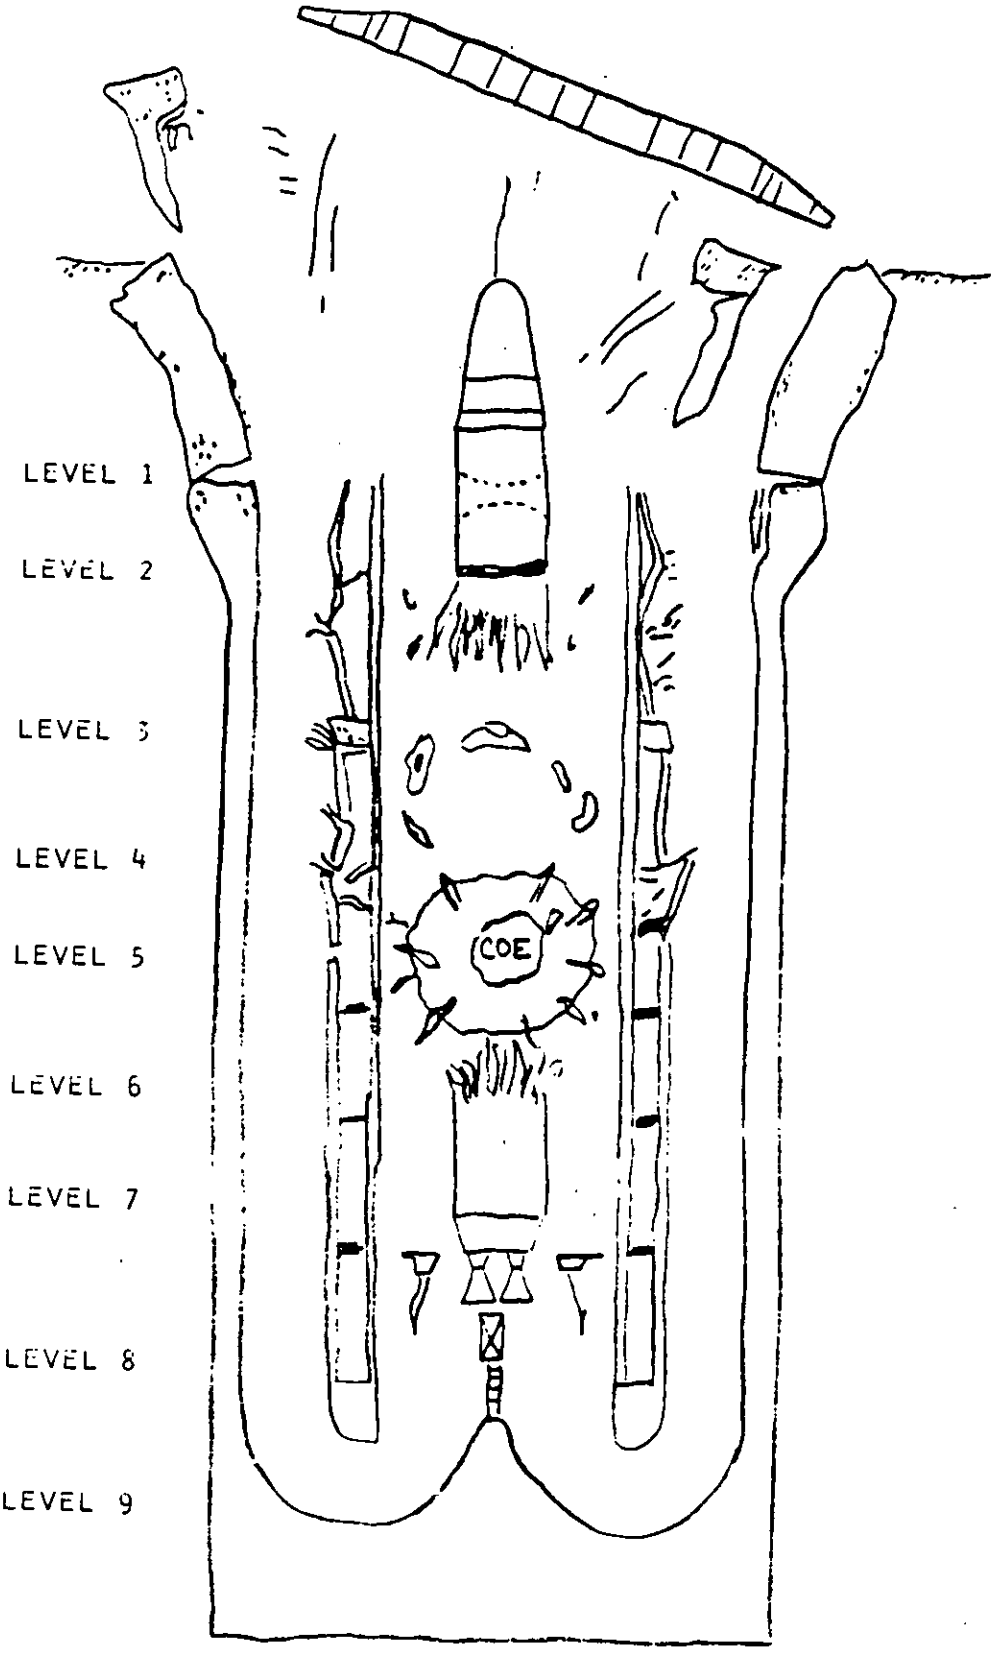
SILO DAMAGE AND CENTER OF EXPLOSION (COE)

MISHAP STAGE I FUEL LEAK DUE TO A DROPPED SOCKET --- A SUBSEQUENT EXPLOSION OCCURRED.
