Service log R-1490/URR , Serial number: 266

Date: 26-Aug-2003 , Service period May-Aug-2003, By: Virgil Cheng,vr2xgm

Service log R-1490/URR , Serial number: 466
Service period : Dec-2003 to Feb-2004, By: Virgil Cheng, vr2xgm

Service log R-1490/URR , Serial number: 466
Service period : 28/30-Dec-2006, By: Virgil Cheng, vr2xgm

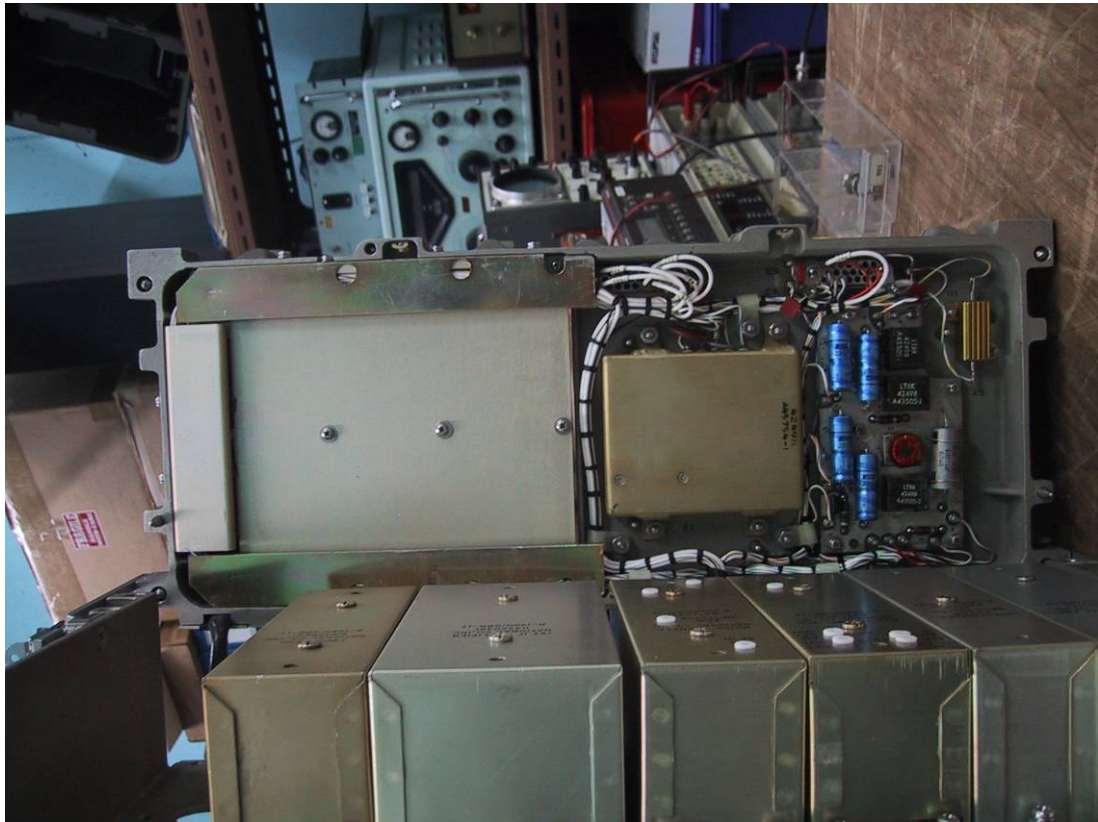
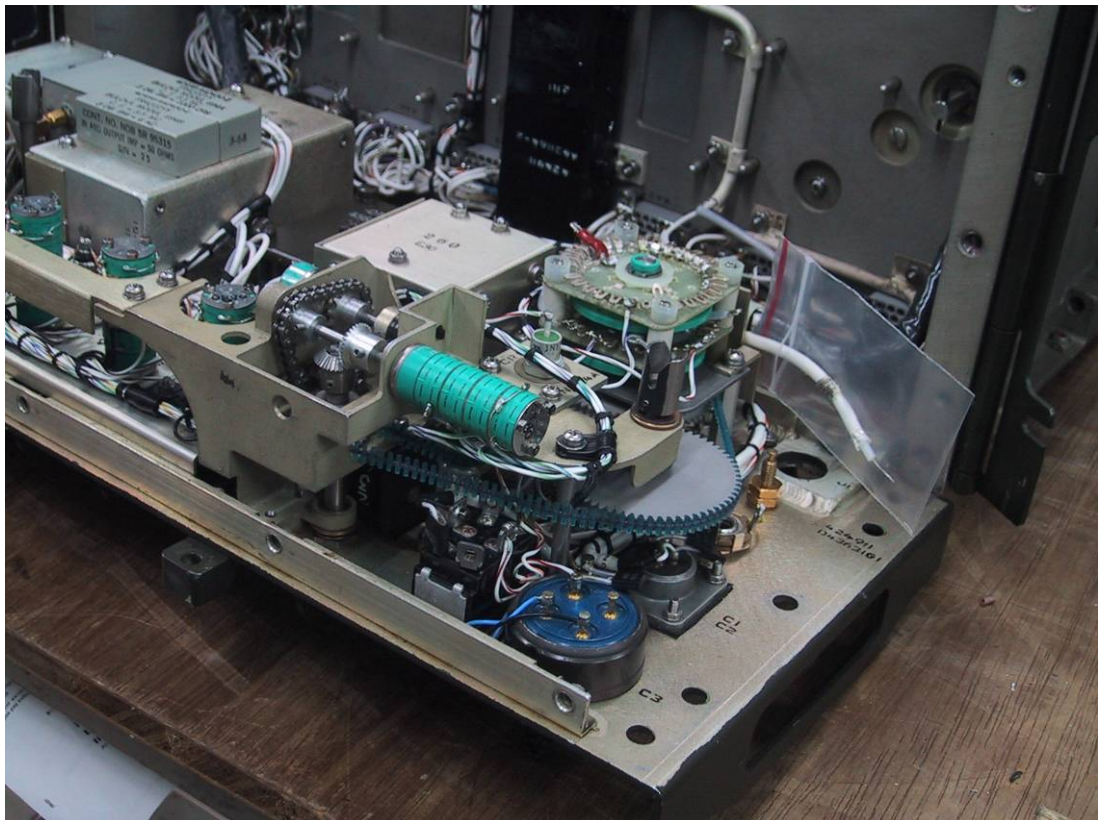
- L3, inductor 1mH, moulded, burnt, sign of overheating. Replaced with new wound part. 12mm Amorphous core, permeability 60, AWG29,110T
- C2,C3, Cap, Elec., 150uF, 30V, axial, electrolyte leaked. C2,3,4,5 Replaced with 220uF35V 105C axial.

Inductor, moulded, PCB mount, located on Rear deck supply decoupling board A1A3A3
