Power MOSFET in High-Side Operating Modes, Possible Failure Modes, and Failure Signatures

By Kandarp Pandya

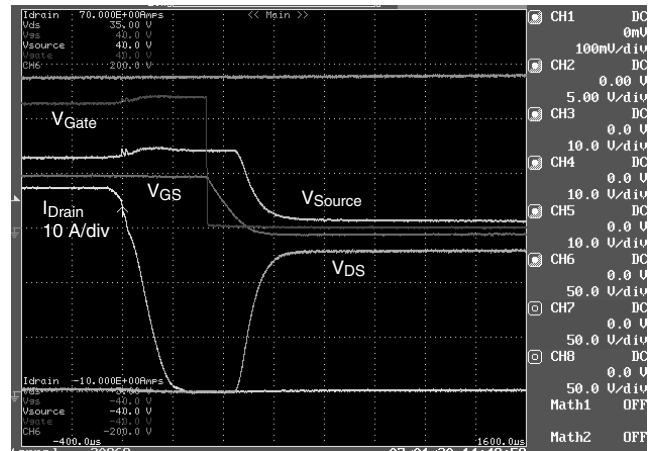
Fig. 2 - Floating Source and Slow Turn-Off

This approach fully satisfies the requirements for steady-state operation, where small amount of current, on the order of a few microamps, is all that is required to maintain the on state. But it can be inadequate for dynamic (transient) turn-on and turn-off operation of MOSFET. In this latter case, the MOSFET switching operation can easily occur in **linear mode**, which is an **unstable** and **non-characterized** area of MOSFET operation (figure 2).

During turn-on and turn-off, switching power losses are likely to dissipate from a very small area of the active die. The resulting failure signature is high-power burn-out, with a random amount of damage located in the active area of the die. Invariably such failure is labeled as **EOS**.
