SB-101 AVC Slow Recovery After Transmit

The Problem and Solution

{ by WA2HIP }

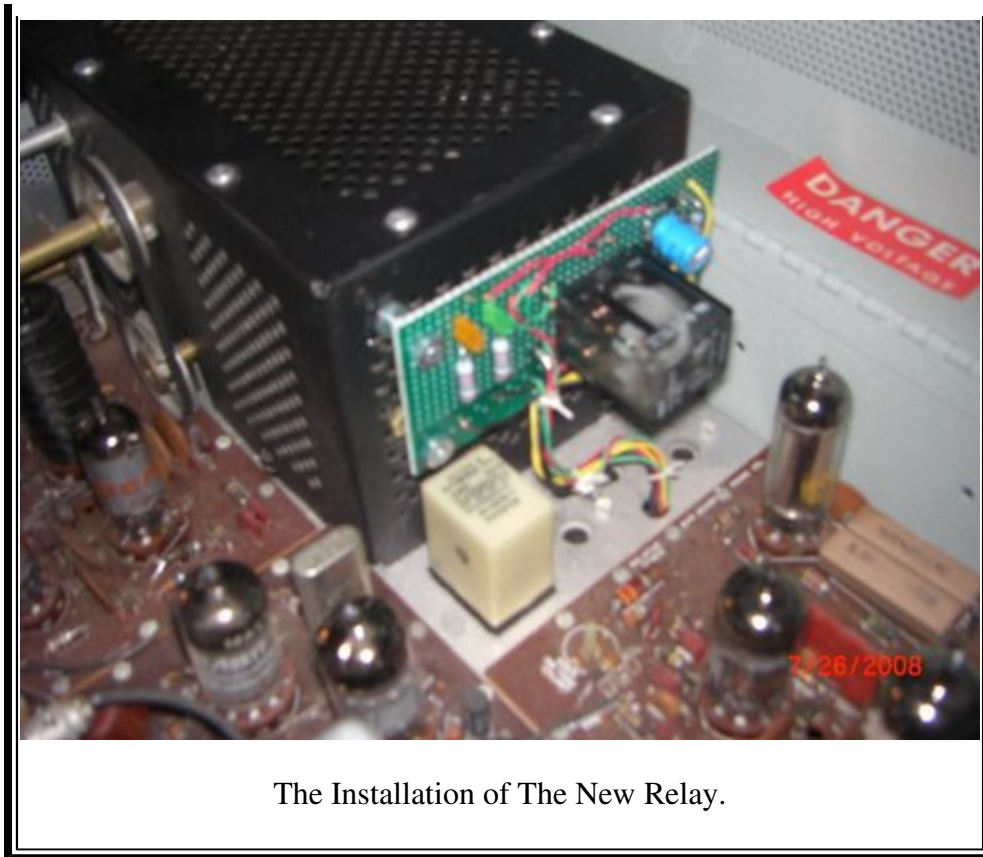
Note that the LED's are just "fluff" an may be eliminated.

I installed a new DPDT 12 volt relay in the rig on and moved the connections from lugs 3, 7, & 11 to
