Technical Service Bulletin No. 23

Created by: Lab.gruppen AB Service Department

Reference no: Measure for broken NTC in DC/DC on SP200PCF

PLM20000Q

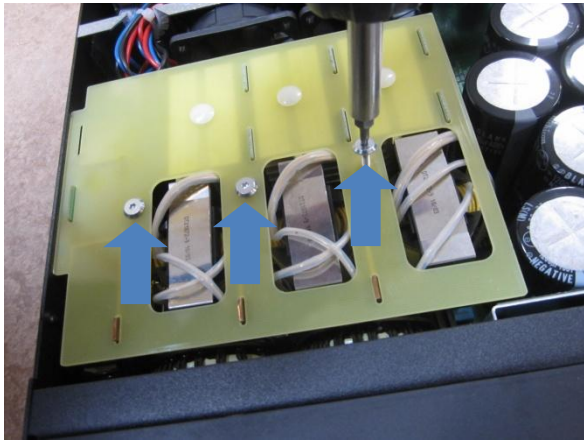
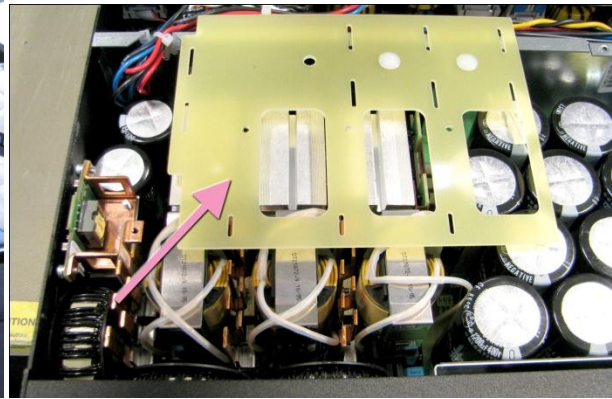
6.	If any of NTC601, NTC702, NTC802 does not pass ~18-20kOhm at room temperature, this NTC needs to be exchanged.		
----	---	--	--

1.1 The following is an example on how to exchange NTC702 (exactly the same for NTC601 or NTC802 on either side).

7.	Remove laminate.		
----	------------------	--	--
