si 881219-14 e

Ref.: EM 2003 TV

Fault: 50 Hz hum when the EM 2003 TV receives an RF-carrier without modulation.

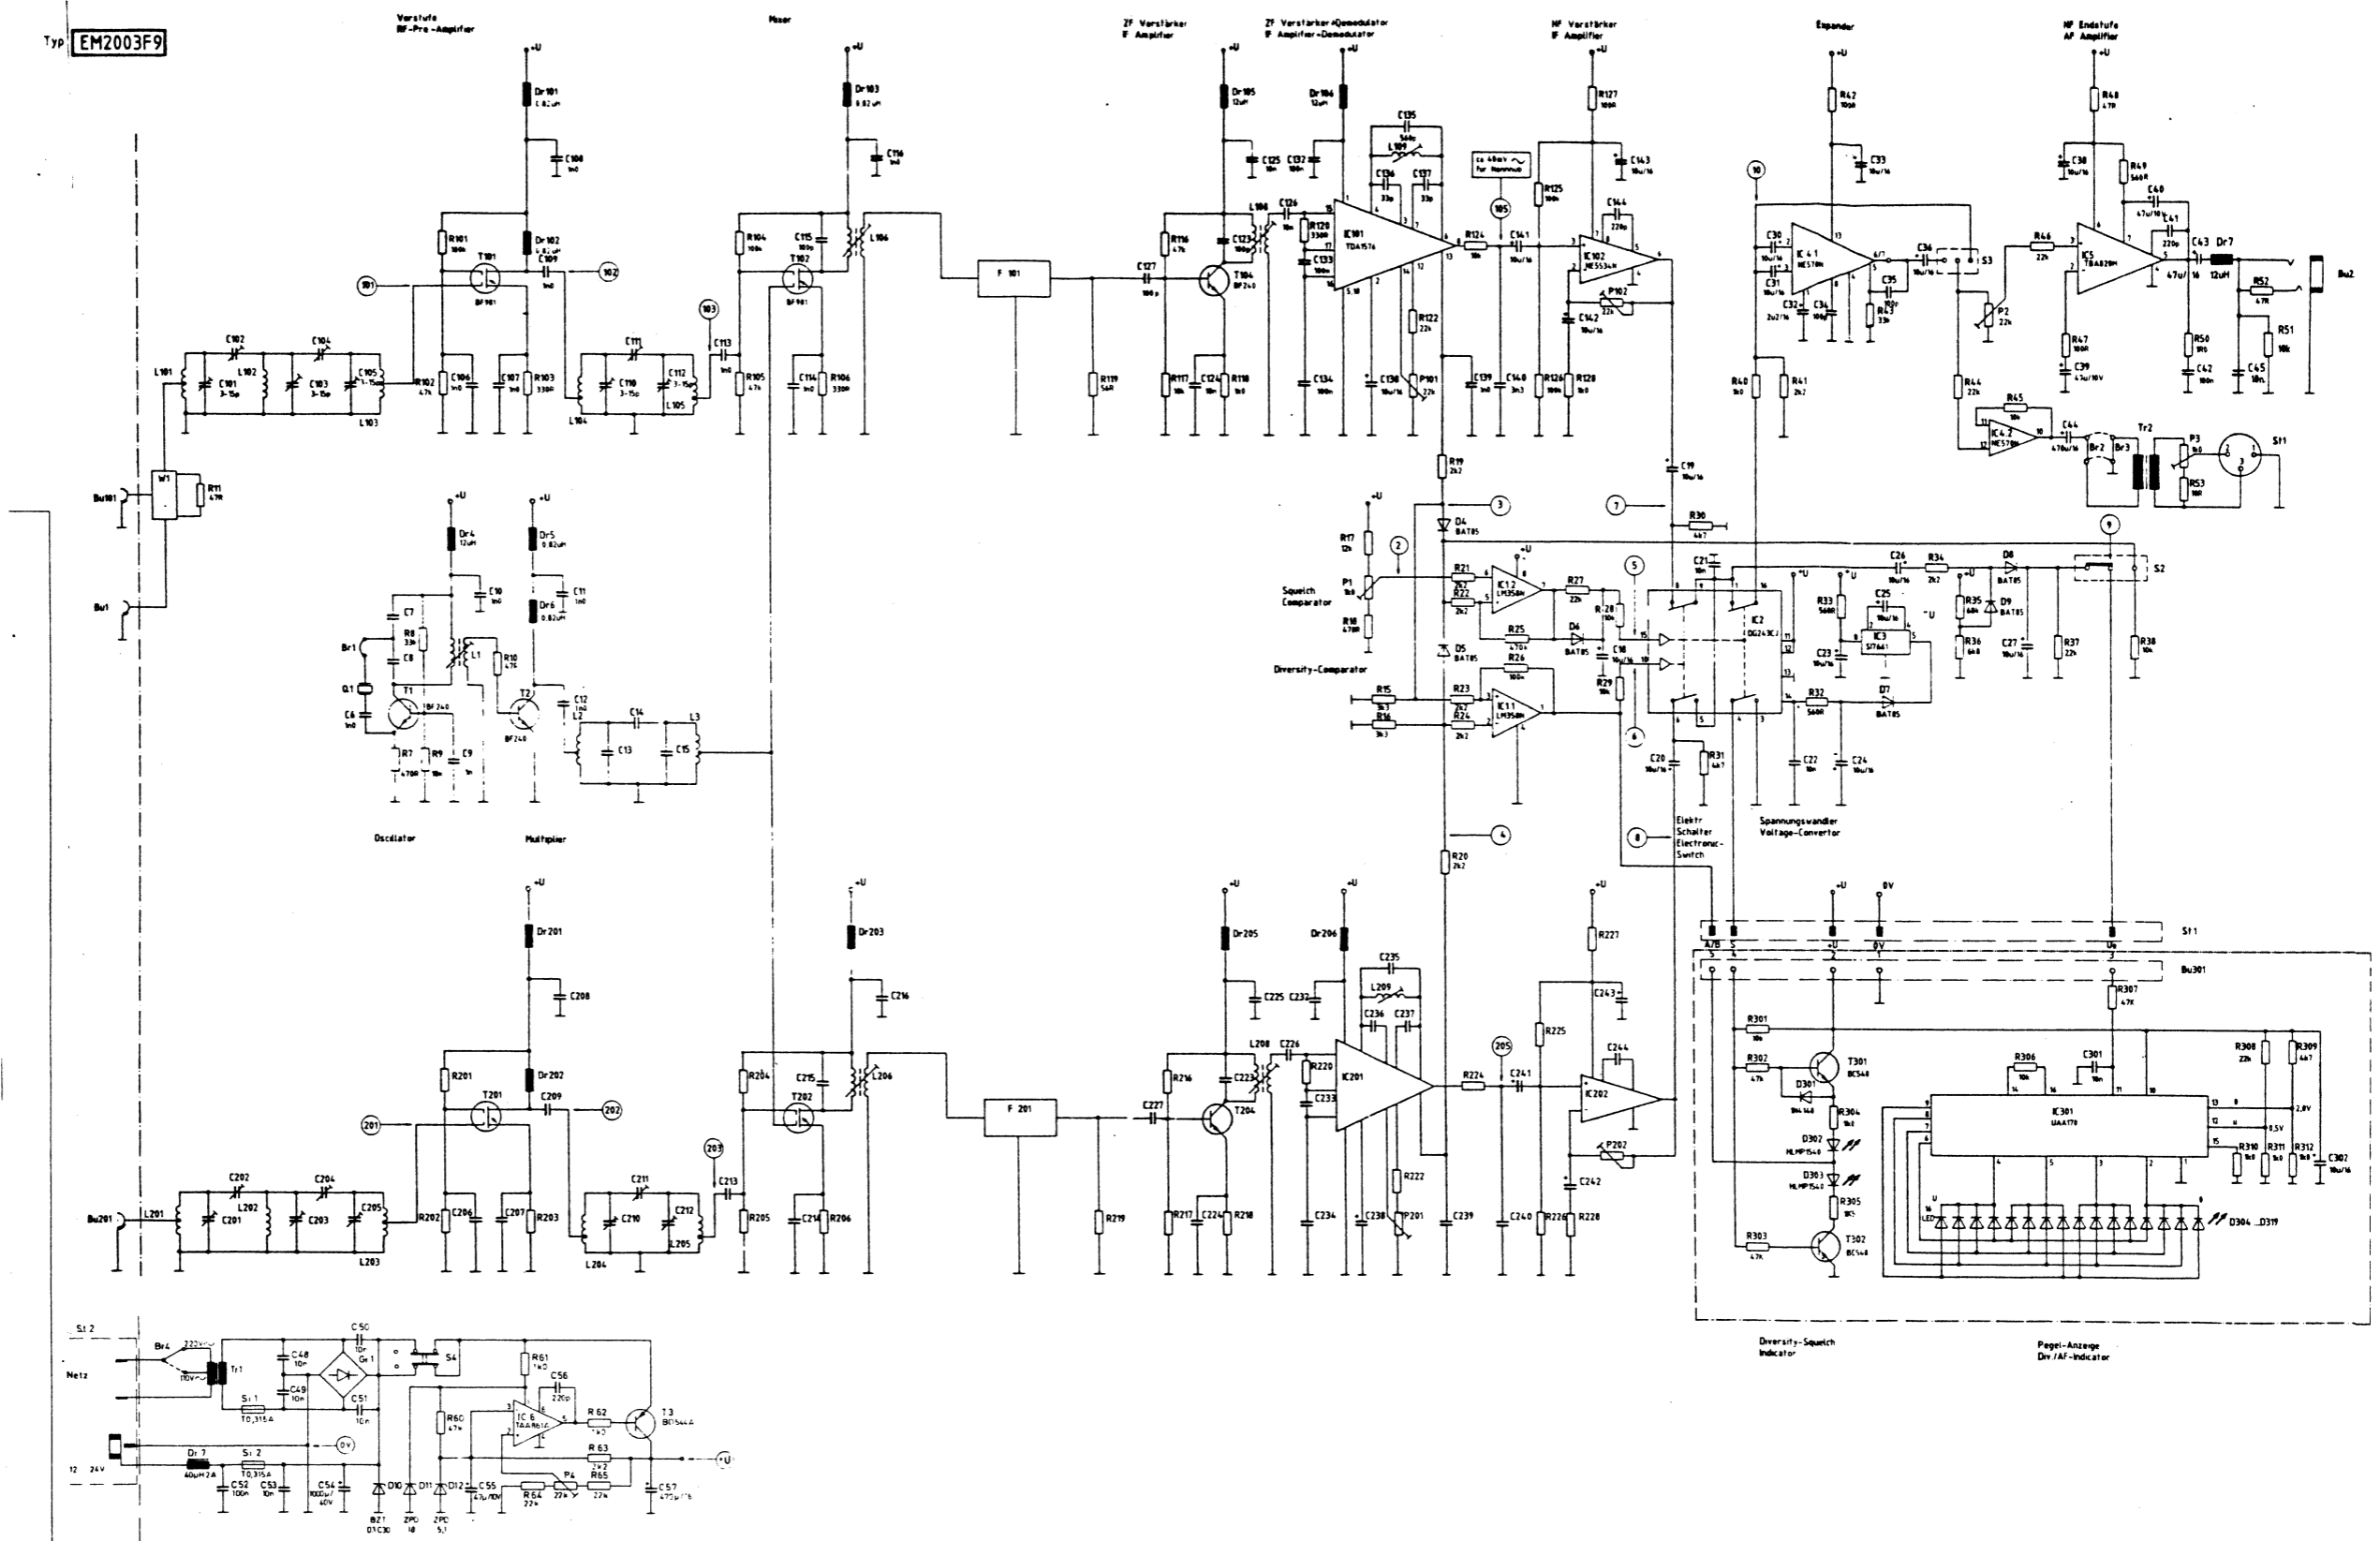
Cause: Insufficient ground connection at HiDyn-IC

Remedy: Connect ground connection of IC 208.1 to ground connection of IC 224. This will reduce the hum by 6 dB.
