CORROSION PREVENTION MANUAL

GENERAL INFORMATION
(VOLUME 1)
SPECIFIC INFORMATION
(VOLUME 2)
MODELS 707 AND 727 THROUGH 777

BOEING DOCUMENT D6-82560
PUBLISHED BY THE BOEING COMPANY, SEATTLE, WASHINGTON, U.S.A.

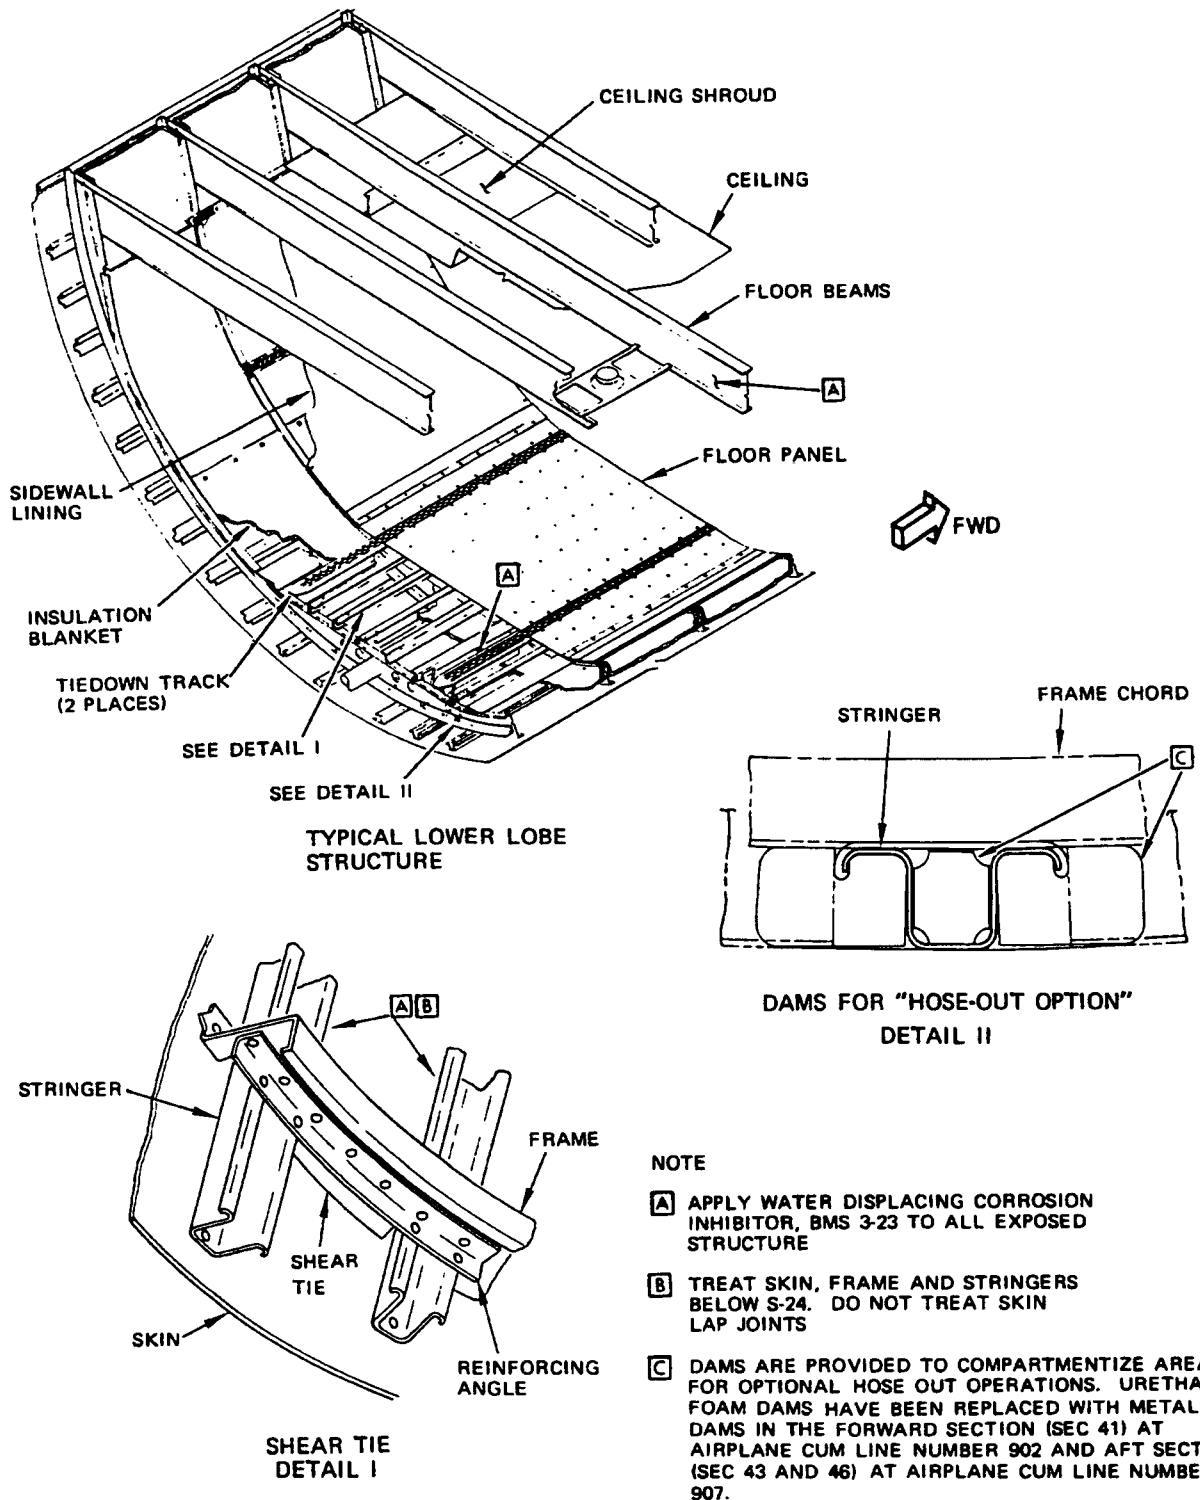
Lower Lobe Structure
 Figure 2 (Sheet 1)

- (1) At line number 897, the tightly sealed insulation blanket covers were replaced with unsealed covers to permit water to flow through the blankets. The blankets become drain paths into the lower lobe drain masts. These blankets have water repellent fillers.

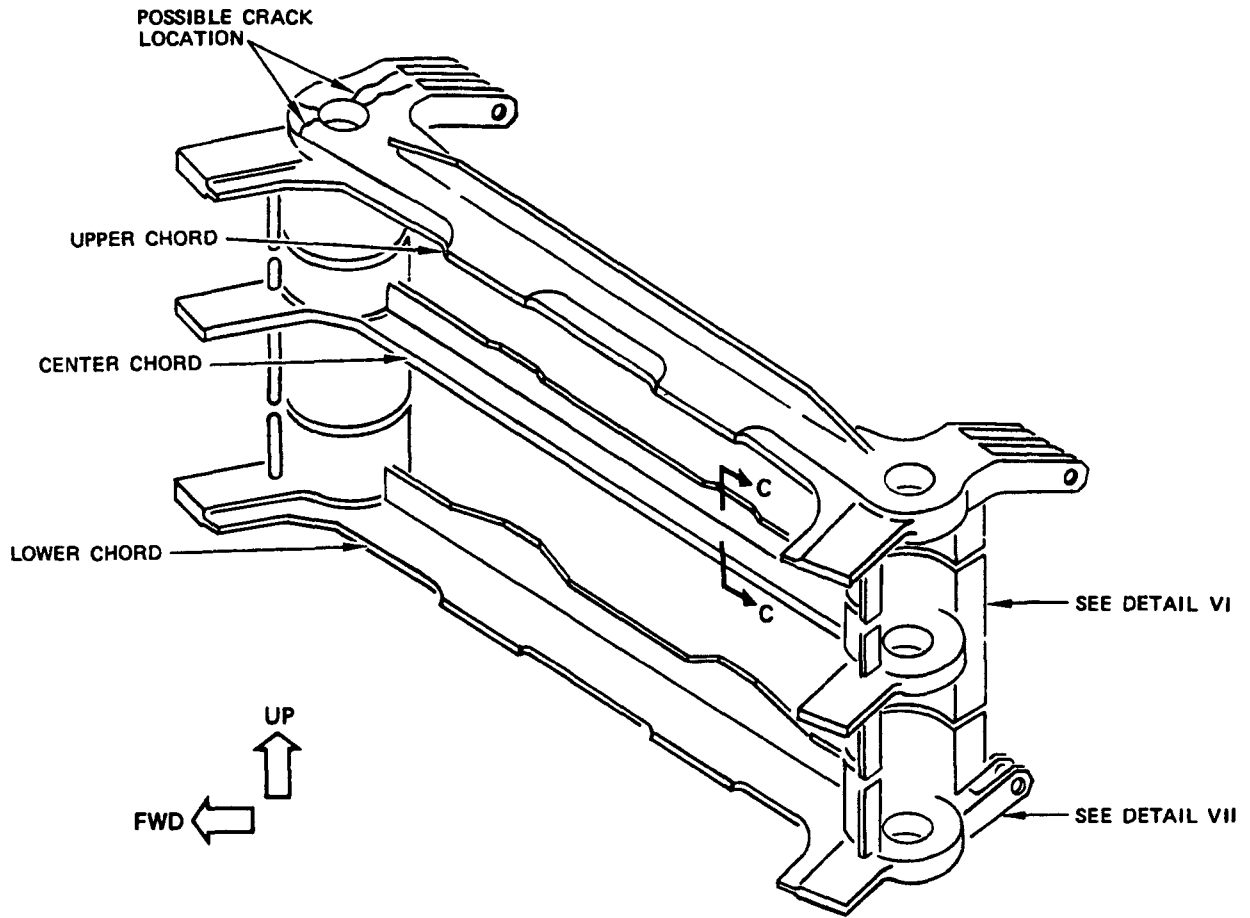
CENTER SECTION REAR SPAR
DETAIL V

- N. Stress corrosion cracks have been found in the horizontal stabilizer center section rear spar structure, in the forward horizontal flange, the chord vertical flange, and the chord lower vertical flange (See Detail V).

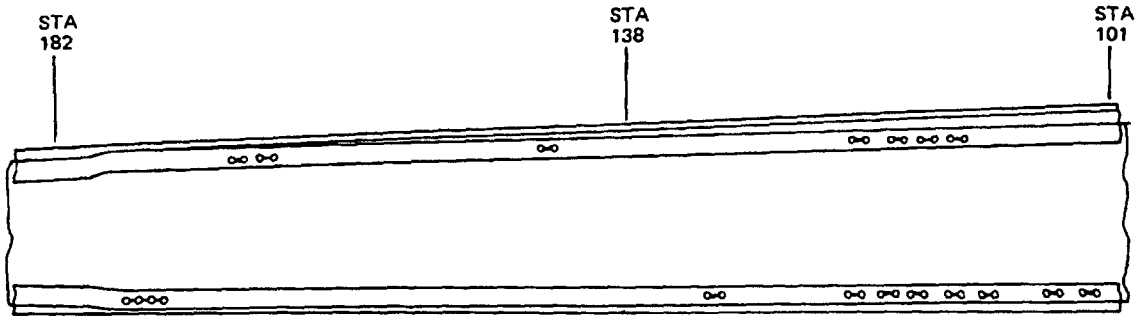
TYPICAL CRACK LOCATIONS
REAR SPAR - REAR VIEW
DETAIL XI

- K. Stress corrosion cracking has been reported on the rear spar upper and lower chords, Cracks were found in the vertical flanges along the centerline of the fasteners attaching the web to the chord. See Detail XI. A material change for the chords from 7079-T6 to 7075-T73511 was introduced at cum line number 884 or 895 depending upon configuration. SB 3356 provides inspection, preventive modification (fastener replacement with sealant) and repair. Stress corrosion cracks have also been reported in the rear spar horizontal flange at approximate stabilizer stations 162, 174, and 224 (LH). Cracks have been found in the LH stabilizer forward spar horizontal flange.

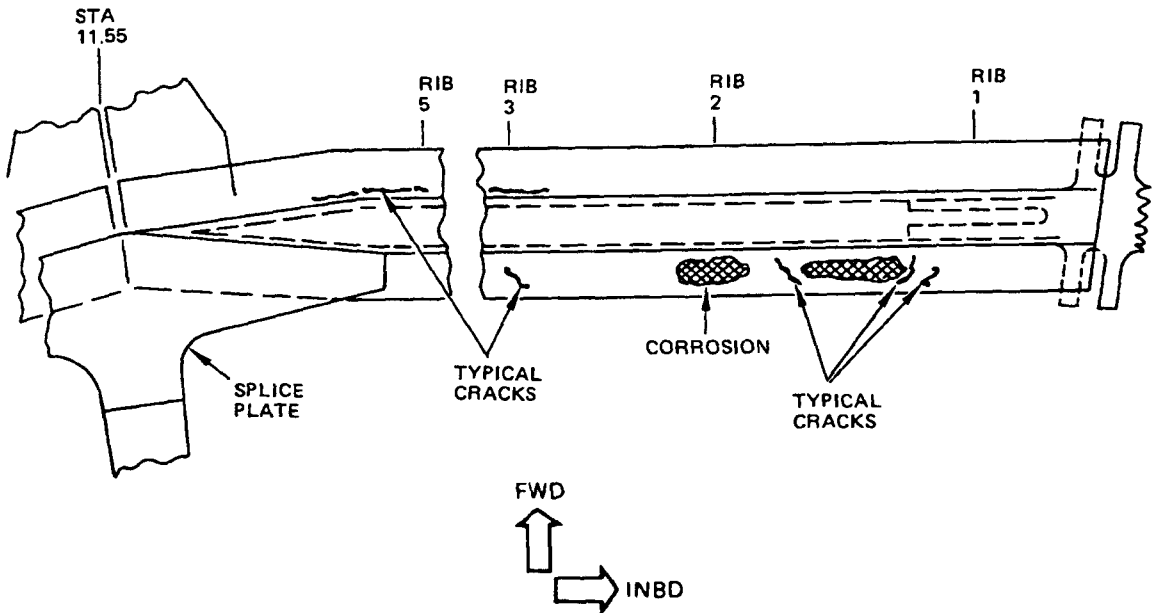
DETAIL XII

- L. Corrosion and stress corrosion have been reported on the stabilizer front spar upper chord sections inboard of the chord splice at station 11.55. See Details XII and XIV.

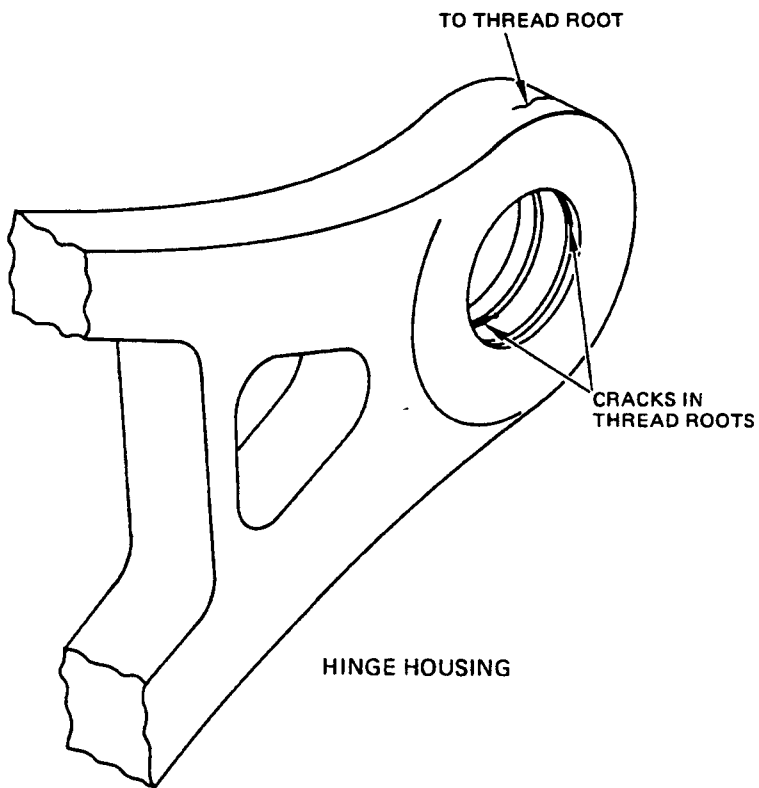
DETAIL XIII

- G. Stress corrosion cracking has been reported on the stabilizer hinge housing. See Detail XIII. A material change was introduced at line No. 862 which replaced 7079-T6 housings with improved housings made from 7075-T73 material. These housings may be incorporated retroactively as described in SB 3046.

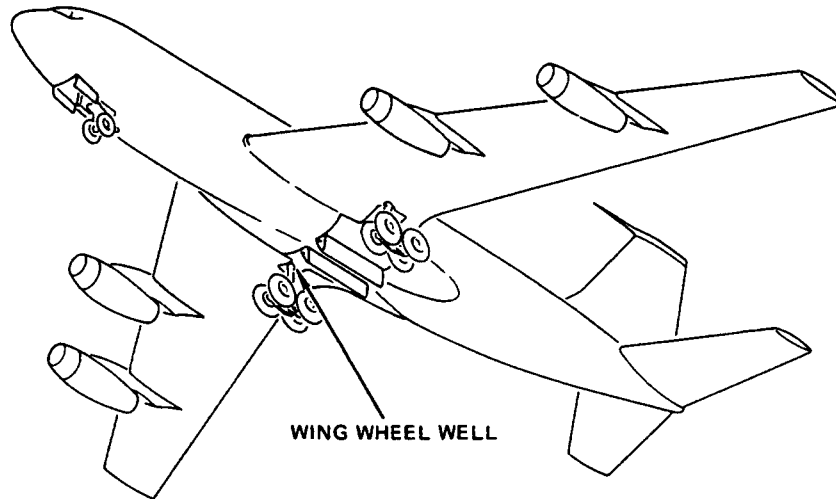
Wing Wheel Well
Figure 2

- A. The wing wheel well located in the inboard trailing edge area immediately aft of the rear spar houses the main landing gear struts and trunnion.
- B. As in the fuselage wheel well, the wing wheel well is exposed to atmospheric pollutants and runway splash and is susceptible to corrosion.
- C. The wing well should be treated at the same time as the wing torque box, trunnion and trunnion support fittings (Ref 57-40-07, Fig. 2).
- D. Refer to the Introduction of this manual for a discussion of the Aging Airplane Corrosion Prevention and Control Program and related documentation. Structural items within this section are subject to the unique requirements of the mandatory Corrosion Prevention and Control Program.

- A. The basic corrosion prevention philosophy is to make periodic inspections described in Volume 1, 20-20-00. Heavily loaded structural members and wheel well closure walls should be regularly inspected for deterioration of protective finishes to minimize the occurrence of corrosion. Missing fasteners, white powdery or discolored deposits are evidences of the existence of corrosion which should alert operators that some corrective action is required. A corrosion program should be initiated to prevent the accumulation of moisture or corrosive products in the structure of the wheel well.

- B. Where extensive corrosion exists (very noticeable web bulges, missing fasteners or large amounts of discolored deposits at fastener heads or faying surfaces), refer to Structural Repair Manual for details of corrosion removal.

- E. Hydraulic tubing, tubing supports and fittings are to be treated per 29-10-07, Fig. 1.
- F. Preventative Treatment
 - (1) At first opportunity consistent with scheduled maintenance activity, corrosion treatment should be accomplished in the wing wheel well.

- (4) Apply BMS 3-23 to all exposed wheel well structure. Special effort should be made to apply the corrosion inhibitor along doubler edges, along edges of structure, forgings, etc., and on fastener heads. The use of spray equipment with nozzle directed into faying surfaces is recommended.
 - (5) Apply BMS 3-23 to landing gear attachment fittings. Ensure that lugs and lug faces are treated.
 - (6) Regrease all grease fittings in the treatment area.
- G. Frequency of Application
- (1) The corrosion inhibitor should be reapplied annually.
 - (2) In cases where the wheel well is cleaned with steam or high pressure water and detergent, reapplication of BMS 3-23 is recommended.

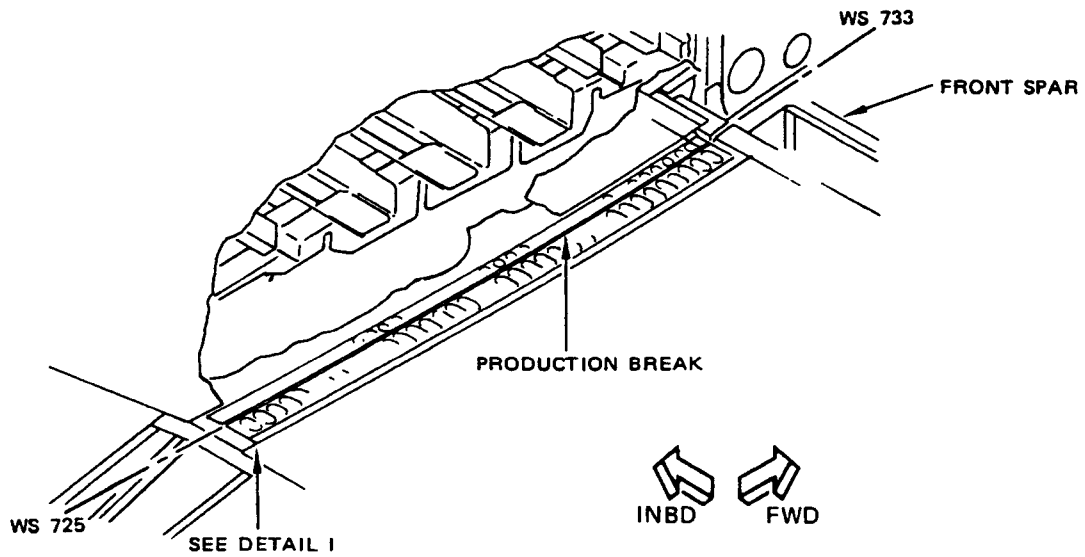
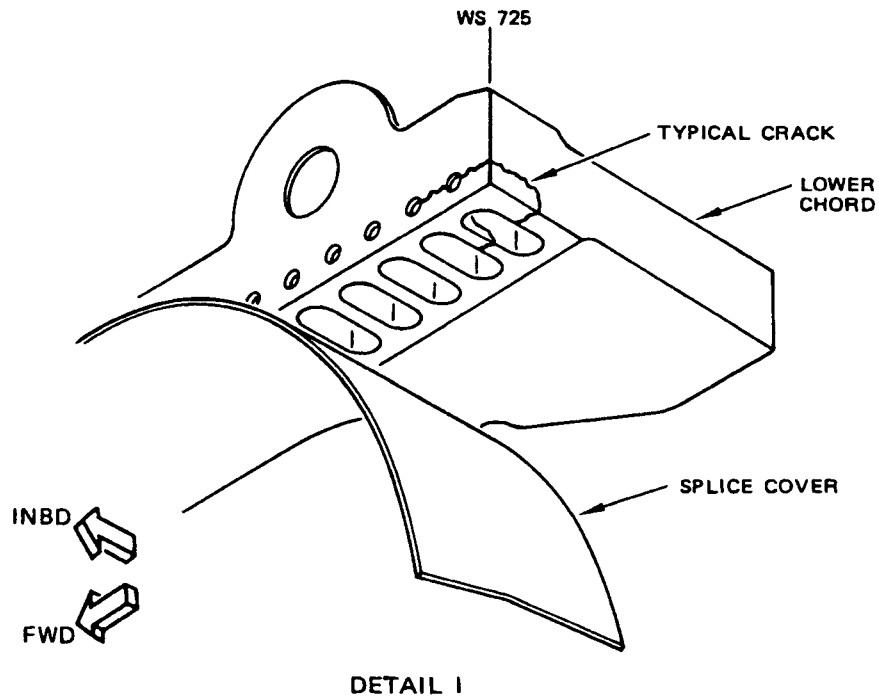
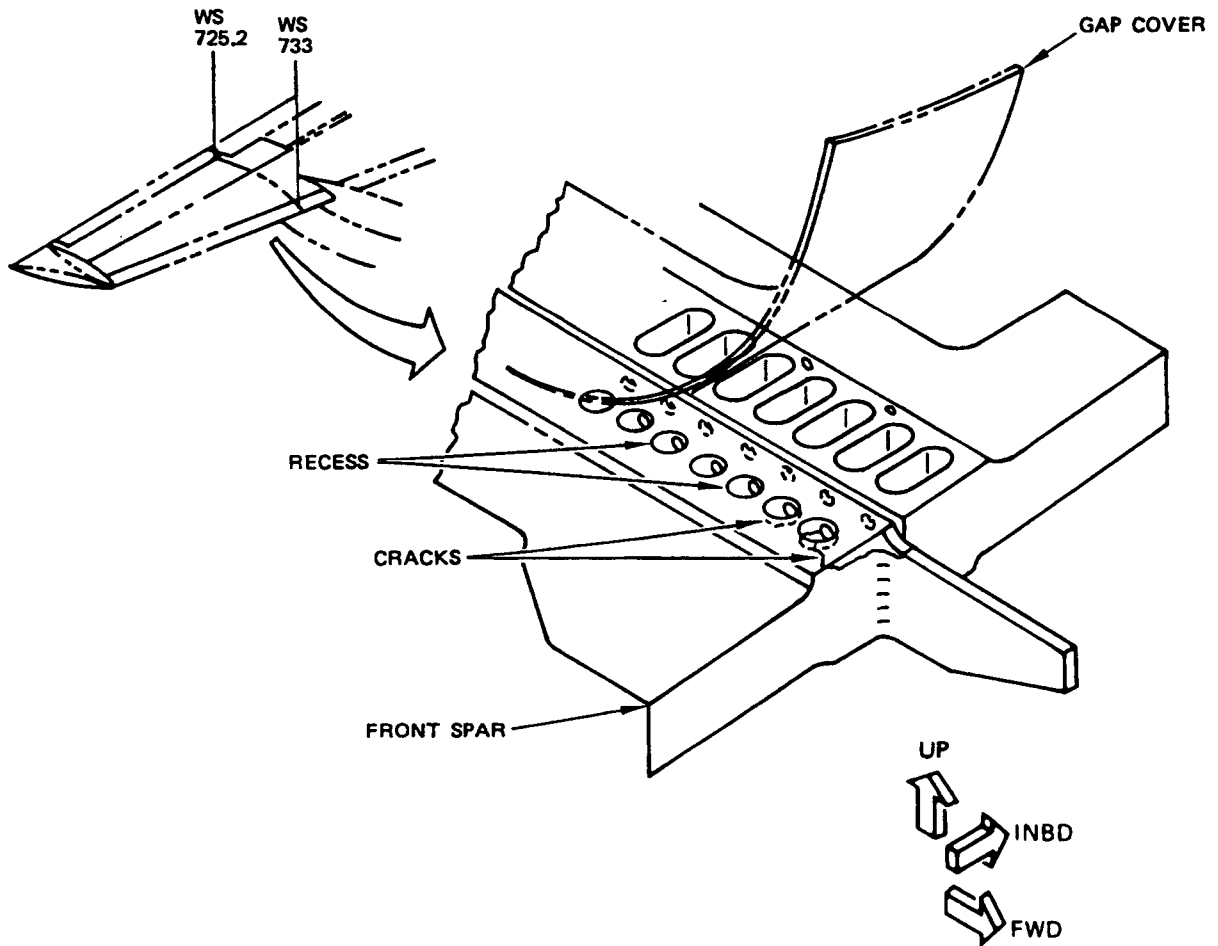
WS 733 Production Break Rib Chord
Figure 3 (Sheet 1)

- A. Stress corrosion cracking of the aft lower rib chord at the production break at WS 733 has been reported by a number of operators. On 720, 707-300B and 707-300C airplanes this chord is manufactured from 7079-T6 aluminum alloy which is considered to be susceptible to stress corrosion cracking.
- B. Stress corrosion cracks have been reported in the upper outboard chord at WS 733 in the area of the two forward recesses.
- C. Refer to the Introduction of this manual for a discussion of the Aging Airplane Corrosion Prevention and Control Program and related documentation. Structural items within this section are subject to the unique requirements of the mandatory Corrosion Prevention and Control Program.

- A. Regularly examine for stress corrosion cracking with SB A3308.
- B. Applications of water displacing corrosion inhibiting compound (BMS 3-23 or equivalent) to the area will help to prevent the initial corrosion which results in stress corrosion cracking.

- C. If you find stress corrosion cracks, refer to SB A3308 for repair procedures.

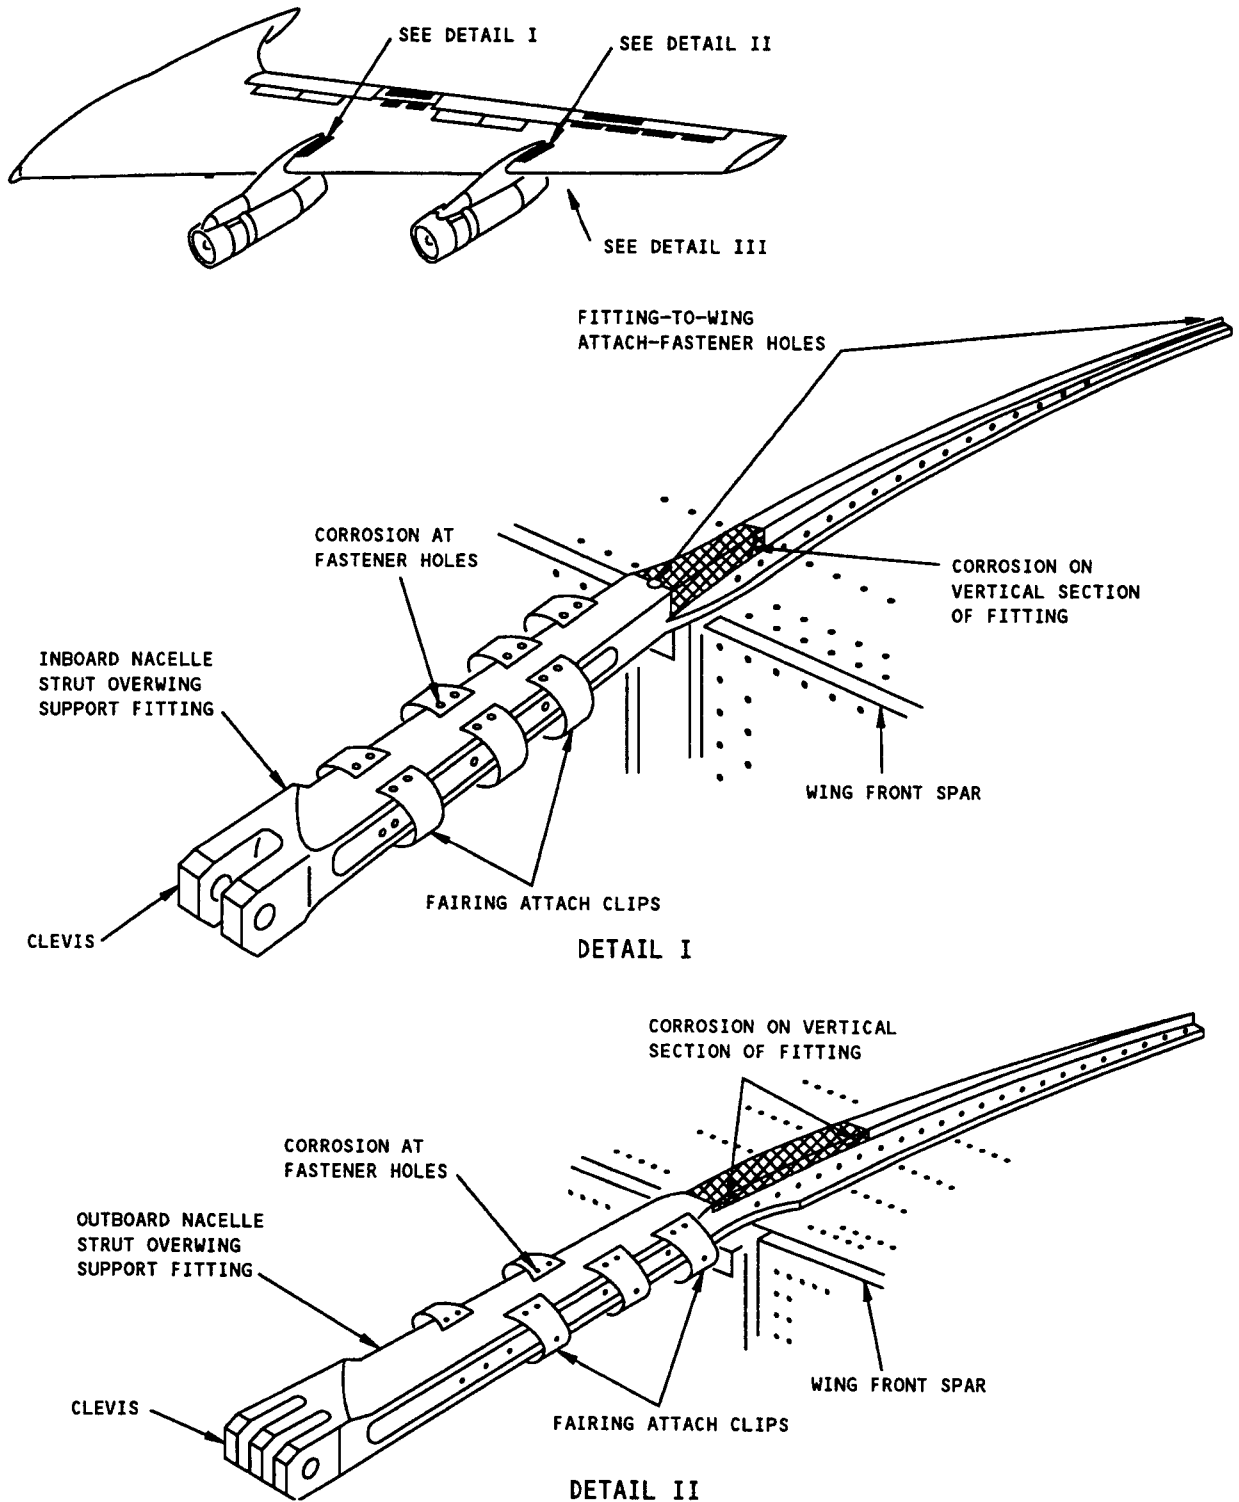
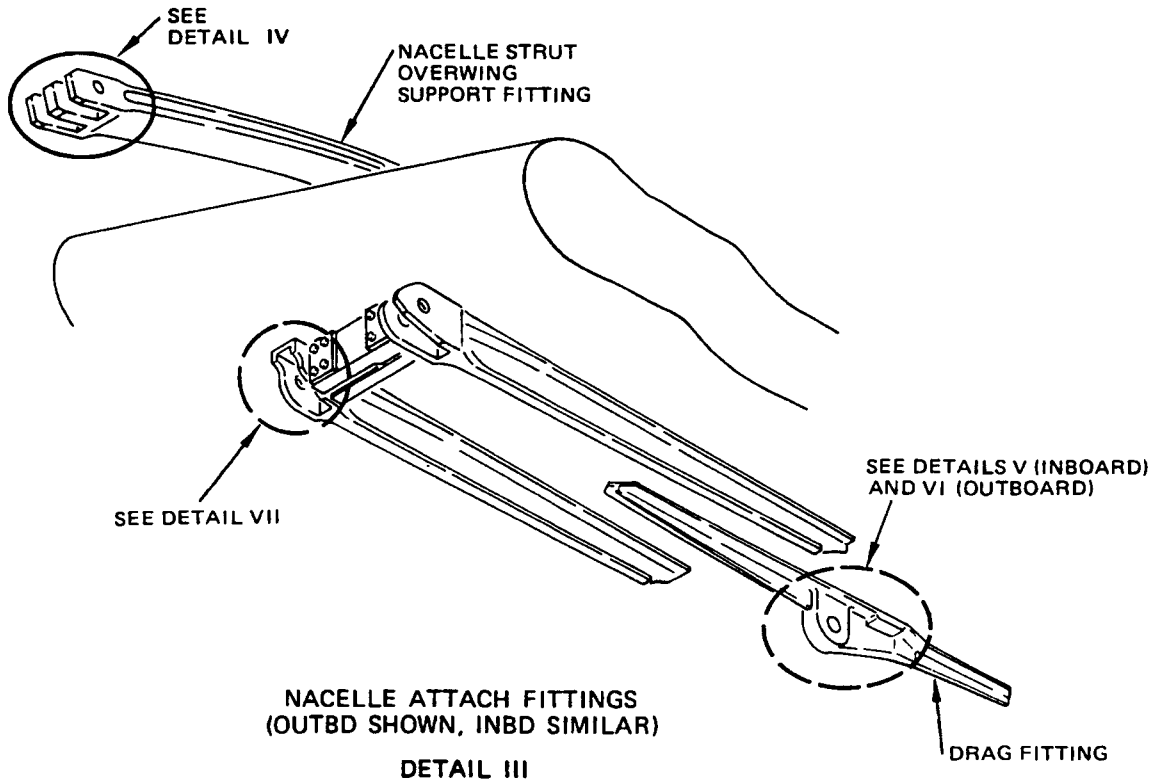
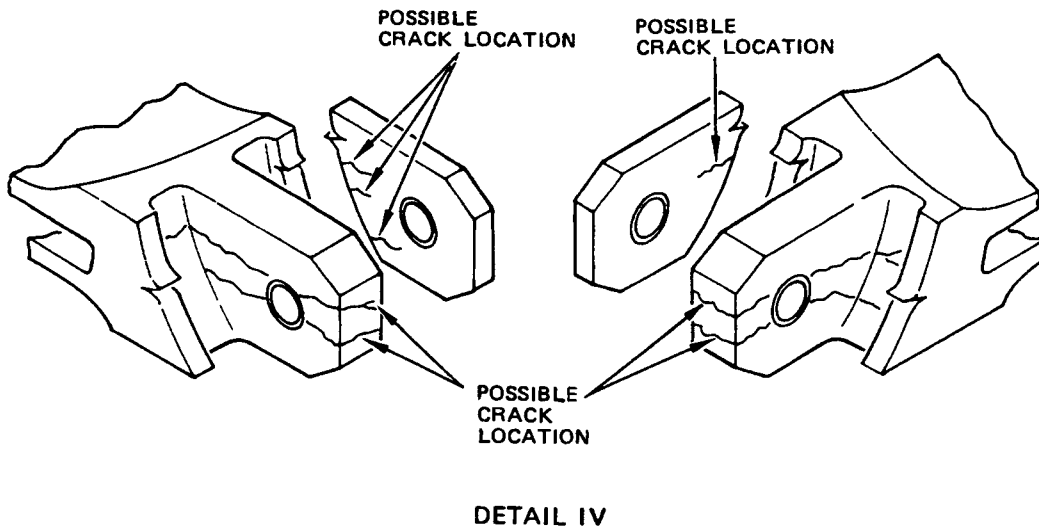
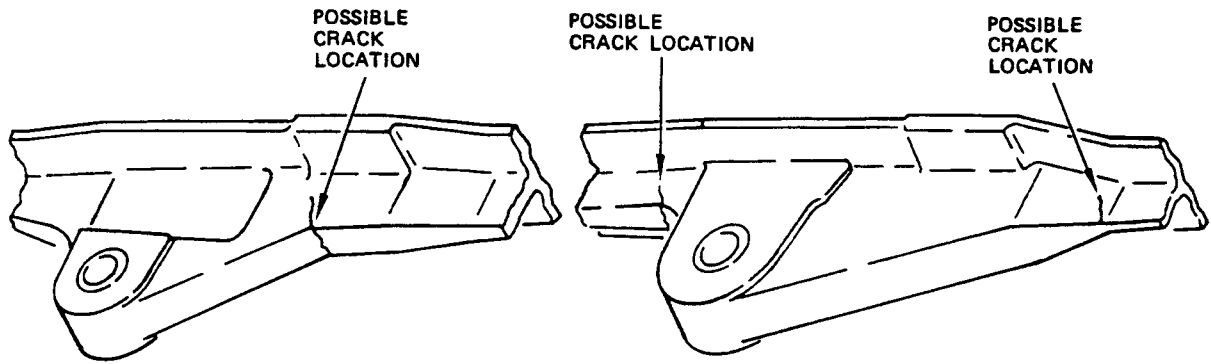
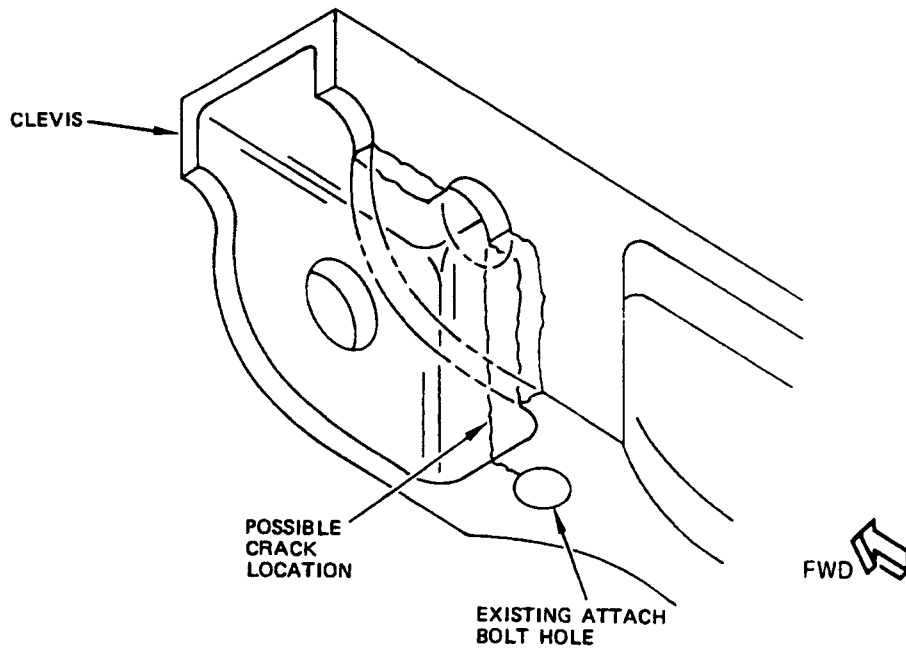
Nacelle Attach Fittings
Figure 4 (Sheet 1)

- A. Stress corrosion and cracks can occur on the nacelle strut overwing support fittings. The problem areas are on the lugs, at the fuse joint hole, the clip attach holes, the fitting-to-wing attach holes and the vertical section of the fitting of the wing front spar.
- B. Cracks can occur in the nacelle drag fittings and inboard nacelle upper support fittings.
- C. Cracks that could be from stress corrosion can occur in the forward end of the No. 1 engine nacelle forward inboard drag support at the aft wall of the clevis.
- D. Refer to the Introduction of this manual for a discussion of the Aging Airplane Corrosion Prevention and Control Program and related documentation. Structural items within this section are subject to the unique requirements of the mandatory Corrosion Prevention and Control Program.

- A. Regularly examine the nacelle strut overwing support fittings, drag fittings, and nacelle forward inboard drag support for corrosion per Volume 1, 20-20-00. SB 3173 gives procedures for the nacelle strut overwing fittings. SB A3364 gives procedures for the drag fittings.
- B. If you find corrosion, refer to Structural Repair Manual for details of corrosion removal.

- C. For details of application of water-displacing corrosion-inhibiting compound, refer to Volume 1, 20-60-00.
- D. For minor corrosion, the corrosion products should be cleaned off followed by an application of a corrosion-inhibiting compound into the affected area to retard the corrosion process. The finish system should be restored at the first opportunity consistent with the maintenance schedule (Ref Volume 1, 20-50-00 and 20-60-00).

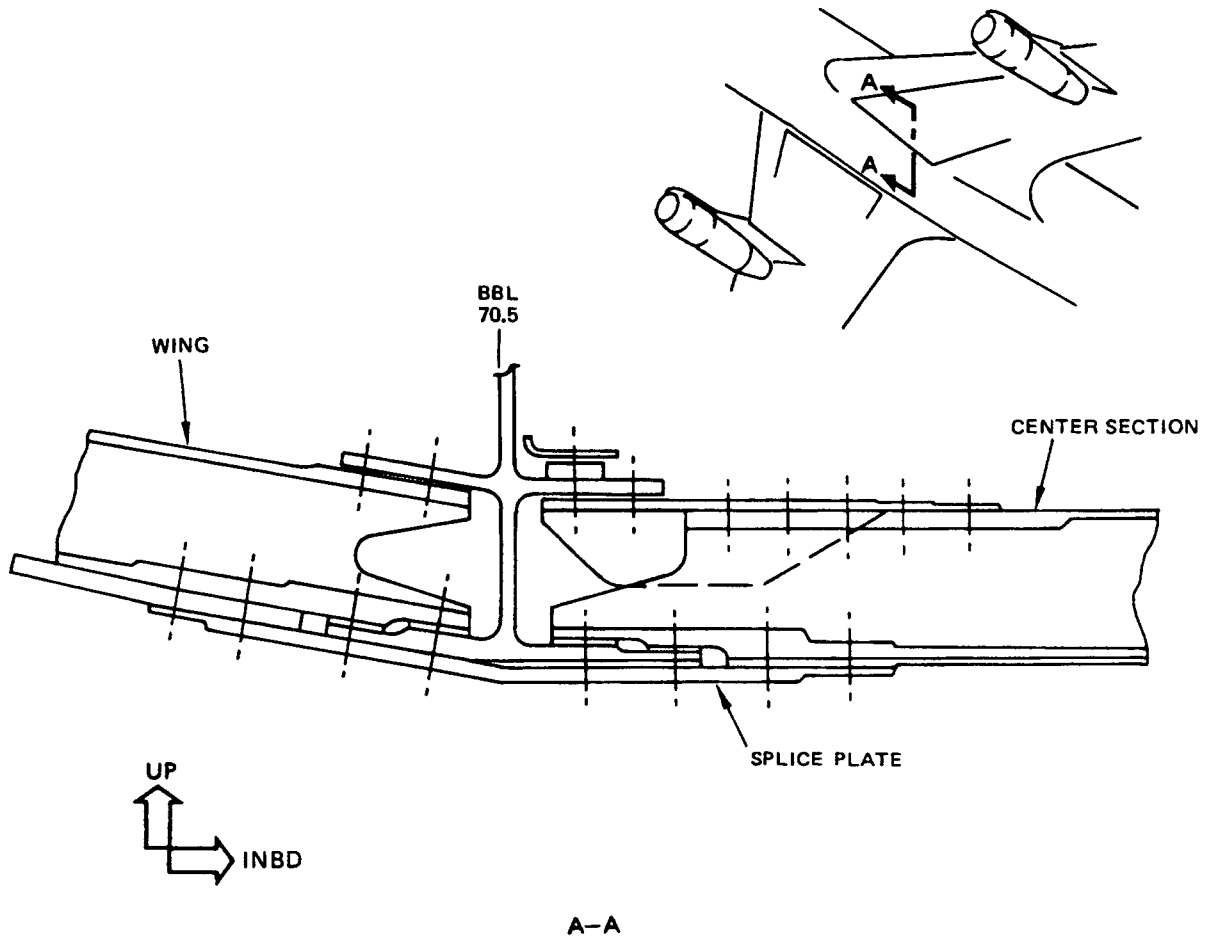
Wing-to-Center-Section Lower Splice Bolts
Figure 5 (Sheet 1)

- A. Bolt head-to-shank separation has been reported during wing-to-center section lower splice plate bolt removal. Subsequent evaluation of some of the bolts indicated fracture was due to stress corrosion.
- B. Refer to the introduction of this manual for a discussion of the Aging Airplane Corrosion Prevention and Control Program and related documentation. Structural items within this section are subject to the unique requirements of the mandatory Corrosion Prevention and Control Program.

- A. Make the periodic inspection described in Volume 1, 20-20-00 to ensure that the protective finishes provided at manufacture remain intact. The preferred treatment for broken finishes is to replace the finish with the same protective system as used originally.
- B. Where it is impractical to restore the finish, temporary corrosion protection can be provided by an application of water-displacing corrosion-preventive compound to fastener heads and skin surfaces where the paint system has cracked or flaked. Allow 30 minutes for the corrosion preventive compound to penetrate under fastener heads and for the carrier solvent of the compound to evaporate. Wipe off excess.

- C. For minor corrosion, to minimize the down time of the airplane, the corrosion products should be cleaned off followed by an application of water-displacing corrosion-preventive compound on the affected area. The finish system should be restored at the first opportunity consistent with the maintenance schedule.
- D. Refer to SL 57-4 for an inspection procedure for these bolts. The procedures uses an overtorque check to see if the bolts have stress corrosion cracks.

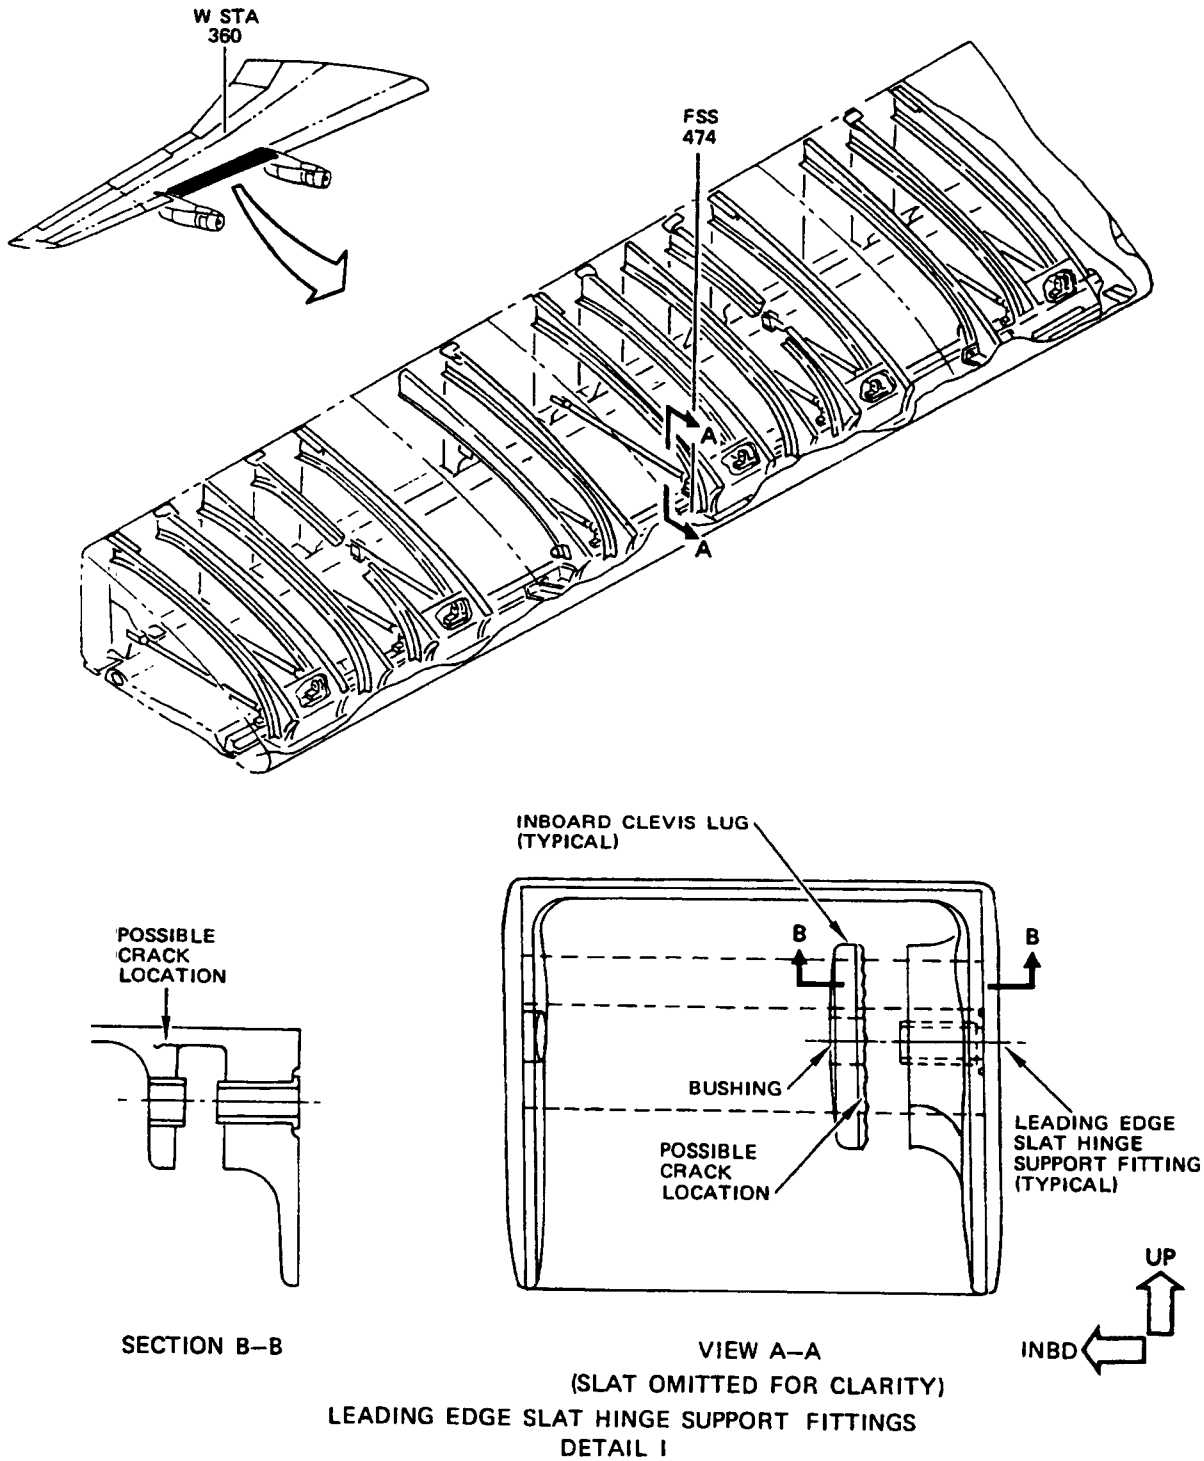
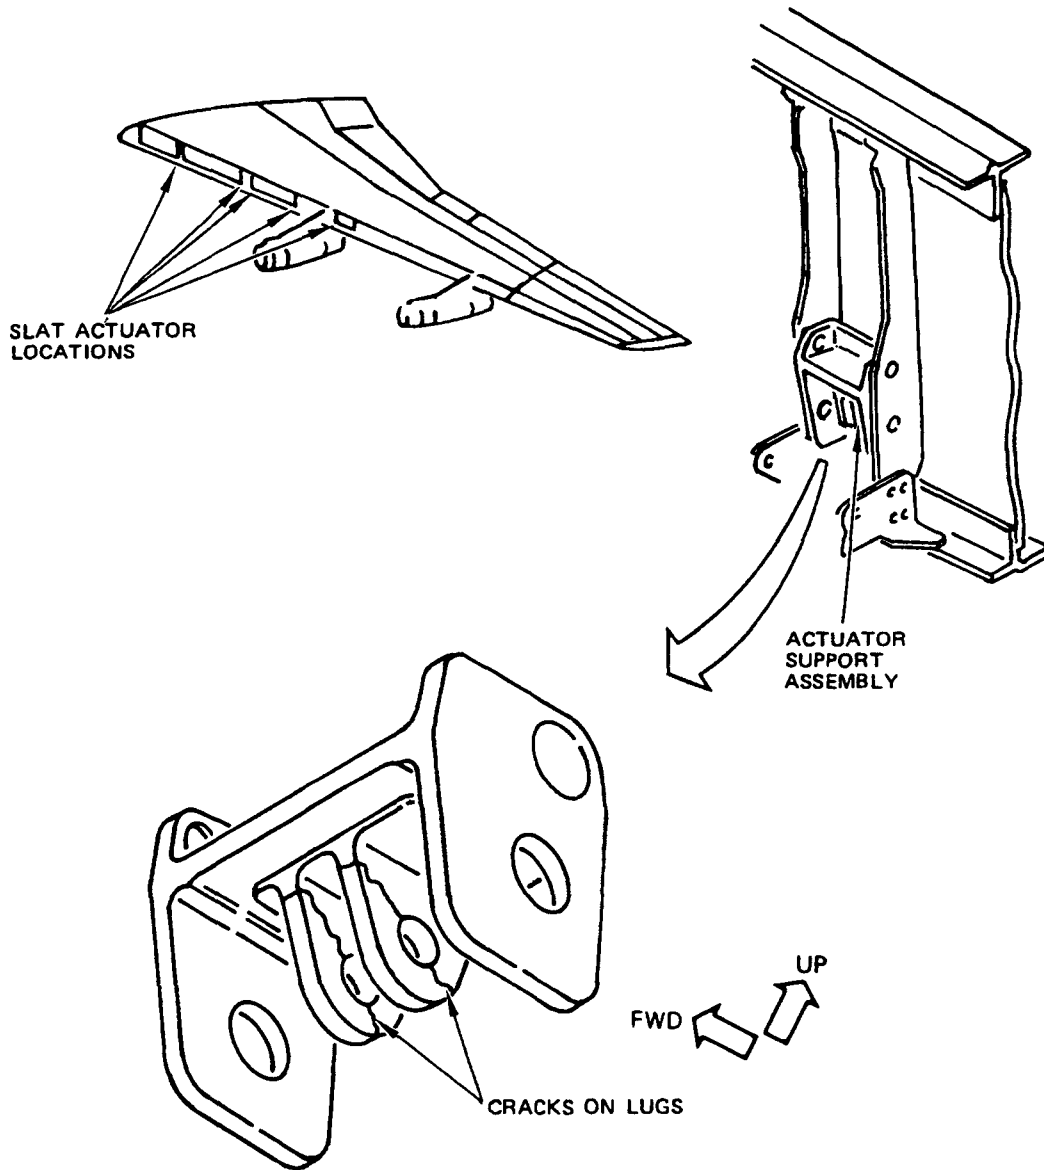
Leading Edge Slat Support Fittings
Figure 1 (Sheet 1)

- A. Stress corrosion has been reported on the leading edge slat hinge support fittings.
- B. Stress corrosion has been reported on the leading edge slat actuator support fitting.
- C. Refer to the Introduction of this manual for a discussion of the Aging Airplane Corrosion Prevention and Control Program and related documentation. Structural items within this section are subject to the unique requirements of the mandatory Corrosion Prevention and Control Program.
