CORROSION PREVENTION MANUAL

Volume 2-727

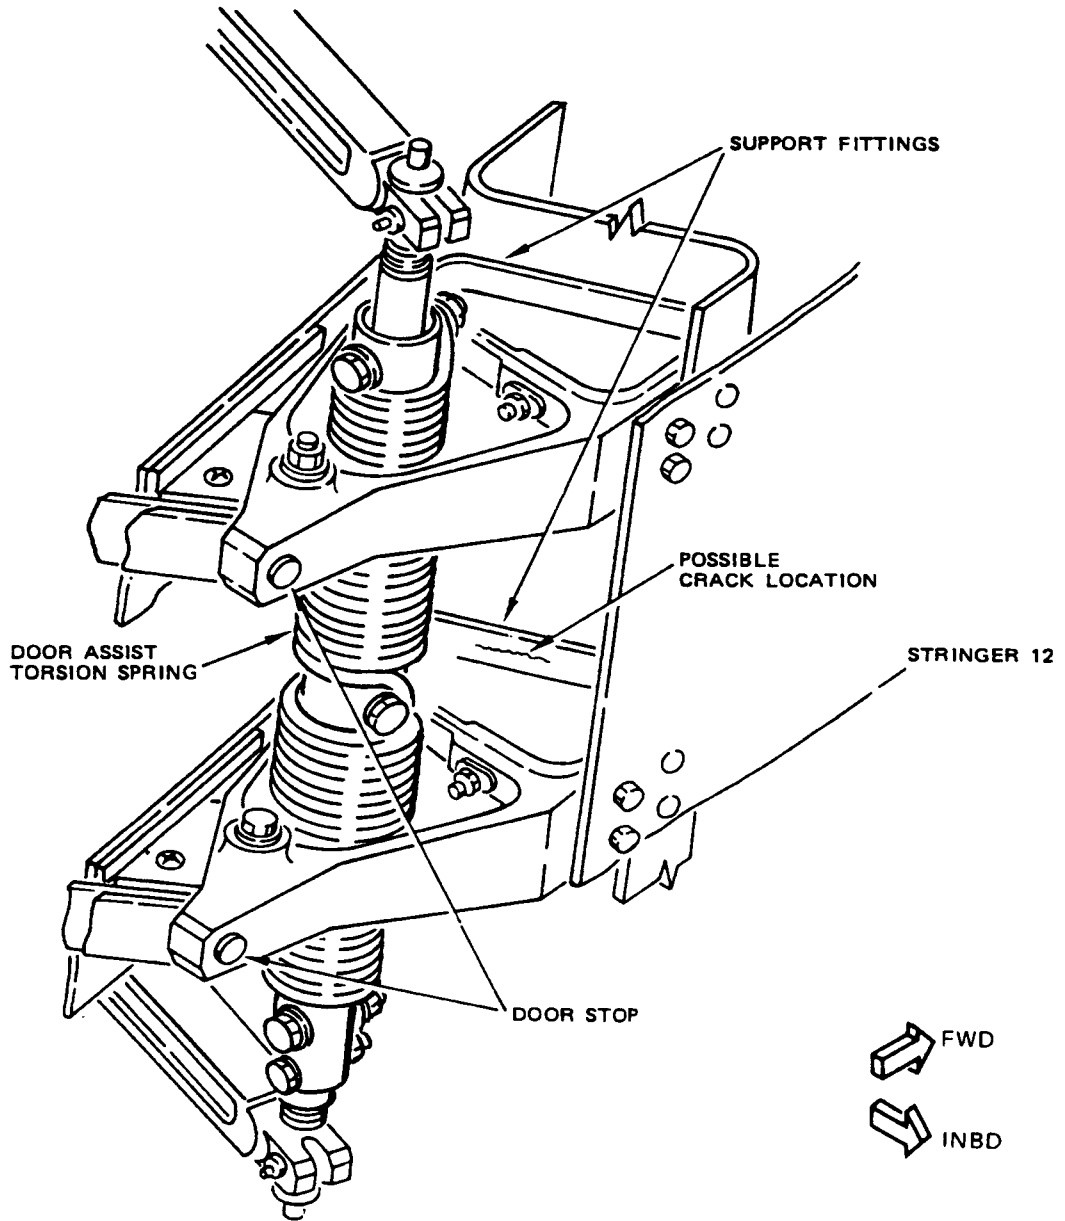
Entry Doors
Figure 1 (Sheet 3)

- E. Stress corrosion cracks have been reported on the forward entry door stop support fitting. The cracks were through the holes of the fitting to frame fasteners (Detail III).

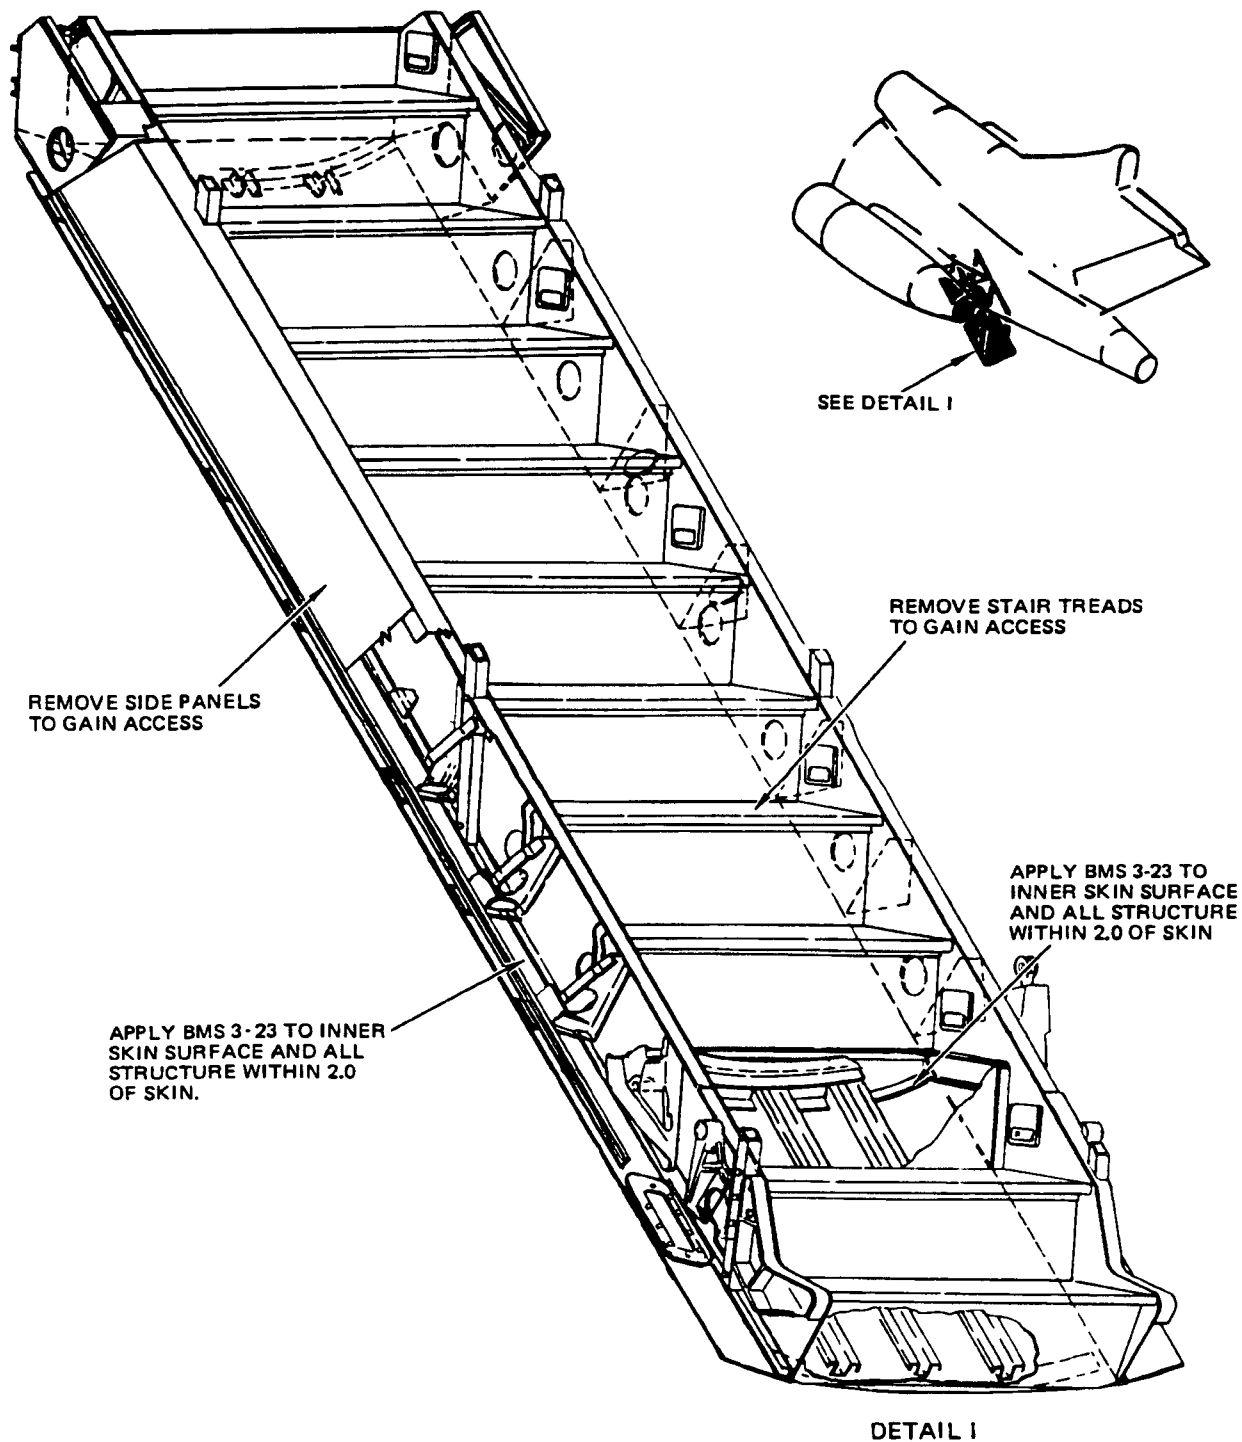
Ventral Airstairs
Figure 2

- A. Extensive exfoliation corrosion of the vertical airstair structure has been reported. In the reported incident 25-40 pounds of slurry (sand, oil and carbon deposits) was found along the length of the airstairs ventral skin. The structure most adversely affected was the tread and riser sidewall attach angles on the lower half of the stairs.
- B. Refer to the Introduction of this manual for a discussion of the Aging Airplane Corrosion Prevention and Control Program and related documentation. Structural items within this section are subject to the unique requirements of the mandatory Corrosion Prevention and Control Program.

- A. Should corrosion be found, refer to Structural Repair Manual for corrosion removal procedure.
- B. On airplanes through line number 1215, at a convenient maintenance period, remove the stair treads and left and right side panels. Apply BMS 3-23 corrosion preventive to the inner surface of the skin and all structure within 2 inches of the skin as well as the tread and riser sidewall attach angles, after corrosion cleanup and structural damage evaluation.

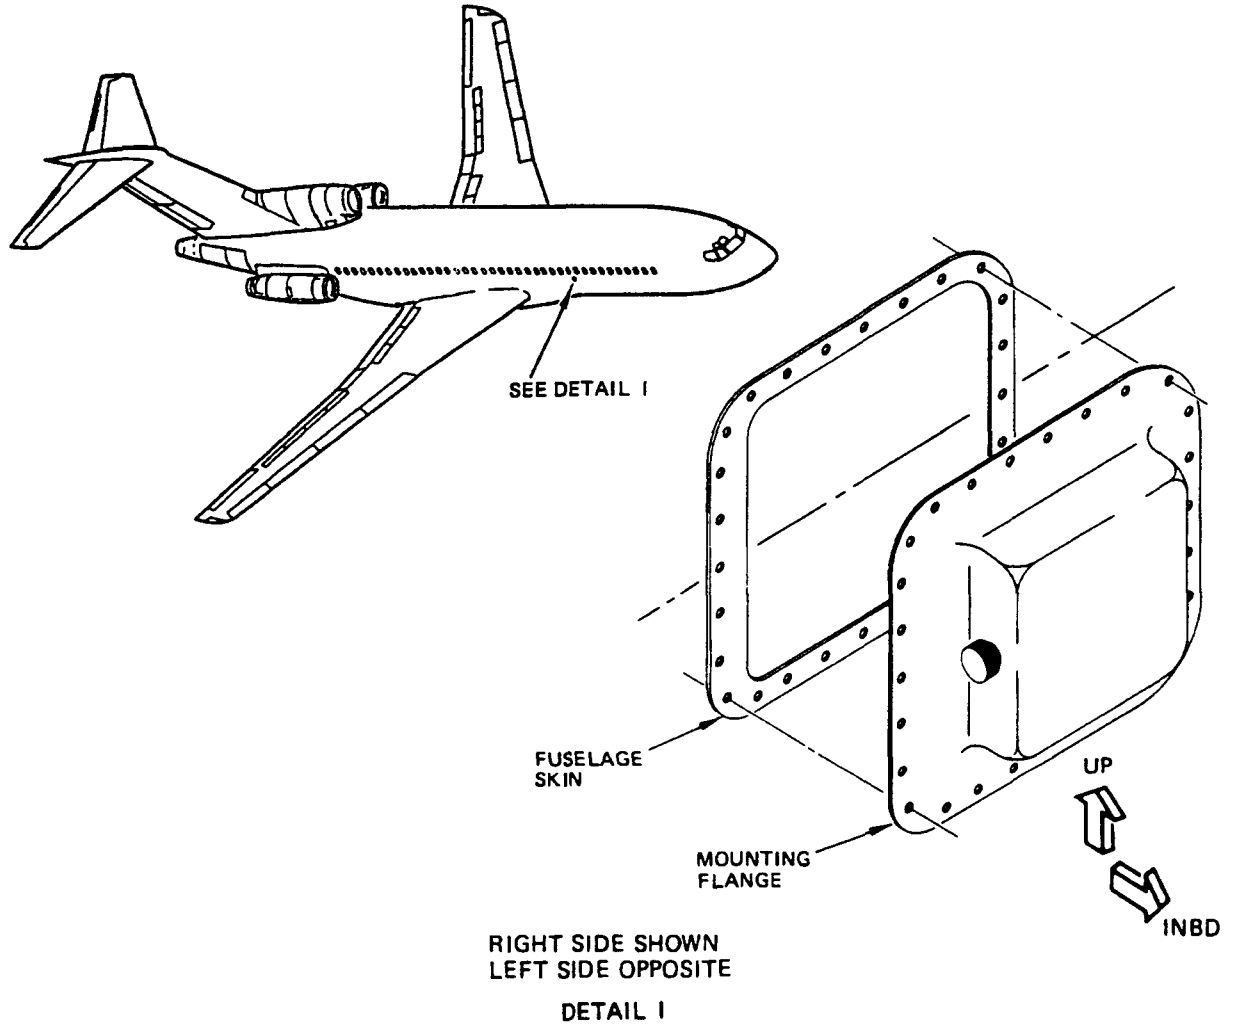
Section 43 Wing Scanning Light
Figure 3

- (6) Corrosion has been reported on the faying surfaces of the wing scanning light mounting flange and the fuselage skins (Fig. 3).
 - (7) Corrosion has been reported at the stringer 4, 10, 14, and stringer 19 body skin lap joints (Fig. 6, Detail I).

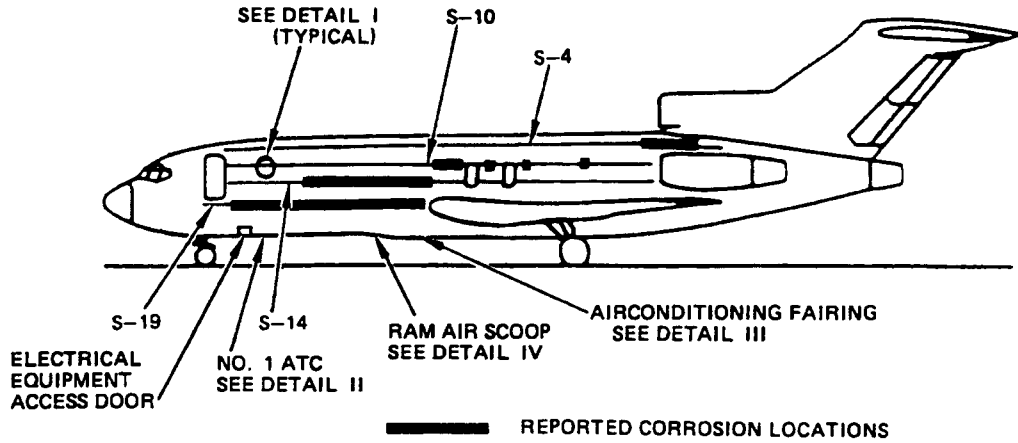
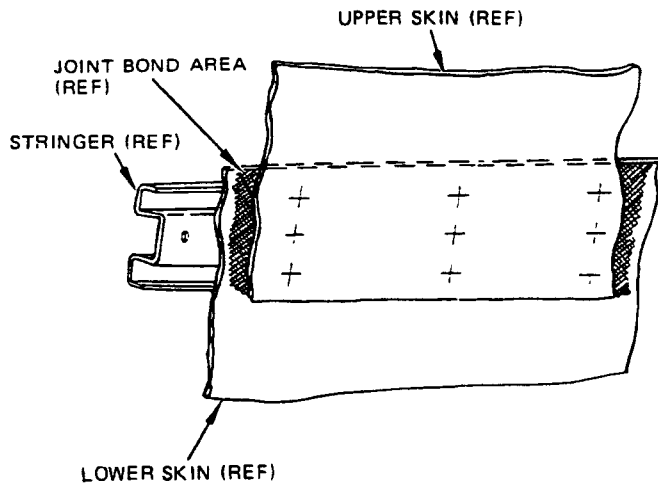
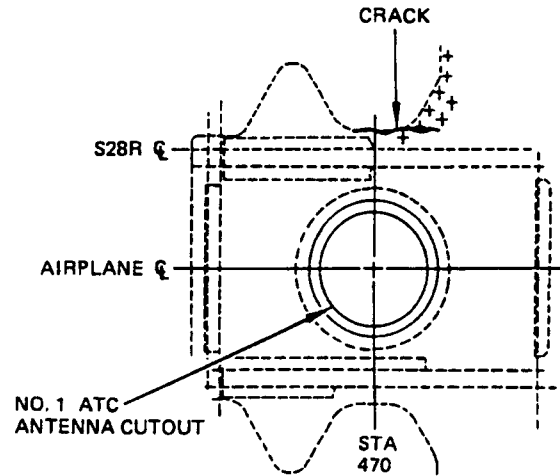
Section 43 Fuselage Skin
 Figure 6 (Sheet 1)

- (10) Exfoliation corrosion has been reported on the lower skin, located approximately 18 inches aft of the electrical equipment access door and 2 inches outboard of stringer S-28R (Fig. 6, Detail II).

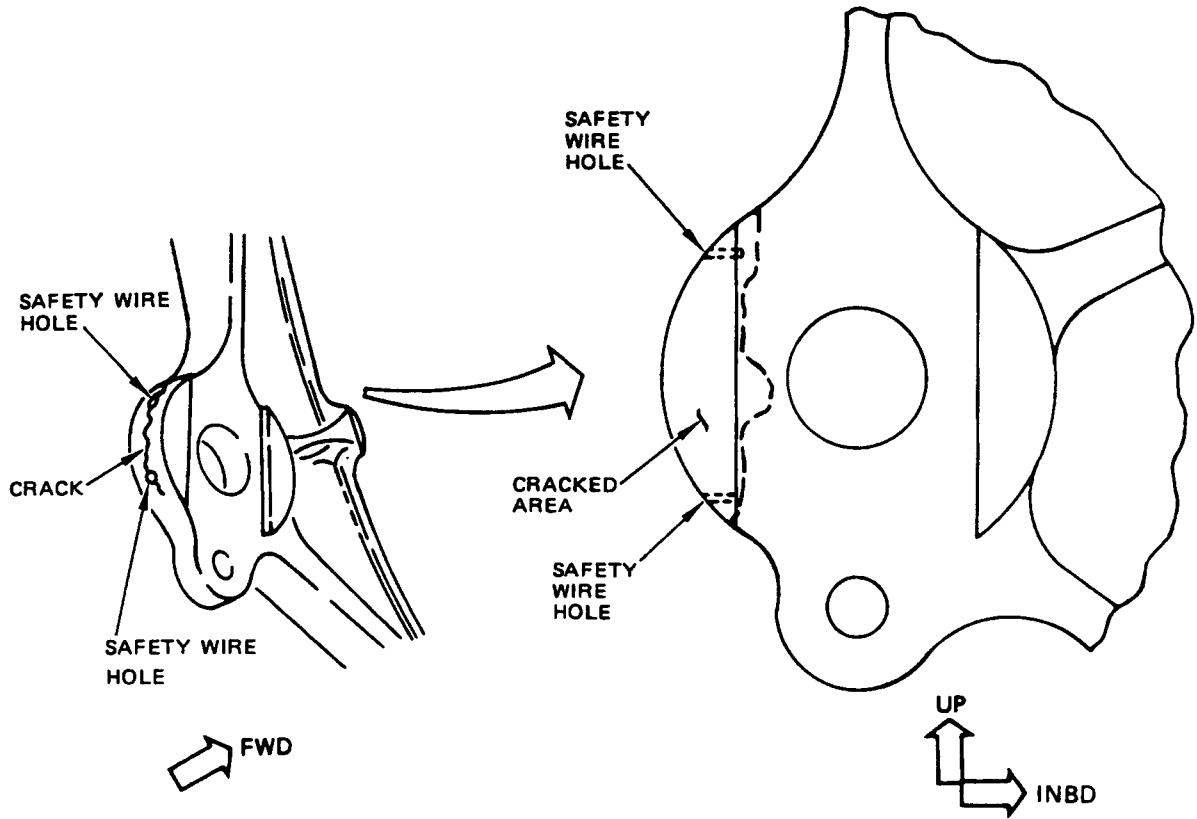
Section 46 - Fuselage Structure
Figure 1 (Sheet 5)

- (2) Stress corrosion cracks have occurred in the 7079-T6 bulkhead fittings at BS 740 between S-18 and S-24. Cracks were detected in the outboard flange below the pressure deck, and in the inboard flange, web, and web-to-outboard flange radius at the lower extremity of the fitting. Material changes (to 7075-T73) introduced on airplanes from line number 875 left side and 877 right side decreased the risk of this problem. A preventive modification introduced by SB 53-62 will reduce the risk of stress corrosion cracking on airplanes with 7079-T6 fittings (Fig. 1, Detail V).

- (3) Stress corrosion cracks occurred on the BS 740 front spar bulkhead terminal fitting. The fitting is made of 7079-T6 aluminum (Fig. 1, Detail V).

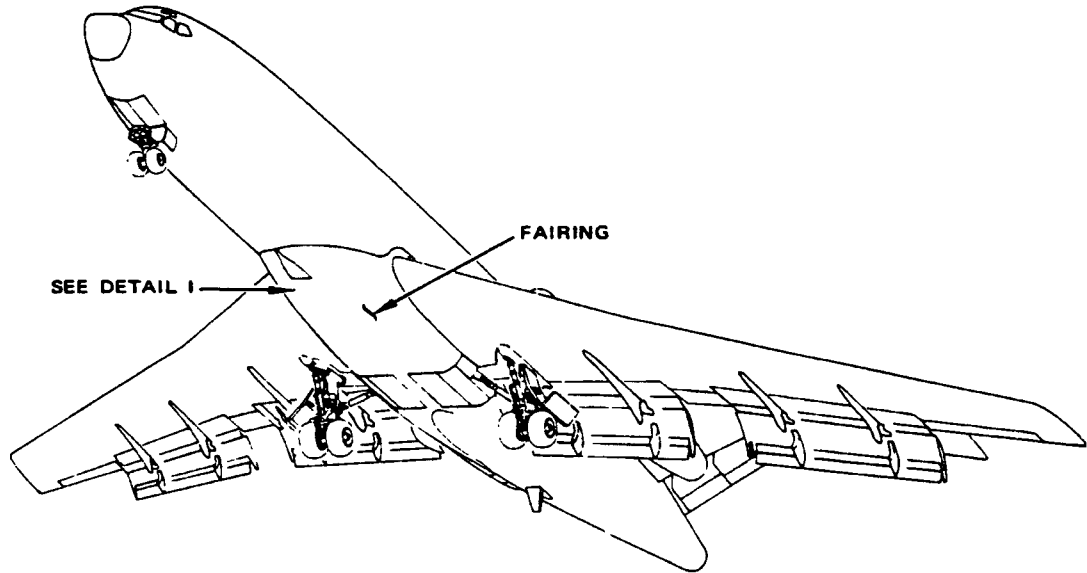
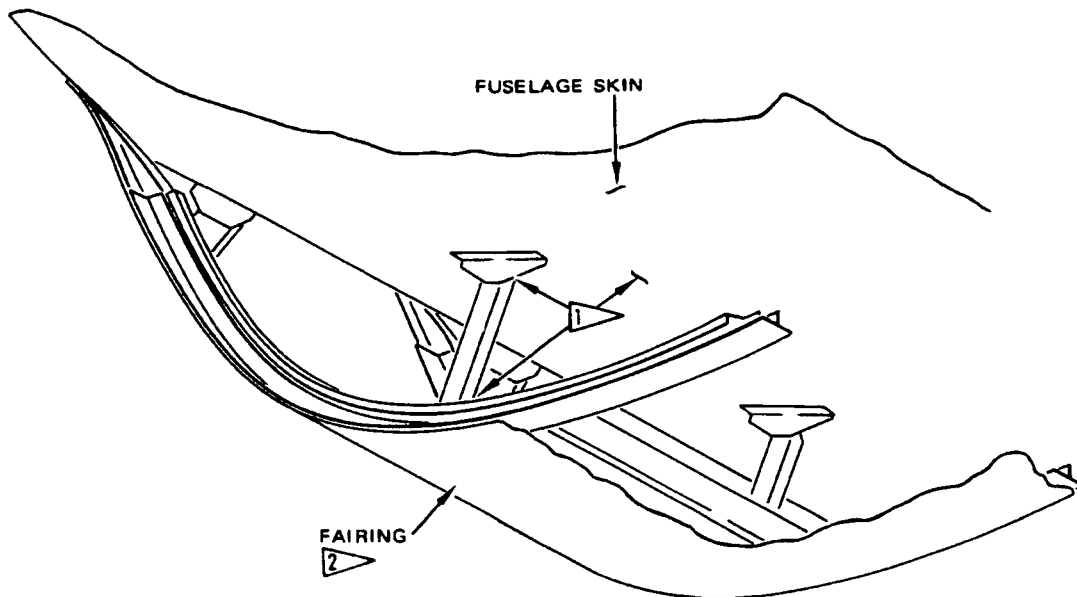
Section 46 - Wing to Body Fairing Cavity
Figure 6

G. The upper wing to body fairing is attached to the upper wing surface and fuselage skin along the wing to fuselage joints. The lower lobe fairing houses the ambient air inlets to the ram air system during pack cooling fan operation. The lower lobe fuselage skin under the fairing extends to the bulkhead below the front spar of the center wing section. The cavity formed by the lower lobe fairing and fuselage skin is the area of concern. Aft of this area, the fairing covers the center wing section (Fig. 6).

- 1 ▷ APPLY BMS 3-23 CORROSION INHIBITOR
- 2 ▷ ON SOME AIRPLANES FAIRING IS ALUMINUM, OTHERS USE FIBERGLASS, HONEYCOMB CONSTRUCTION

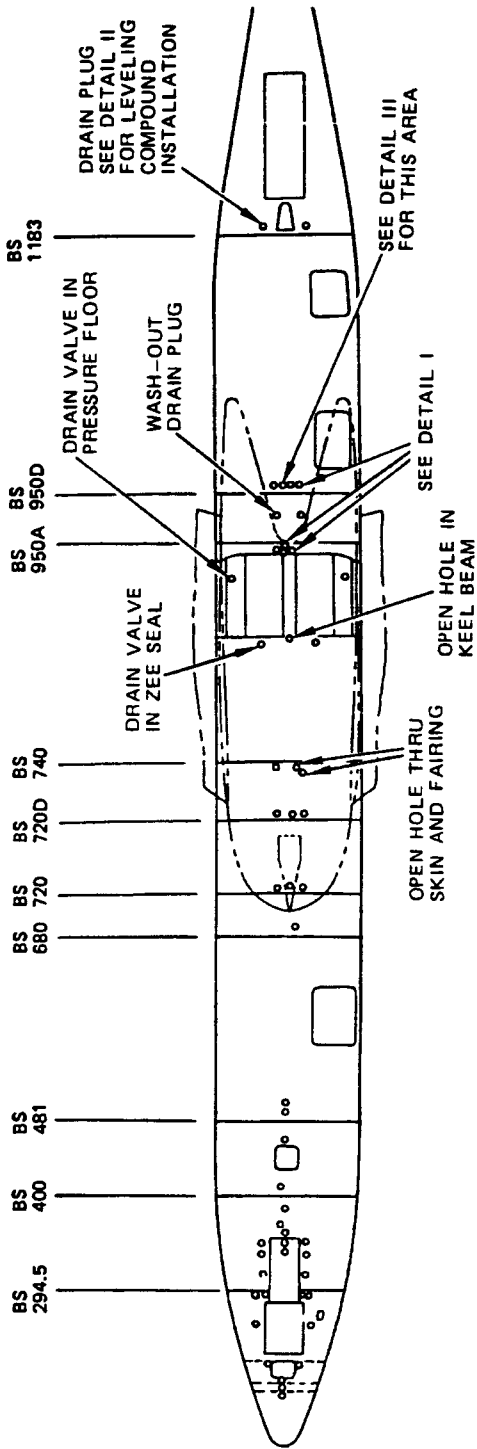
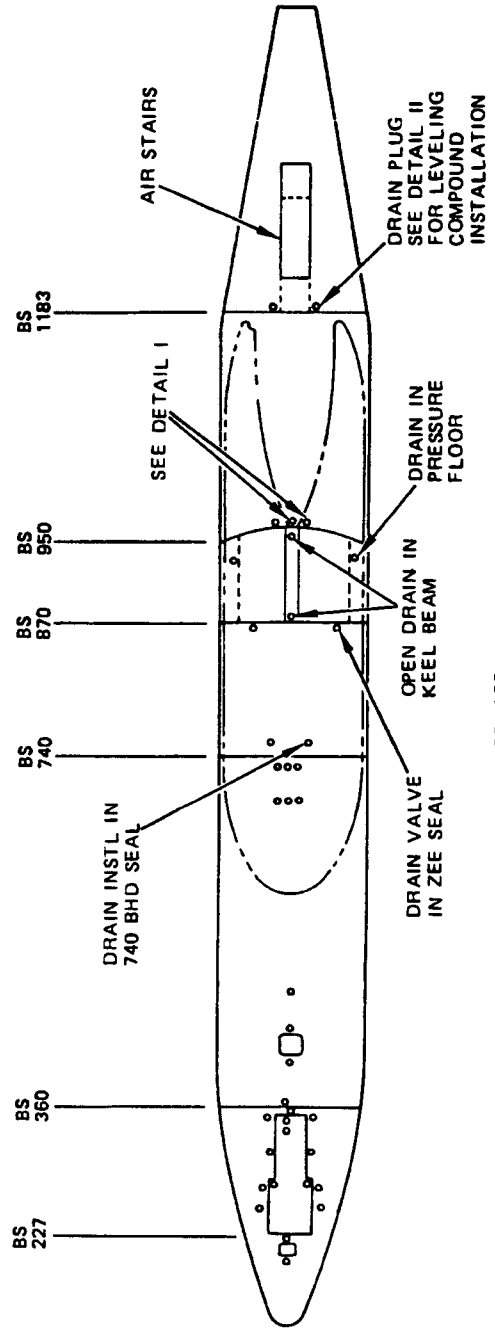
Section 46 - Fuselage Drain Holes
Figure 7 (Sheet 1)

H. Overboard drains are either the mechanical closure type (pressurized areas) or open hole type (unpressurized areas). These drains are strategically located so that they are at the lowest point in any assembly or area. Drain holes through internal structures and leveling compounds are used to provide drainage paths to lead the overboard drains (Fig. 7).

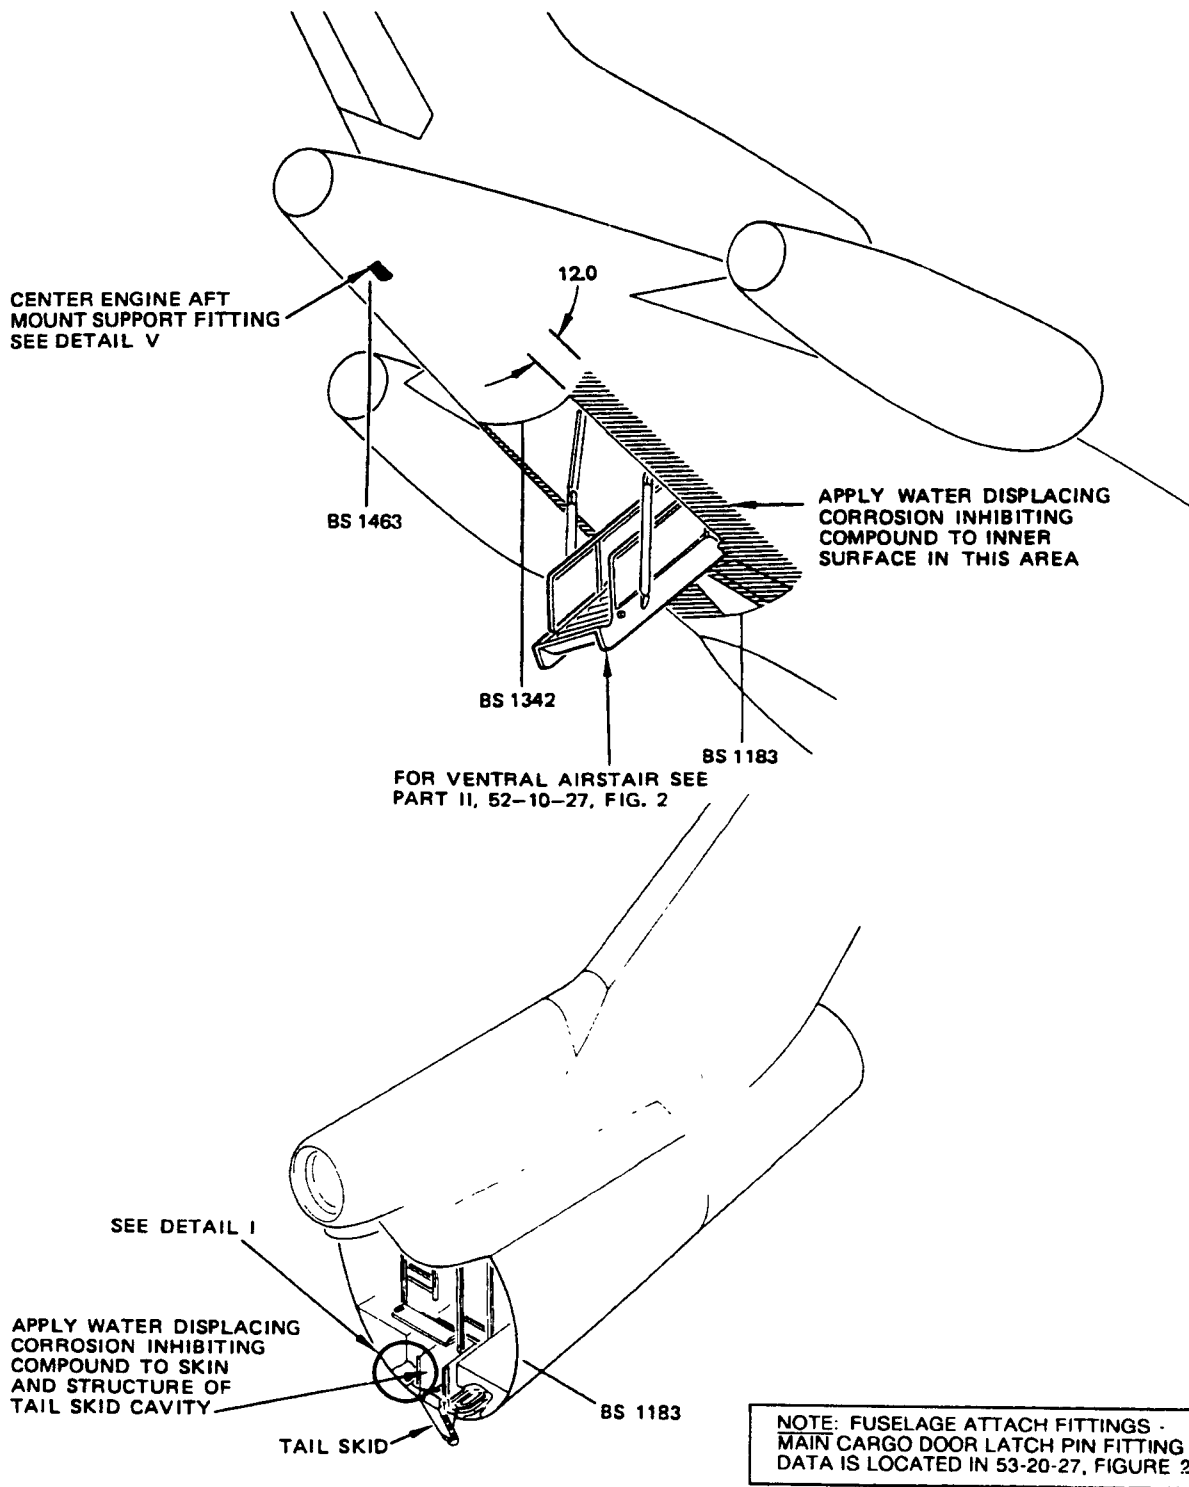
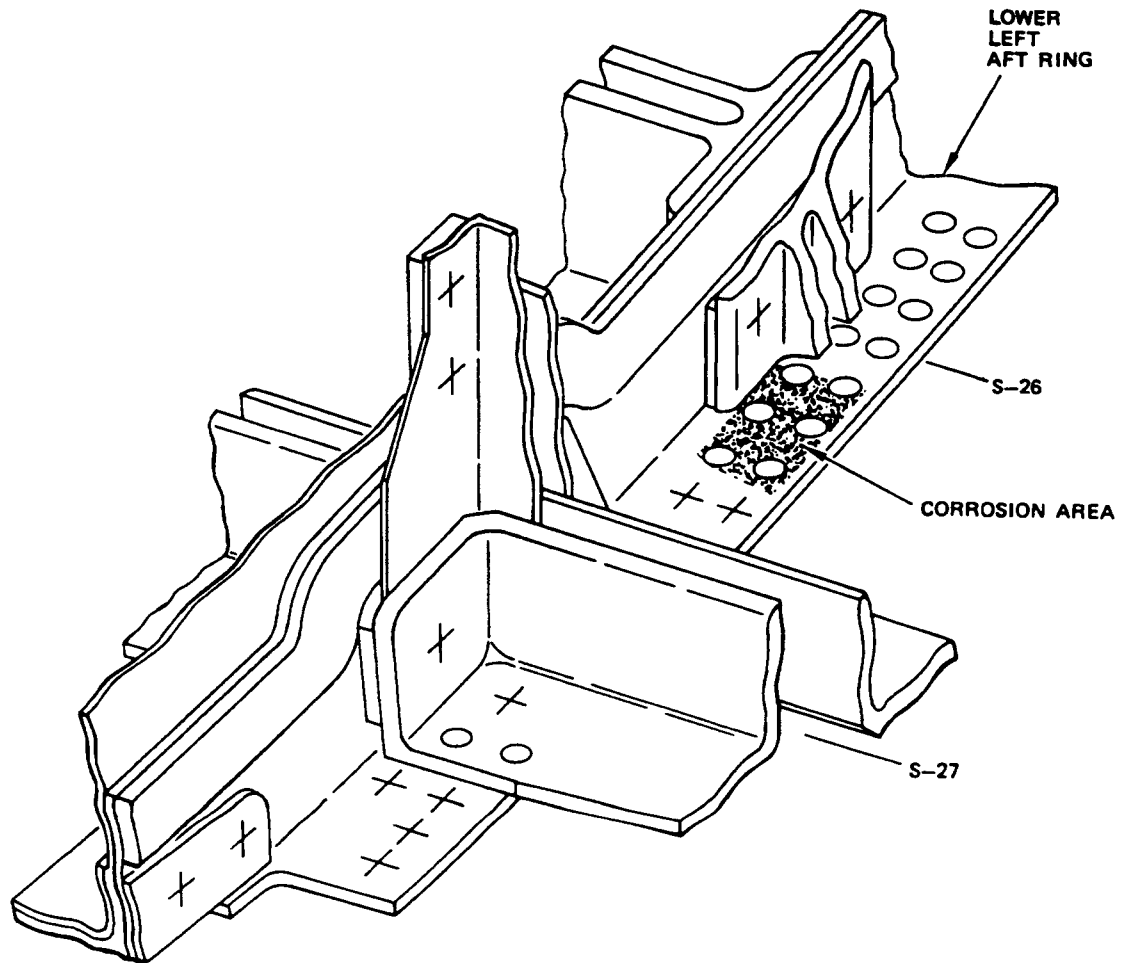
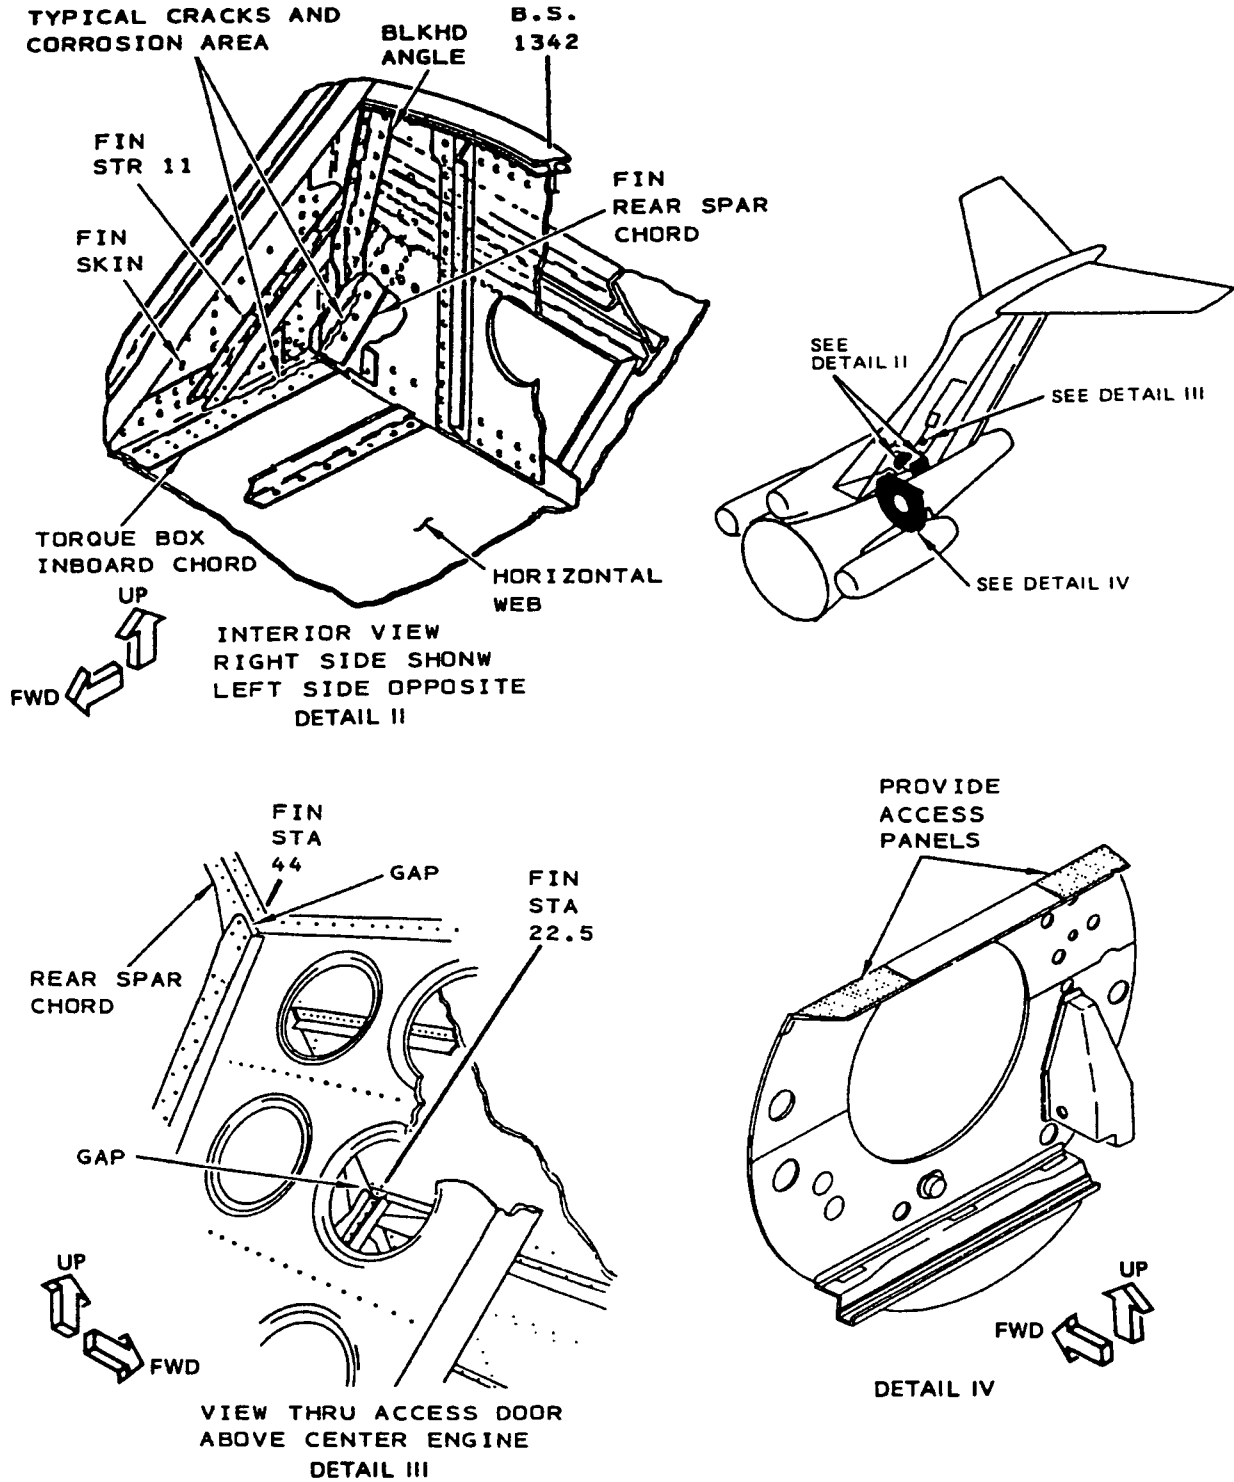
Section 48 - Fuselage Structure
Figure 1 (Sheet 1)

- C. The stringers, frames, and skins have been found susceptible to corrosion due to moisture entrapment between the skin and insulation blankets. Corrosion can readily start where protective finishes have been broken or deteriorated.

- (1) Corrosion has been reported on the left lower aft ring between and around rivet heads and between stringers S-26L and S-27L at the BS 1183 pressure bulkhead.

- (2) Corrosion can occur on alloy steel tension bolts at the BS 1183 circumferential frames.
 - (3) Corrosion has been reported in the tail skid cavity.

- (4) Corrosion has been reported at the spar chord in the area of attachment to the fin rear spar terminal fitting at BS 1342. Removal of the center engine or installation of special access doors is required for repairs. SB 55-76 provides instructions to gain access through center engine farewell, without removing the engine, for repair or replacement of the fin rear spar chord (Fig. 1, Detail II).

- A. Make the periodic inspection described in Volume 1, 20-20-00 to preclude or detect the early stages of corrosion. Missing fasteners, white powdery or any discolored deposits are evidences of the existence of corrosion which should alert operators that some corrective action is required. A corrosion prevention program should be initiated to prevent the accumulation of corrosive products in order to minimize the occurrence of corrosion.
- B. After you clean areas, make the inspections per Volume 1, 20-20-00 to make sure that protective finishes stay serviceable. Refer to SB 53-209 for details about the tension bolts at the BS 1183 circumferential frames.

- (1) On airplane line number 1216 and on, water displacing corrosion preventive compound has been applied to the inner surface of the lower skin between BS 1183 and BS 1342 in the vicinity of the aft airstairs and tail skid.
- (2) On airplane through line number 1215, apply water displacing corrosion inhibiting compound to the inner skin surface and all structure within 3 inches of it, for a distance of 12 inches outboard of the ventral airstair aperture. This area, which extends from BS 1183 to BS 1342, includes the tail skid aperture and the adjacent access panels.
- (3) Drainage fittings for the lower torque box area are located just aft of the bulkhead at BS 1183.
- (4) For corrosion on alloy steel tension bolts at the BS 1183 circumferential frames, SB 53-209 gives inspection and replacement procedures.

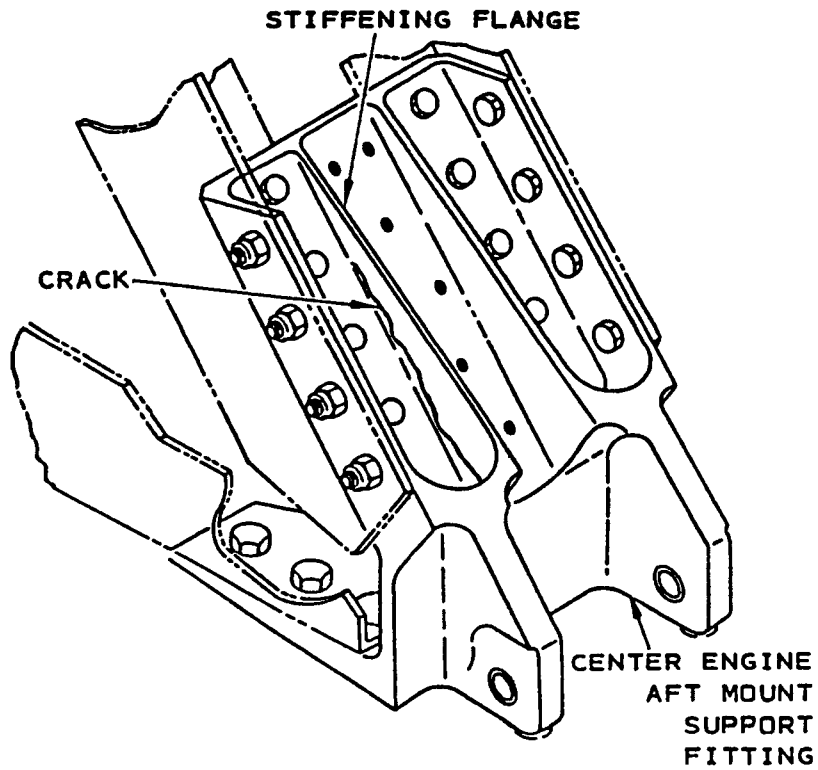
DETAIL V

- (5) Severe corrosion has been reported in the surface of the fractured Center Engine Rear Support Fitting (Fig. 1, Detail V).
- D. Refer to the Introduction of this manual for a discussion of the Aging Airplane Corrosion Prevention and Control Program and related documentation. Structural items within this section are subject to the unique requirements of the mandatory Corrosion Prevention and Control Program.

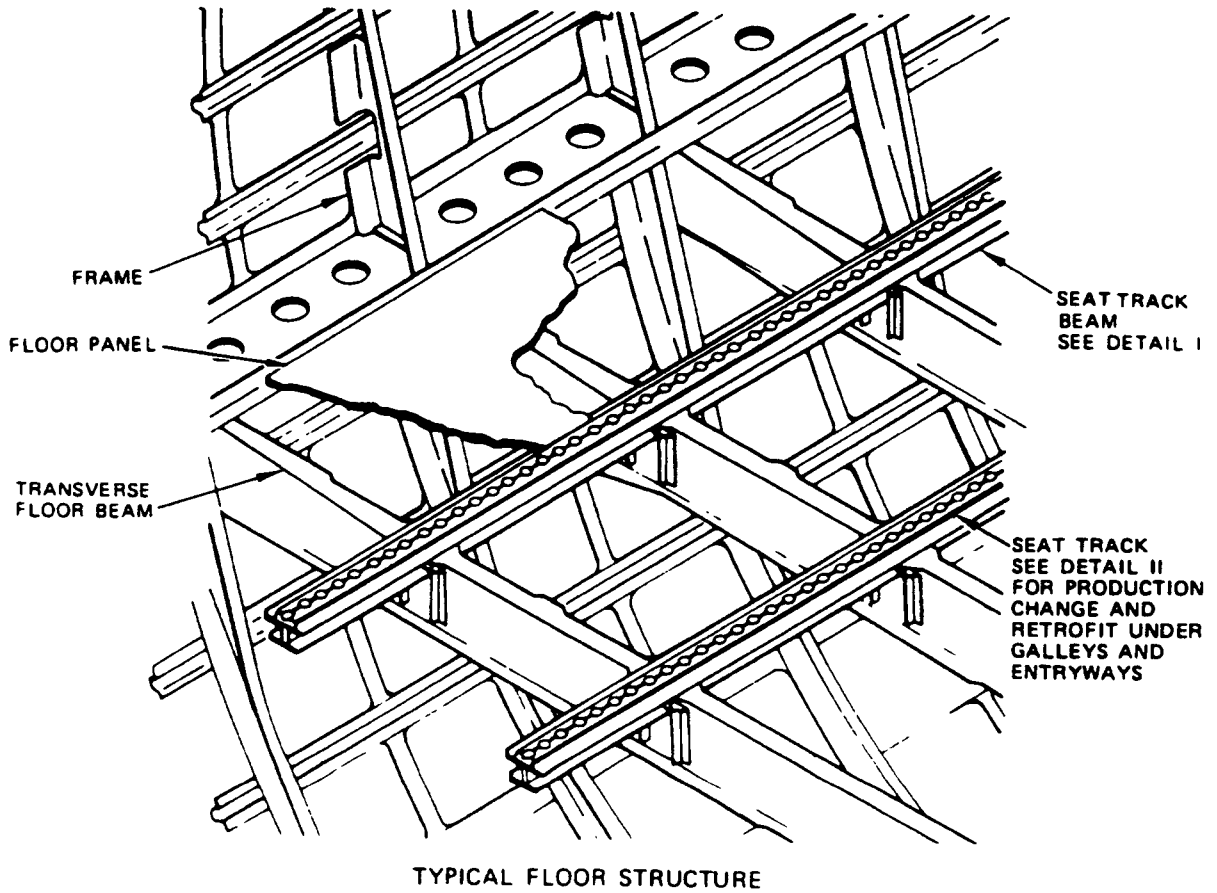
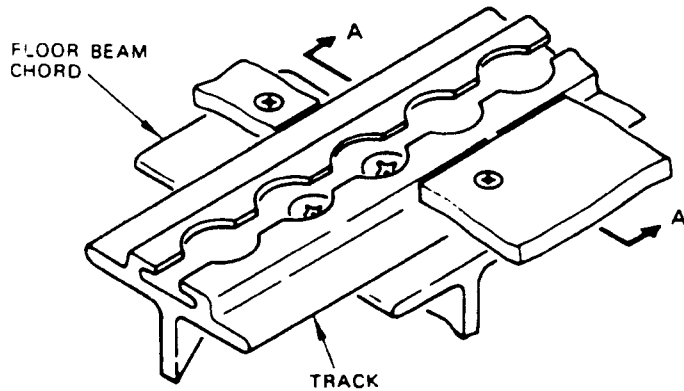
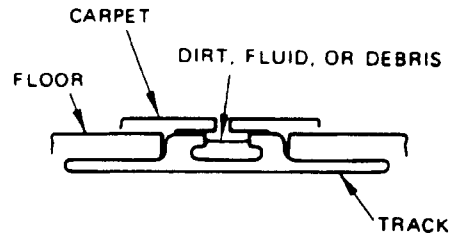
Seat and Cargo Tracks
Figure 1 (Sheet 1)

- A. The passenger seat and cargo tracks are made from extrusions of 7178 aluminum alloy.
- B. Because they are a channel on the floor, the seat and cargo tracks tend to collect dirt and spilled liquids. Dirt holds the moisture and promotes corrosion. The areas near galleys, lavatories and entrances are particularly susceptible to corrosion.
- C. Refer to the Introduction of this manual for a discussion of the Aging Airplane Corrosion Prevention and Control Program and related documentation. Structural items within this section are subject to the unique requirements of the mandatory Corrosion Prevention and Control Program.

- C. Where corrosion exists (noticeable bulges of the skin or white deposits of corrosion products at fastener heads or joint edges), refer to Structural Repair Manual for details of corrosion removal.

- F. Prevention Treatment
 - (1) At earliest opportunity consistent with the scheduled maintenance activity, corrosion prevention treatment should be accomplished in the seat and cargo tracks.

- (2) For track treatment and inspection, remove mylar or vinyl tape and inserts to expose track channel. Check to ensure that tape is not broken.

- (3) Vacuum seat and cargo tracks regularly as volume of the cabin cleaning procedure to prevent buildup of dirt and debris.
- (4) Open any plugged drains in dammed portion of the tracks.
- (5) Clean tracks with aliphatic naphtha for removal of oil and grease.
- (6) Repair or replace damaged or broken dams.
- (7) Apply corrosion inhibitor to all parts of the track, especially the channel portion. The use of spray equipment with nozzle will make application easier and its use is recommended.
- (8) Apply corrosion inhibitor into seat attachments, galley and lavatory tiedown fittings, and cargo fittings attached to the track.
- (9) Allow the corrosion inhibitor to dry before reinstalling inserts and restoring the airplane to normal.

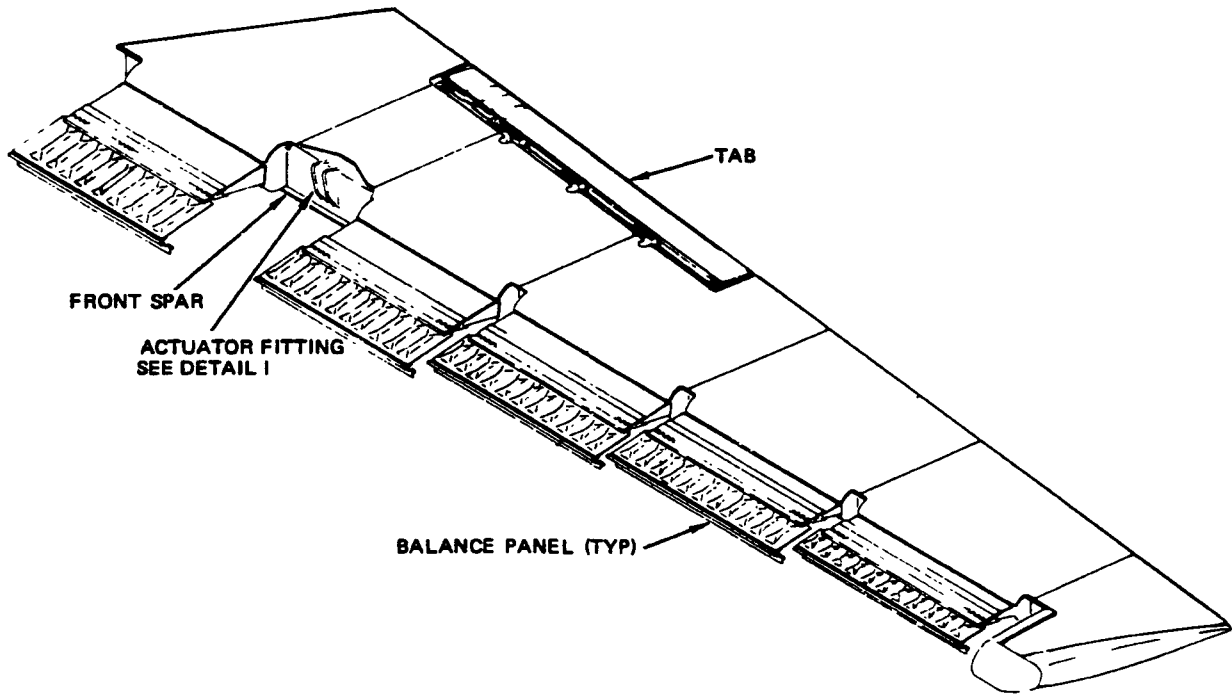
Elevators
Figure 1 (Sheet 1)

- A. Corrosion has been reported on the elevator balance panels and the elevator skin, especially in the region of the static dischargers. The silver-filled adhesive used to electrically bond the static dischargers has been replaced with BMS 5-79 sealant and electrically bonding with rivets with airplanes starting at line number 864.

- E. Prevention Treatment
 - (1) Apply water displacing corrosion inhibiting compound to exposed areas of the elevator spar, with particular attention to the attachment and hinge points, except on seals and seal wiping areas.

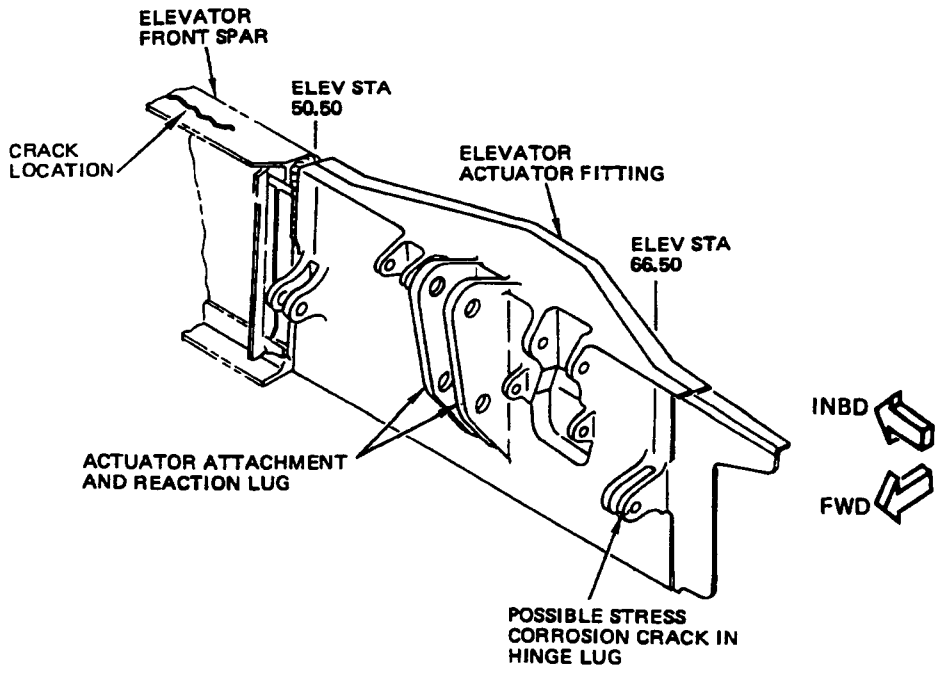
DETAIL I

- B. Stress corrosion cracking of the hinge lug on the actuator fitting has been reported (Detail I). Material change of the actuator fitting has been incorporated in production at cum line number 854 for the left side and cum line number 858 for the right side.

- C. Stress corrosion has been the cause of cracks in the upper inboard horizontal flange of three elevator actuator fittings (Detail I).
- D. Refer to the Introduction of this manual for a discussion of the Aging Airplane Corrosion Prevention and Control Program and related documentation. Structural items within this section are subject to the unique requirements of the mandatory Corrosion Prevention and Control Program.

- (2) SB 55-53 provides preventive modification procedures for stress corrosion cracking of the hinge lug on the actuator fitting.

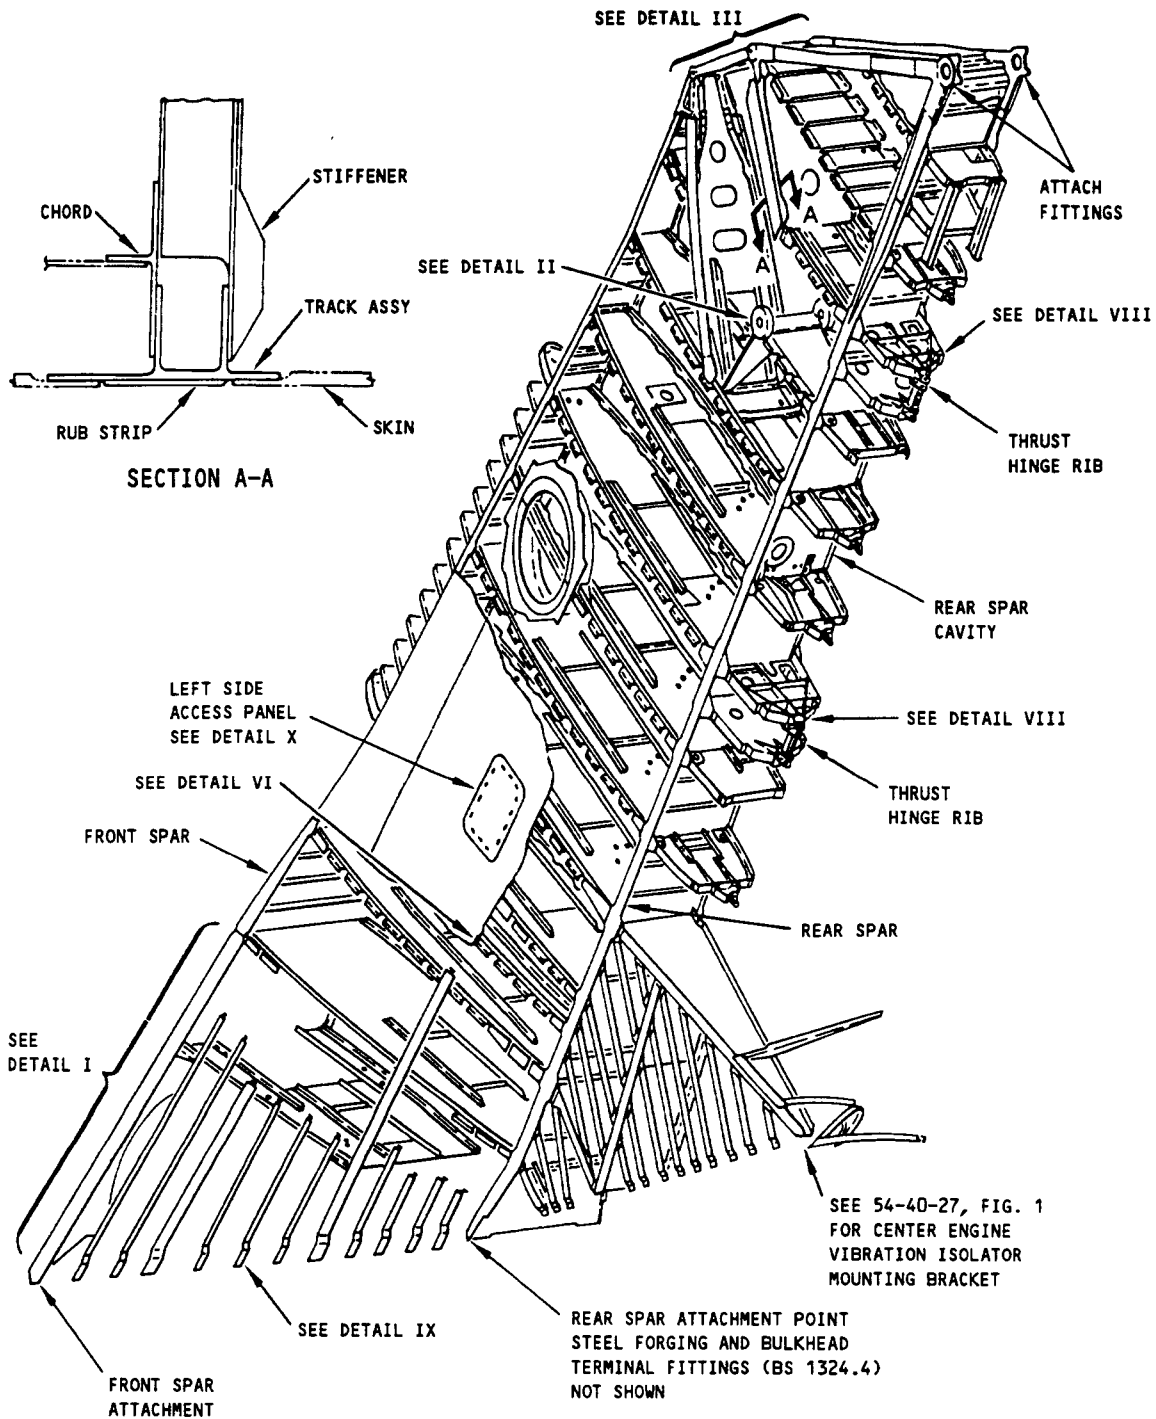
Vertical Stabilizer
Figure 1 (Sheet 1)

- A. Corrosion has been reported on the vertical stabilizer skin, on the rear spar and in the vicinity of the attach fittings.
- B. Production improvements were introduced at line number 906 including the wet installation of non aluminum fasteners using primer or sealant and an improved finish on the inspar skin, using Alodine 1000, BMS 10-79 epoxy primer and BMS 10-60, type II polyurethane enamel.

- C. Stress corrosion cracks have been reported in the lower front spar forgings in the area of the fail-safe strap and on the outboard flanges of the forgings. Material change in the forging has been incorporated at cum line number 865.

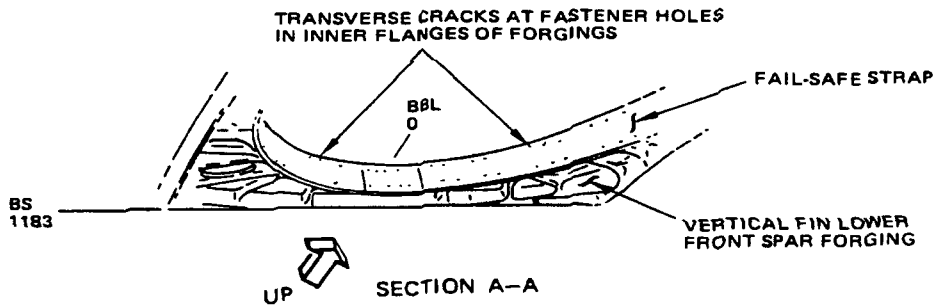
Vertical Stabilizer
 Figure 1 (Sheet 2)

- A** NUMEROUS STRESS CORROSION CRACKS AT FORGING FASTENER HOLES COMMON TO FIN SKIN
