CORROSION PREVENTION MANUAL

Volume 2-727

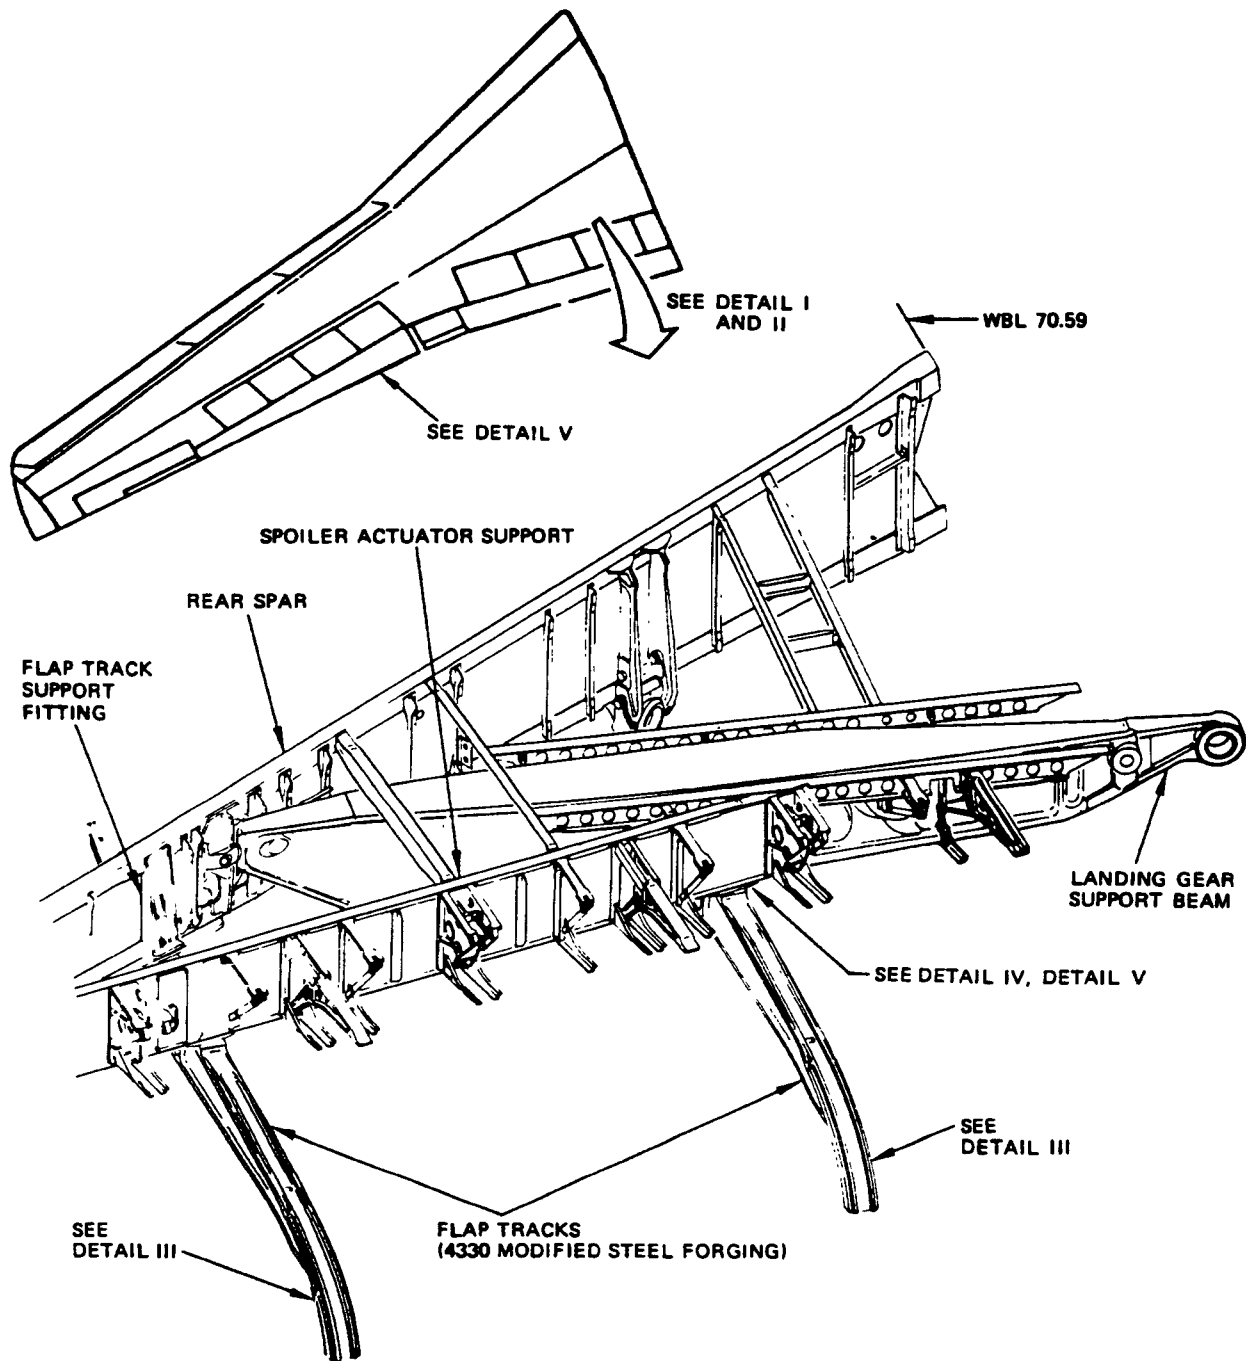
Trailing Edge Flaps
Figure 1 (Sheet 1)

**FLAP SUPPORT STRUCTURE
DETAIL I**

- A. The flap tracks, track attachment fittings on rear spar and actuator rods being in exposed positions are all prone to corrosion. Damaged finishes of these fittings and of the flap skin panels and ribs are attributed to exposure to the weather and runway debris. Service wear also contributes to galling of the moveable bearing surfaces.

- C. Where corrosion exists (noticeable bulges of the skin or white deposits of corrosion products at fastener heads or joint edges), refer to Structural Repair Manual for details of corrosion removal.

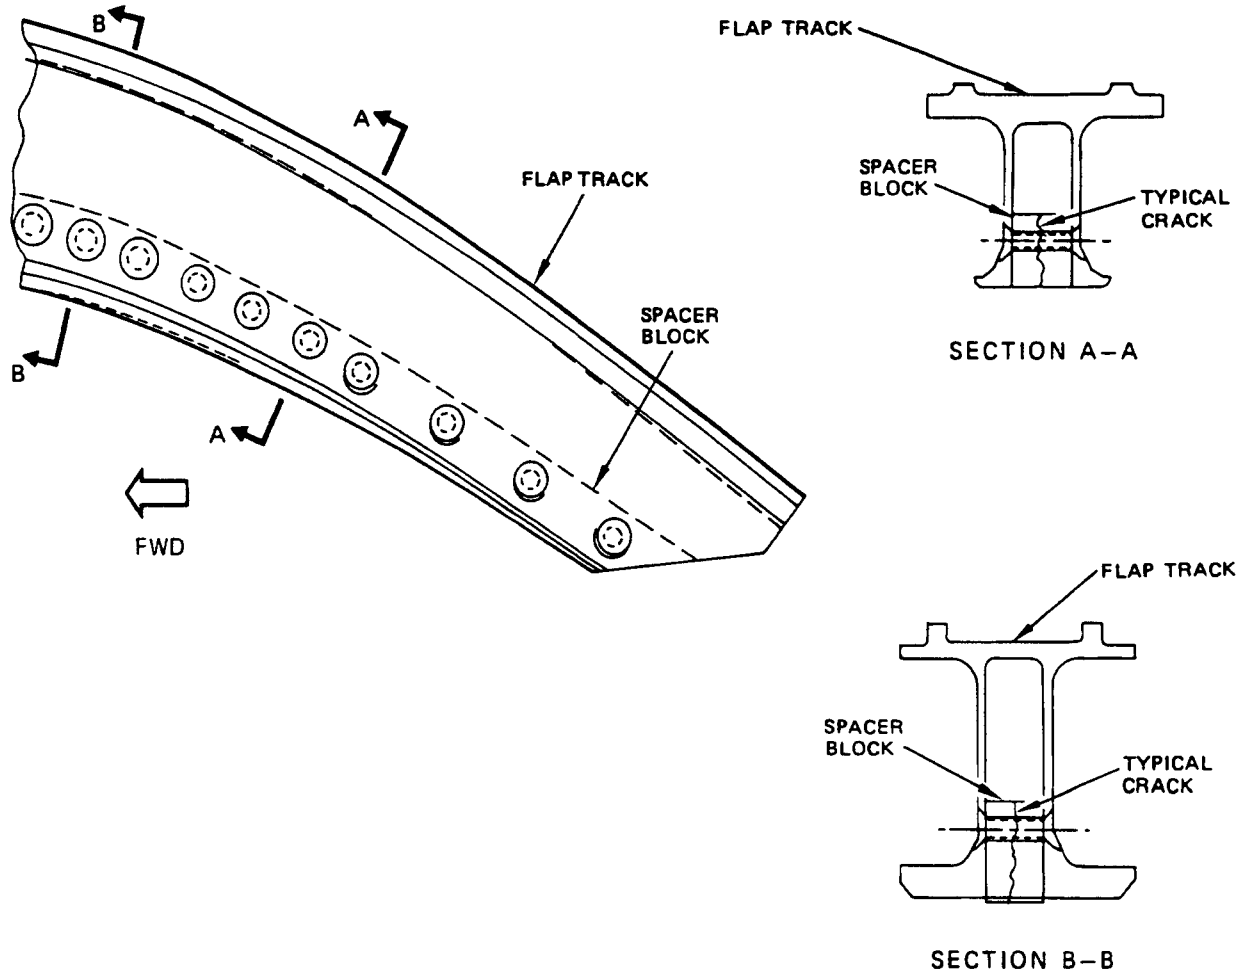
Trailing Edge Flaps
Figure 1 (Sheet 3)

DETAIL III
INBOARD FLAP TRACK SHOWN
OUTBOARD TRACK SIMILAR

- B. Stress corrosion cracking of the 7079-T6 aluminum alloy spacer blocks between the lower flanges of the flap tracks has been reported (Detail III). The 7079-T6 material has been replaced with 2024-T351 in production at cum line number 938 and can be installed retroactively by incorporating SB 57-136.

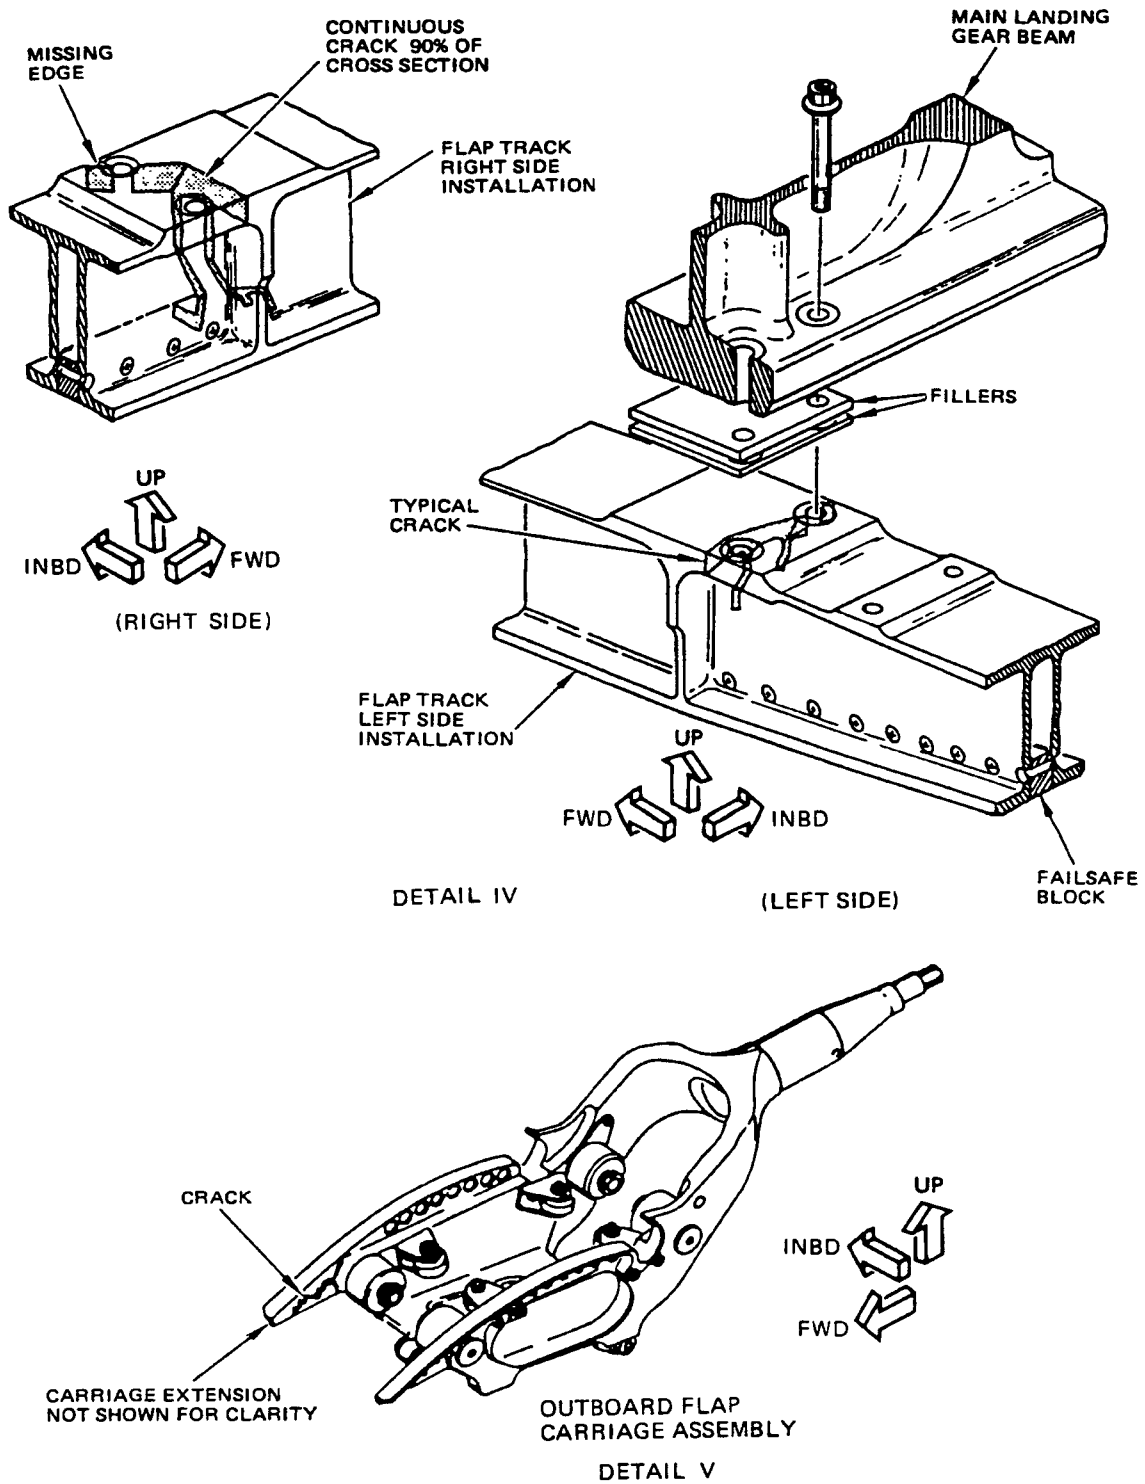
Trailing Edge Flaps
Figure 1 (Sheet 4)

- F. Stress corrosion cracks have been reported in the inboard track of the inboard trailing edge flap. Earlier reports of cracks on this track resulted in installation of an improved track. Cracks have been found in the improved tracks. The cracks propagated both inboard and outboard until upper flange was severed. The cracks also propagated down both vertical webs. The most severe case severed the inboard web and inboard lower flange and 75% down the outboard leg for a total crack area of 90% of the track cross section (Detail IV).

- G. Stress corrosion cracking has been reported in the trailing edge outboard flap carriage. The crack was found extending 2.0 inches from the lower edge of the forward end of the carriage right hand upper chord web, up and aft through one of two holes in the web where a carriage extension was attached and terminated in the second hole (Detail V)
