737 CORROSION PREVENTION MANUAL

Volume 2-737

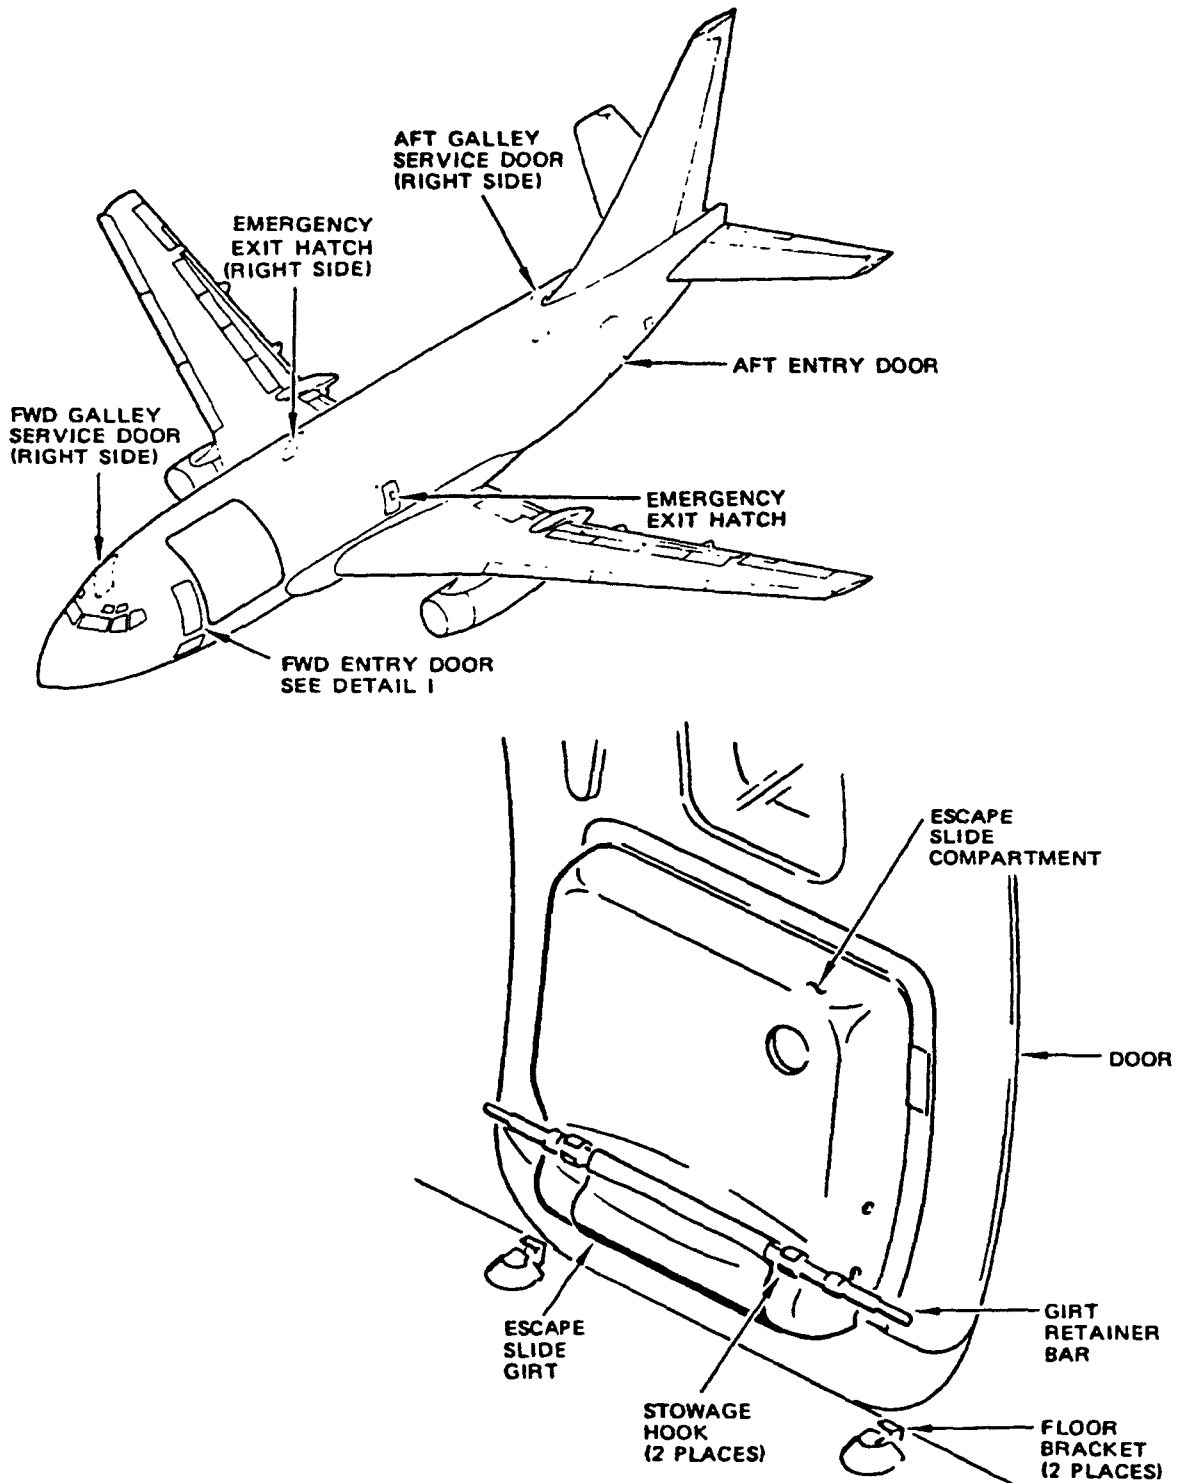
Door Mounted Escape Slide  
Figure 1 (Sheet 1)

AREA	PROBLEM	INDEX	TERMINATING ACTION (IF ANY)
		PREVENTION VOLUME 2	
Door Mounted Escape Slide	Corrosion has been found on girt retainer bar under the nylon sleeve	25-60-37 Fig. 1	Escape slide vendors notified to provide moisture barriers

- B. Severe corrosion has been the cause of floor bracket assemblies separating from the floor mounted adapter plate when the evacuation slide girt bar was attached.
- C. Corrosion has been encountered on the girt retainer bar under the nylon sleeve. Slide vendors have been notified to provide moisture barriers on new assemblies.

- (a) Remove nylon sleeves from girt retainer bar and make periodic inspection described in Volume 1, 20-20-00.
- (b) As an interim measure pending full inspection, apply water displacing corrosion inhibiting compound to the assembled girt retainer bar in the airplane by placing corrosion inhibiting compound adjacent to the sleeve ends with the aid of an eyedropper or similar applicator. Capillary action will distribute it to the sleeve/bar faying surface, thereby expelling any moisture.

- (1) SB 25-1084 provides modification procedures on evacuation slide floor bracket assemblies and floor mounted adapter plates.
- (2) Aluminum floor brackets were installed on early production airplanes and replaced with steel brackets to increase service life. Steel brackets may be installed retroactively by incorporating SB 25-1113. Service experience on other Boeing airplanes indicate that due to dissimilar metals this area can be a corrosion suspect area unless installations are accomplished with sealants and use of mylar shims as outlined in the service bulletin.

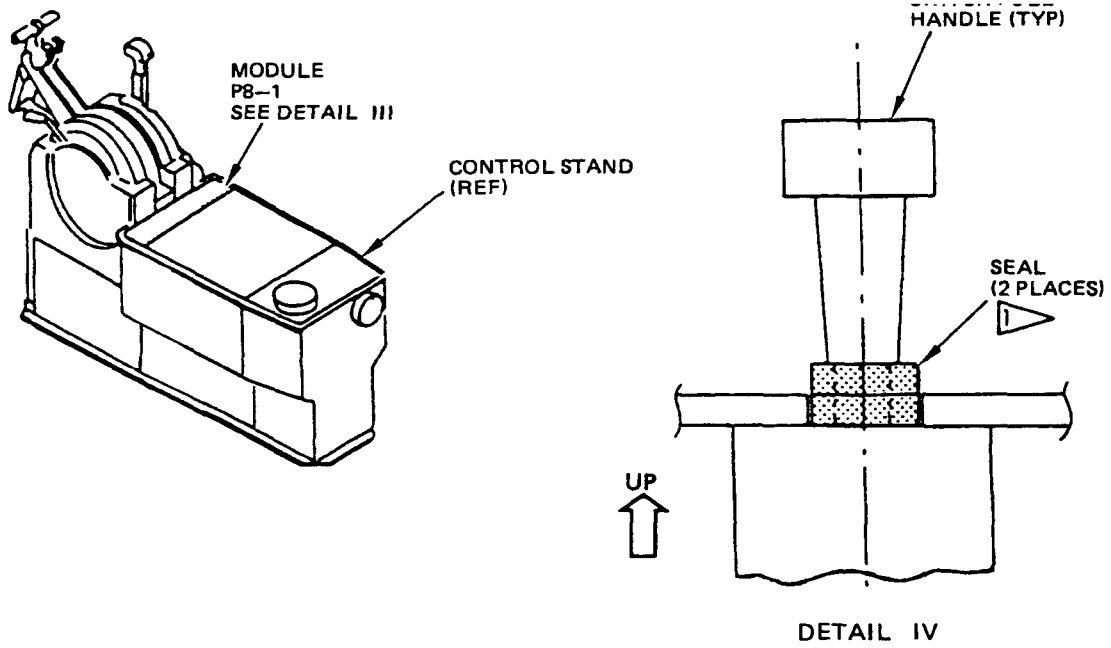
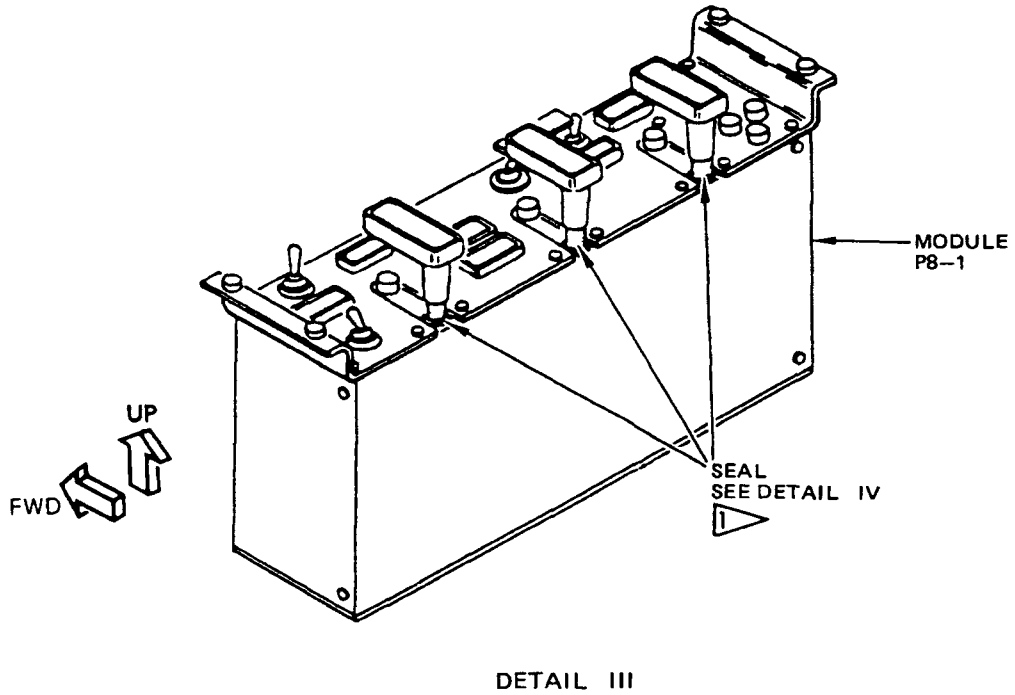
Fire Protection  
Figure 1 (Sheet 2)

▷ FIRE CONTROL SWITCHES SEAL  
MODIFICATION PER SB 26A1023

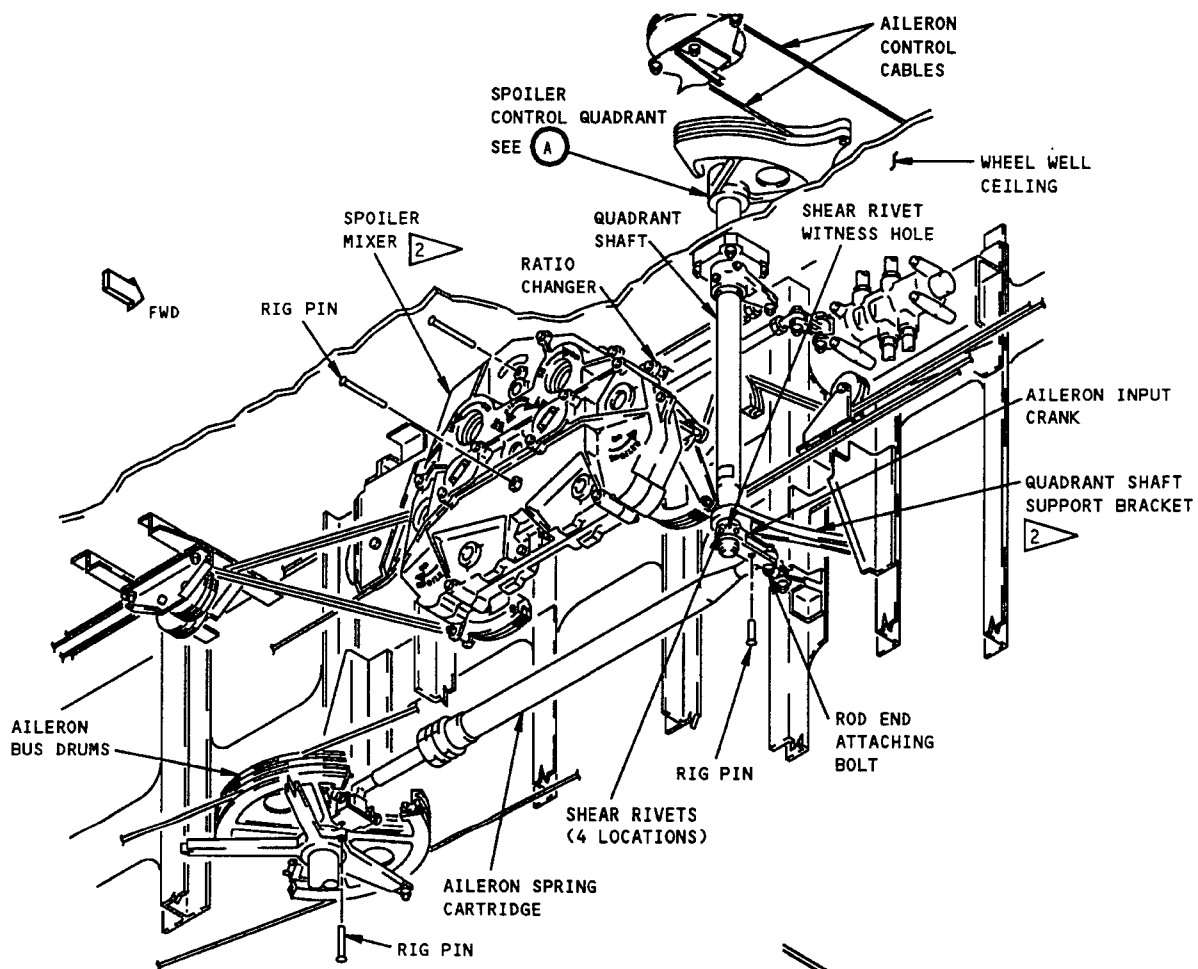
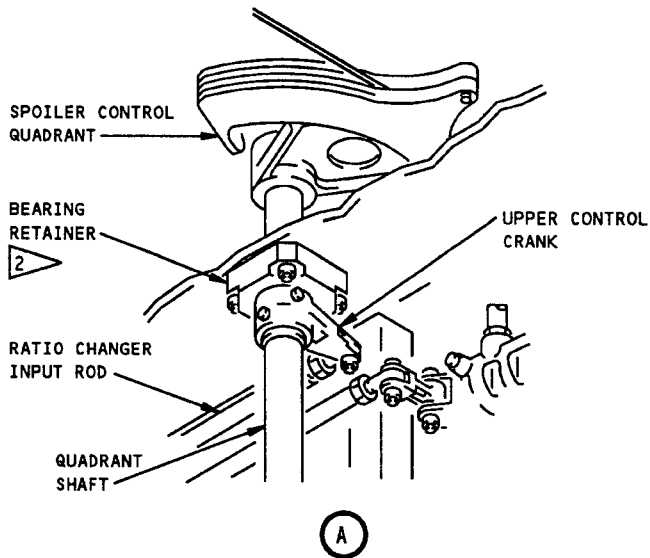
Spoiler Control System  
 Figure 1 (Sheet 3)

- 1 CORROSION CAN CAUSE CRACKS ON THE INTERNAL SURFACES OF THE HOUSING
- 2 CORROSION CAN OCCUR ON THE BEARINGS

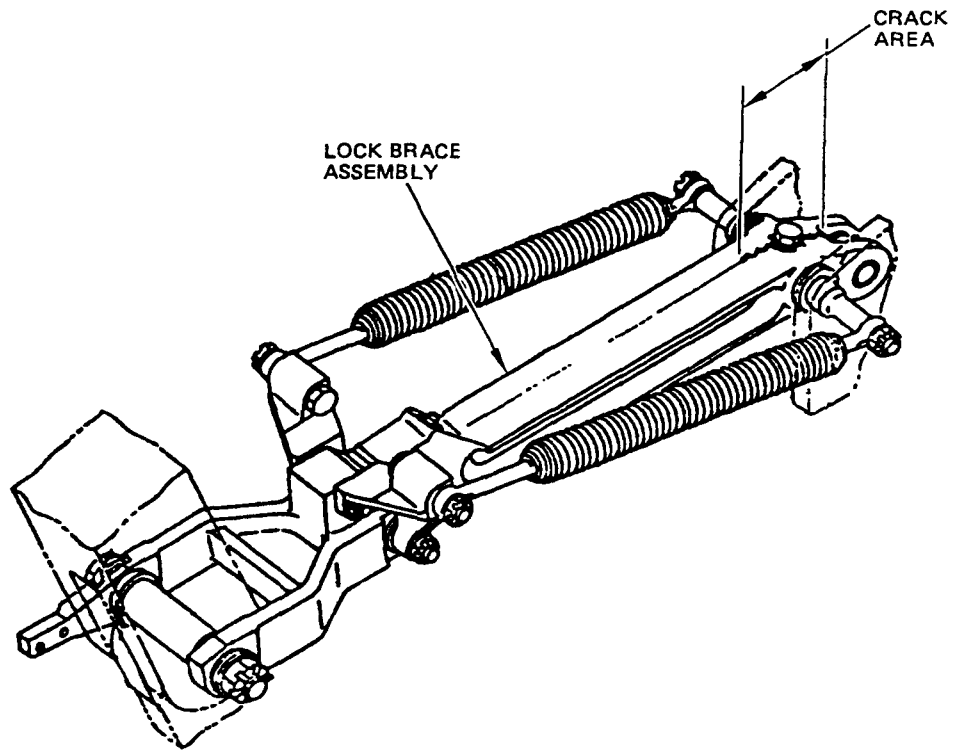
DETAIL III

- C. Stress corrosion cracks have been reported on the nose landing gear lock brace assembly. All cracks originated at the intersection of the 0.875 and 0.250 inch diameter holes and propagated along the forging parting plane. A lock brace assembly of 7075-T73 material is the preferred replacement for those assemblies manufactured from 7073-T6 (Fig. 1, Detail III).

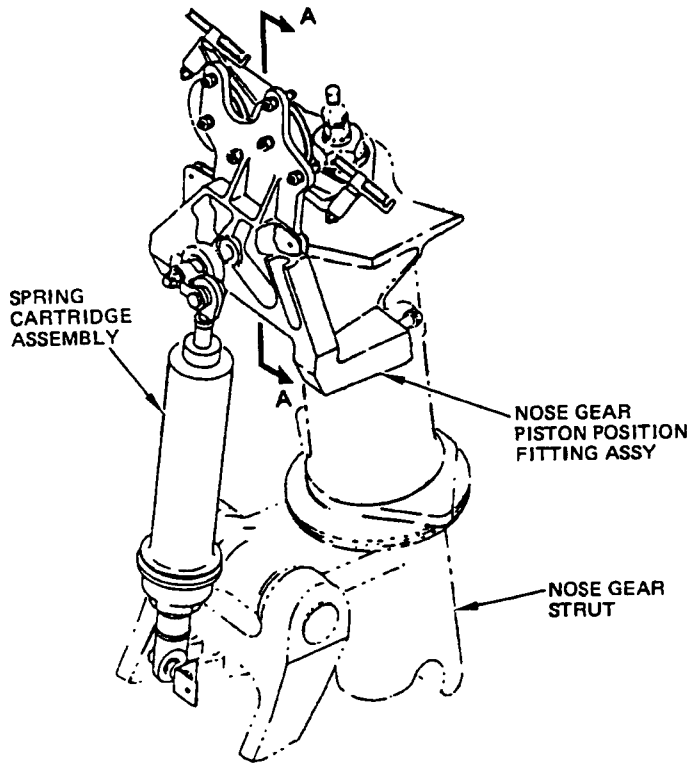
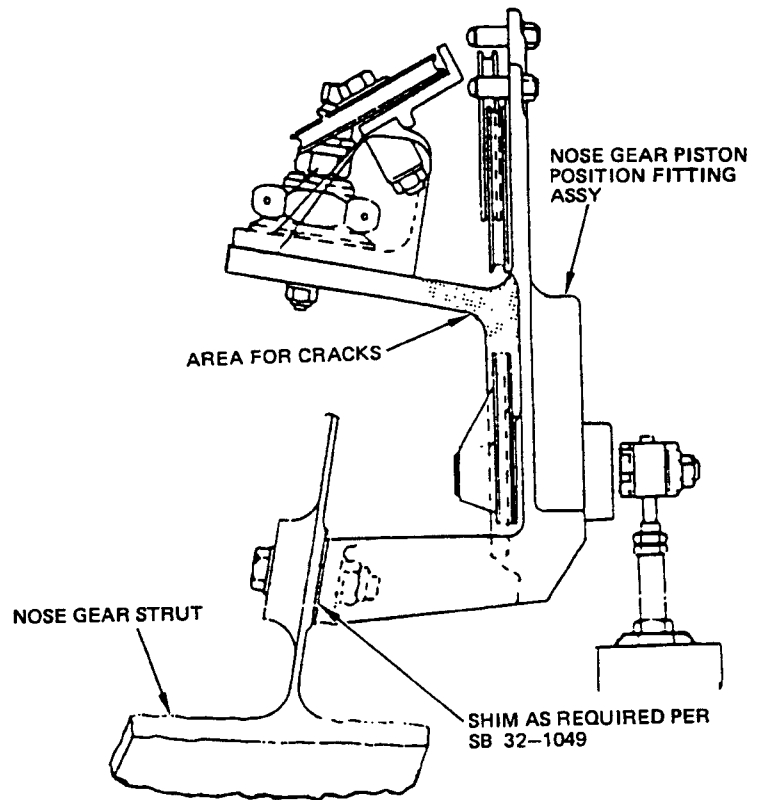
DETAIL IV

- D. Stress corrosion has been the cause of a fractured nose gear piston fitting assembly. The improper shimming, between the two lower legs of the fitting assembly and nose gear strut, permitted a hinge fit-up stress to develop in the fitting assembly and caused stress corrosion cracking (Fig. 1, Detail IV).

- E. Corrosion has been reported on tide piston position spring cartridge assembly. The spring cartridge assembly separated from the upper rod end fitting. Bearing corrosion, believed to be the cause of bearing separation, is attributed to moisture collecting in the spring cartridge assembly (Fig. 1, Detail IV).

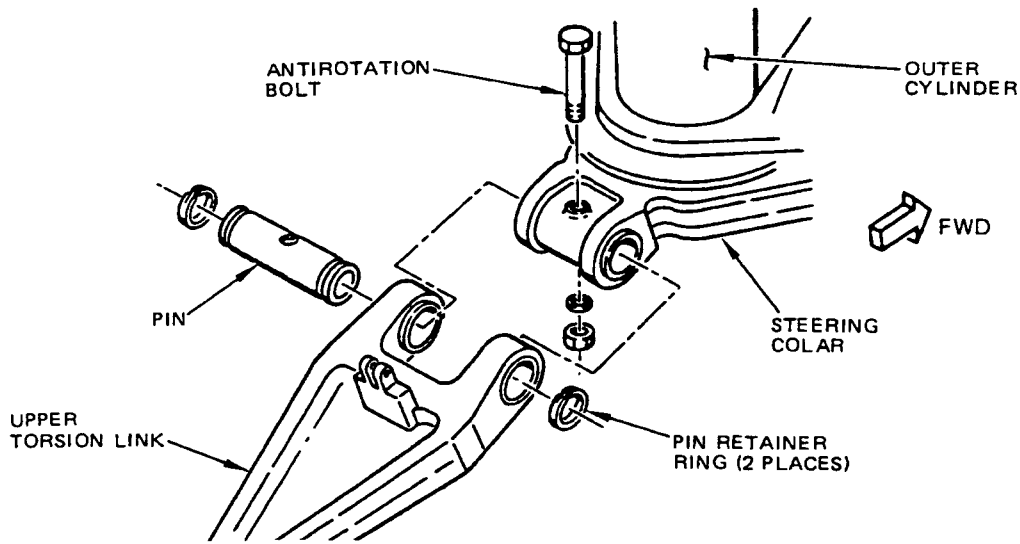
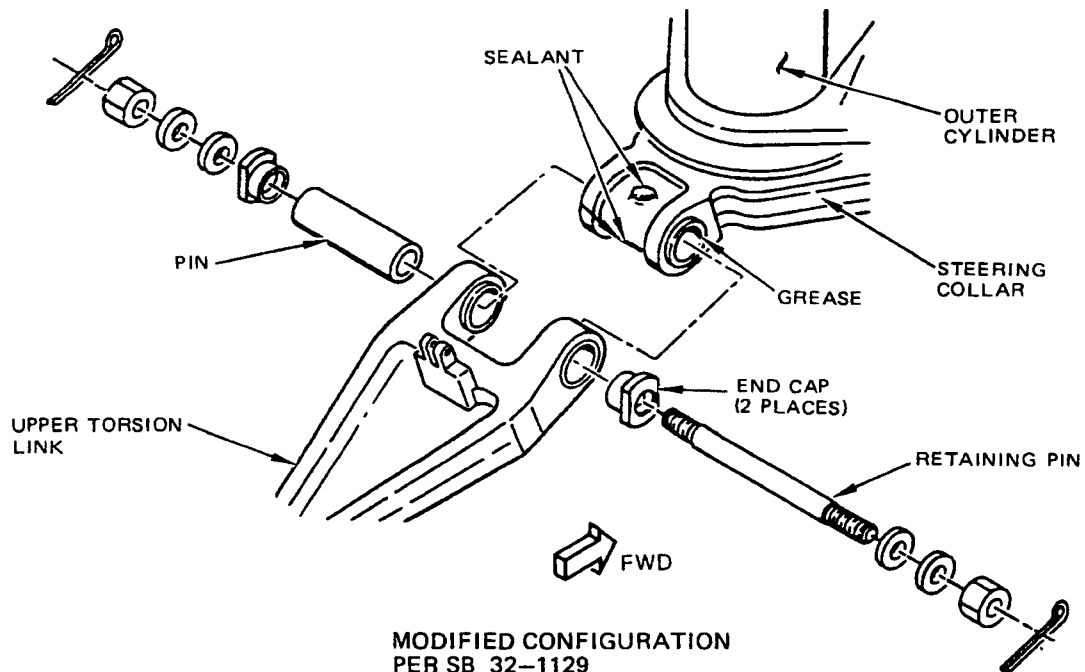
DETAIL V

- F. Stress corrosion fracture has been reported on hydraulic transfer cylinder end caps. Aluminum is the material used on the fractured end caps.
- G. Excessive corrosion has been reported on the nose landing gear torsion link pin and shaft (Fig. 1, Detail V).

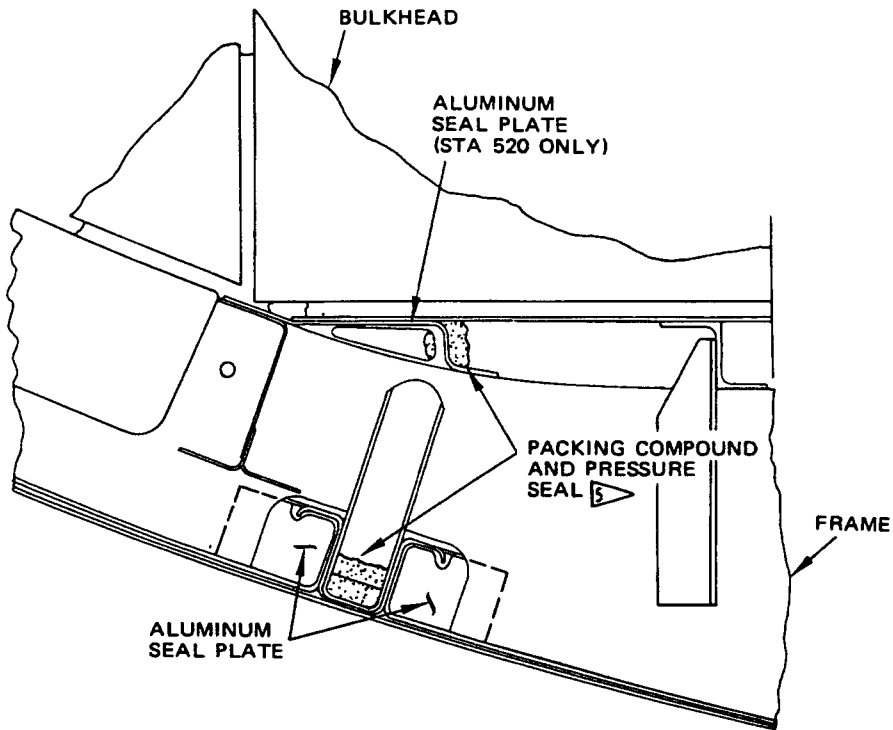
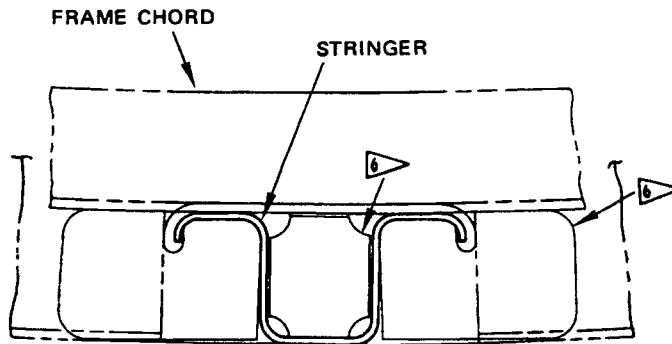
Lower Lobe Structure  
Figure 2 (Sheet 3)

- C. To help clean out contamination in the lower lobe, dam divide the bilge into compartments for optional hose out operations (see Detail V). But on some airplanes, these dams have foam blocks which can become soaked with moisture and cause corrosion. Also, some 737-400 and 737-500 airplanes were delivered without the metal seal plates in the forward cargo compartment for the hose out option. Corrosion can occur if these airplanes are hosed out, because the water gets into adjacent areas and soaks insulation blankets. On line numbers 2547, 2609 and 2655, MC 5121 MP3070 provides for sealing of the aft side of station 380 frame and the forward side of station 5006 frame.

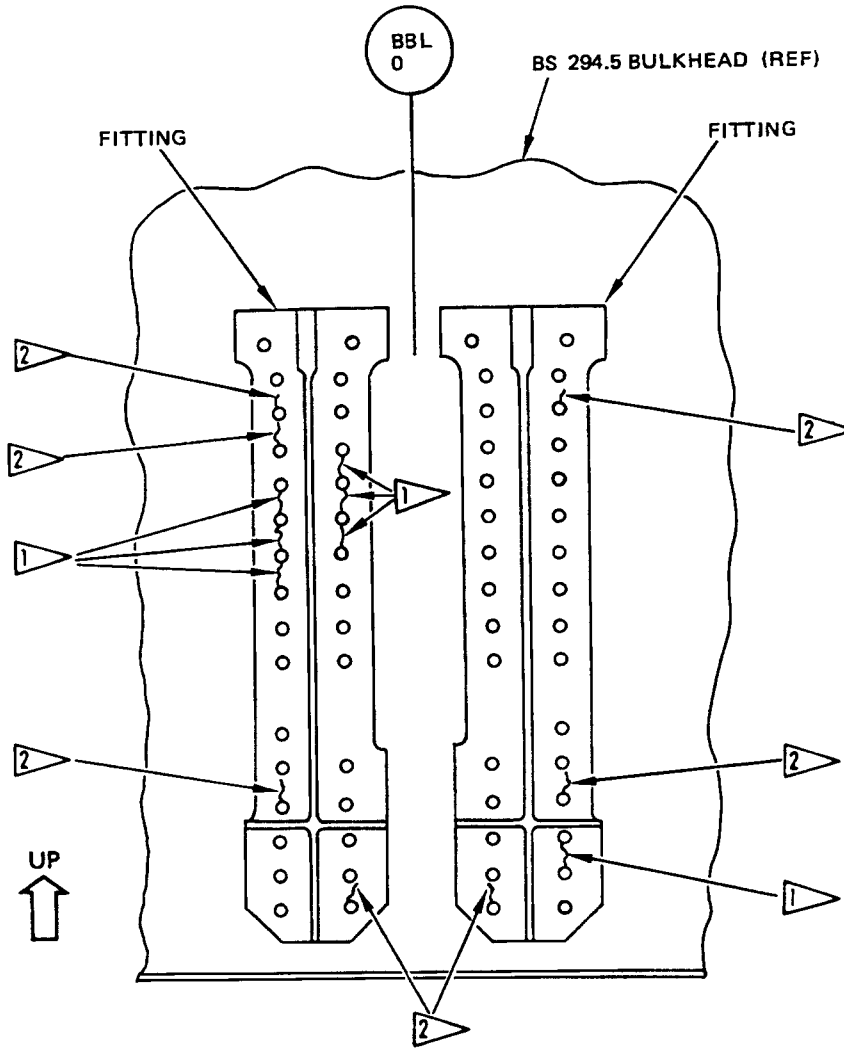
Nose Gear Wheel Well  
Figure 5 (Sheet 2)

- 1 ▷ CRACK LOCATION ON AIRPLANE WITH 5567 FLIGHT HOURS
- 2 ▷ CRACK LOCATION ON AIRPLANE WITH 5648 FLIGHT HOURS.

- C. The lock support fittings on the BS 294.5 bulkhead have been the subject of stress corrosion cracking. Fittings of improved material were introduced at line number 285 and may be installed retroactively by SB 53-1033 (refer to Fig. 5, Sec. A-A).

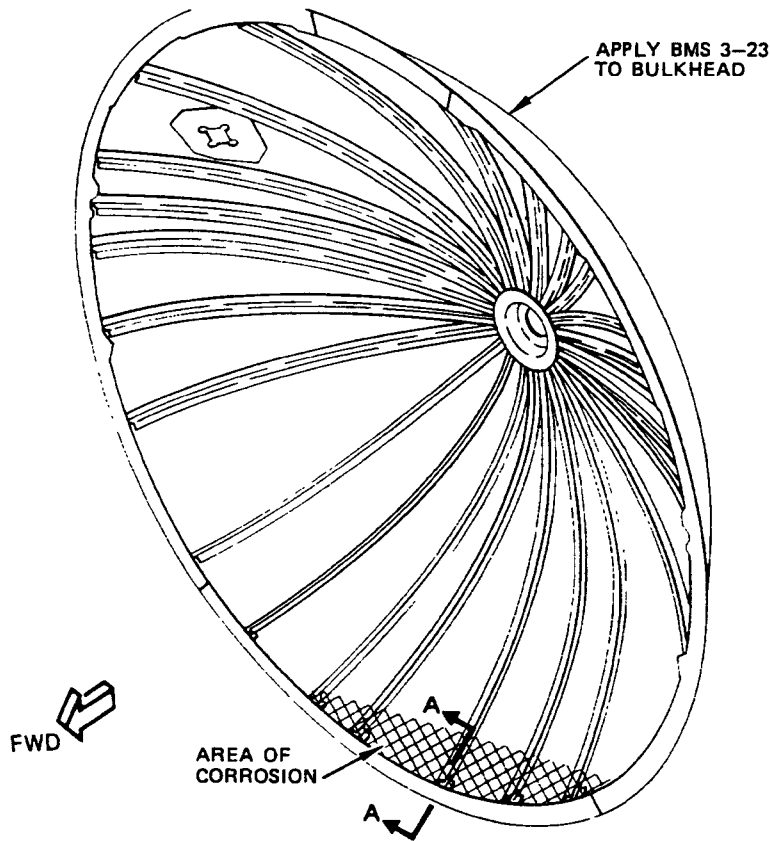
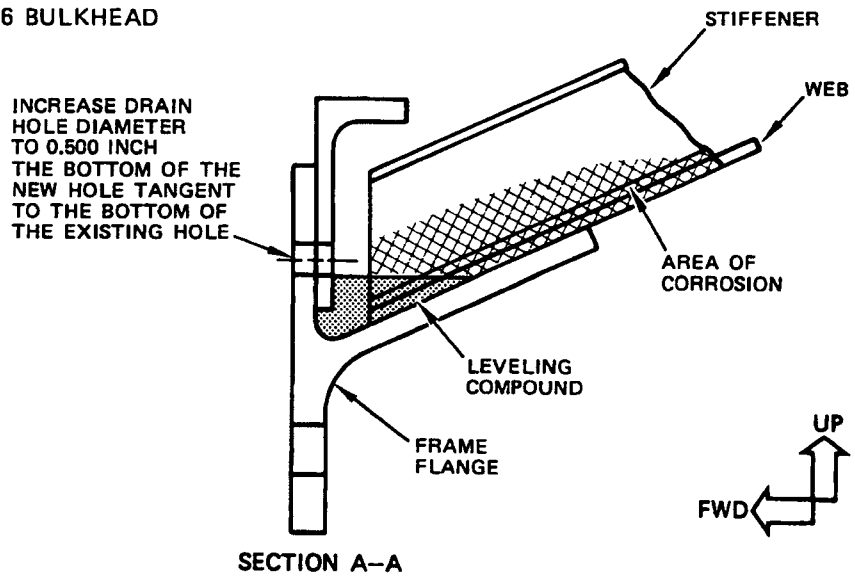
Aft Pressure Bulkhead  
Figure 8 (Sheet 1)

- G. Severe corrosion and corrosion cracking have been reported on the lower ten inches of the bulkhead forward face. Corrosion of the bulkhead web can result in severe cracks and rapid cabin depressurization. The corrosion, as noted in SB 737-53A1075, has been attributed to fluids from galleys and lavatories. A plugged drain hole in the station 1016 frame chord assembly can trap these fluids and thereby accelerate the corrosion process. See 53-10-37, figure 8 for aft pressure bulkhead.

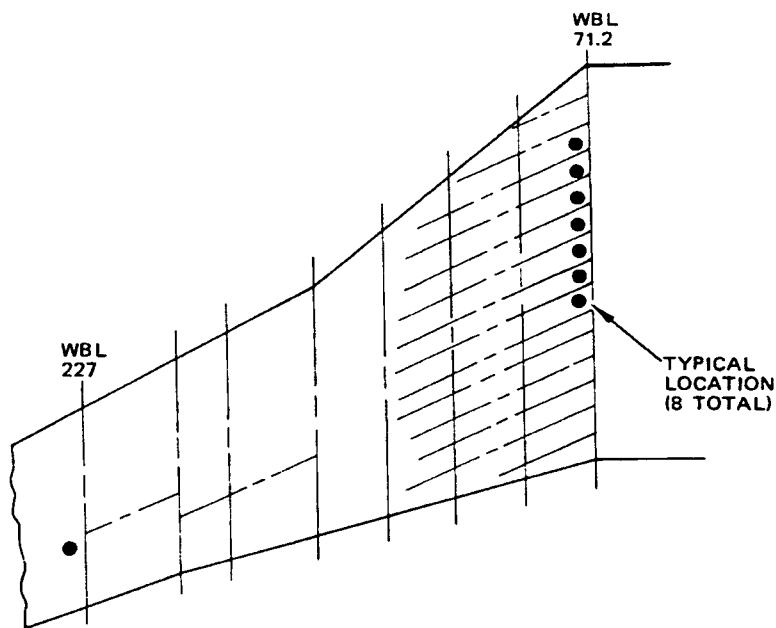
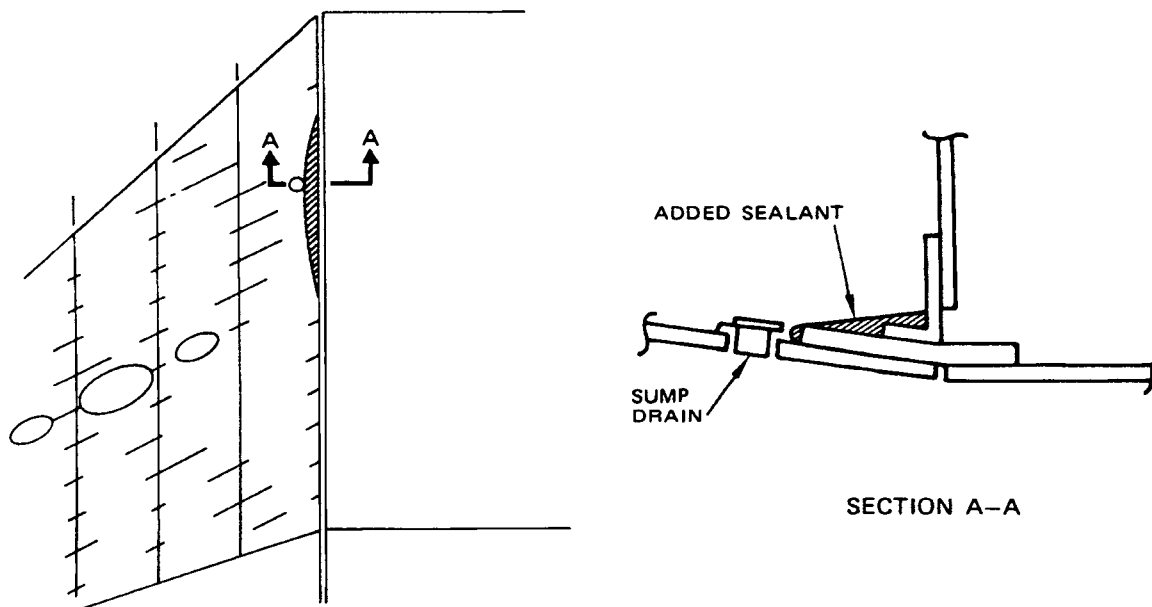
Outer Wing Internal Structure  
Figure 2 (Sheet 2)

- C. Some operators have experienced corrosion on the interior surfaces of the wing. This corrosion is usually caused by microbial growth which requires the presence of water in the tank (Fig. 2).

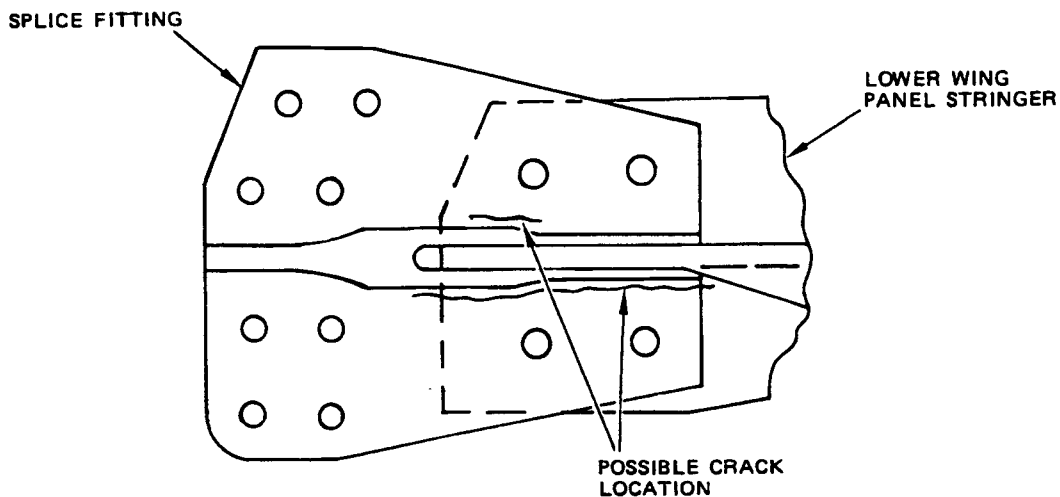
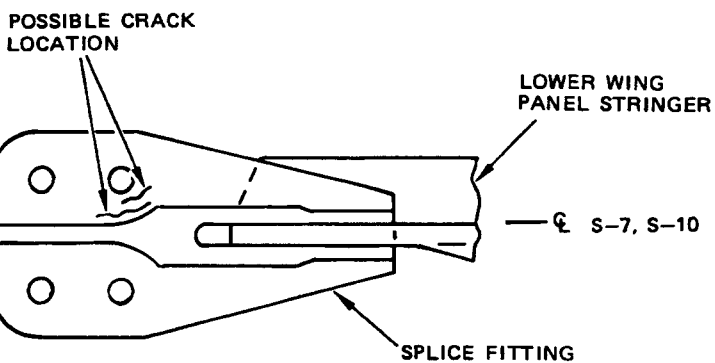
Outer Wing Internal Structure  
Figure 2 (Sheet 3)

- (10) Stress corrosion cracks have been found in the lower wing panel stringer-to-rib splice fittings (WBL 70.85) at left wing stringers 5 and 7, and right stringers 5 and 10. These cracks were located in the fillet between the vertical and horizontal flanges of the fittings (Fig. 2, Detail V, VI).

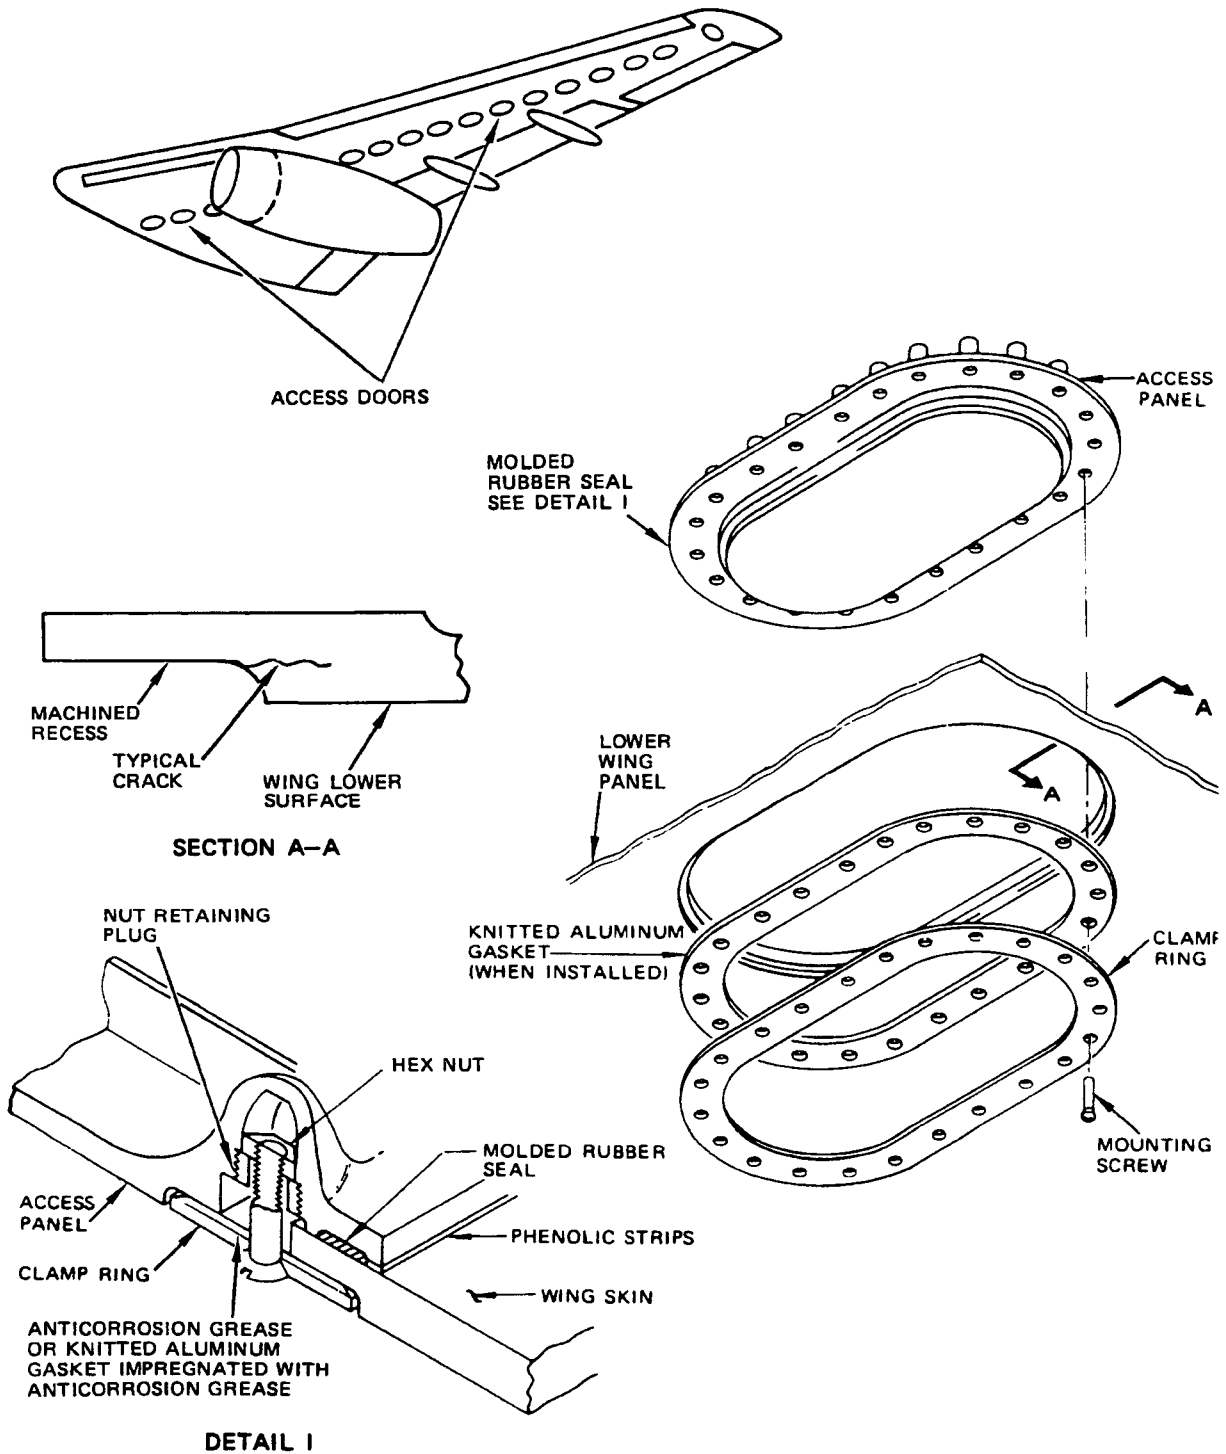
Outer Wing Fuel Tank and Boost Pump Access Cutouts  
Figure 3

- D. The wing lower skin in the area of the reserve and main tank access door cutouts is susceptible to inter granular corrosion. This is attributed to exposed aluminum end grain combined with fretting between the access panel and the wing lower skin. Reports indicate that corrosion occurs on the wing lower skin faying surface adjacent to the access door clamp ring. Cracks have been reported originating in the machined radius of the wing skin extending into the skin in a plane parallel to the skin surface (Fig. 3).
