CORROSION PREVENTION MANUAL

Volume 2-747

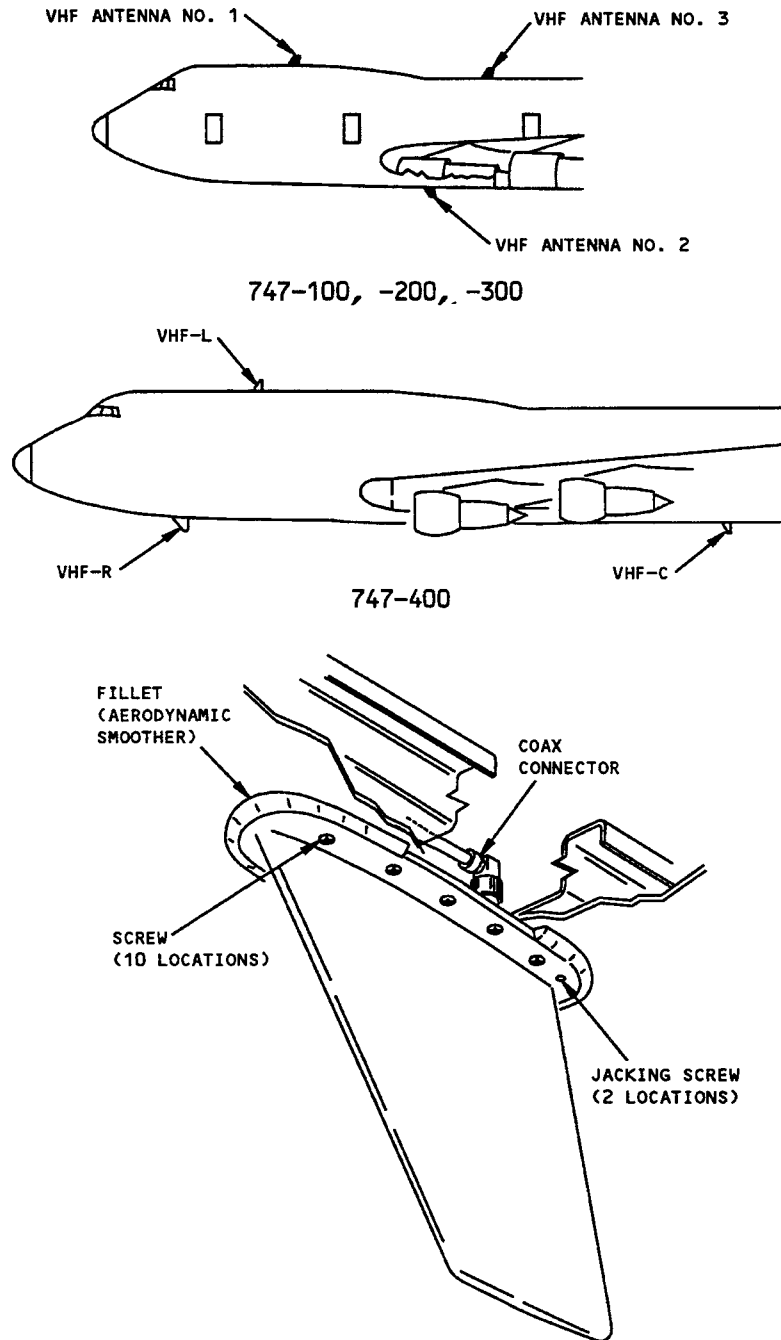
VHF Antenna Installation
Figure 2

A. Corrosion can occur between the exterior-mounted VHF antennas and the fuselage skin.

A. Regularly remove the antennas and examine the mating surfaces for corrosion.

(1) At line number 937, PRR 82473 changed the procedure that installs these antennas on the exterior of the airplane. BMS 10-79, Type III primer and BMS 3-27 corrosion preventive compound are applied to the skin under the antennas, and the fasteners are cadmium-plated stainless steel.

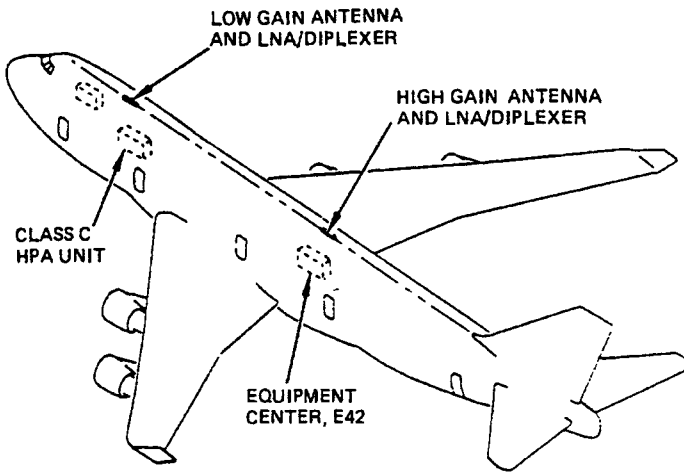
Aviation Satellite Communication System
Figure 1

- A. The aviation satellite communication (SATCOM) system gives data and voice links between the airplane and the ground. The signals go through geostationary satellites. Not all 747 airplanes have this system.
- B. Corrosion can occur between the SATCOM antennas and the fuselage skin.

- A. Regularly remove the SATCOM antennas and examine the mating surfaces for corrosion.
- B. Improved Corrosion Protection
 - (1) At line No. 937, PRR 82473 changed the procedure that installs this antenna on the exterior of the airplane. BMS 10-79, Type III primer and BMS 3-27 corrosion preventive compound are applied to the skin under the low-gain antenna, and the fasteners are cadmium-plated stainless steel. (The SATCOM high-gain antenna installation is not changed by this production change.)
 - (2) Some installations of the SATCOM high-gain antenna did not include protective finish or sealant. These and other changes can be made with SB 23-2254.

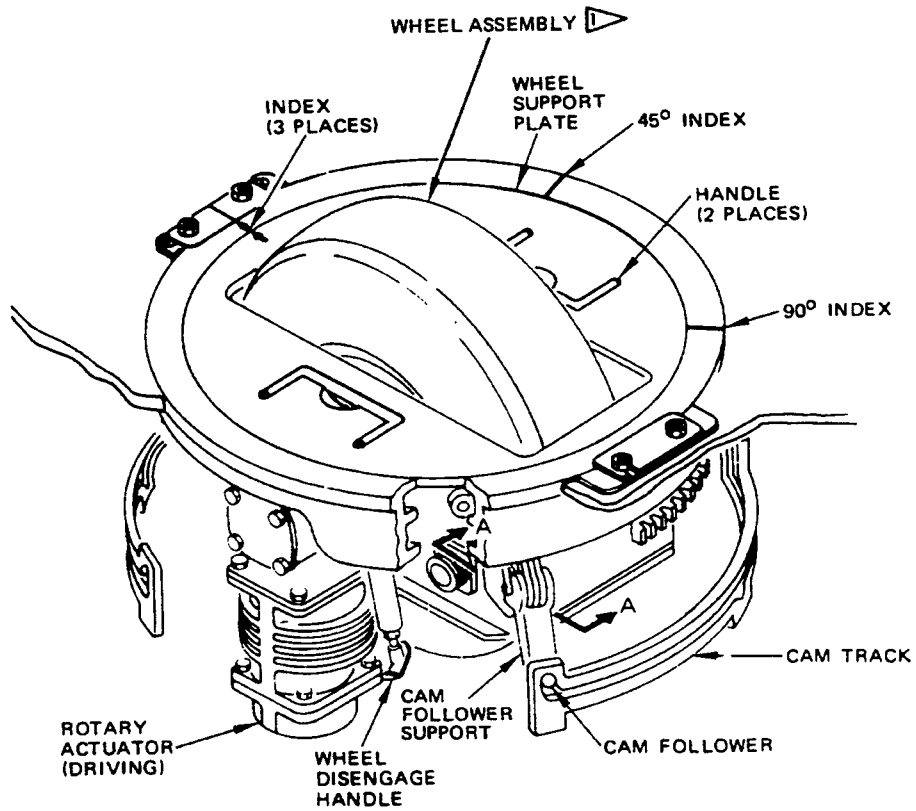
RETRACTABLE DRIVE UNIT
(AIRPLANES WITH SIDE CARGO DOOR)
DETAIL III

CORROSION CAN OCCUR ON THE AXLE OF THIS WHEEL ASSEMBLY

- A. On freighters, the main deck cargo compartment has a power-driven conveyor system that moves cargo containers into and out of the airplane, or into locations on the deck for shipment. Power drive units in the floor move the cargo containers. Each power drive unit has a wheel assembly driven by a rotary actuator.
- B. Corrosion can occur on the axle of the wheel assembly. The axle material is cadmium-plated carbon steel.

- A. Regularly examine the wheel assemblies of the power drive units for corrosion. For wheel assemblies 4000162-series (60B60008-series), refer to Aircraft Braking Systems (V25500) Overhaul Manual 25-53-06 for details.

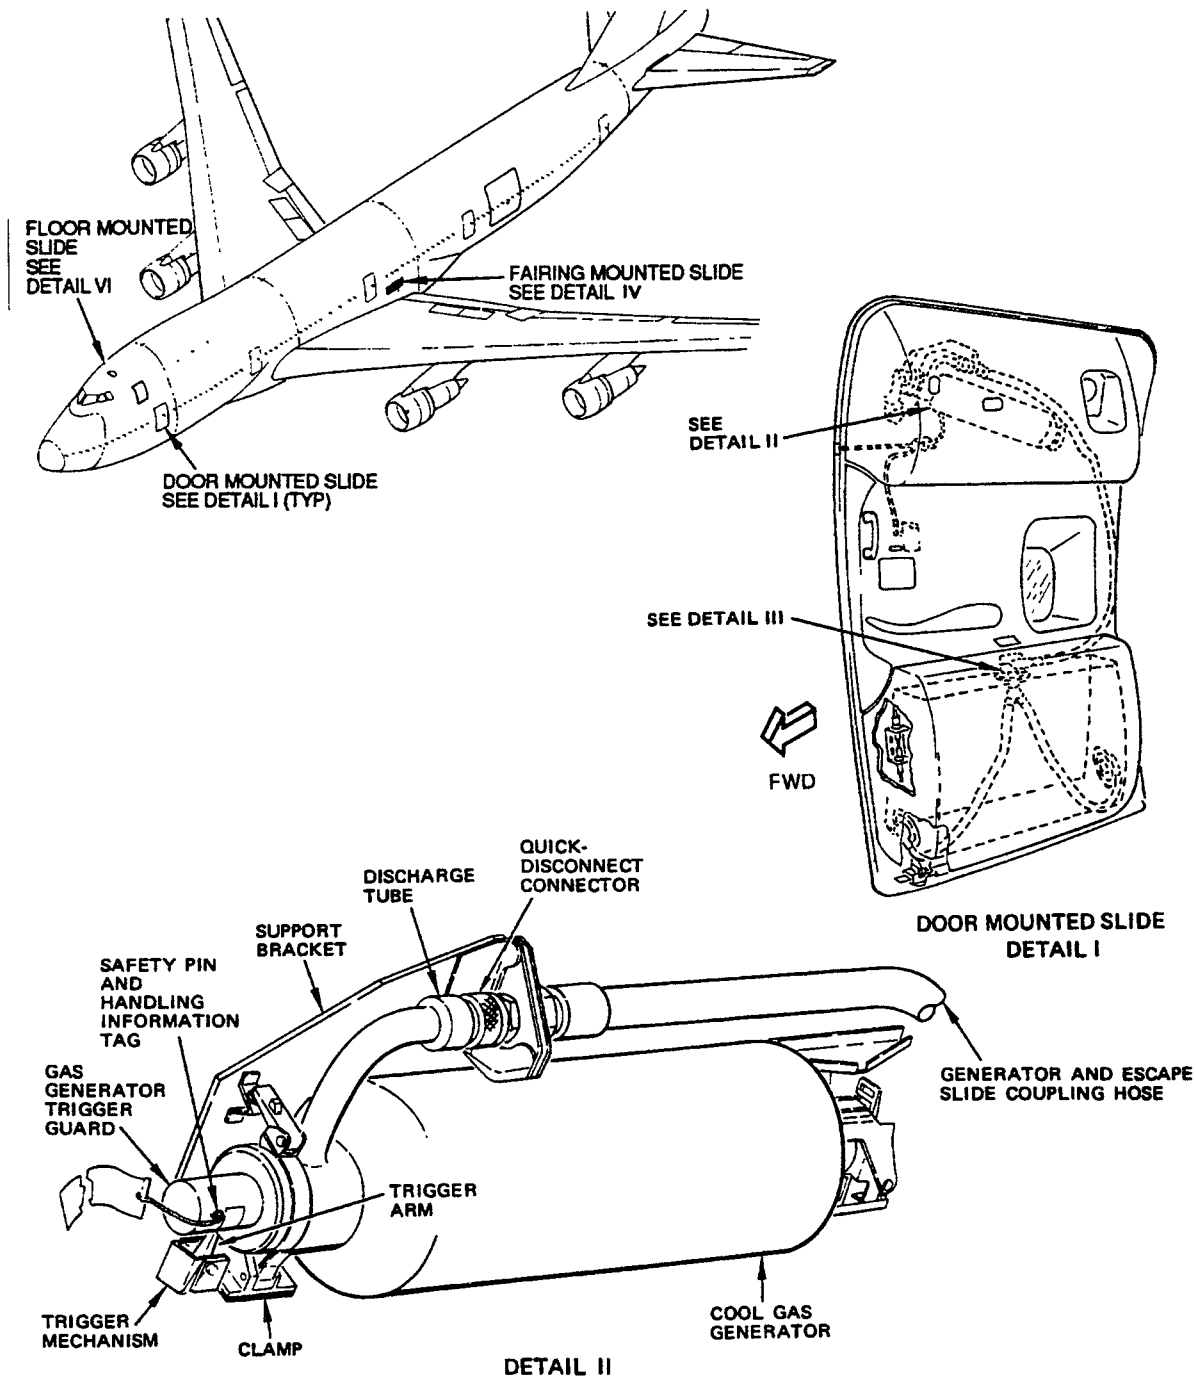
Escape Slides
Figure 2 (Sheet 1)

- A. Emergency escape slide system components have been involved with corrosion problems. Various degrees of corrosion on the latch mechanism, manifolds, couplings, fittings and associated lines has been reported. It is possible that prolonged exposure to condensation may be a factor in the deterioration of these components since the installations are not readily accessible for inspection and maintenance.

- A. Off-wing escape slide compartment door components such as the latch integrator, latch mechanism and slide pack release mechanism are protected in production by the application of butter lube with Dow Corning 33 light consistency grease. However, prolonged exposure to condensation during operation has caused moderate corrosion to these components.
- B. In normal operations, the escape slide compartment mechanisms are lubricated during maintenance checks on the escape systems. Where an airline has a history of corrosion in this area, more frequent lubrications should be performed in accordance with 12-21-14 of the Maintenance Manual.
- C. Refer to Structural Repair Manual for corrosion removal procedures.

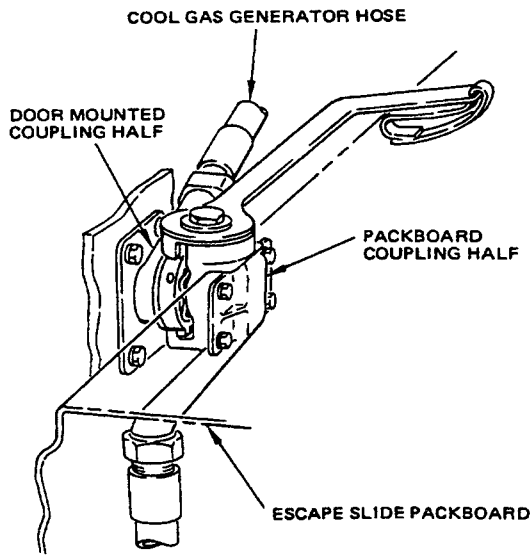
SLIDE INFLATION COUPLING
DETAIL III

- B. Corrosion can occur within the cool gas generator tank on the inner parts exposed to freon residue.
- C. Corrosion can occur on the door mounted coupling half on the escape slide inflation system.

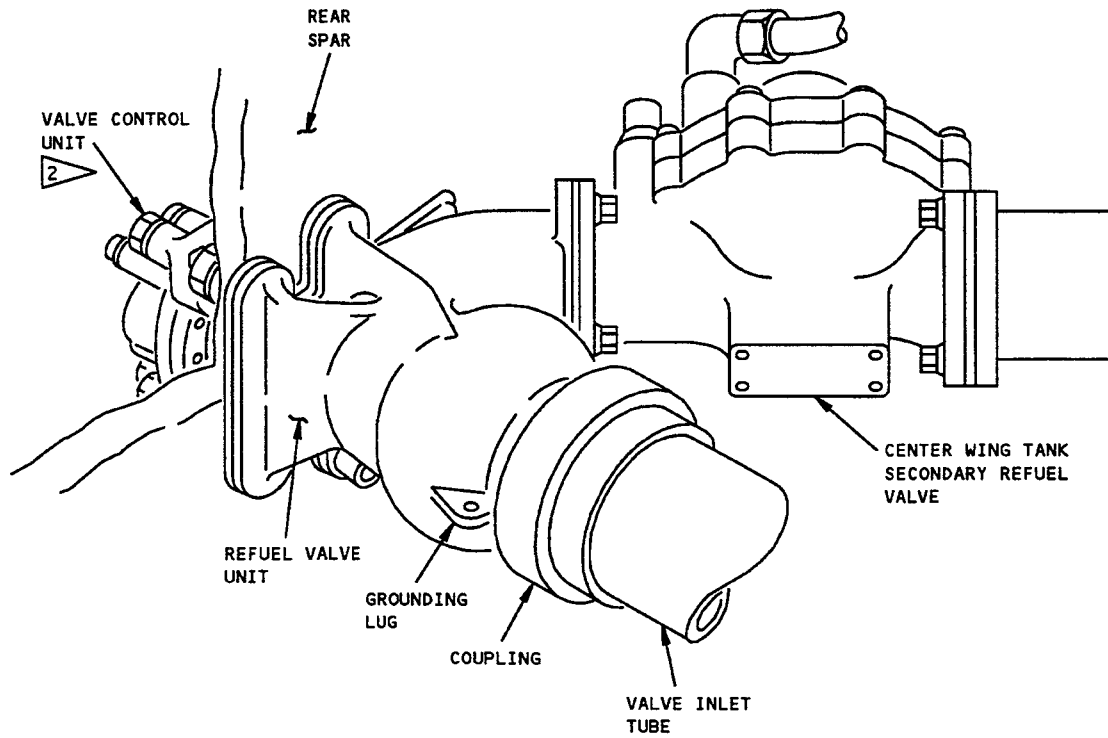
CENTER TANK REFUEL VALVE UNIT
DETAIL II

- 1 INSTALLED ON AIRPLANES WITH A HORIZONTAL STABILIZER FUEL TANK
- 2 CORROSION CAN OCCUR ON THE SWITCH BECAUSE OF FUEL IN THE SWITCH CHAMBER

- A. The pressure fueling system refuel valves include a solenoid-operated control unit mounted on the exterior of the tank. The solenoid is connected to the valve mechanism inside the tank with an O-ring seal. If the O-ring seal is defective or not correctly installed, fuel can come through it and get into the housing to cause corrosion of an electrical switch.

- A. Regularly examine the interior of the control unit for signs of fuel in the switch chamber, and for corrosion of the switch contacts. Make sure the O-ring is correctly compressed and the cover is correctly shimmed. For J.C. Carter (V86090) units, refer to J. C. Carter CMM 28-20-05.

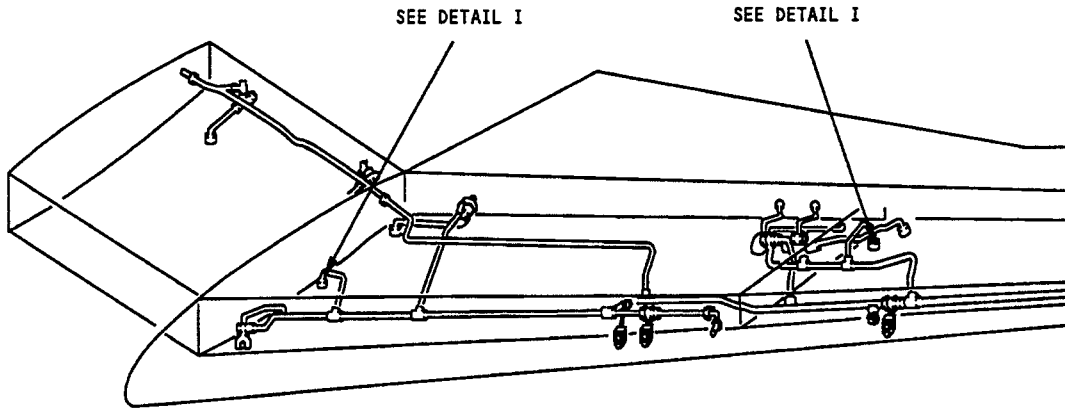
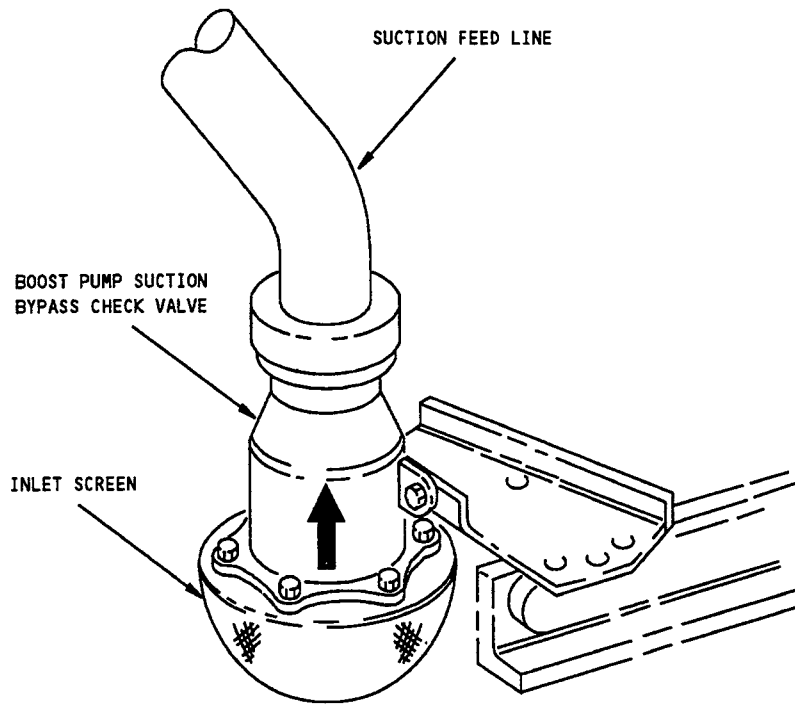
Boost Pump Suction Bypass Check Valve
Figure 2

- A. Corrosion can occur on the disc closure spring in the fuel boost pump suction bypass check valve. This could cause spring failure and unwanted fuel transfer, or damage to the bypass check valve assembly.

- A. Regularly examine the disc closure spring for signs of corrosion. For Allen Aircraft Products (V82829) units, refer to Allen Aircraft Products CMM 28-22-01.
- B. The vendor plans to make a decision about a corrosion resistant material for this spring.

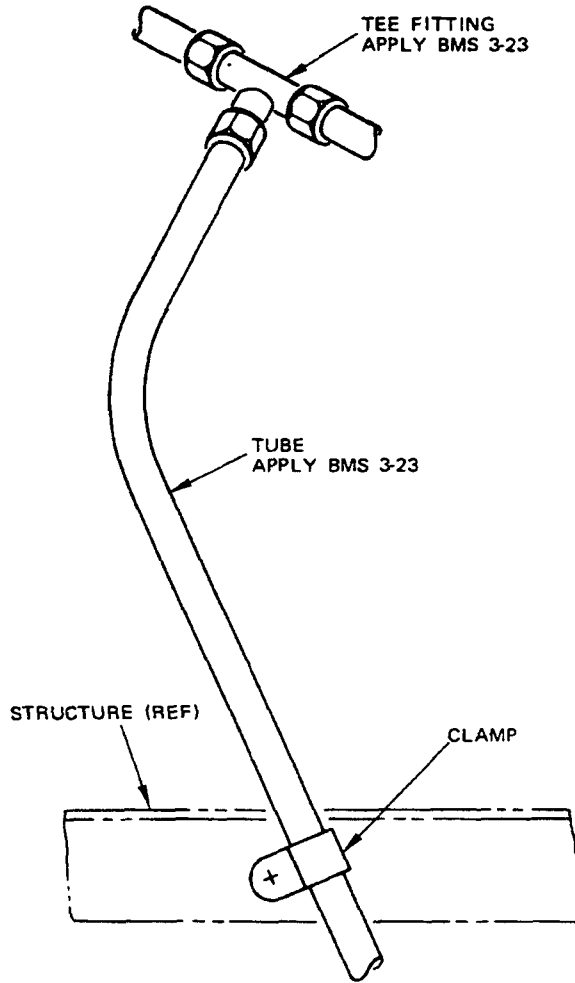
Hydraulic Plumbing
Figure 1

- A. The high pressure hydraulic lines are unpainted corrosion resistant steel. The low pressure hydraulic lines are unpainted 5000 or 6000 series aluminum alloys. Valves and fittings are anodized aluminum or corrosion resistant steel. Sometimes these items get signs of superficial pitting which must be removed to prevent leaks.
- B. Clamps are usually solid nylon or silicone rubber cushioned steel.
- C. For better corrosion protection, some customers apply BMS 3-23 (LPS-3) water-displacing corrosion inhibiting compound or Ardrox 3961 to all steel hydraulic lines located in the unpressurized areas.
- D. Corrosion pitting has been found on 14 aluminum hydraulic tubes. This is the first reported instance of corrosion pitting of primer-coated aluminum tubing. The protective finish was also damaged by scratches and abrasion in some areas.

- A. Make the regular inspections of Volume 1, 20-20-00 to prevent or find the start of corrosion. Fasteners that are gone, white powdery or other deposits are signs of corrosion.

- B. After you clean the areas, do the inspections of Volume 1, 20-20-00 to make sure that protective finishes stay serviceable.
- C. If you find corrosion (bulges of the skin or white deposits of corrosion products at fastener heads or joint edges), refer to Structural Repair Manual for details of corrosion removal.

- D. For small amounts of corrosion, to decrease the downtime of the airplane, clean off the corrosion products. Apply a corrosion inhibiting compound into the affected area to stop the corrosion process. Refer to Volume 1, 20-60-00 for how to apply corrosion inhibiting compound. Repair the finish system when the maintenance schedule permits.

- E. Prevention Treatment
 - (1) Apply water displacing corrosion inhibiting compound on tubings and fittings with a cloth wet with this compound. This will clean them and put a thin protective layer on the tubings and fittings.

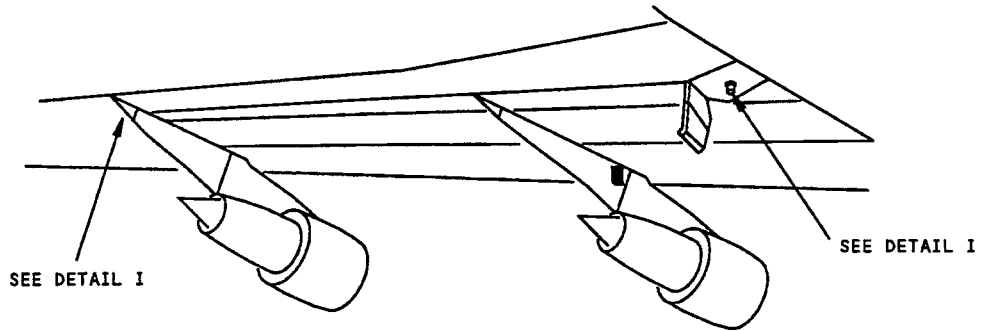
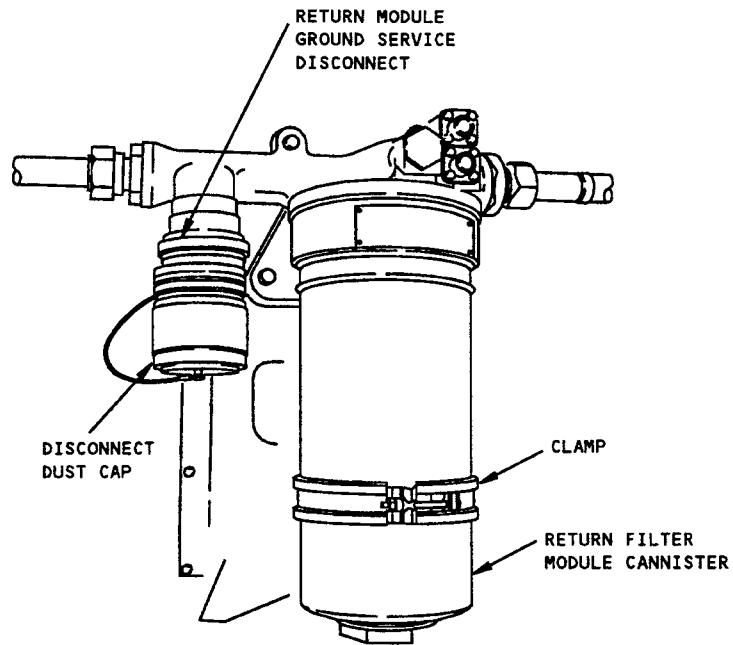
Return Hydraulic Filter Installation
Figure 2

- A. The return hydraulic filter installation has filter cannisters which are held in clamps that have rubber cushions. Corrosion can occur because of sulfur compounds from the rubber cushions, if the rubber was not cured correctly.

- A. Regularly examine the return filter module cannisters for corrosion. If you find signs of corrosion, replace the clamps with new clamps that have ethylene propylene rubber.
- B. Improved Corrosion Protection - In November 1988, the material of the clamp cushion was changed from BMS 1-33 synthetic rubber to BMS 1-50 ethylene propylene rubber. This change can be made on earlier airplanes with a service letter scheduled for release in 1991.

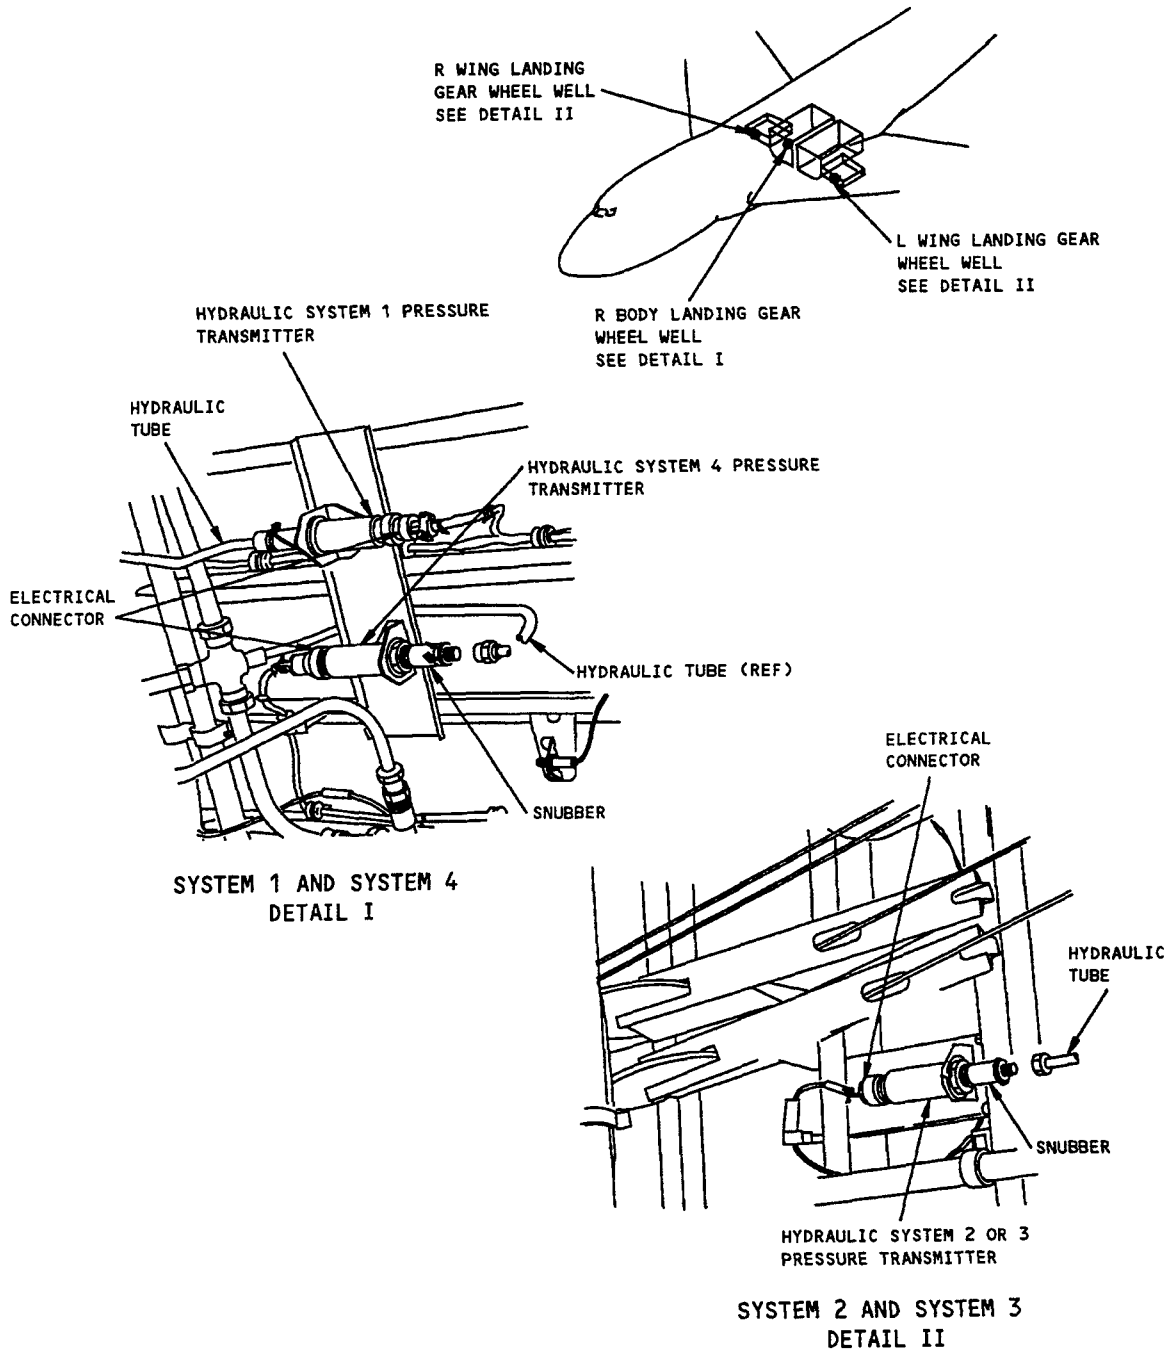
Hydraulic System - Pressure Transmitters
Figure 1

- A. Stress corrosion can cause cracks in the threads of hydraulic pressure transmitter snubbers 8195-33. This can cause leakage of hydraulic fluid from the system.

- A. Regularly examine the hydraulic pressure transmitters for leakage, which could be caused by cracks in the snubber threads. Replace defective snubbers.

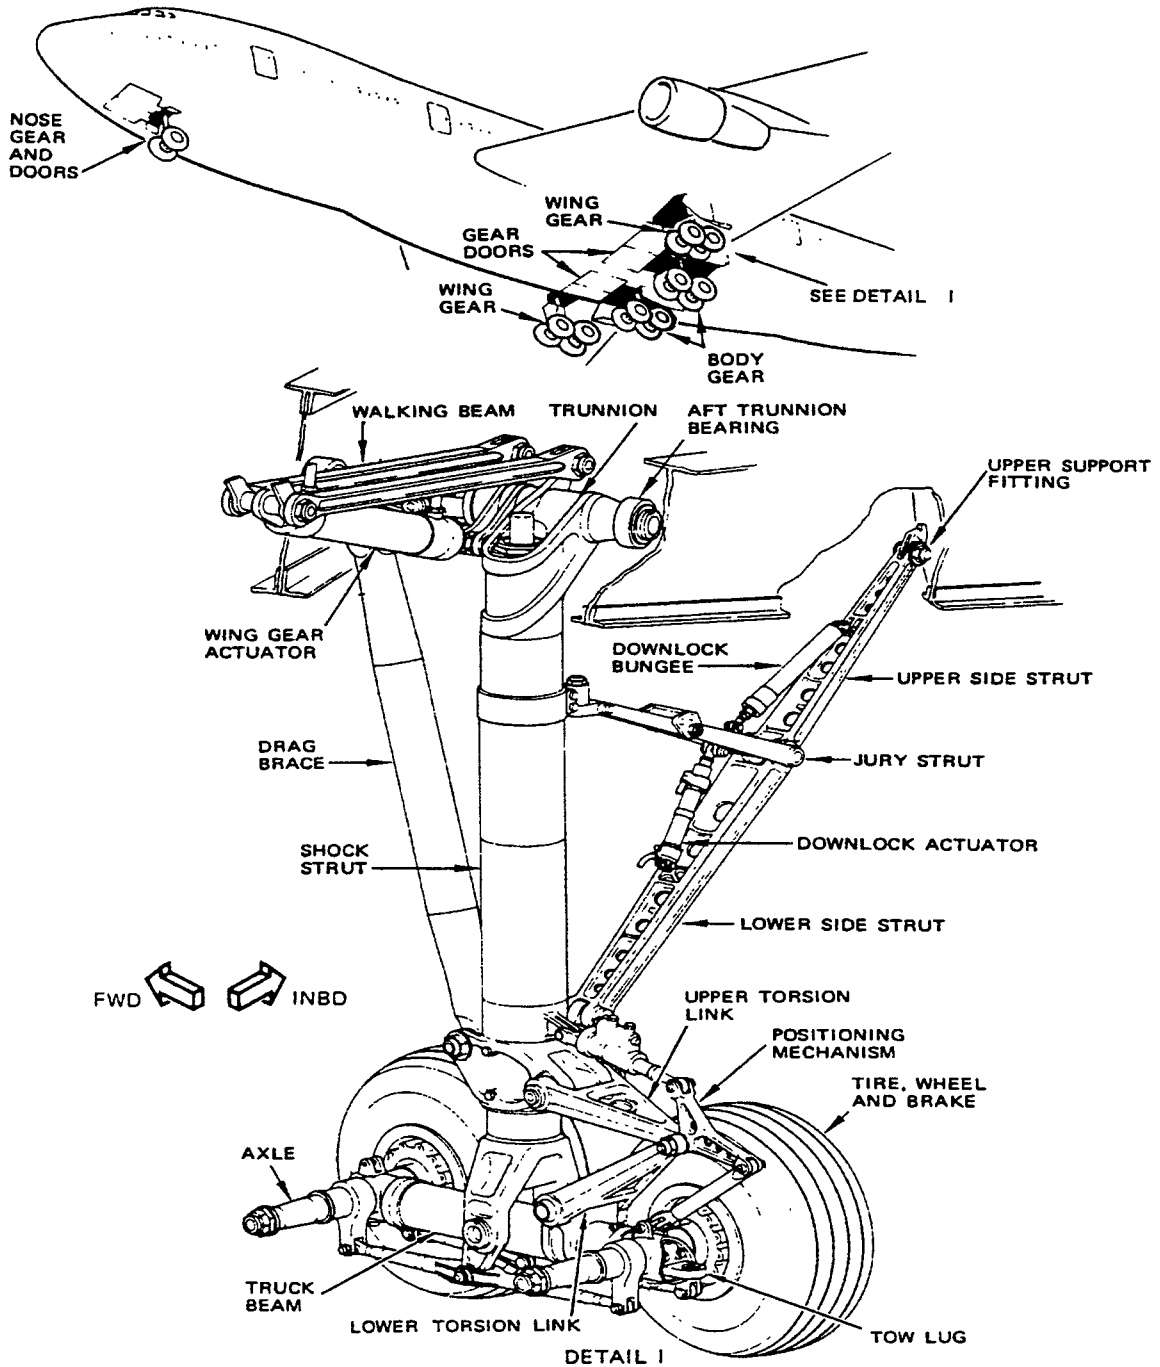
Wing Landing Gear
Figure 1

- A. The wing landing gear, because of its exposure to dirt and water from the runway, is susceptible to corrosion.
- B. Corrosion can occur on the forward trunnion, in particular between the housing bore and the spherical bearing outside diameter. Improved lubrication was introduced at line number 247 and by SB 32-2151 and chrome plating added to the bore. From line number 292, primer was added to the threads of the retaining nut and housing and other bare cadmium plated areas.

Stress corrosion cracks can occur on the aft trunnion. The stress corrosion cracks start from corrosion pits on the outer surface of the trunnion journal near the edge of outboard hole.

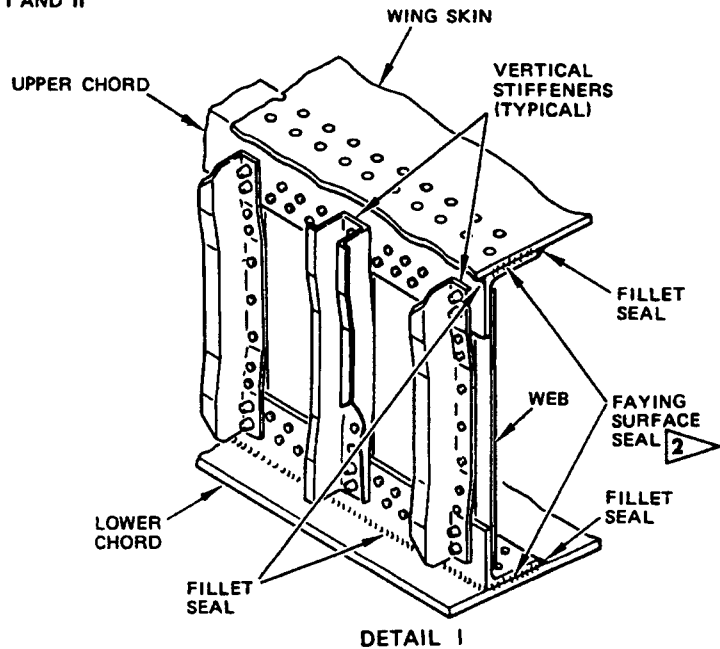
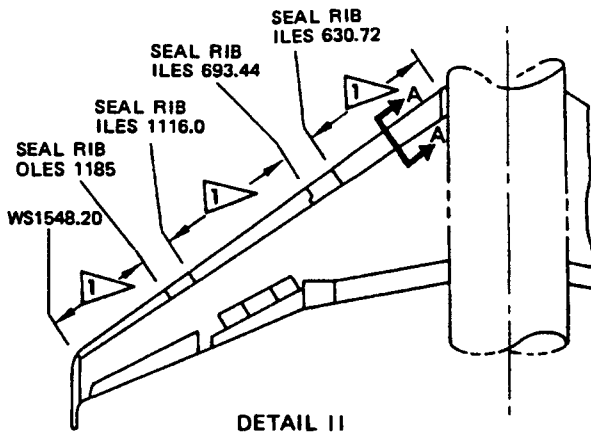
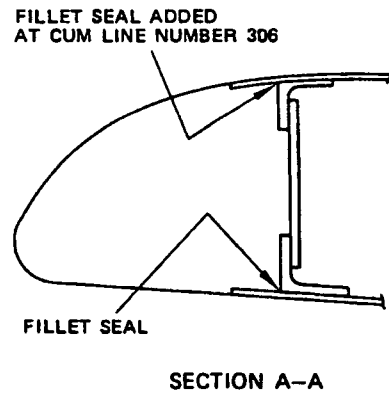
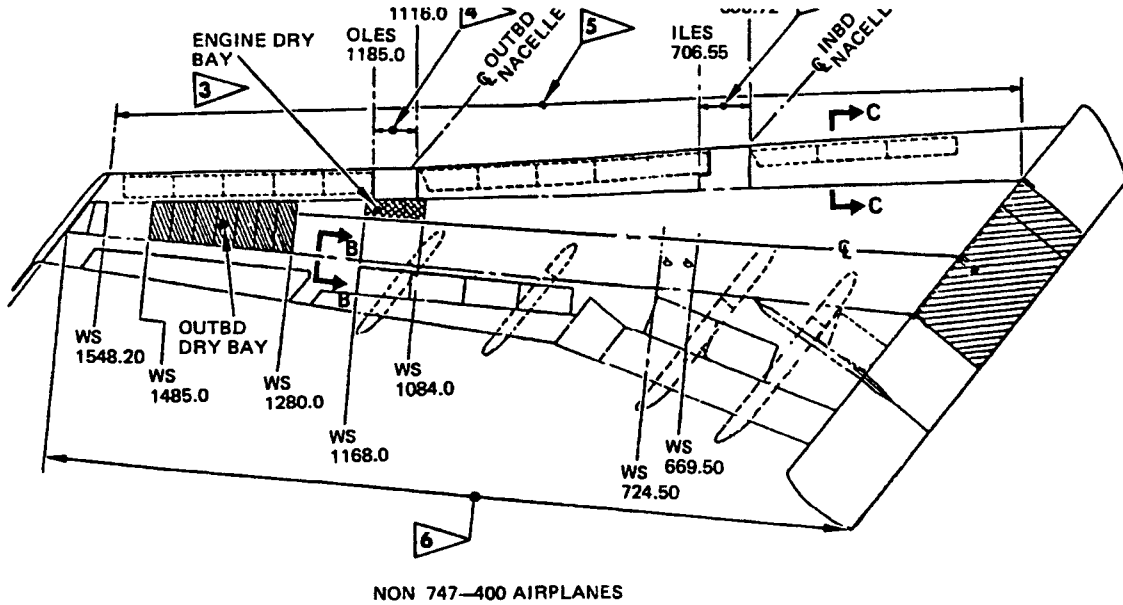
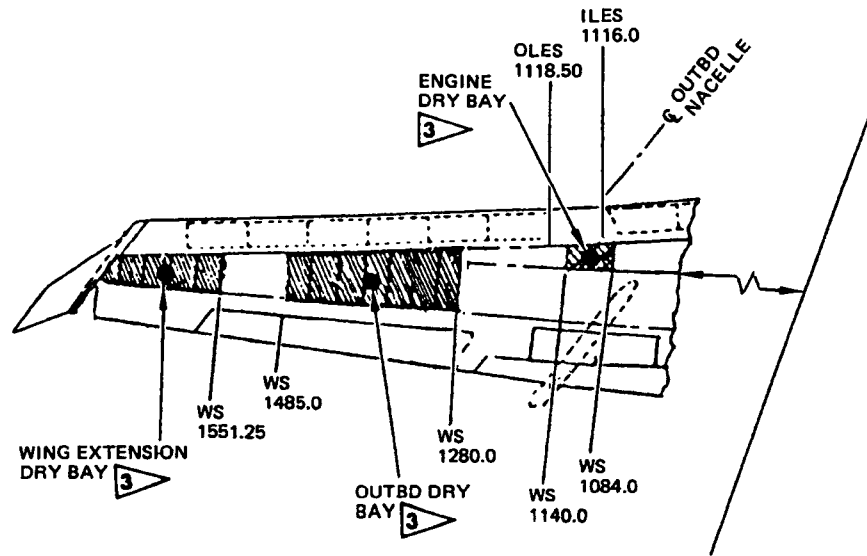
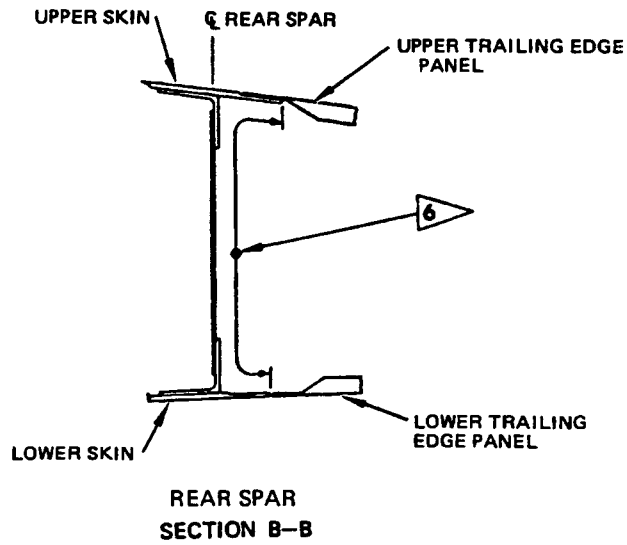
Outer Wing Front and Rear Spars
 Figure 1 (Sheet 1)

- (1) The deployment of flight control surfaces expose the spars to the ground and near ground air contaminants, runway dirt and debris and inclement weather elements all of which contribute to corrosion.

- (2) The spar chords are the details of this structure most susceptible to corrosion and it originates most frequently at the fasteners common to the chord and web, or chord to leading or trailing edge structure. Instances of corrosion at edges have also been observed.

- (3) Spanwise cracks have been reported on the wing front spar vertical flanges. This is attributed to intergranular corrosion in the wing front spar upper and lower chords. SB 57-2188 gives inspection and repair procedures for airplanes thru line number 305.

- (4) Cracks have been found in the front spar lower chord horizontal flange at the fastener holes. This is attributed to lower skin corrosion which penetrates the skin-spar chord faying surface. SB 57-2158 gives inspection and repair procedures for airplanes thru line number 305.

- (5) Corrosion has been reported on the wing lower skin upper surface forward of the front spar. SB 57-2183 Rev. 1 adds drain holes to the wing lower skin forward of the front spar of airplanes line No. 306 thru 423.

- (6) Corrosion has been reported on right wing rear spar web just under spoiler No. 12 at WS1114 to WS1117, WS1143 to WS1152 and WS1160 to WS1165.
- C. The nacelle strut support fittings attach bolts have instances of failures attributed to stress corrosion. Failure was initiated by corrosion pits formed at damaged areas of nickel-cadmium plating. From airplane line No. 254, these bolts have been installed with sealant, and the boltheads, nuts, and thread fillet sealed after installation. SB 57-2127 provides instruction procedures for inspection, replacement, and installation with BMS 5-95 sealant of these bolts (Fig. 3).

- 5 ▷ APPLY BMS 3-23 TYPE II TO FORWARD SIDE OF FRONT SPAR WEB ALONG ENTIRE LENGTH OF FRONT SPAR FROM SIDE OF BODY TO WS 1548.2.
- 6 ▷ APPLY BMS 3-23 TYPE II TO REAR SPAR AFT CAVITY ALONG ENTIRE LENGTH OF REAR SPAR FROM SIDE OF BODY TO WBL 1169. REF SL-20-19 ON AIRPLANES PRIOR TO LINE NUMBERS 646.

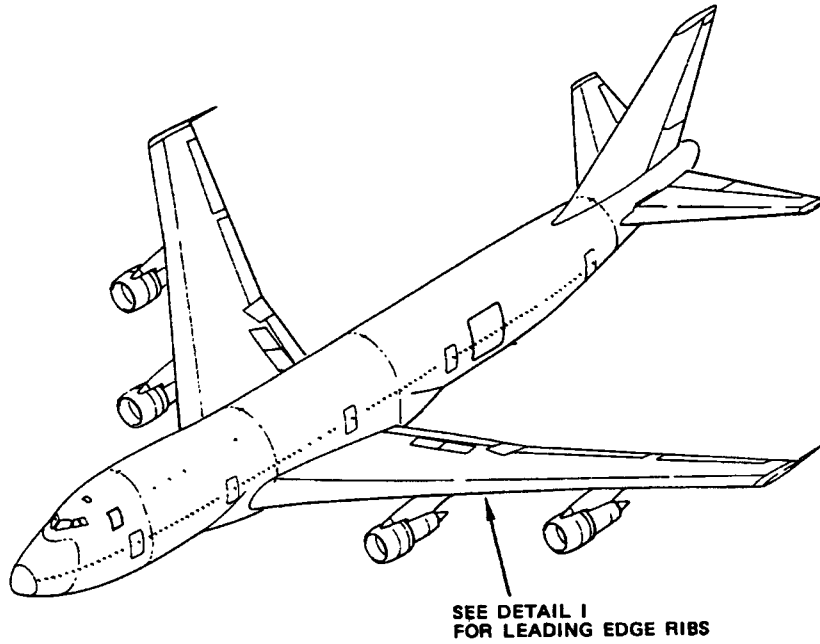
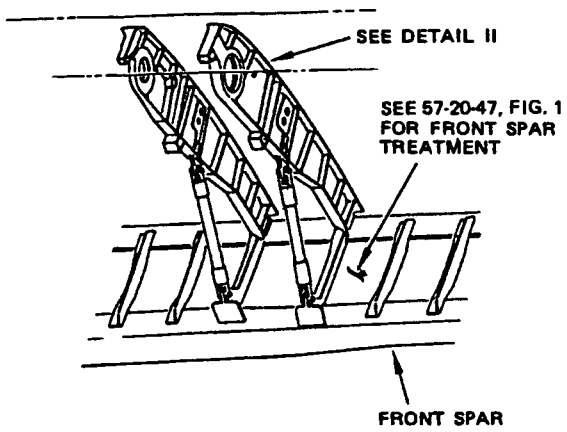
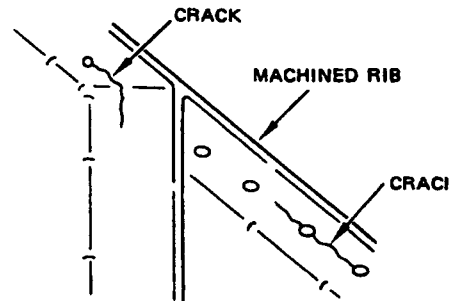
Outer Wing Leading Edge Machined Ribs
Figure 2

TYPICAL STRESS CORROSION CRACKS
DETAIL II

- (1) Corrosion has been found on the inner surface of the skin within the boost pump housing cavity.
- E. Ribs and Stringers
- (1) Reports of corrosion cracking on the wing leading edge machined 7079-T651 or 7075-T652 ribs outboard of the inboard engines have been reported. The 7079-T651 and 7075-T652 materials were installed on 747-100, 747 SR and 747 SP airplanes (Fig. 2).

- NOTE: Service Bulletins 57-2116 and 57-2160 provide inspection and preventive measure procedures and repairs for cracked ribs
- (2) On 747-200, -200C, and -200E airplanes, the subject ribs were machined from 7075-T73 forgings which have a substantially greater resistance to stress corrosion cracking.

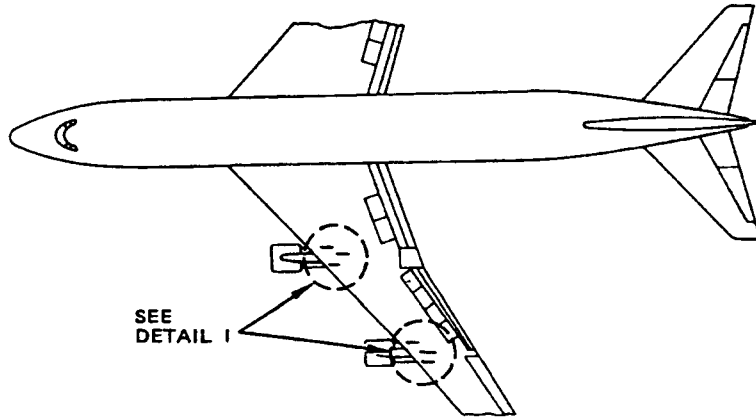
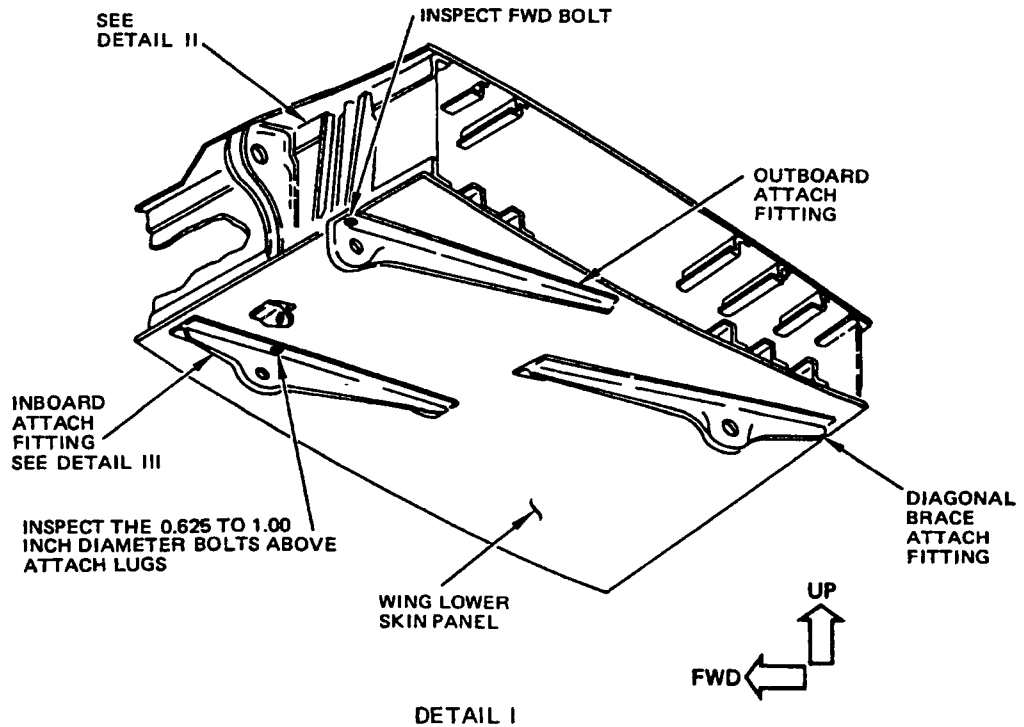
Outer Wing Nacelle Strut Support Fittings
Figure 3 (Sheet 1)

- (1) Stress corrosion fractures have been reported on two forward nacelle strut outboard support attach fitting bolts at the No. 4 strut.

- (2) Cracking of more than one of the nacelle strut attach fitting fasteners could result in significant damage to adjacent structure and potential loss of the engine and the strut.

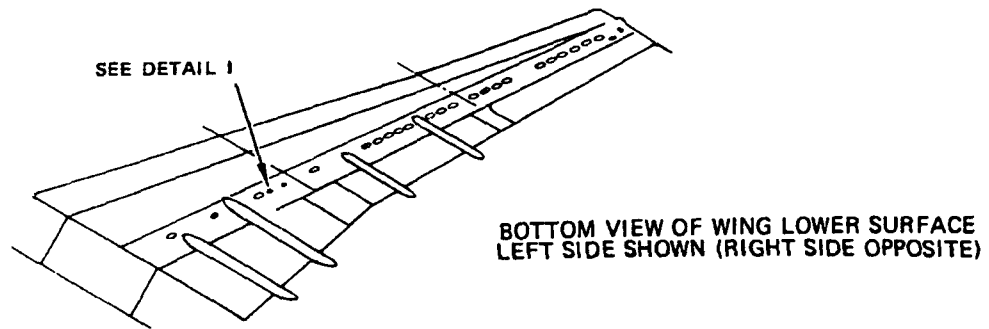
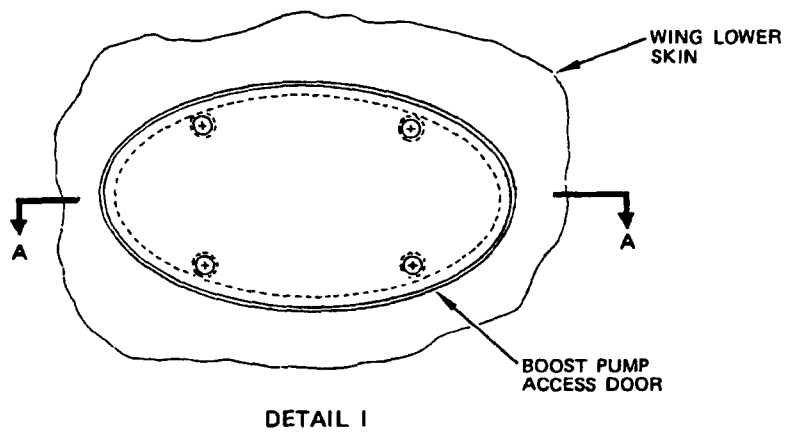
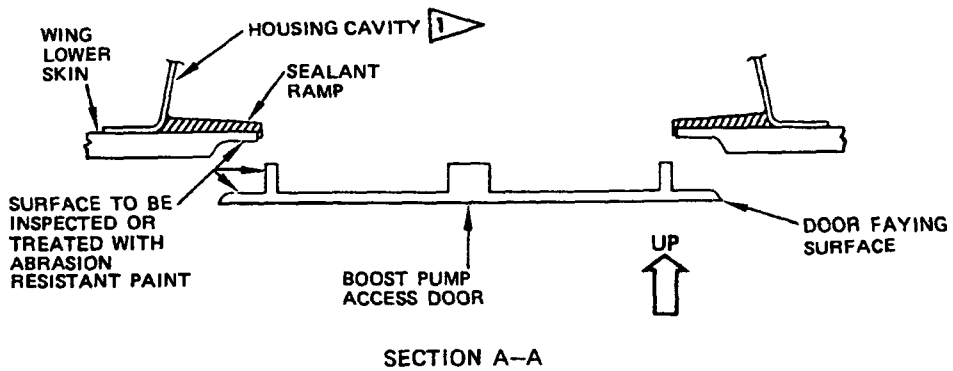
Outer Wing Boost Pump Access Door and Cutouts
Figure 4

- D. The boost pump access door and cutouts are susceptible to intergranular corrosion. This is attributed to exposed aluminum end grain combined with fretting between the door and wing skin. Abrasion resistant paint has been applied to the interfacing surfaces (line number 196 and on), and this modification may be incorporated on airplanes with earlier line numbers by SB 57-2091. The modification provides corrosion protection at the boost pump access door cutouts (Fig. 4).

1 APPLY BMS 3-23 TYPE II TO ALL INTERIOR SURFACES OF CAVITY

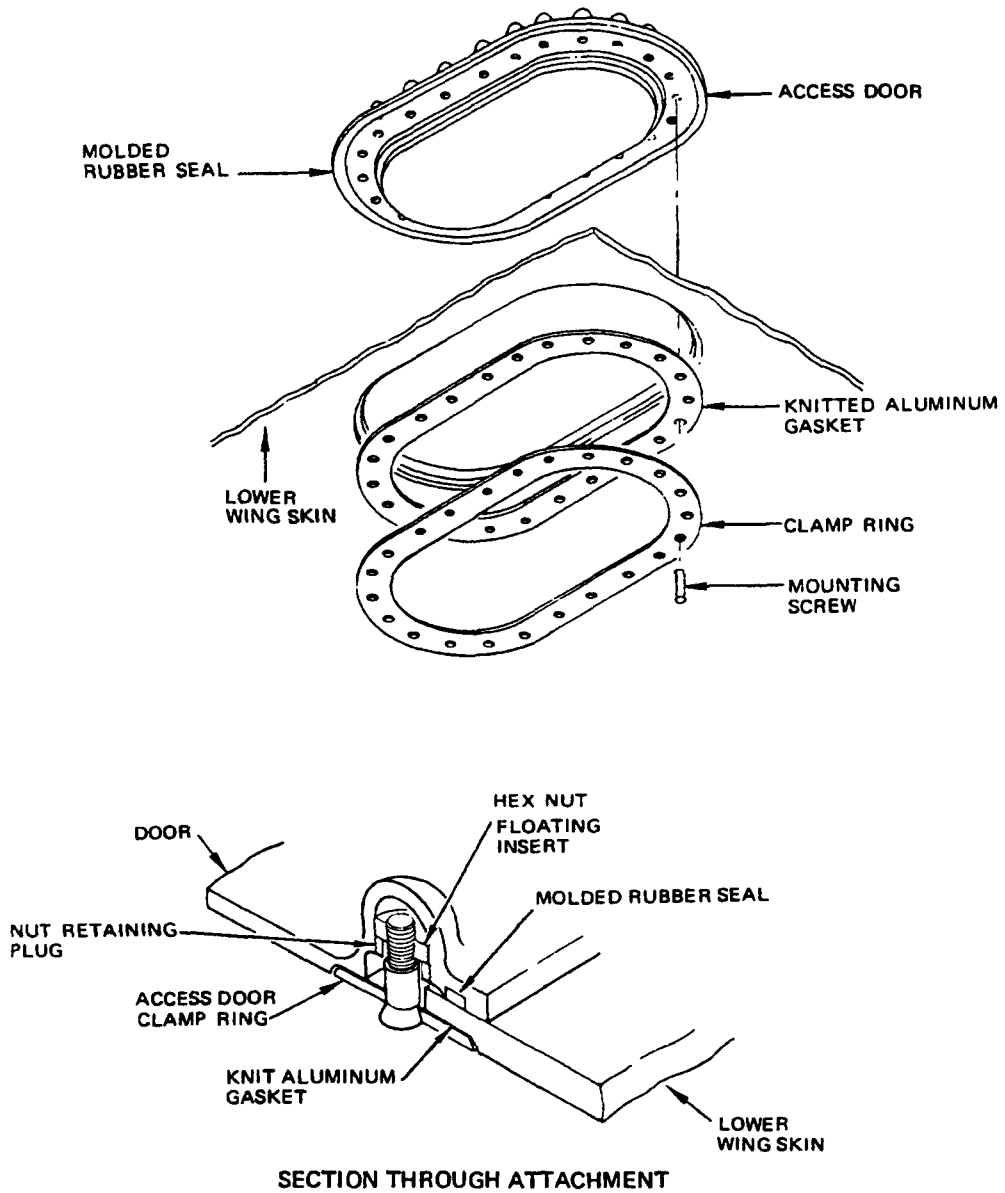
Outer Wing Fuel Tank Access Panel
Figure 5

- F. The wing lower skin in the area of the reserve and main fuel tank access door cutouts can get intergranular and fretting corrosion, because of exposed aluminum end grain, and because of fretting between the access panel and the wing lower skin (Fig. 5).

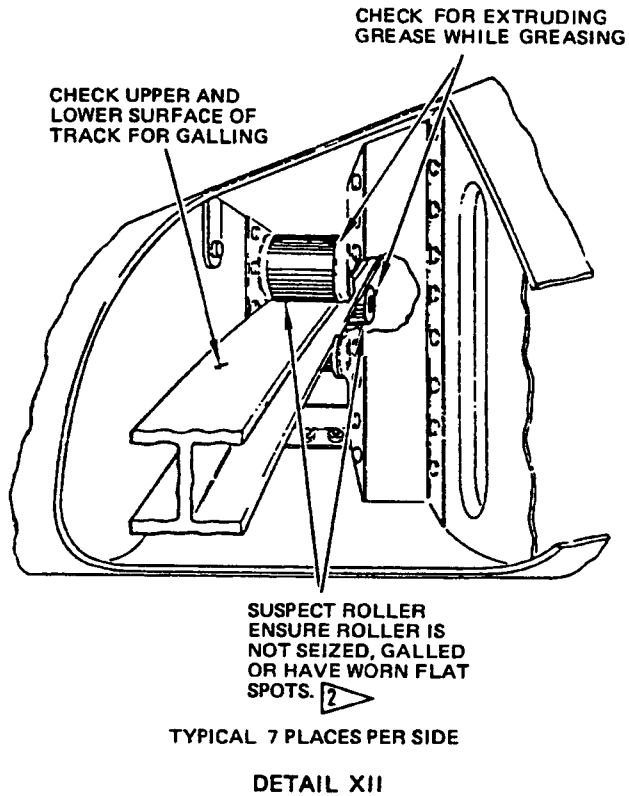
Trailing Edge Flaps
Figure 1 (Sheet 9)

2 RECOMMENDED TO LUBRICATE WITH MIL-6-23827 OR EQUIVALENT GREASE NOT CONTAINING MoS₂ ON AIRPLANE PRIOR TO LINE NUMBER 253 PER SB 57-2107.

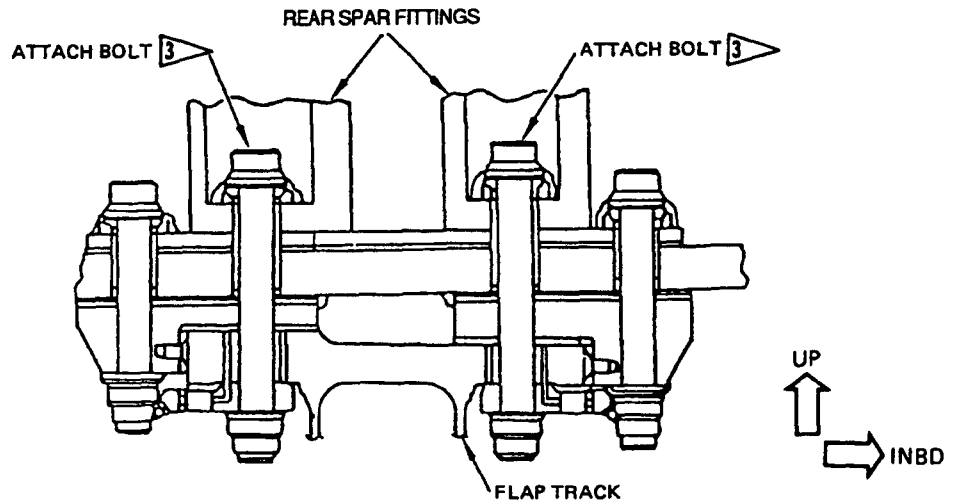
SECTION J-J

3 POSSIBLE STRESS CORROSION CRACKS
(REF SB 57-2228)
