Volume 2-767

#### LEP

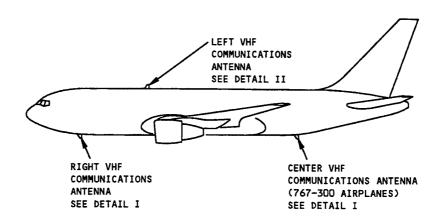
VHF COMMUNICATIONS ANTENNA LOCATIONS

A. Corrosion can occur between the exterior-mounted antennas and the fuselage  ${\sf skin}$ .

- A. Regularly remove the antennas and examine the mating surfaces for corrosion. On airplanes which have the Airfone (airborne public telephone) system, refer to 767 Maintenance Manual 23-80-00 for maintenance instructions.
- B. Improved Corrosion Protection
  - (1) At line number 448, PRR B12253 changed the procedures that install the VHF and the Airfone antennas on the exterior of the airplane. BMS 10-79, Type III primer and BMS 3-27 corrosion preventive compound are applied to the skin under the antennas, and the fasteners are cadmium-plated stainless steel.

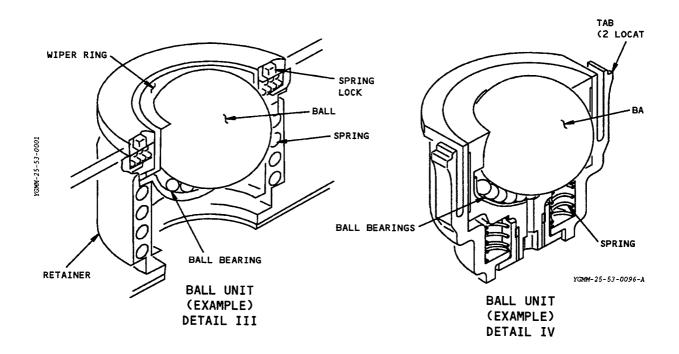
Ball Transfer Panel
Figure 1 (Sheet 2)

A. Corrosion can occur on the ball transfer panels (ball mats) in the forward and aft cargo compartments.

A. Regularly examine the ball transfer panels for corrosion.

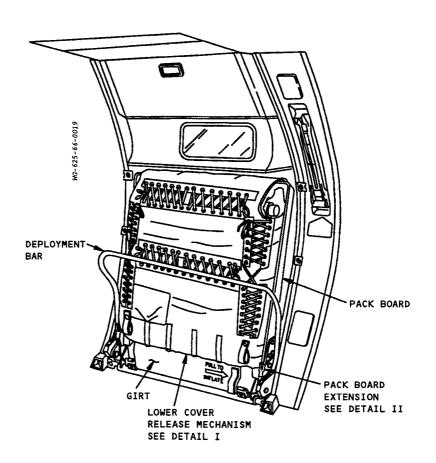
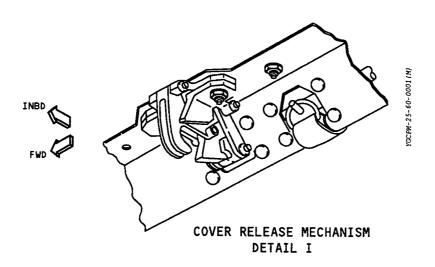
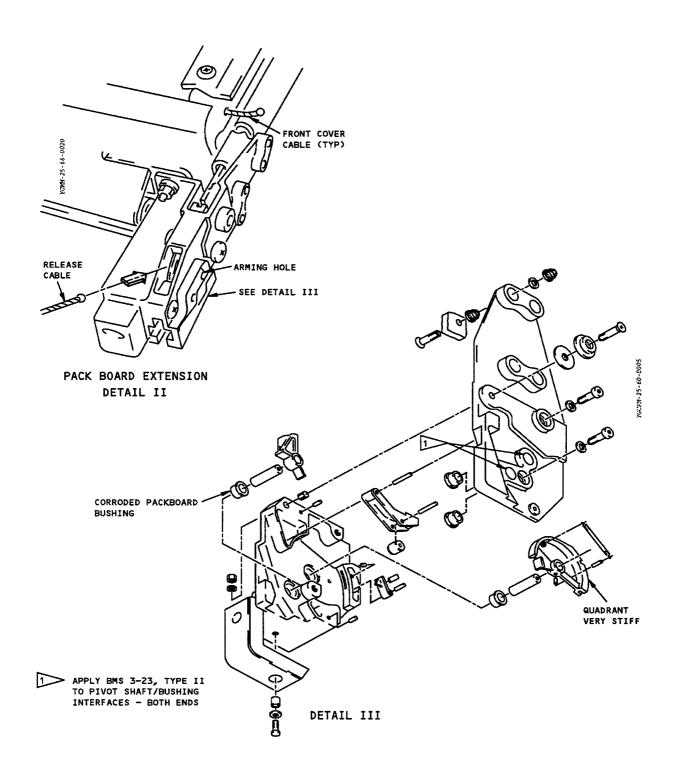
Escape Slides Figure 1 (Sheet 1)

- (1) Corrosion can cause much friction in the escape slide release mechanism. This condition may prevent the escape slide retaining shaft from rotating. Without rotation of the shaft, the slide cover will not deploy and the pressure vessel will not trigger (Ref 25-60-02, Fig. 1, Detail I).

- (2) Corrosion can occur on packboard bushings. Also, one packboard had very stiff quadrants and pawl assemblies on each side (Ref 25-60-02, Fig. 1, Detail III). Parts were loosened with the application of WD-40 and were subsequently sprayed with silicone.

- (3) Corrosion can occur between the packboard cover release rod and the bearing, which are made of different metals.
- (4) Corrosion can occur around the fittings because of water which can collect in the stowed escape slide. This water can also cause mold to start on the slide surfaces.

- B. For minor corrosion, to minimize the downtime of the airplane, the corrosion products should be cleaned off, followed by the application of a corrosion inhibiting compound into the affected area to retard the corrosion process (Ref Volume 1, 20-60-00). The finish system should be restored at the first opportunity consistent with the maintenance schedule.

- (1) On airplanes line number 138 and on, PRR B11511 changed and lubricated the cover latch mechanism to eliminate binding and possible corrosion. These changes can be incorporated on other airplanes per SB 25A0071.
- (2) On airplanes line number 193 and on, per PRR B11716, the switch terminals of the off-wing escape switch panel are coated with a potting compound.
- (3) On the off-wing escape slide integrators, a production change uses 302 CRES pins MS51923-297 between the cams and the bellcrank. Service Letter 767-25-070 gives more details.

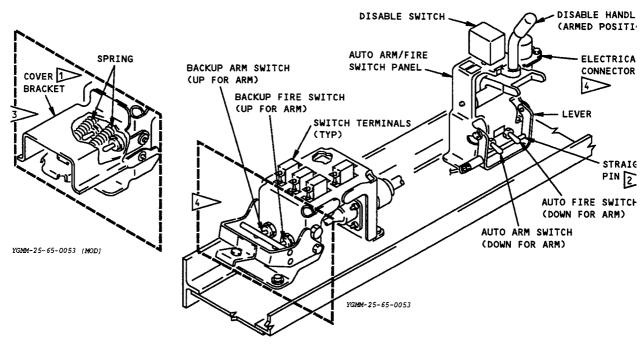
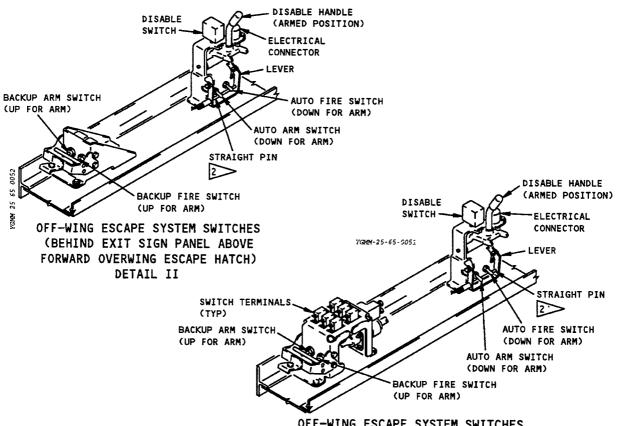
OFF-WING ESCAPE SYSTEM SWITCHES
(BEHIND EXIT SIGN PANEL)
DETAIL I

- C. In the off-wing escape system switch panel, moisture accumulation can cause corrosion of switch terminals (Ref 25-60-03, Fig. 1).

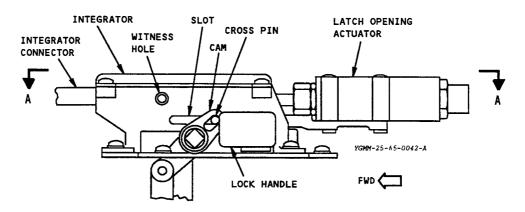
INTEGRATOR IN UNLATCHED POSITION
(CAM IN AFT POSITION)
(LOCK HANDLE IN "SAFETY" POSITION)
DETAIL II

- (5) In the integrator at the latch opening actuator, stress corrosion can occur on the 400 CRES pins MS16562-236 that attach cams to the bellcrank (Ref 25-60-04, Fig. 1, Detail II).

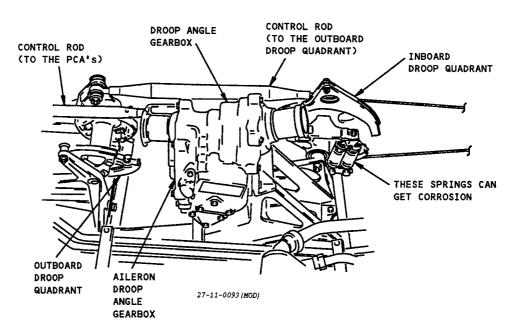
### INBOARD AILERON DROOP MECHANISM DETAIL I

- D. Corrosion can occur on the bearings in the input linkage of the power control actuators (Ref 27-10-03, 27-10-04).
- E. Corrosion can occur on the springs of the inboard aileron droop mechanism (Ref 27-10-03, Fig. 2).

- (3) Improved Corrosion Protection
- (4) At line number 218, PRR B11715 installed bearings in the pilots' control wheel that have low starting torque.
- (5) At line number 334, PRR B11857 installed corrosion-resistant bearings in linkage of the power control actuators, the outboard aileron Lockout mechanism, and the aileron control feel mechanism.
- (6) At line number 529, PRR B12522 installed corrosion-resistant-steel bearings in the input linkage of the power control actuators.
- (7) At line number 563, PRR B12597 installed corrosion-resistant-steel bearings in all lateral flight controls.

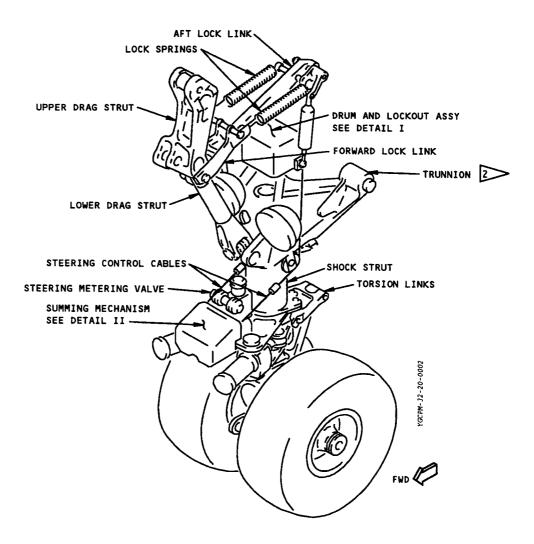
NOSE LANDING GEAR [>>

- A. The nose gear supports the nose of the aircraft while the aircraft is on the ground. This includes the shock strut, drag strut, doors, linkages, and attach bolts. The nose landing gear and its components are exposed to air contaminants and runway splash which can cause corrosion.

- B. Water intrusion and subsequent corrosion has been reported in the trunnion drum bearing.
- C. Corrosion can occur in the steering shutoff valve of the steering metering valve module.

- D. Corrosion can occur in the park brake indicator light assembly.
- E. Corrosion can occur on bearings in the nose wheel steering system. These are in the drum and lockout assembly, its housing, and in the summing lever. Water can get into these bearings if the bearings do not contain sufficient grease.

- F. Corrosion can occur in the extendable door operating strut. The corrosion occurs on the inner tube and on the end fitting. This strut is volume of the nose gear forward door mechanism installation.

- B. Where corrosion has already started, refer to Structural Repair Manual for details of corrosion removal.
- C. Apply BMS 3-23 water displacing corrosion inhibiting compound to damaged finish on exposed surfaces. Refer to Volume 1, 20-60-00 for details of application of BMS 3-23.

- G. Improved Corrosion Protection
  - (1) Steering metering valve module: Airplanes line number 248,249,254, and on have a new module per PRR B11765, with changes in the shutoff valve. The valve has a chrome plated plunger and a CRES retainer. The cavity behind the retainer has a vent hole. The slide and sleeve are 440C CRES. These changes can be incorporated on other airplanes per SB 32-0067.

- (3) Nose wheel steering system:
    - (a) At line number 86, PRR B11106 added tube fittings and changed bearings in the housing of the nose wheel steering drum and lockout assembly. This change can be added to earlier airplanes with SB 32-0022, but you must regularly lubricate the bearings or the corrosion could come back.

- (b) At line number 334, PRR B11857 changed to 440C CRES the material of the bearings in the drum and lockout assembly, its housing, and in the summing lever.

APPLY BMS 3-23 TO DAMAGED FINISH ON EXPOSED AREAS. REAPPLY AFTER CLEANING WITH STEAM OR HIGH PRESSURE WATER AND DETERGENT. DO NOT APPLY BMS 3-23 TO GREASE FITTINGS, LUBRICATED SURFACES OR JOINTS, ELECTRICAL CONNECTIONS AND CONTACTS, TEFLON BEARINGS OR PULLEYS AND CONTROL CABLES.

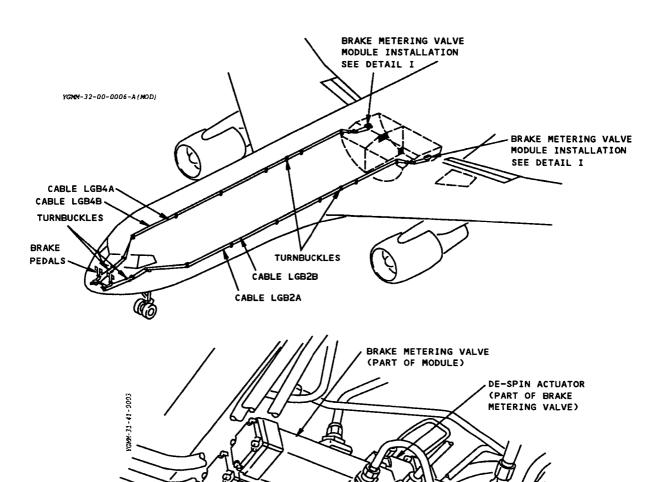
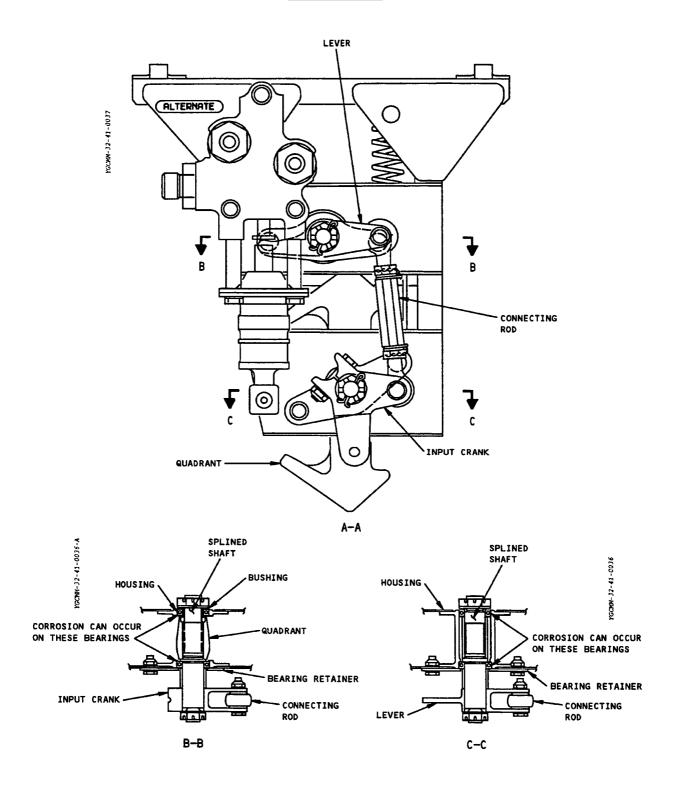
Brake Metering Valve Module Figure 1 (Sheet 2)

- A. The hydraulic brake system includes main landing gear brake assemblies, mechanical control linkage from the pilot's foot pedals to the brake metering valve modules, hydraulic valves, actuators and accumulators.
- B. Corrosion can occur on bearings in the linkage of the brake metering valve module.

- A. Make regular checks of the brake metering valve module for corrosion of bearings in the linkage. If you find corrosion, replace the defective bearings with equivalent corrosion resistant bearings.

- B. Do not apply corrosion inhibiting compounds on grease joints or sealed bearings. These compounds dissolve grease and other lubricants. They are penetrating compounds and can get around the seals and into the bearings.

- E. Improved Corrosion Protection
  - (1) Airplanes line number 334 and on have corrosion resistant bearings in the module linkage per PRR B11857. This change can be incorporated on other airplanes by service letter scheduled for release approximately August 1990.

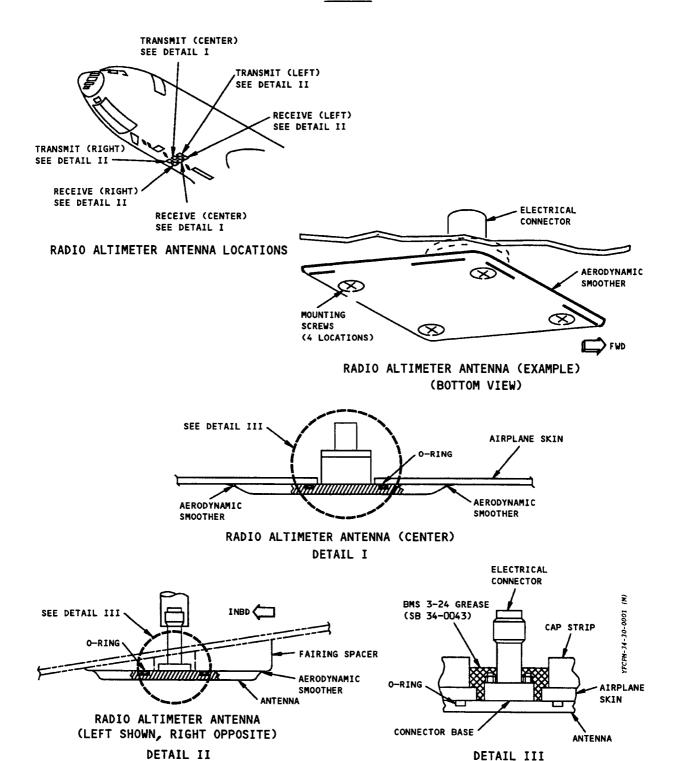
Radio Altimeter Antenna Figure 1

- A. Corrosion can occur between the exterior-mounted antennas and the fuselage skin.
- B. Moisture came into the antennas for the radio altimeter. This caused corrosion and subsequent antenna failures.

- A. Regularly remove the antennas and examine the mating surfaces for signs of corrosion. For the radio altimeter antennas, refer to SB 34-0043.
- B. Improved Corrosion Protection
  - (1) At line number 131, a production change applied BMS 3-23 corrosion inhibiting compound to the connector base of the radio altimeter antennas, and filled the base with BMS 3-24 grease. This change can be incorporated on earlier airplanes with SB 34-0043.
  - (2) At line number 448, PRR B12253 changed the procedures that install the antennas for the marker beacon, the microwave landing system, and the radio altimeter. BMS 10-79, Type III primer and BMS 3-27 corrosion preventive compound are applied to the skin under the antennas, and the fasteners are cadmium-plated stainless steel.

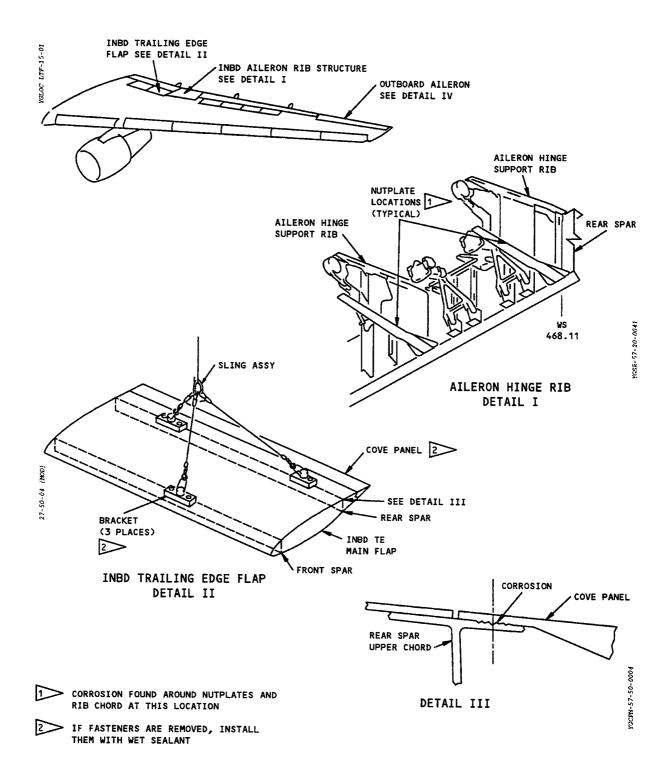
Wing Trailing Edge Figure 1 (Sheet 1)

- (1) At line number 140, structural honeycomb components covered with Kevlar fabric were replaced with components covered with fiberglass fabric to reduce cracking and subsequent water intrusion.

- (4) Some airplanes line number 327 and on have more BMS 3-23 corrosion preventive compound on the fittings of the spoilers, ailerons, and elevators.
- (5) At line number 480, PRR B12388-1 applied BMS 3-23 compound to all metallic structure aft of the rear spar, the ailerons, the flaps and the spoilers.

- (6) At line number 677, RR B41019-023 applied BMS 3-27 (MASTINOX) to the inboard trailing edge flap internal splines, internal surface of collar fitting and torque tube nuts. This change from MIL-G-23827 grease will be applied to all model 767-300 airplanes.

- (1) Regular inspection is required in areas that can get corrosion. Use the schedules in the Maintenance Planning Document. Operators must know of reported problems and areas.
- (2) Regular application of BMS 3-23 compound is necessary in areas identified. Use the schedules in the Maintenance Planning Document.

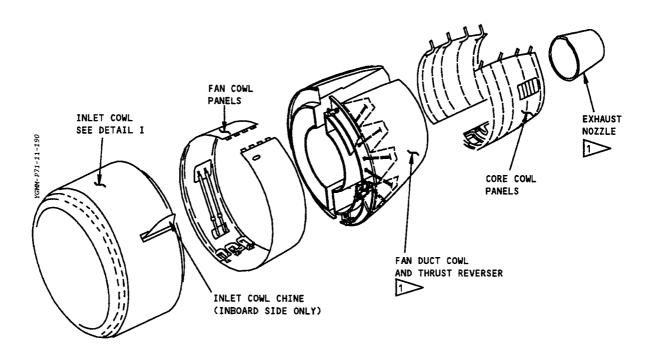
### ILLUSTRATION SHOWN IS FOR JT9D ENGINES

- B. Corrosion has been reported found on the left engine inlet cowl cover aft bulkhead chord horizontal flange during C-check. Corroded area was along the top forward side of the humped area of the "tee" angle and extended for a distance of 6 inches with corroded area centered at NBL 0.

- C. Corrosion can occur on the lower backskins of the acoustic panels on CF6-80C2 inlet cowls. This can be galvanic corrosion because of different metals in the panels. Corrosion can also be caused by moisture caught in the skins.

- B. For minor corrosion, to minimize the downtime of the airplane, the corrosion products should be cleaned off, followed by the application of a corrosion inhibiting compound into the affected area to retard the corrosion process (Ref Volume I, 20-60-00). The finish system should be restored at the first opportunity consistent with the maintenance schedule.

- C. Do not apply corrosion inhibiting compounds near engines, cowling, or other areas of high temperature, or where firewall sealant is used. The high temperatures can cause deterioration of the compounds. Corrosion inhibiting compounds can cause damage to the sealant.
