Diagnosis of Vibration Problems in Holland

Case Studies from the Groenpol Vibration Consultancy

Matt o'Sullivan
Mechanical Engineer
Brüel and Kjær, Denmark

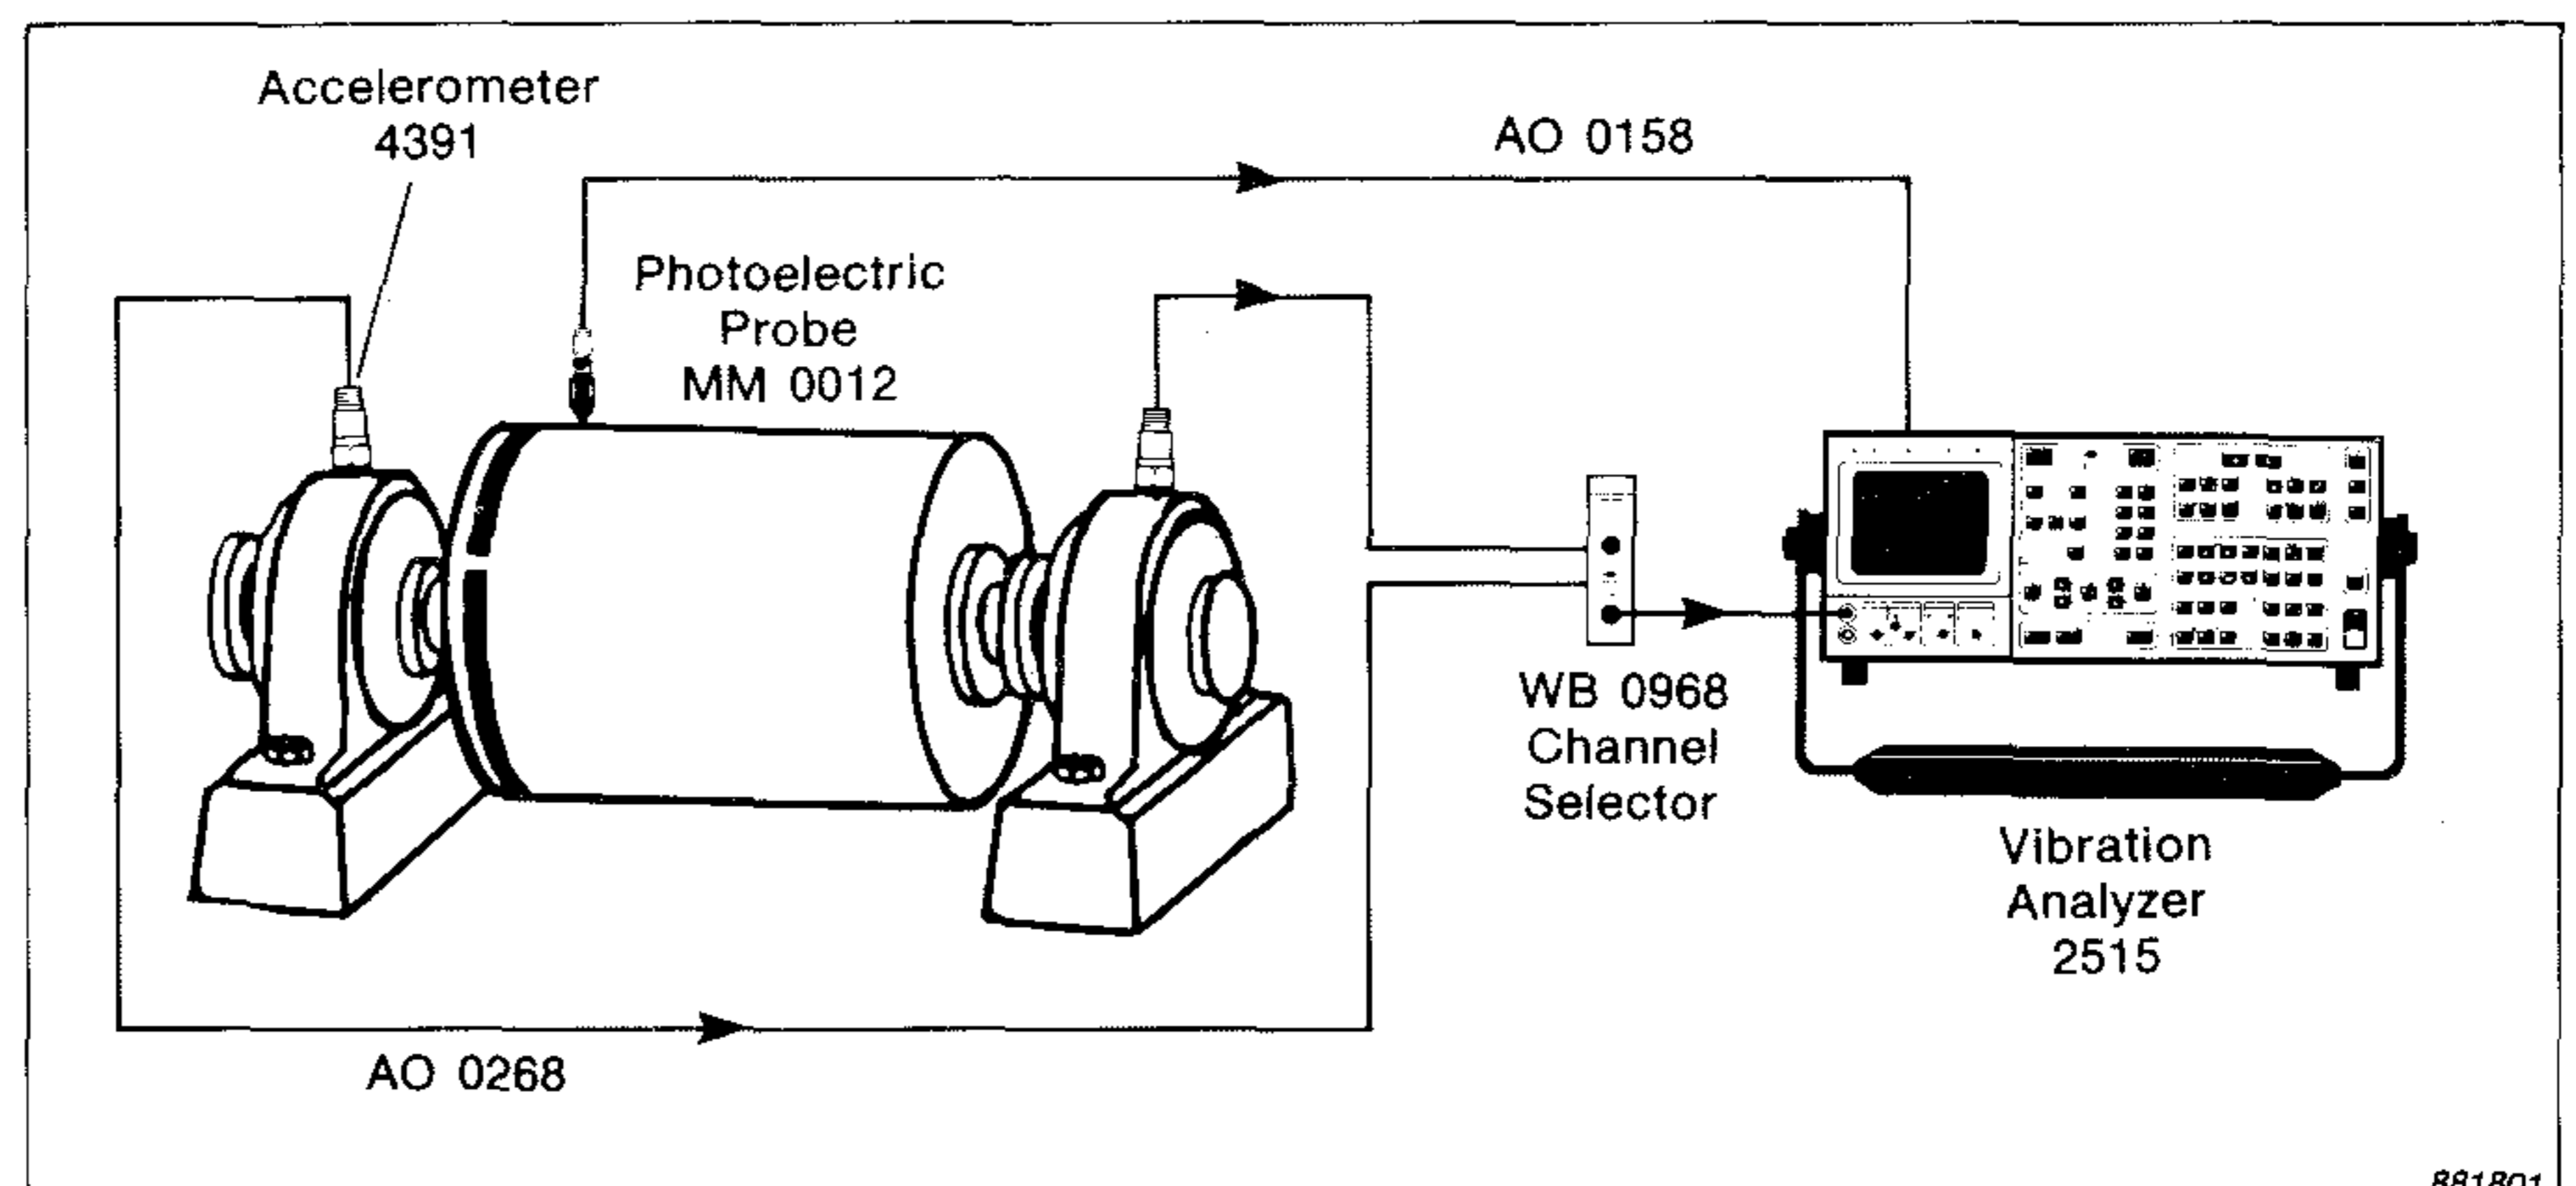
Fig. 10. A typical instrumentation set-up for in-situ balancing with a portable vibration analyzer

When the vibration level became excessive, the company asked Groenpol to balance the fan. A typical instrumentation set-up for 2-plane, in-situ dynamic balancing is shown in Fig. 10.

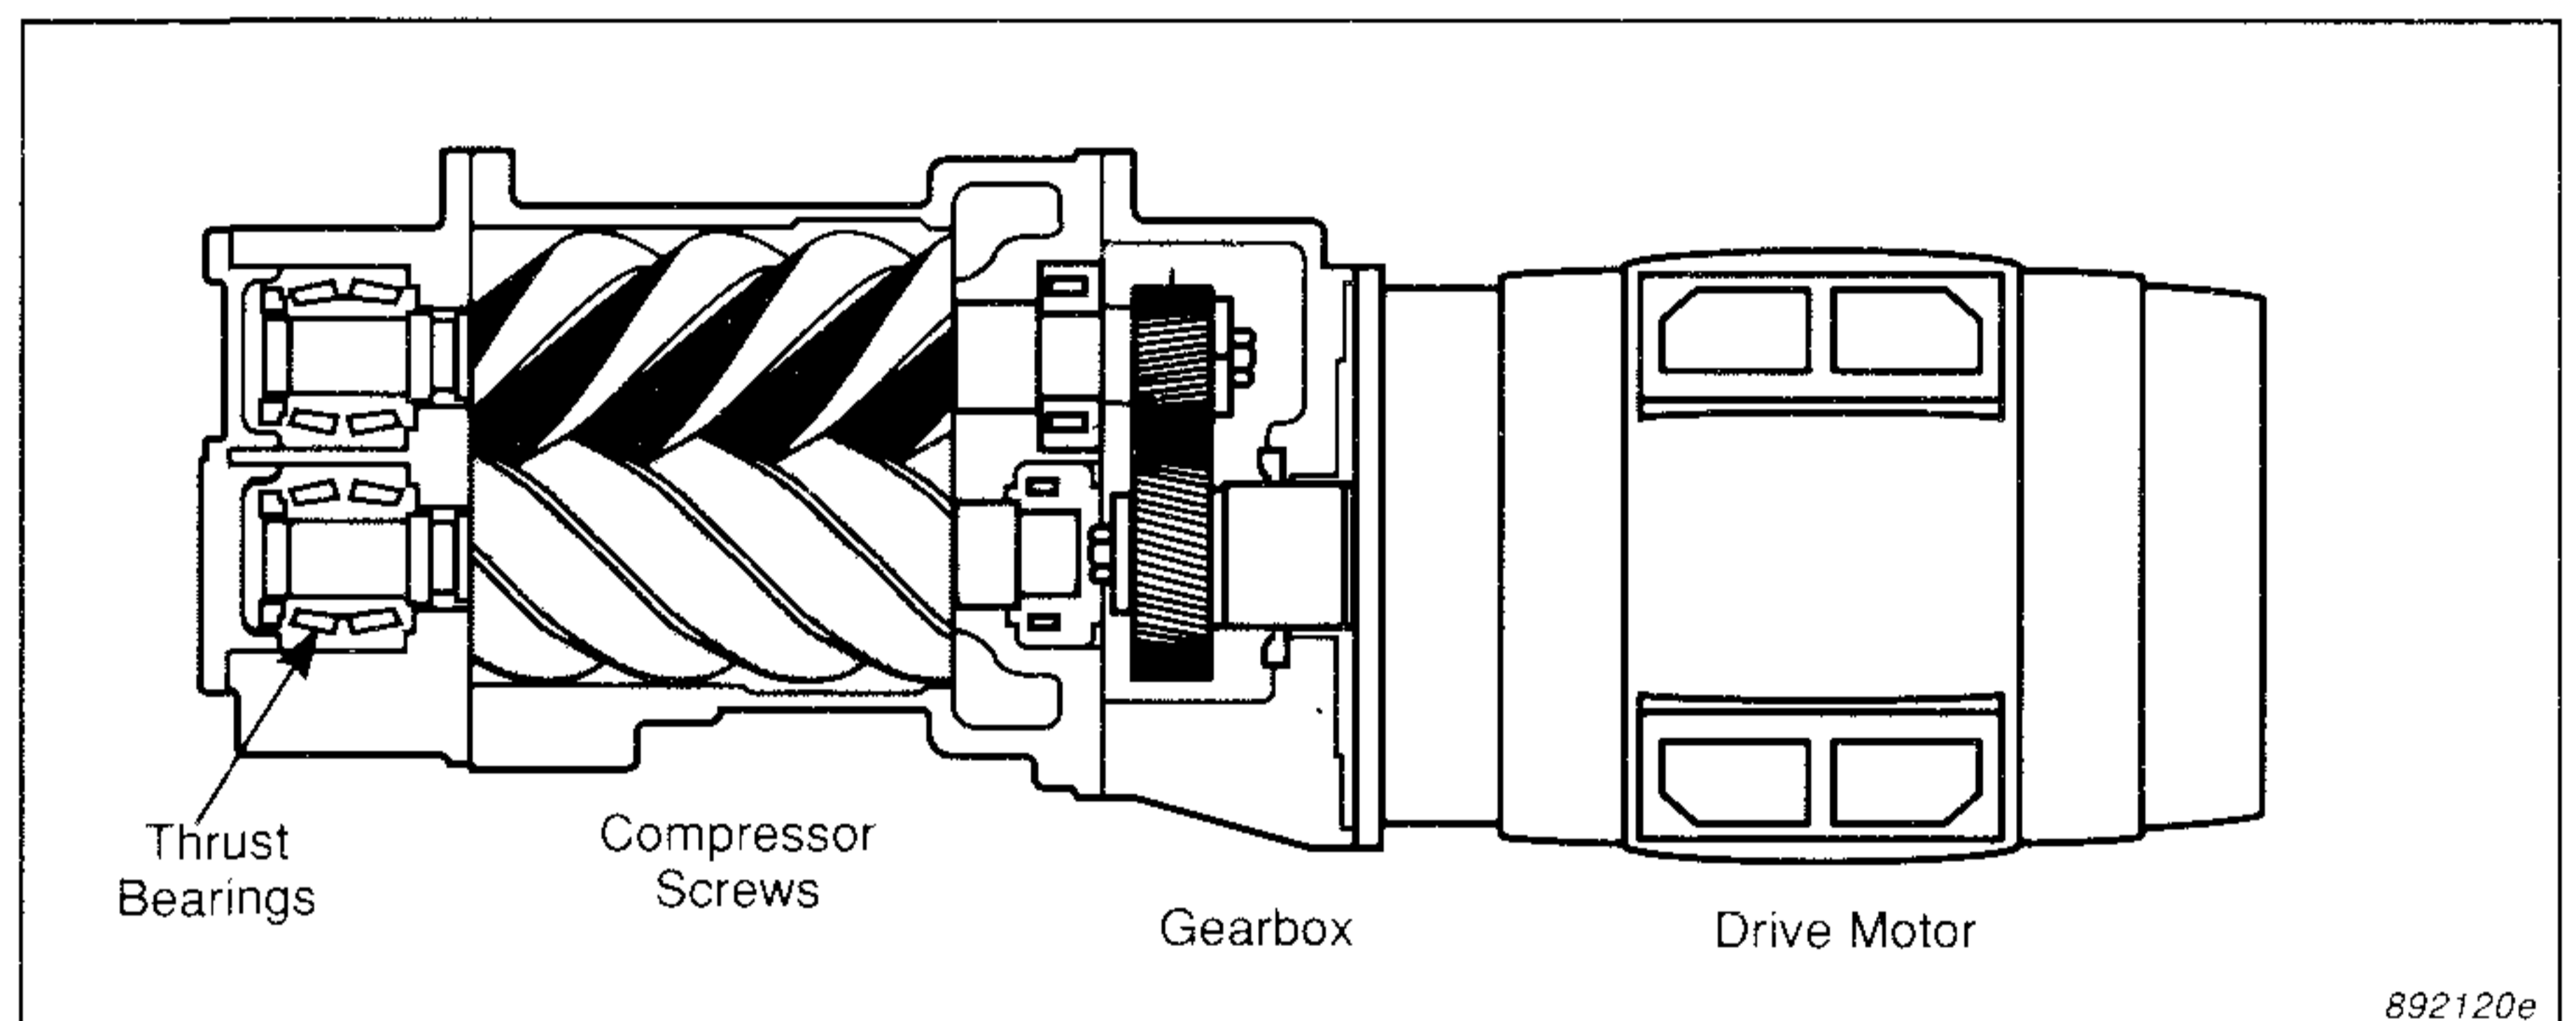
Screw compressors are used for high-pressure compression. Two adjacent, rotating spiral screws trap the gas at one end and force it out the other, see Fig. 13. In small compressors, as in this case, an electric motor drives one screw, which in turn drives the other screw. The speed ratio of the screws depends on the numbers of lobes. These are normally 4 and 6, which means a speed ratio of 6:4.

Fig. 13. A typical, small screw compressor, in which the top screw drives the bottom screw. The spiral profiles on the screws are called lobes; normally one screw has 4 lobes and the other has 6 lobes. The lobemeshing frequency is the product of the number of lobes and the screw rotation-frequency
