LaserJet / LJ2000 Troubleshooting Guide

Classic Printers

Volume 1
April 1995
Revision 13

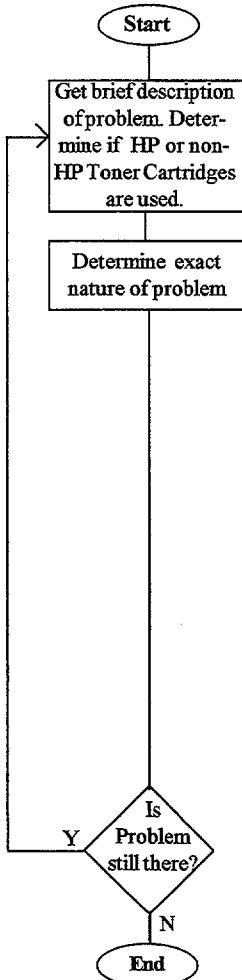
When Troubleshooting please use the flow diagram below to help decide if the Toner Cartridge is the cause of the problem. This can be especially useful to Call Qualifiers.

Note: In some circumstances customers may believe the toner cartridges are HP. Also in a very few cases, there are non-HP cartridge boxes designed to look like HP Toner Cartridges and deceive. *ENSURE, where possible, customer or CE use HP Toner cartridges to diagnose potential toner cartridge problems.*

Note: *If problem is similar to above, before embarking on replacing major LJ assemblies, try replacing the Toner Cartridge. It is quick and easy to replace.*

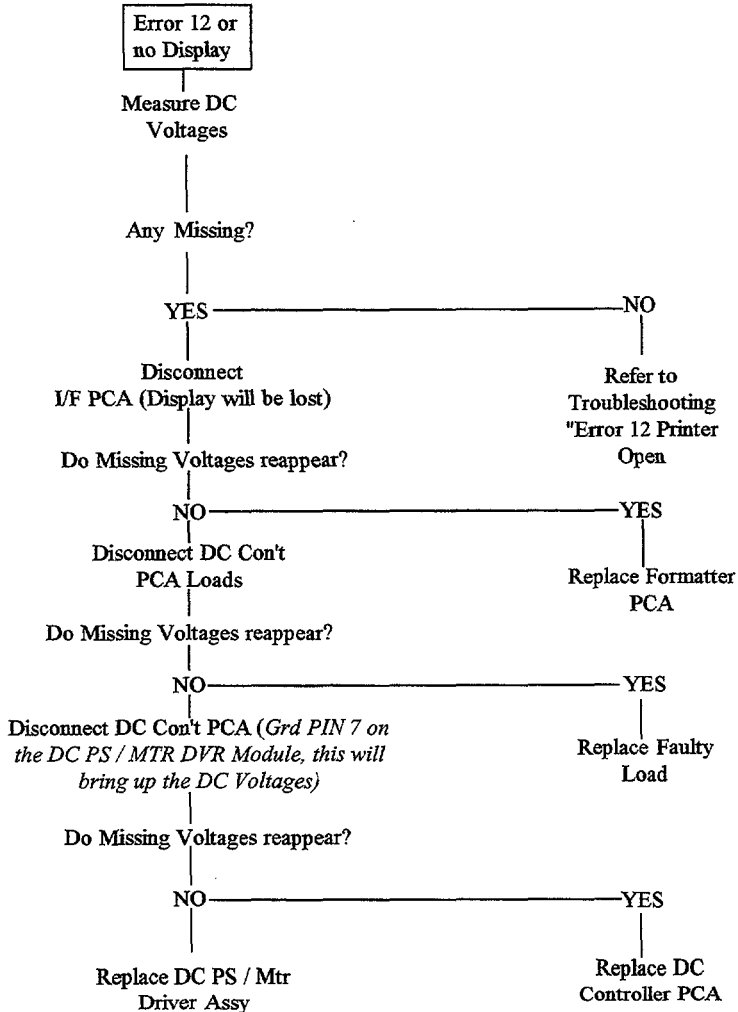
With Error 12, No Display, Dead & Power Supply problems on the LJII, LJIII, LJIID & LJIIID printers use the flow diagram below to help isolate the problem. Do NOT jump to cause, use a logical troubleshooting for the more difficult types of this problem. Error 12 means the Top Lid is open or the +24v is missing. Use this process to ascertain why the +24v is not present.

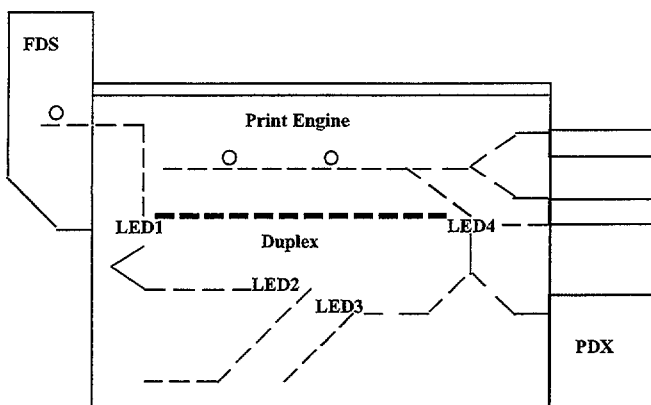
FIG 1 2684 Front Panel Display

Setting switches 5 & 6 (SW1) on the PD/DU Controller PCA to the "ON" position enables LED's 1 to 4 (FIG 1) on the Display panel to display an ERROR CODE. This error gives the location of the paper jam in the duplex area.

After Paper Jam has occurred, set switches 5 & 6 on the PU/DU Controller to the "ON" position. If jam was in the duplex area, an error code will be displayed using LED's 1 thru 4 (see above FIG1). The actual location can be verified using Table 1. *Two "Pings" occur, 13.3 then 13.1. When complete return switches 5 & 6 to "OFF".*

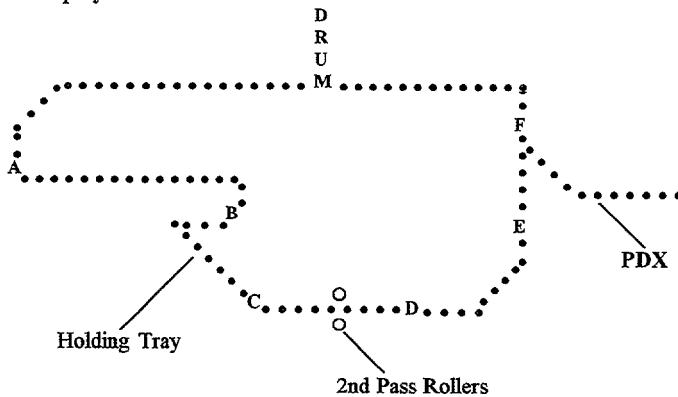
FIG2 Duplex Paper Path

Area	Jam Location	LED1	LED2	LED3	LED4
(Fig 2)	No Jam Detected	0	0	0	0
A	Duplex Unit Inlet Jam	1	0	0	0
B	Holding Tray Delivery Jam: a) Delay in paper reaching the holding tray.	0	1	0	0
	b) Build-up of paper in the holding tray.	1	1	0	0
C	Holding Tray Jam	0	0	1	0
D	2nd Pass Pick-up Jam	1	0	1	0
E	Vertical Pass Jam	0	1	1	0
F	Paper Inlet to the Print Engine Jam: a) Jam feeding paper from Duplex unit.	1	1	1	0
	b) Jam in feeding paper PDX unit.	0	0	0	1
