Qualitative Assessment on the Effects of Damaged Connectors and Optical Interfaces in Fiber Optic Measurements

White Paper

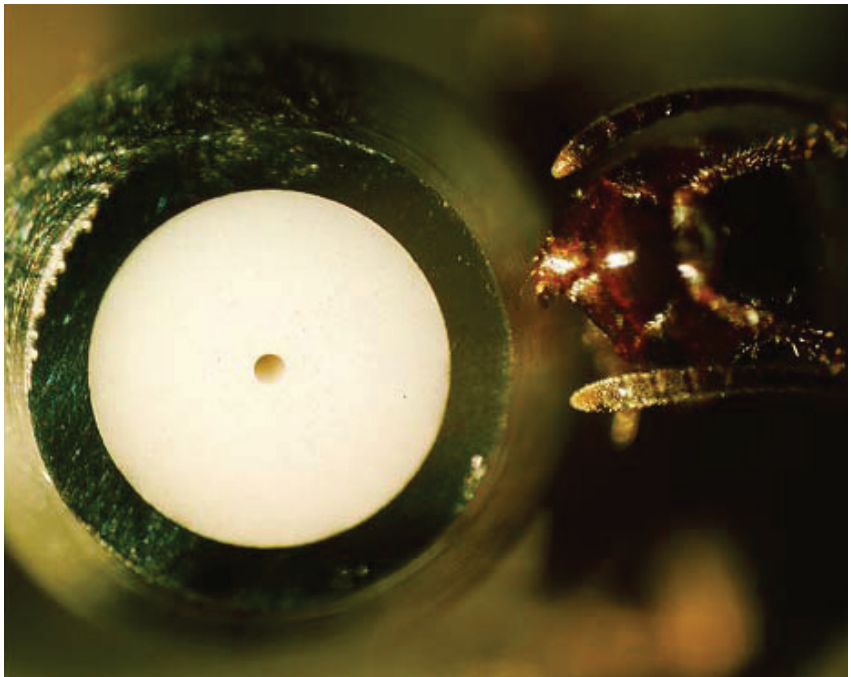
Feel of Dimensions ... (4)

- Same scale as previous slide.
- This time FC/PC and head of an ant.
- The center circle inside the white area is 125 μm !
- The core itself is only a fraction of it, 9 μm . Seen as the red dot in the center

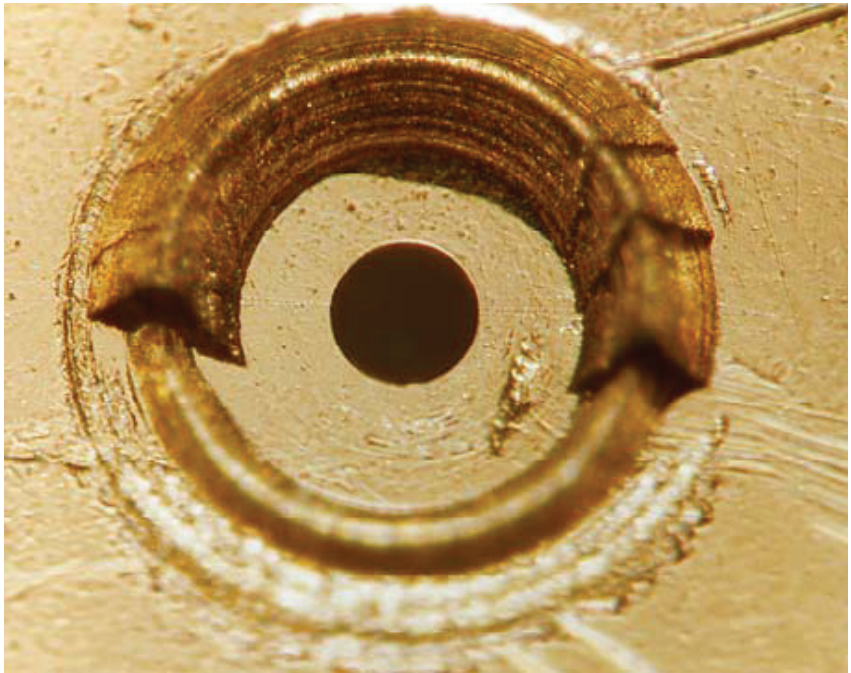
HMS-10

Good fiber in connector.

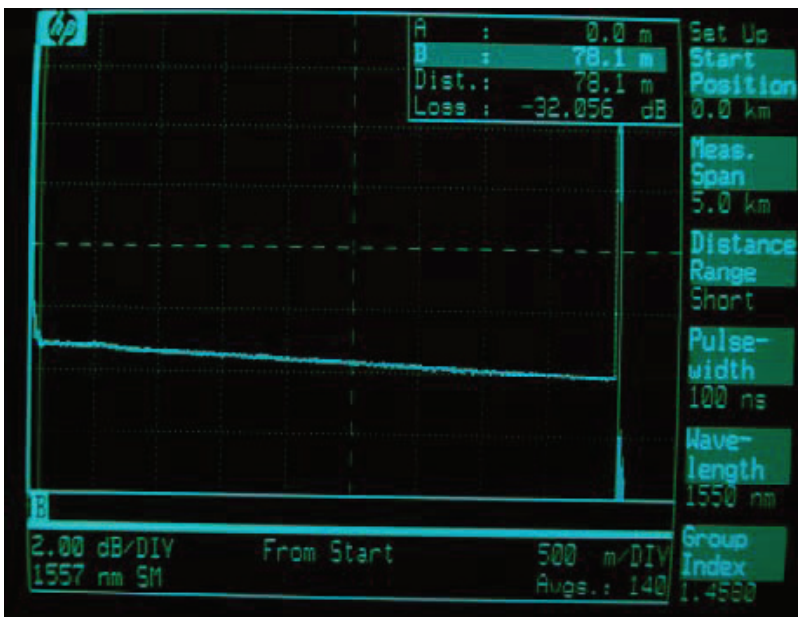
OTDR Trace

Good trace of 4.5 km delay line

Note good launch into a good fiber, i.e. minimum backreflection at connector interface

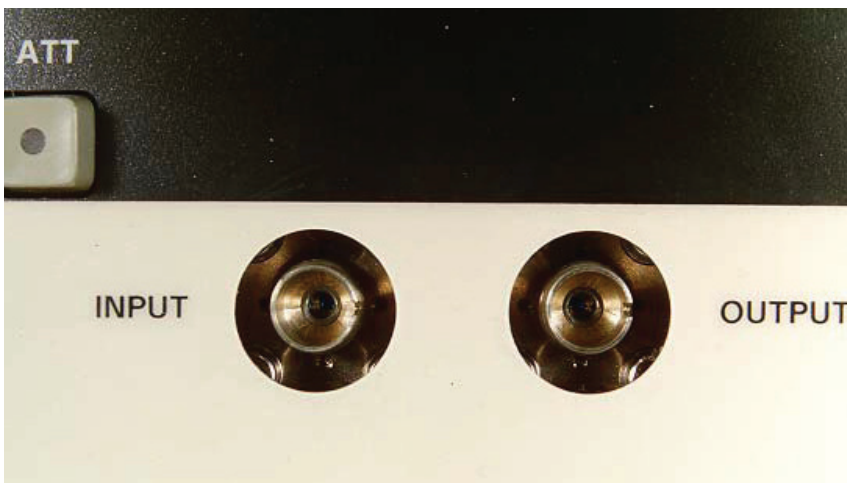
Optical Interfaces

Front panel

Note collimating lenses (bluish color)

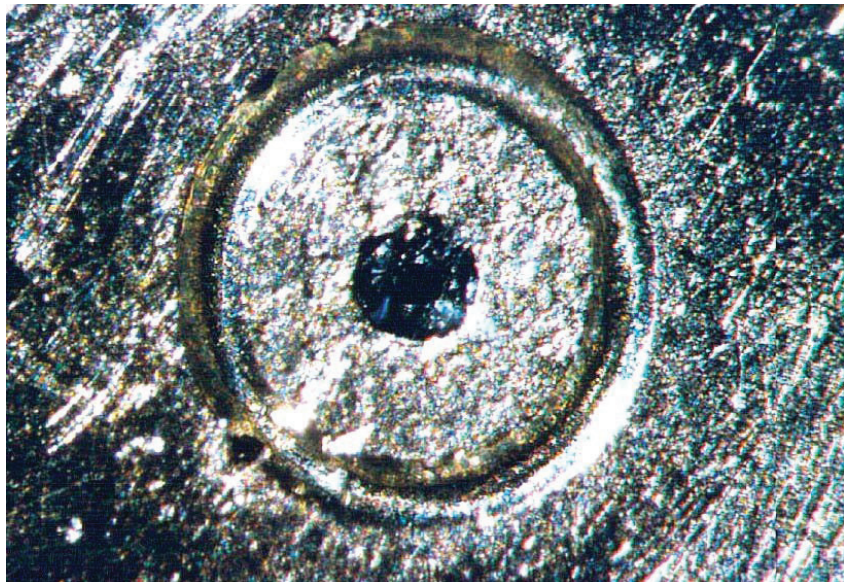
OSA Input Connector

Multimode fiber with 62.5 μm core and 125 μm cladding diameter (black and dark blue, respectively).
