Fiber Optic Connectors

Agilent Technologies

Qualitative Assessment on the Effects of Damaged Connectors and Optical Interfaces in Fiber Optic Measurements

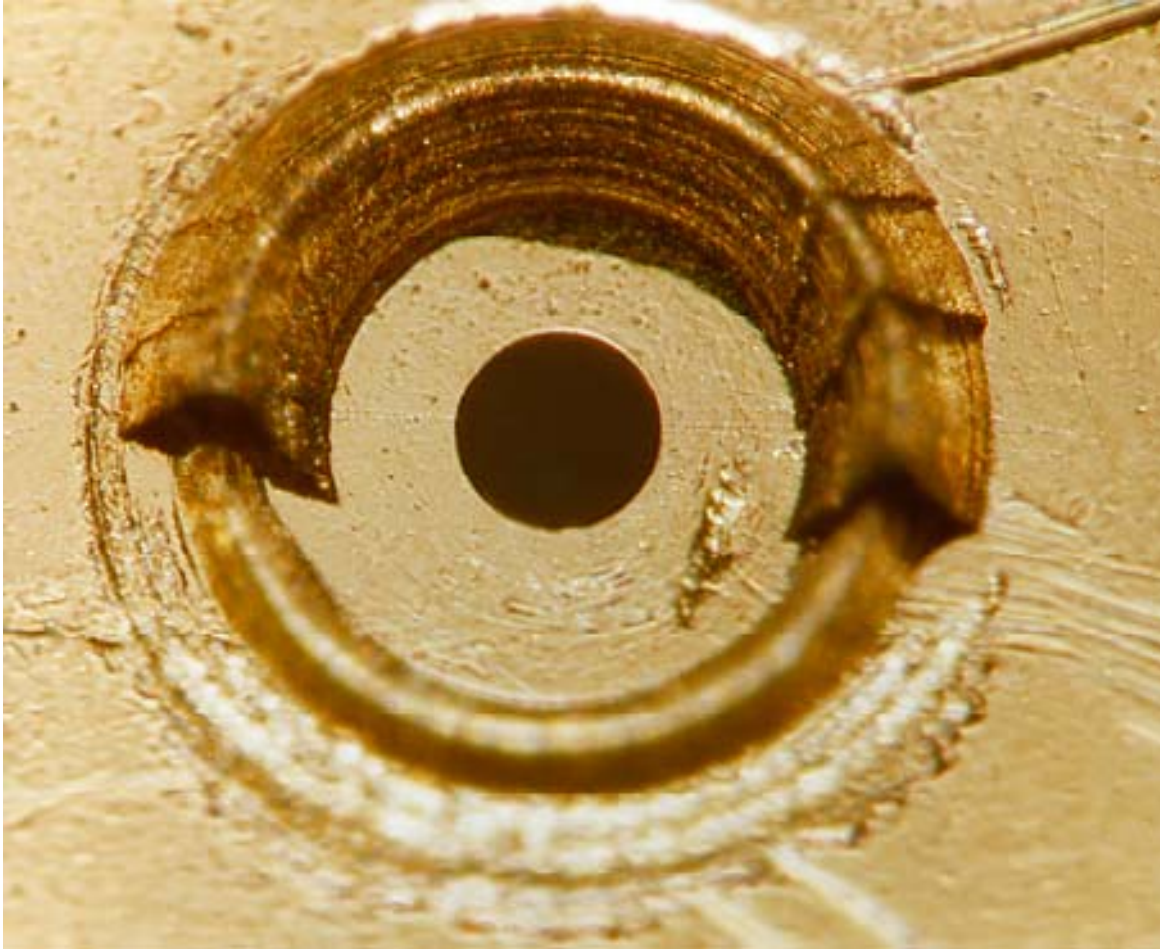
HMS-10

Good fiber
in connector.

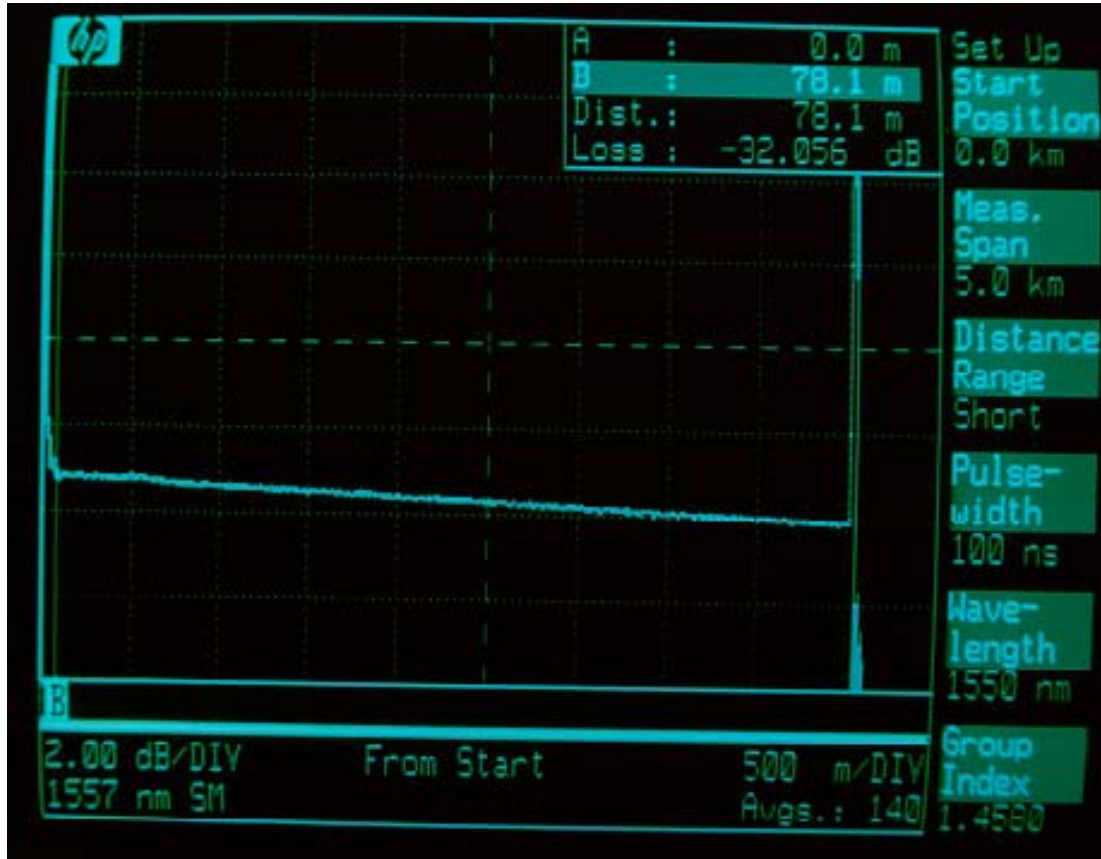
OTDR Trace

Good trace of 4.5km
delay line

Note good launch into a good
fiber, i.e. minimum
backreflection at connector
interface

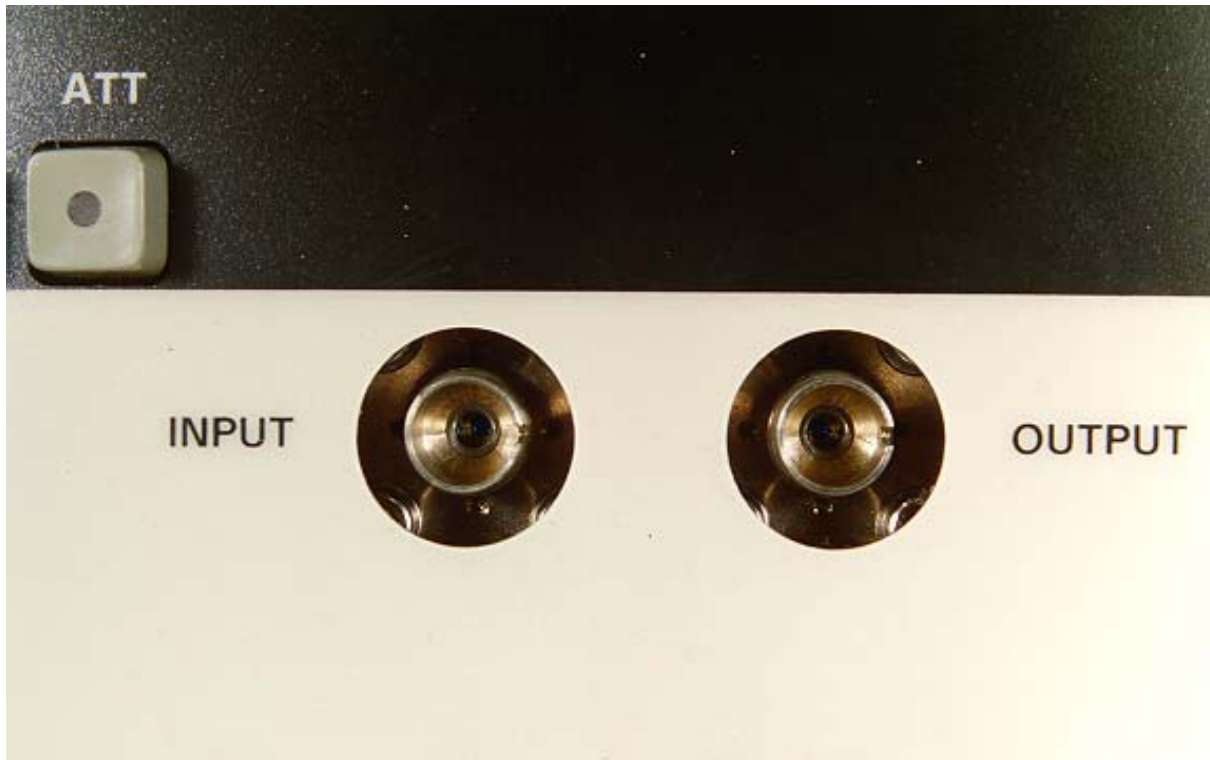
Optical Interfaces

Front Panel

Note colimating lenses
(bluish color)

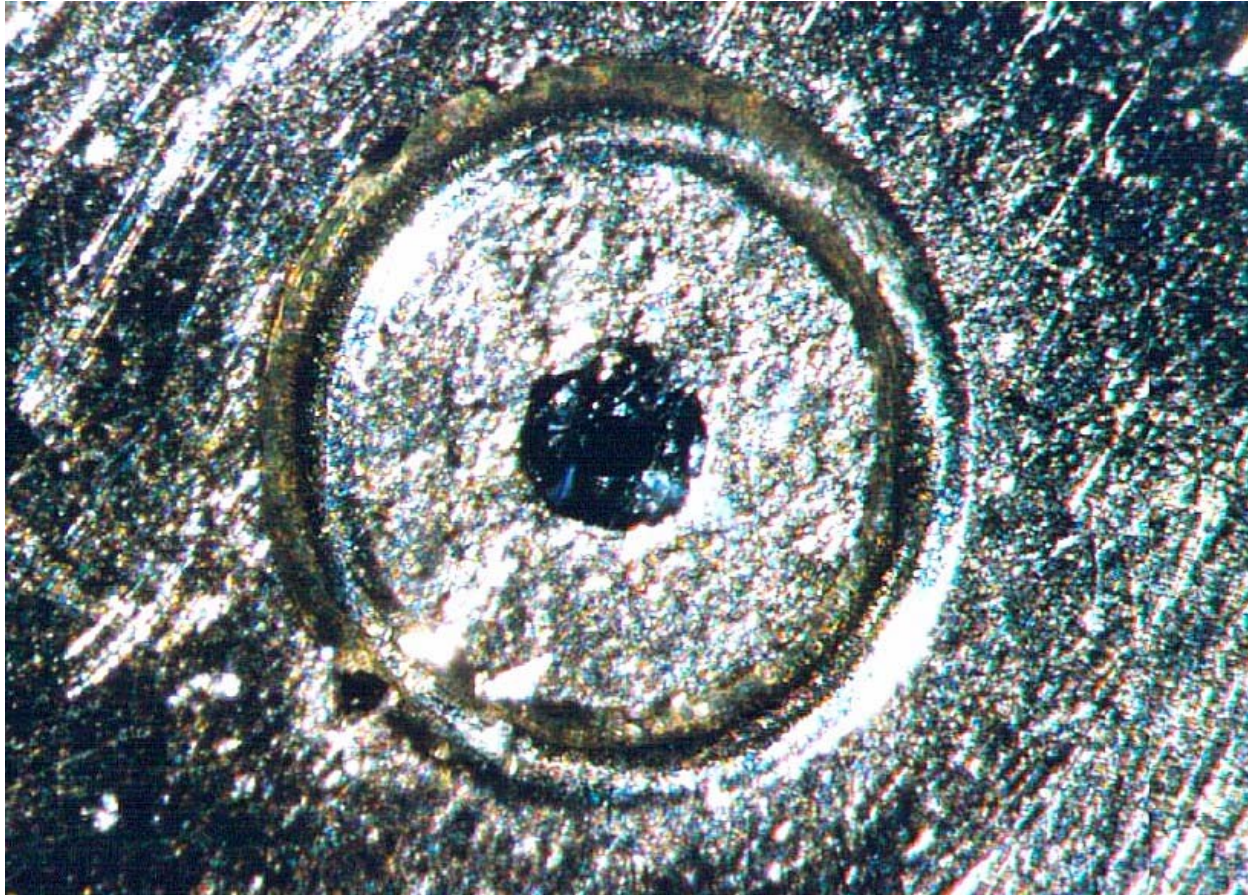
OSA Input Connector

Multimode Fiber

with $62.5\mu\text{m}$ core and $125\mu\text{m}$ cladding diameter (black and dark blue, respectively).
