Jitter Effects On 100BASE-T Timing

Time Interval Error Detects Excessive Phase Jitter

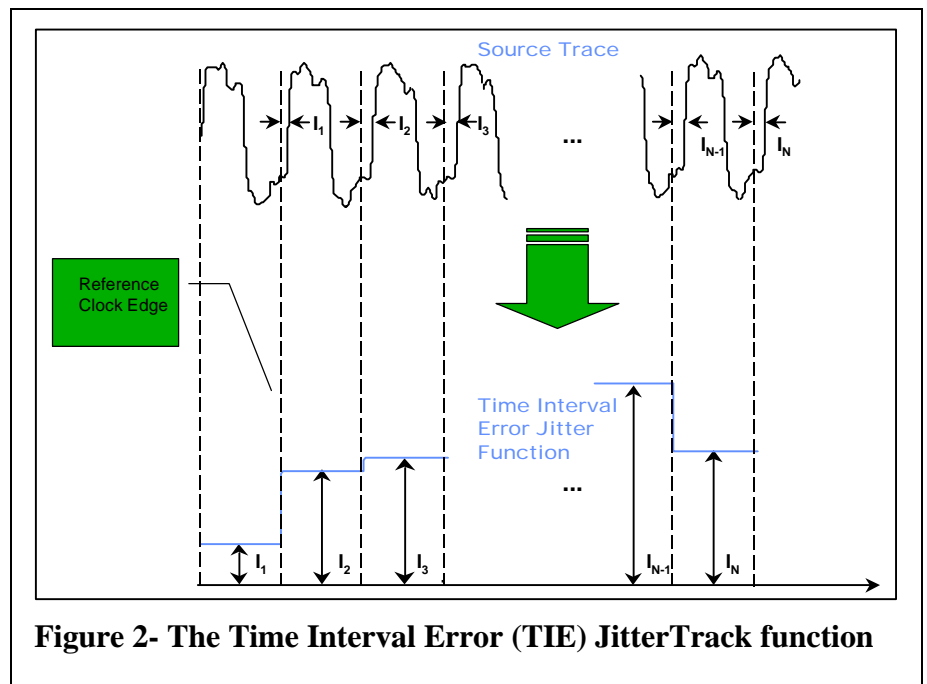
LeCroy's implementation of the Time Interval Error (TIE) JitterTrack function, shown in figure 2, measures the actual locations of a selected clock edge against an ideal location based on a user specified clock frequency. When applied to a uniform clock waveform the time interval error measures the instantaneous phase variation of the clock on a cycle by cycle basis. Even if the average frequency of the clock is constant there can be large variations in phase. These variations can cause major timing errors as can be seen in the following example

Figure 2- The Time Interval Error (TIE) JitterTrack function
