Repairhints

3210

NSE-8/9

The purpose of this document is to provide some further service information for NOKIA 3210 phones.

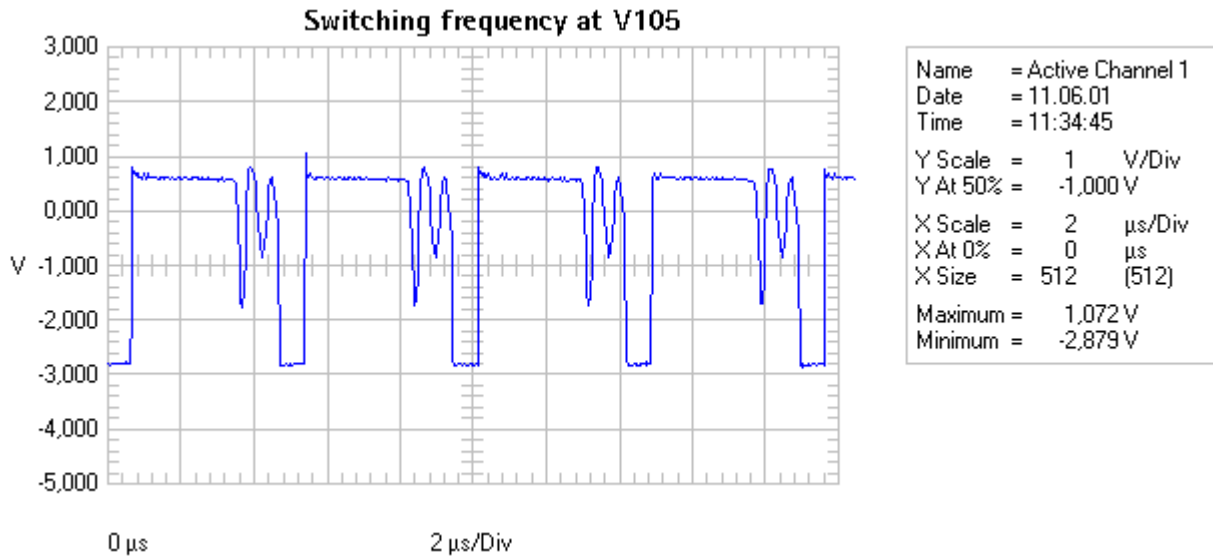
Check at V105, pin3: 0V. If not, check the respective voltage dividers R131, R132, R134, R143, R144.

If all ok – change V105.

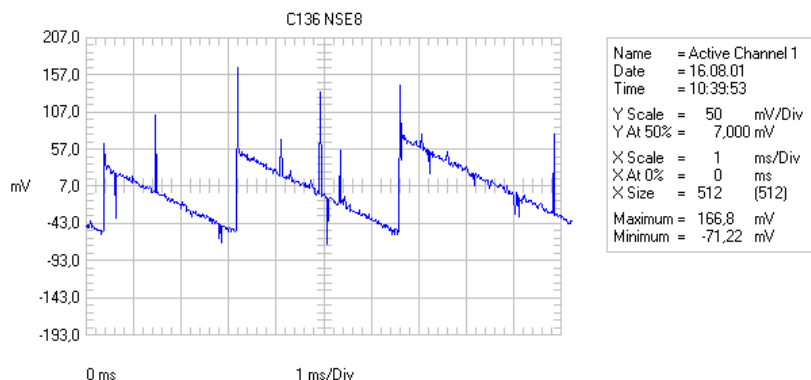
Check if VSIM at C136 is approximately 4.8V-5.2V, with maximal 350mVpp noise overlap - see diagram below.

Diagram of normal noise at C136.

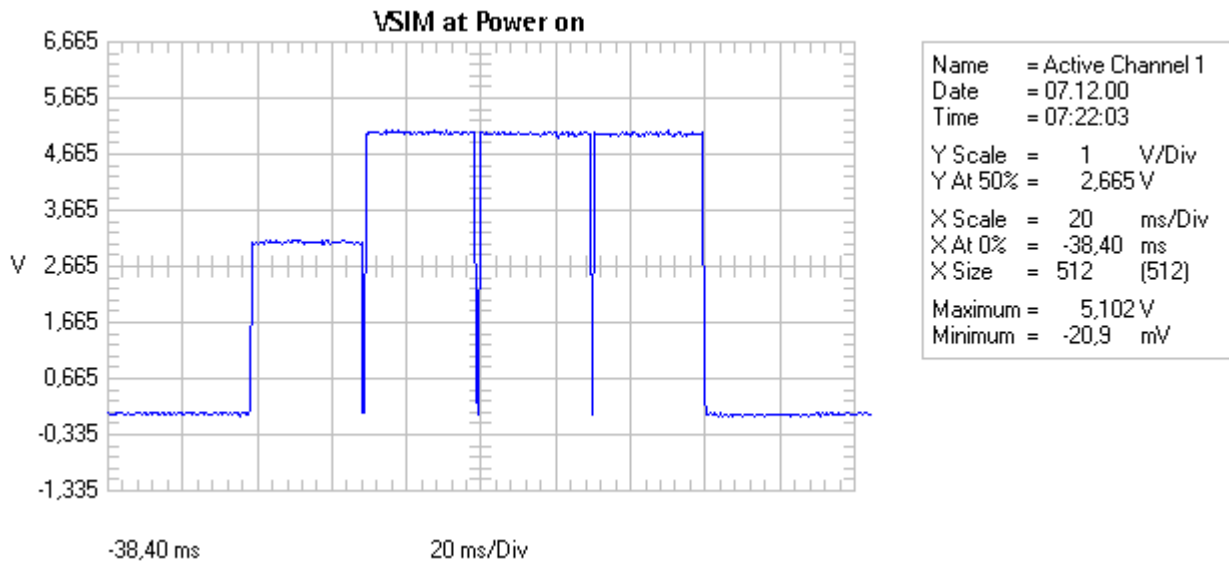
Check if the phone works properly with a Test SIM.
 If Test SIM works check R115, R116 (both 100Ω) if these are in a high Ohm range.
 Check at SIMcard reader if VSIM is pulsed to 3/5Vpp, refer to VSIM picture – if not, change N100 if necessary.
 Check SIM lines and especially V112 for shorts to GND.
 Check components in SIM lines (R115, R116 and C137 – C141) for short circuits or capacity loss.

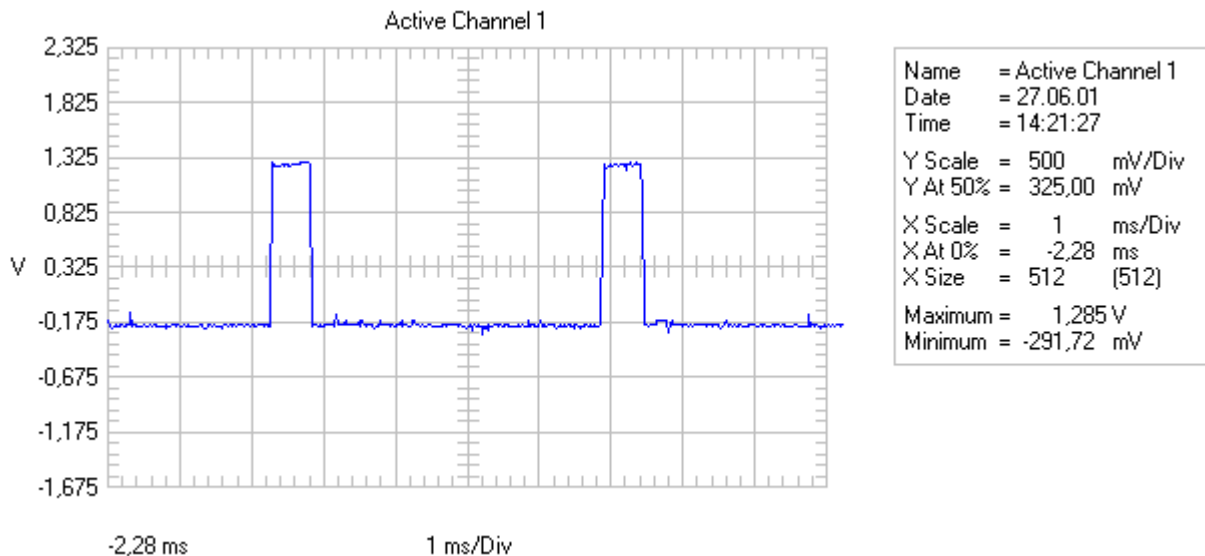
CTL_PCN signal at N700, pin 28 – in this example measured at power level 0

Change corresponding PA if control lines are ok
