Repair-Hints

3210

NSE-8/9

The purpose of this document is to provide some further service information for NOKIA 3210 phones.

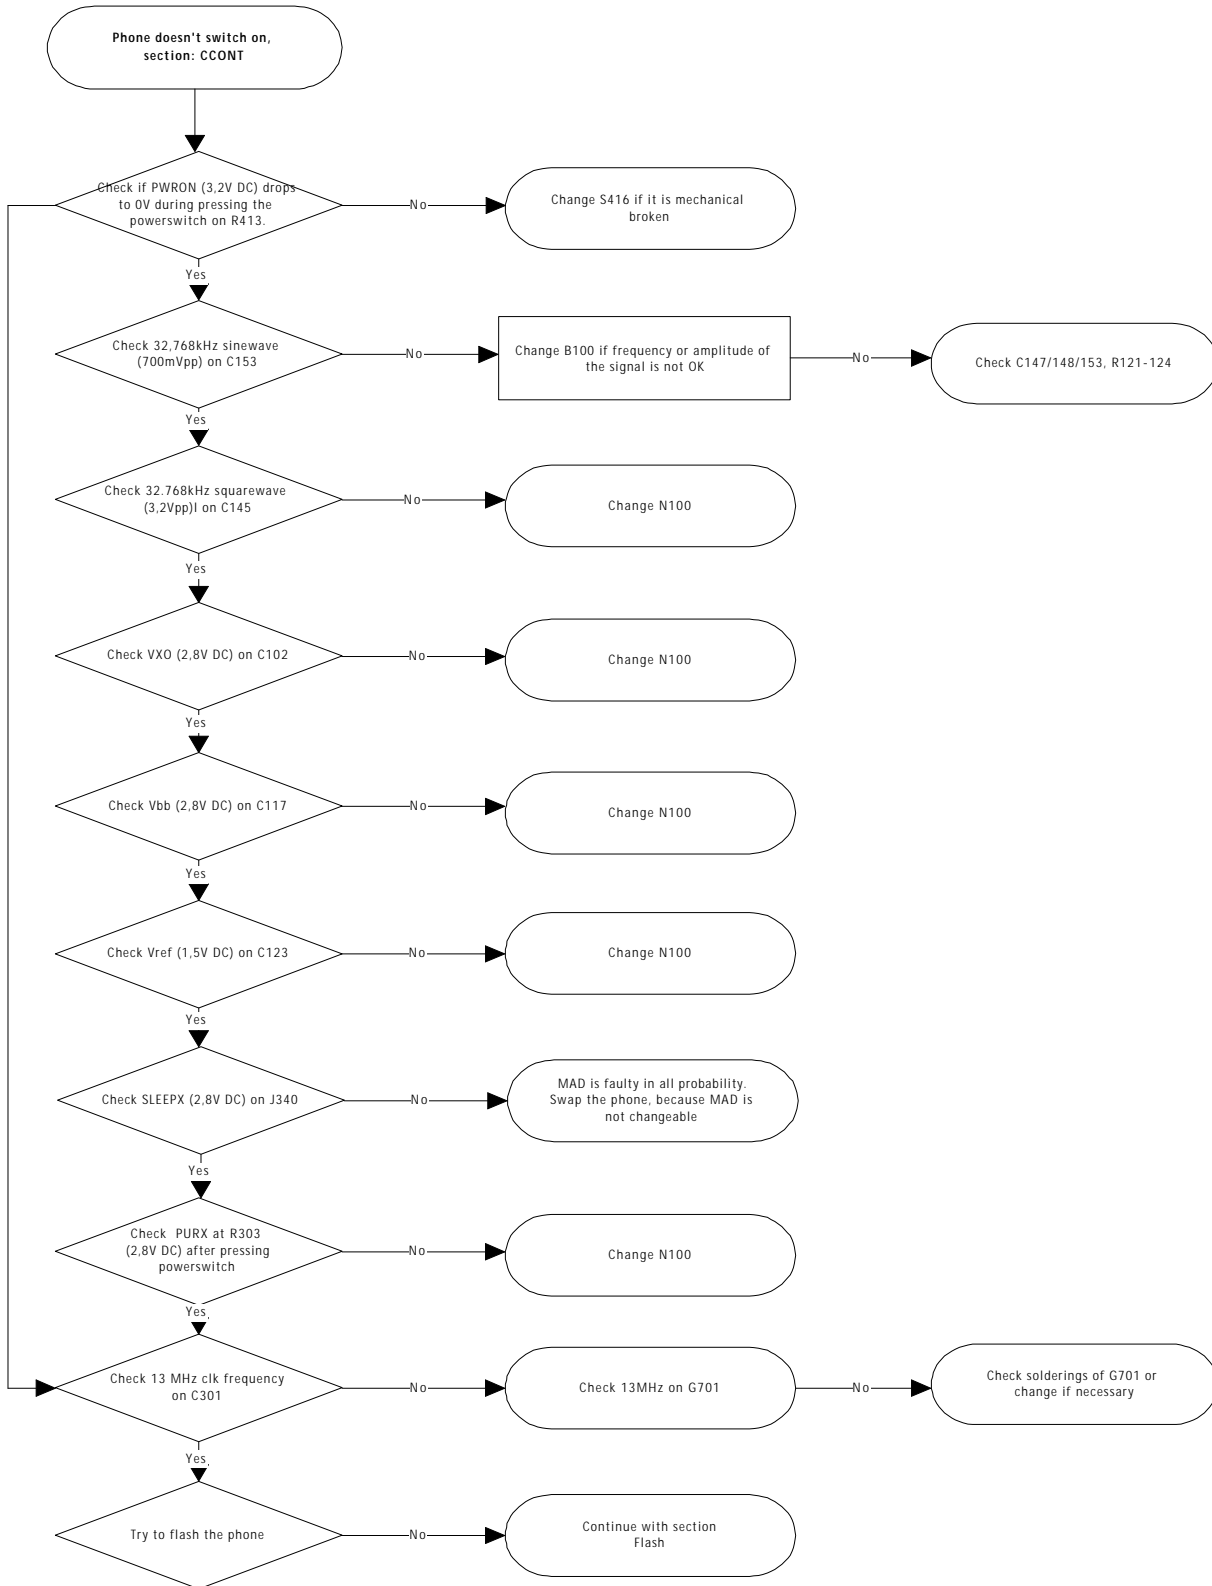
PHONE DOESN'T SWITCH ON-SECTION CCONT

Battery connectors X101/ X102 / bend or dirty.

Power on/off switch S416 faulty/ mechanical broken.

L102 poor soldered.

N100 CCONT faulty:

B100 faulty 32,768 kHz

G701 faulty 13 MHz

VB to R132 board faulty.

MAD (D300) faulty.

-Check soldering of L102, note different versions of L102 , also see HW- changes.

-Resolder L102 or change it.

Don't forget to put the additional label on the PCB, it saves the layer (see HW-changes).

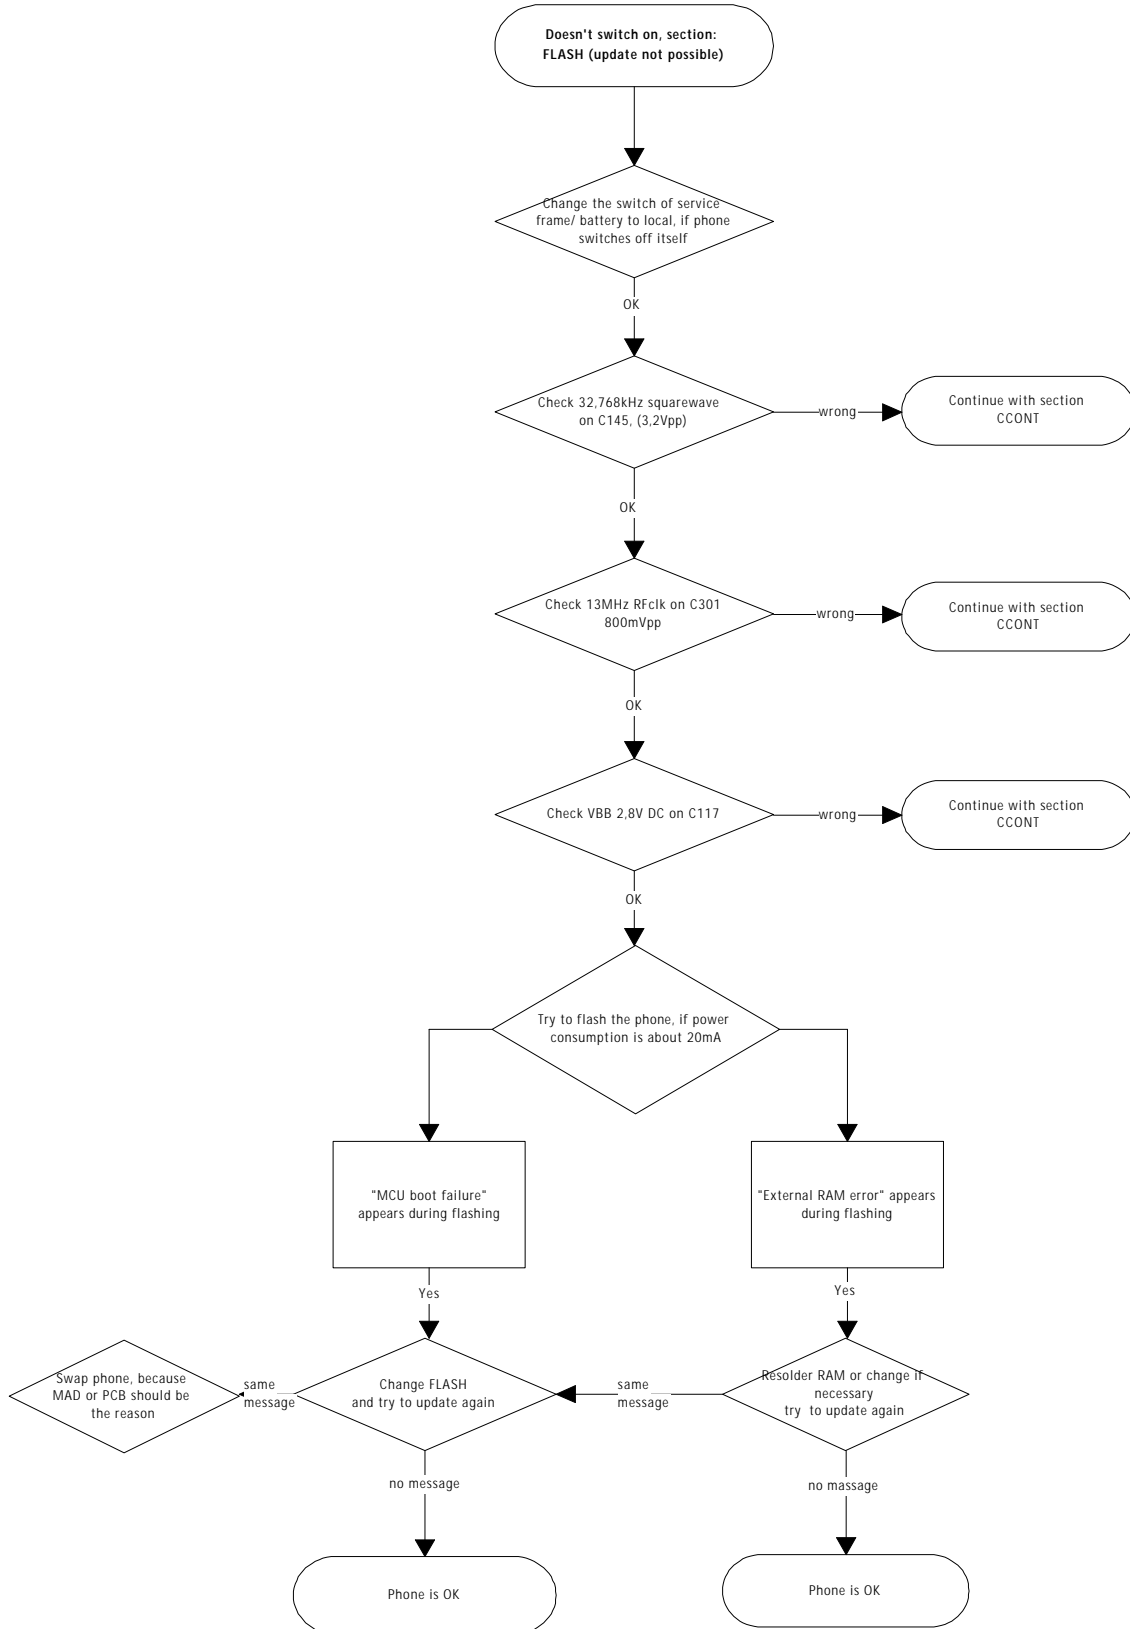
FLASH UPDATE NOT POSSIBLE/ PHONE DOESN`T SWITCH ON

D301 Flash faulty

- Check if the unit switches on after reflashing the memory.
- D301 Flash internal fail or poor soldering balls.
- Check D302, N100, L102 (broken soldered ?).

- If the unit switches off itself, change the switch of the service frame to local mode.
- Check 32.768 kHz sleep clock signal at C145 (3.2Vpp).
- Check 13 MHz main clock oscillator at C301 800mVpp.
- Check VBB voltage at C117.
- If power consumption is approximately 20mA, try to flash the phone.
- If you get an error message during the flashing process, change D301 and try again.

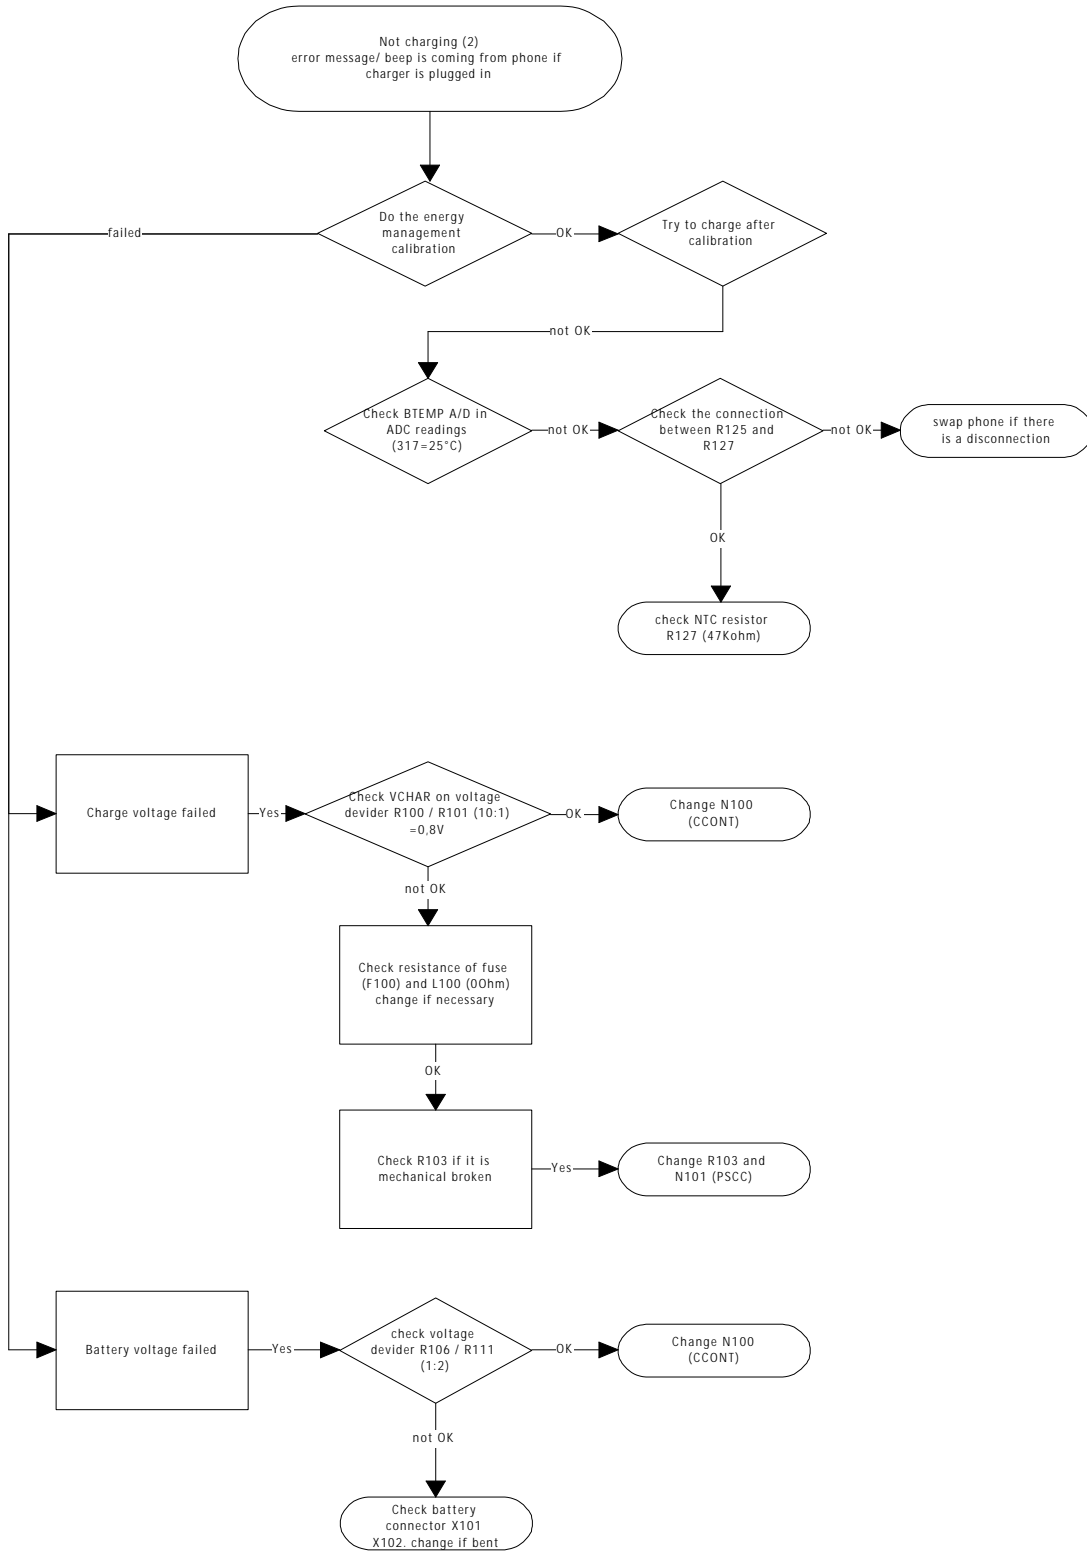
NOT CHARGING (2)

If you are using WinTesla NSE-8/9 DLL 2.41.03 or lower version the error message "current calibration fail" will appear in every charge tuning calibration test! See Service manual chapter "service software instructions" page 19 (Energy Management Calibration)

R103 broken and N101 PSCC electrical fail.

- Check if the unit doesn't charge with the ACP-9 fast charger.
- Check the mechanical appearance of the varistor R103.
- If broken, change it, in this case also change N101 PSCC.
- Replace C-Cover or cut away the arrow in the time-dial e.g. using scalpel, see HW changes.

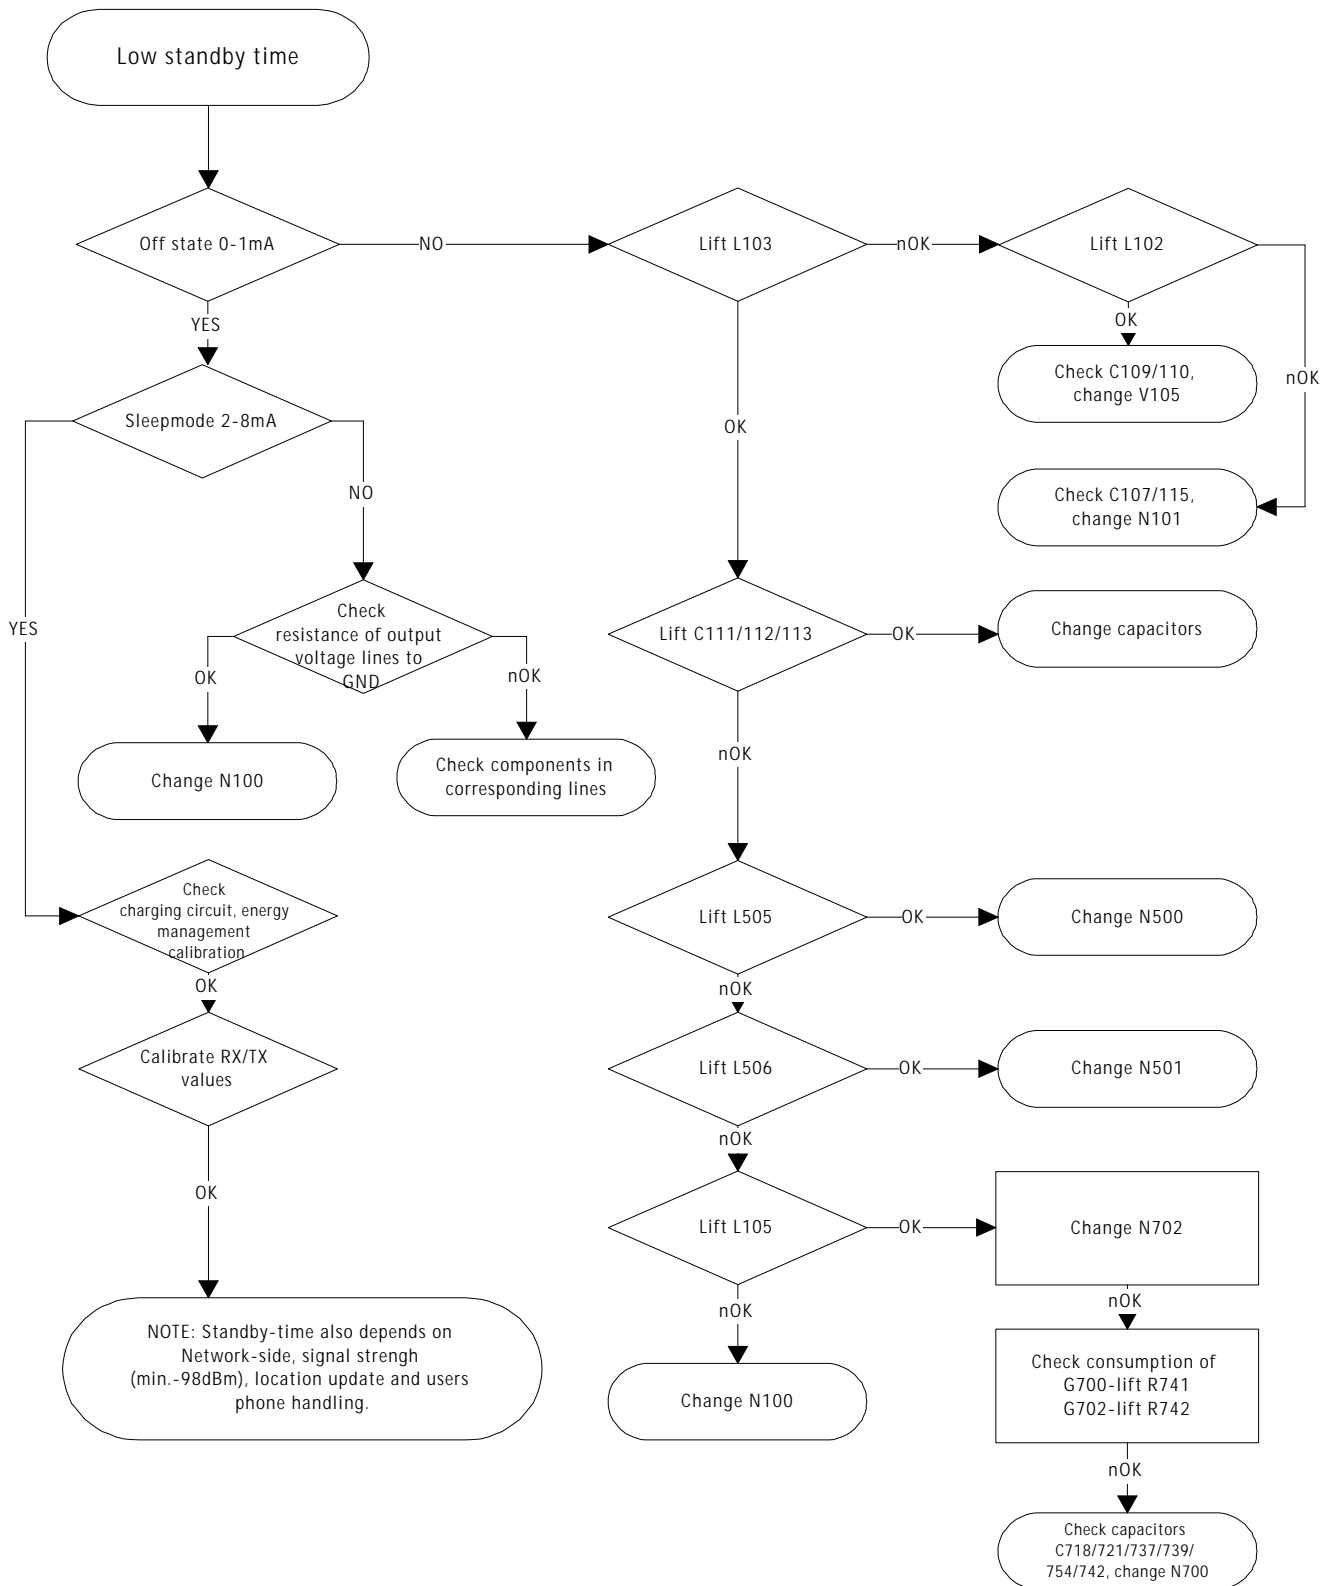
LOW STANDBY TIME

C111, C112 C113, C115 faulty

- Check the current consumption in different operation modes (refer to the table below).
- Check if the high current consumption results from the VB, Vout or output voltages of CCONT.
Disconnect coil by coil L105 (→N702) L505, L506 (→PA's) and check consumption again.
- Check and desolder C111,C112, C113 and C115.
- Calibrate Battery values if charging stops too early or battery is too hot after charging (also see chapter "Not charging).

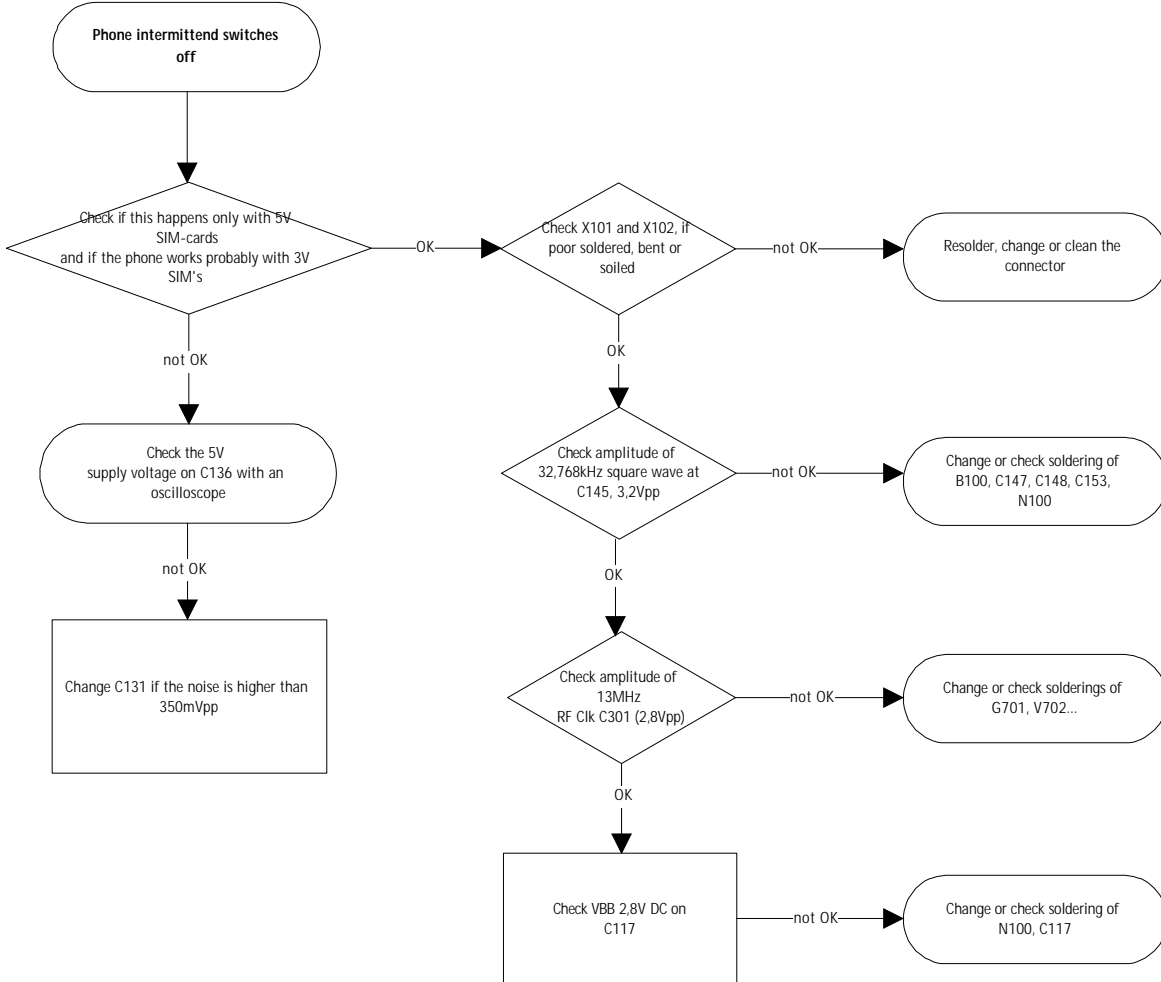
PHONE SWITCHES OFF ITSELF

C136 10µF/10V

- Check, if the phone doesn't switch off with 3V SIM-Cards.
- Check that the 5V VSIM voltage at C136 is approximately 4,8V-5,2V with maximal 350mVpp noise overlap (view diagram below).

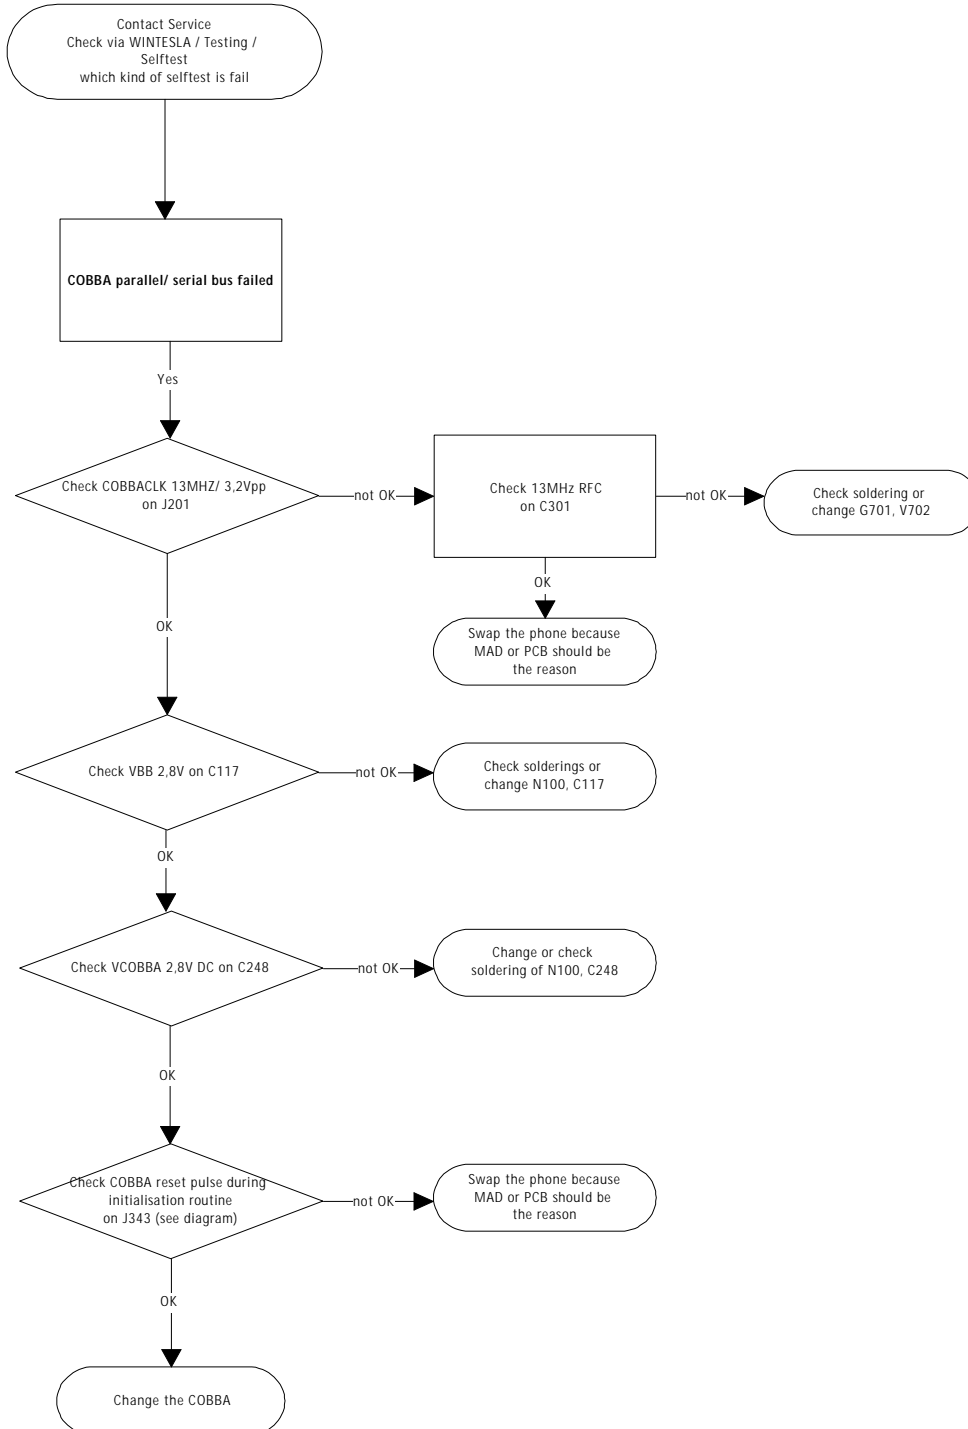
CONTACT SERVICE- COBBA PARALLEL / SERIAL BUS FAIL

N200 COBBA faulty /solder balls broken

- Check VBB 2,8V DC at C117 near to CCONT.
 - Check VCOBBA 2,8V DC C248 near to COBBA.
 - Check COBBACKL 13MHz 3,2Vpp at J 201 (see diagram below).
 - Check COBBA reset impulse during initialisation routine at J343 (see diagram below) .
 - Change COBBA and write the IMEI and SIM-LOCK DATA back to the phone.
- If error persists, MAD or PCB should be the reason.
SWAP the unit because MAD is not changeable.

Note! Rewrite SIMLOCK and IMEI entries with use of the Nokia security Password and make a SW-update or send these phones to SACE, if this procedure is not permitted to you

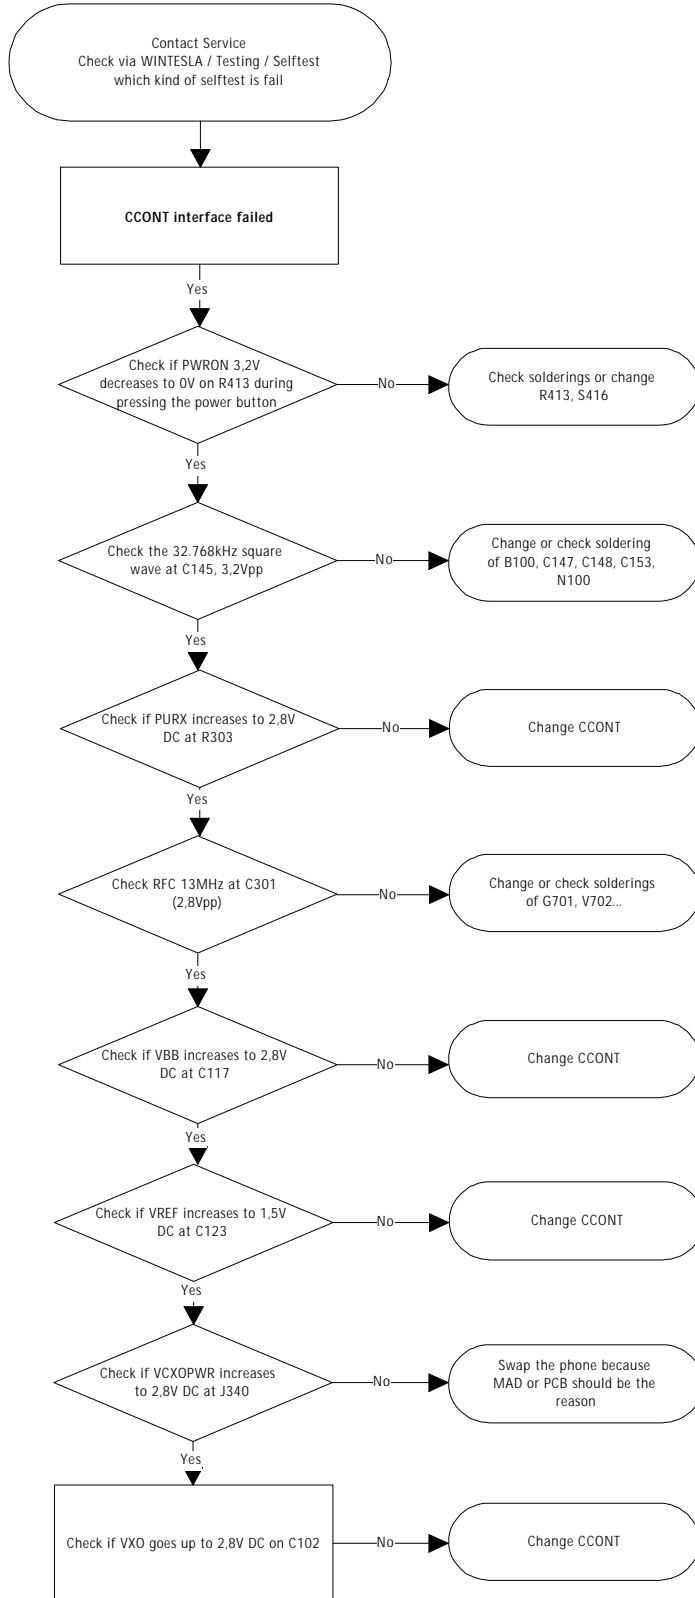
CONTACT SERVICE-CCONT INTERFACE FAIL

N100 CCONT faulty

- Check if 3,2V at R413 decreases to 0V during pressing the power on button.
- Check if there is a 32.768 kHz square wave at C145 (3,2Vpp).
- Check if PURX at R303 increases to 2.8 V DC.
- Check if VXO at C102 increases to 2.8 V DC.
- Check if VBB at C117 increases to 2,8V DC.
- Check if Vref at C123 increases to 1,5V DC.

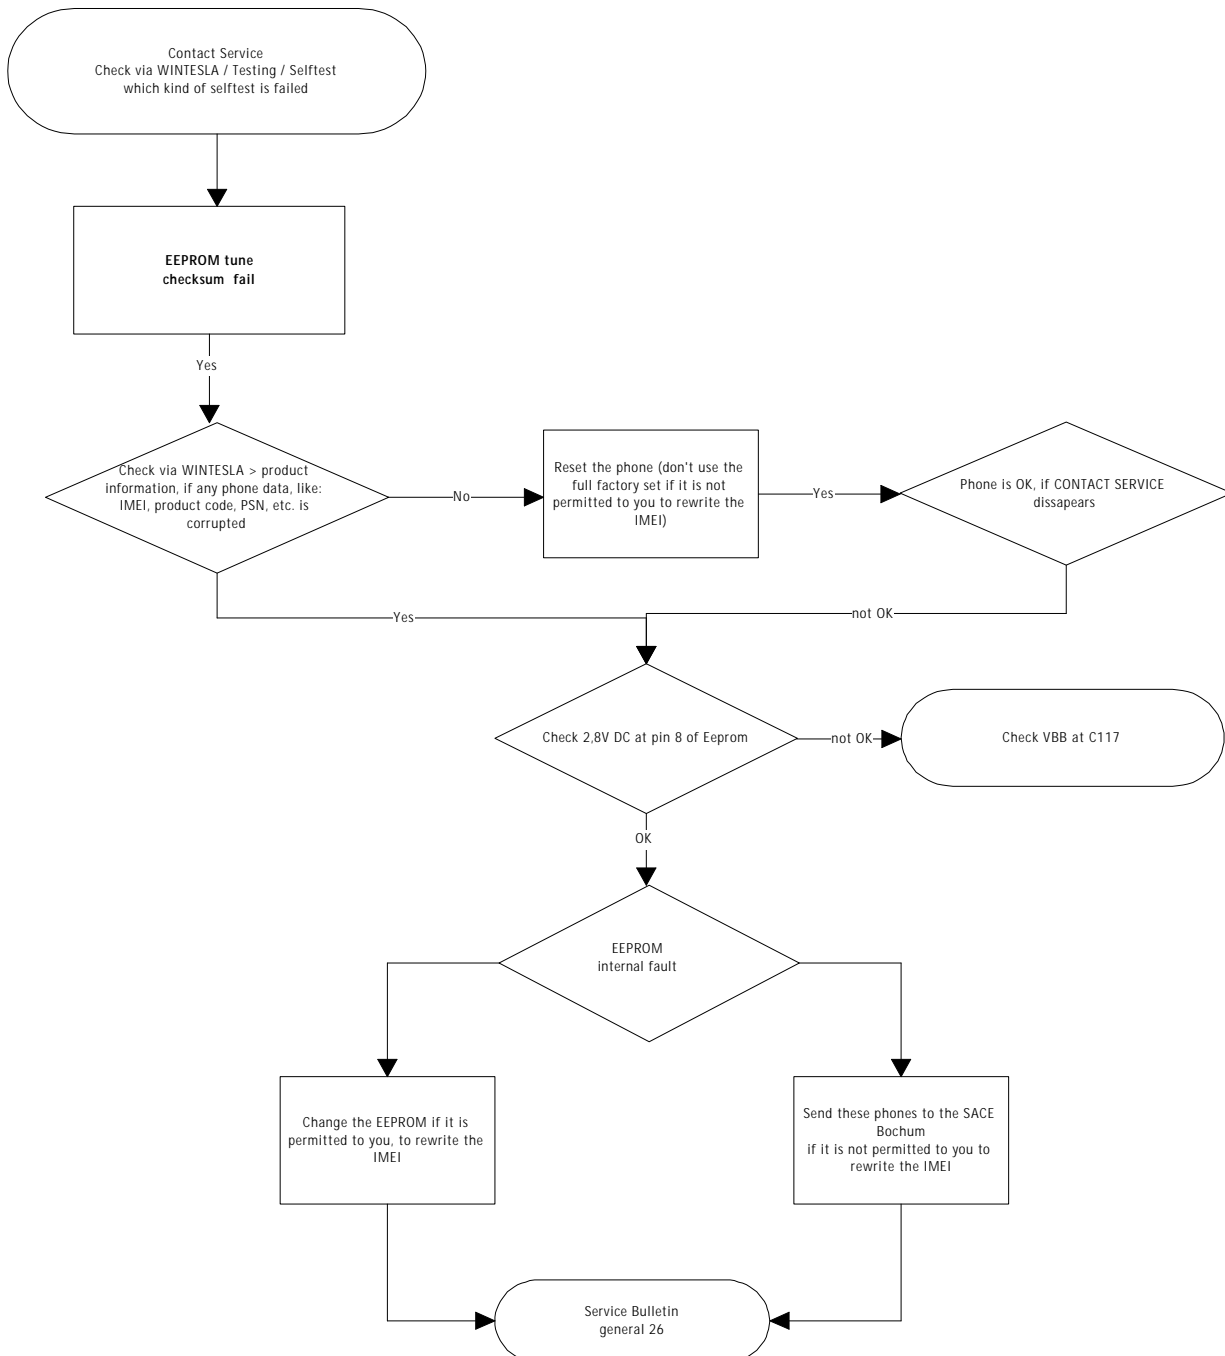
CONTACT SERVICE - EEPROM CHECKSUM FAIL

D303 Eeprom faulty

- Check with WinTesla if IMEI or product data are corrupted.
- Check 2.8V DC at pin 8 of Eeprom.
- Don't use the "Full factory set" with WinTesla, otherwise the original IMEI will be changed to "65656565..."
- Change the Eeprom if it is permitted to you and write back all ID data (IMEI, product code...).
- If you are not authorized to change Eeprom and the IMEI is missing, write a note with a short comment, and send it together with the phone to the SACE.

Note! Rewrite SIMLOCK and IMEI entries with use of the Nokia security Password and make a SW-update or send these phones to SACE.

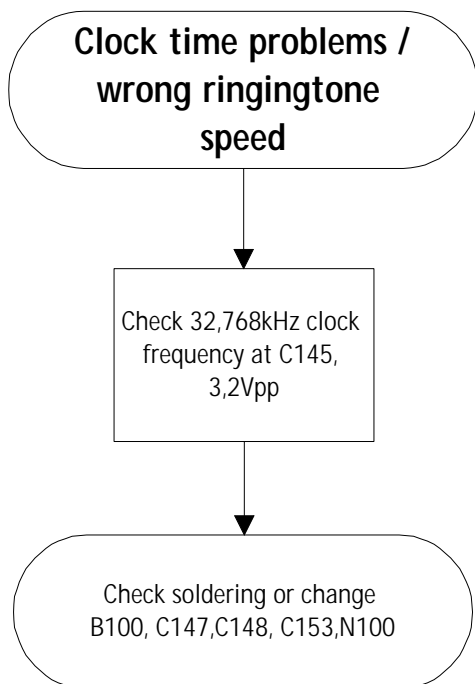
Clock time or user settings problems

**Clock time / Ringing tone is too fast or too slow****32.786 kHz sleep oscillator B100**

- Check that the sleepclk 32.768kHz square wave frequency at pin C145 isn't higher or lower
- Check the crystal B100, C147, C148, C153, N100.
- Also view the Service Bulletin 017 (capacitors C148, C153 change the value).

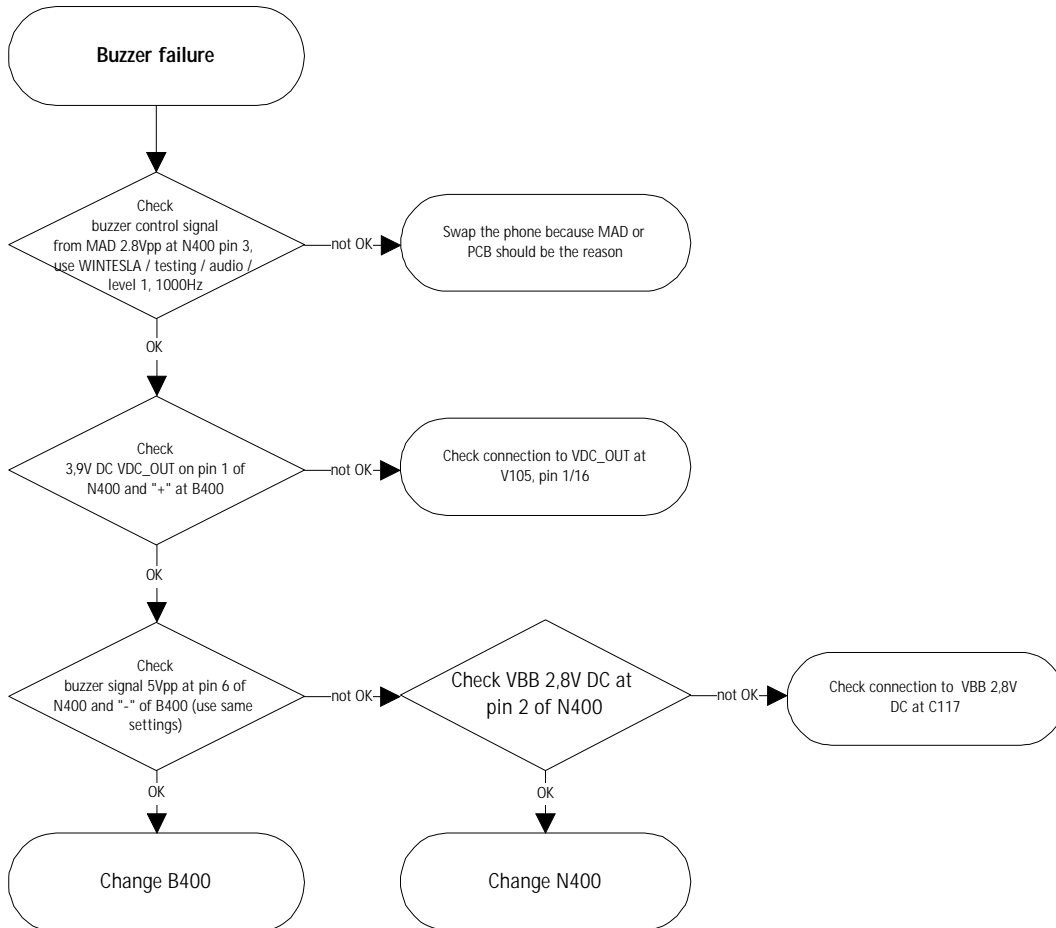
BUZZER FAILURE

B400 / board connections broken

- Check the buzzer control signal from the MAD at pin 3 of N400 2,8Vpp 1kHz (use WinTesla / testing / audio Level 1, 1000Hz)
- Check VDC_OUT 3,9V DC pin 1 N400 and "+" of buzzer.
- Check VBB 2,8V DC at pin 2 N400.
- Check the buzzer Signal on "-" of buzzer ~5Vpp, 1kHz.
- Check the board connection pin 6 of N400 to "-" of buzzer.
- Change the buzzer.

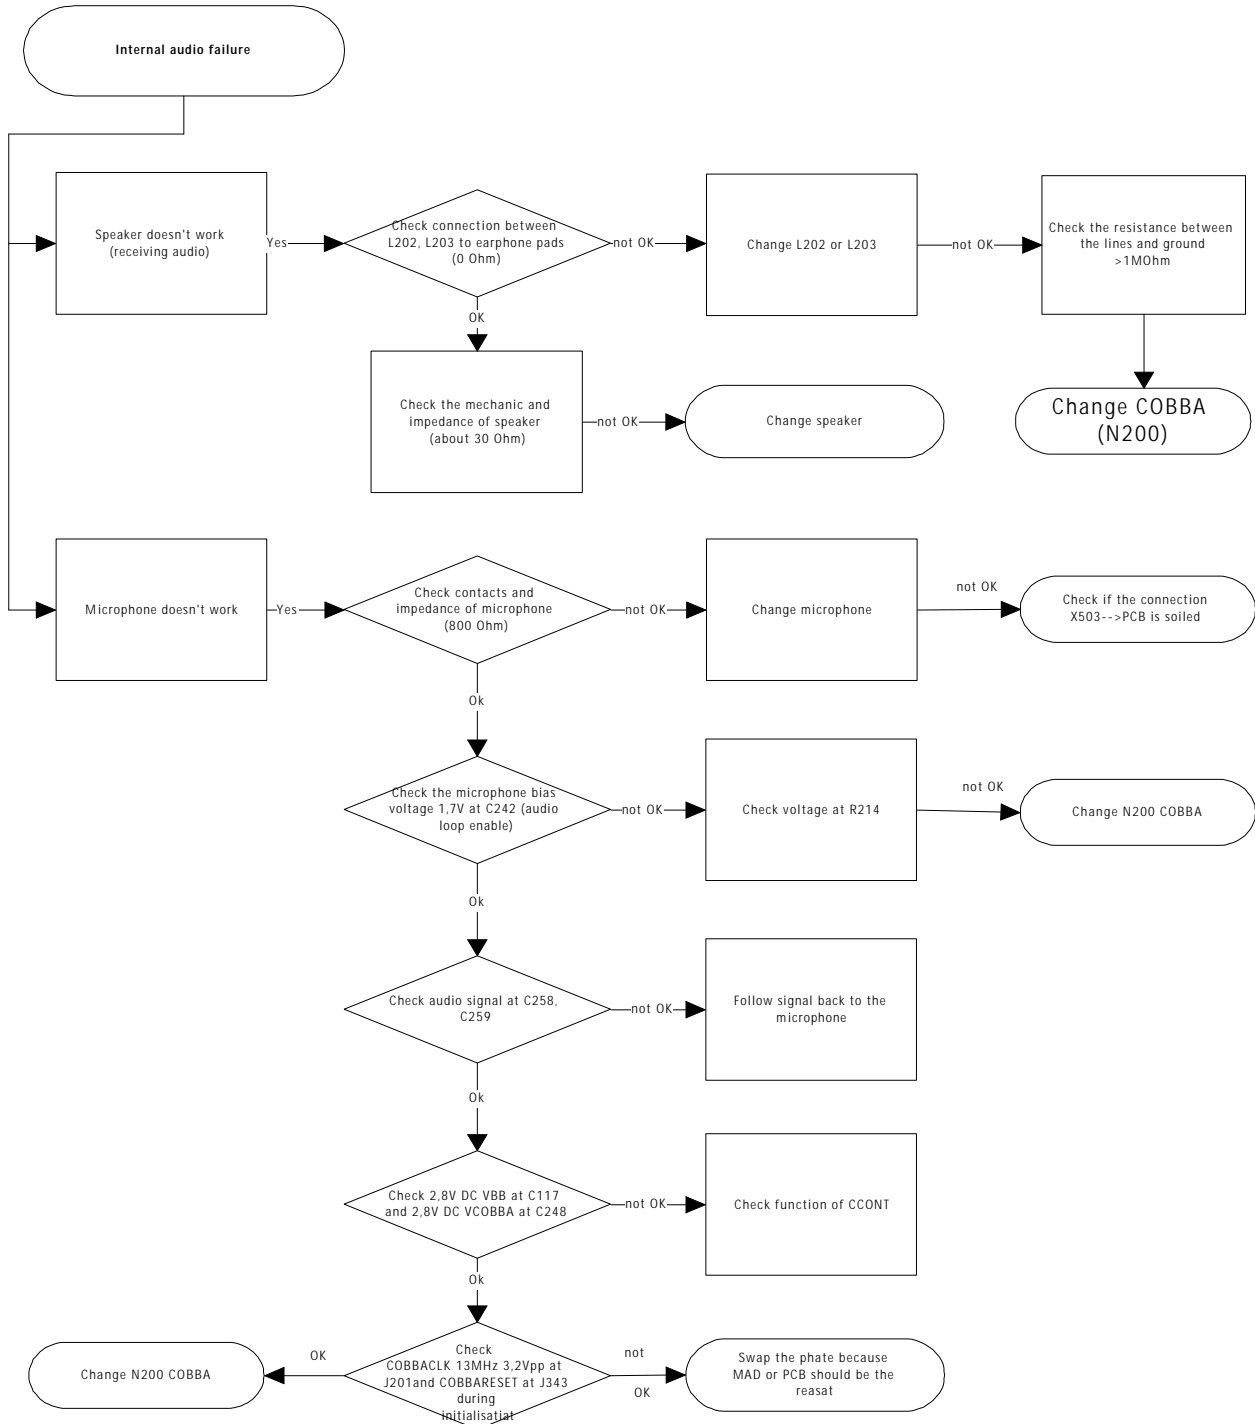
INTERNAL AUDIO FAILURE

L202, L203 faulty

- Check resistance from L202, L203 to the earphone pads normal 0Ω .
- Check resistance from L202, L203 to ground and between both lines (normal high resistance $>1M\Omega$).

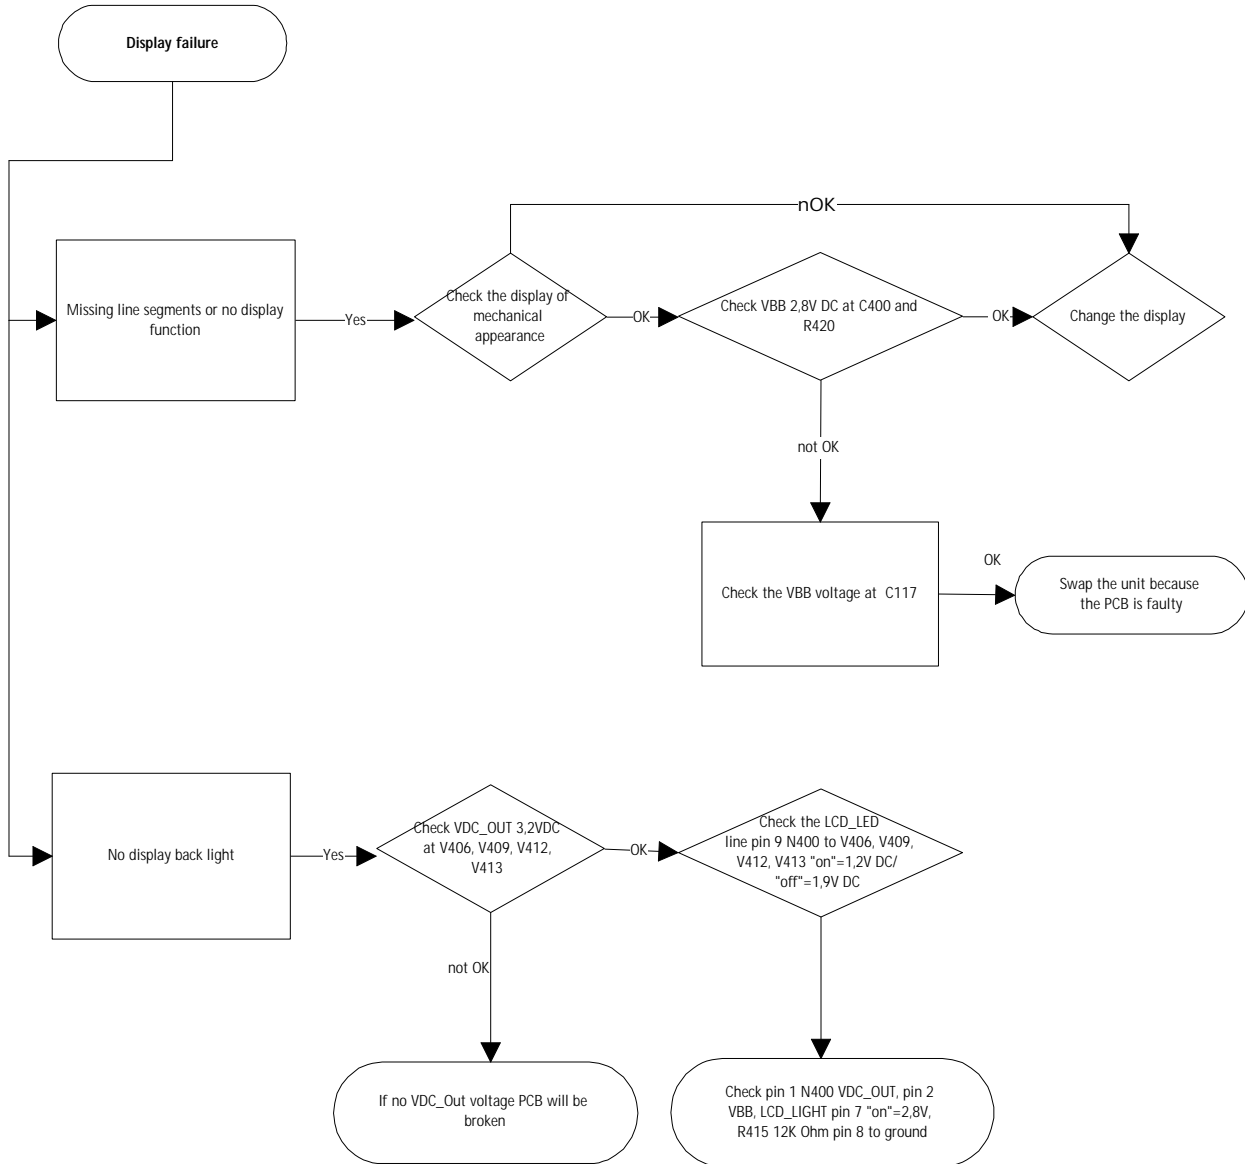
DISPLAY FAILURE

Black lines on the display or no display function

- Check VBB 2.8V DC at C400 and R420
- Change display

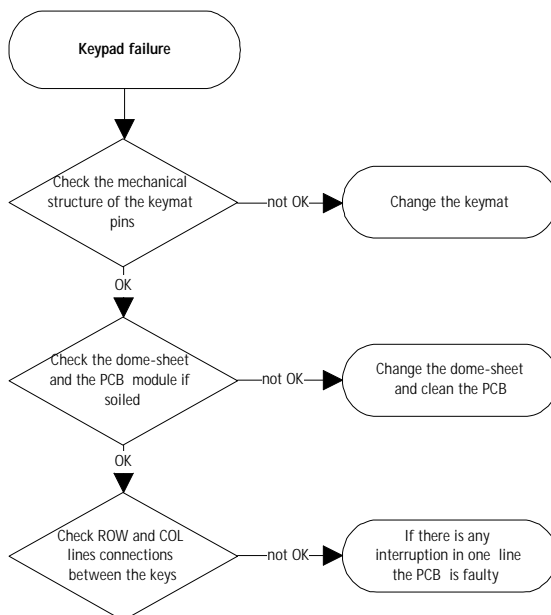
KEYPAD FAILURE

Keymat mechanical faulty

-Check the bottom of the keymat if no pins are broken or mechanically damaged

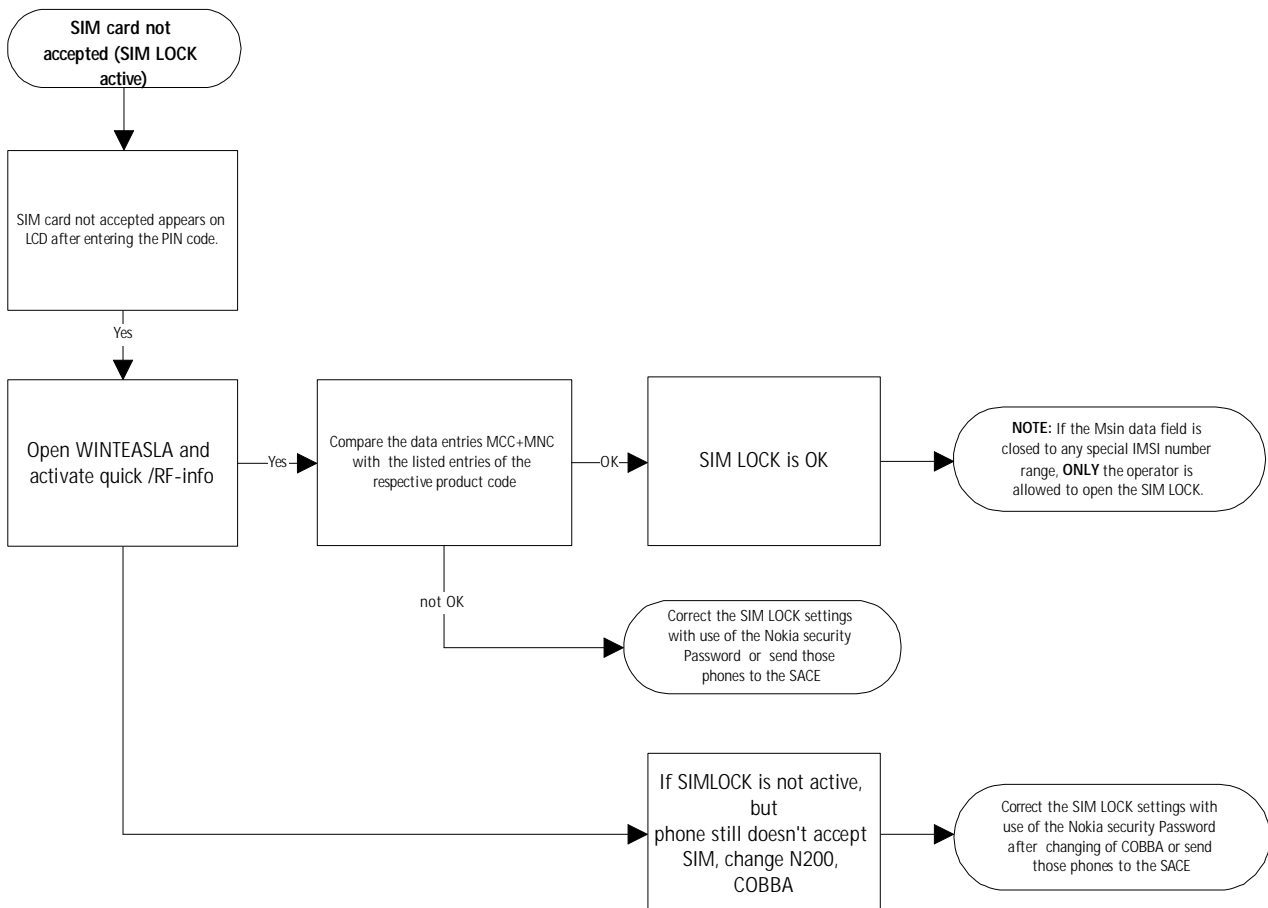
SIM card not accepted, SIM LOCK failure

If message "SIM Card not accepted" appears on LCD after entering PIN code, a SIM LOCK is probably activated in this phone or COBBA has been changed and not reprogrammed with the SIM LOCK DATA. Initialise phone into [normal mode](#) and activate [Quick/ RF-info \(WinTesla\)](#) ,compare the SIM LOCK entries with the references from the operator. *Look at Figure: List of current SIM-LOC...*

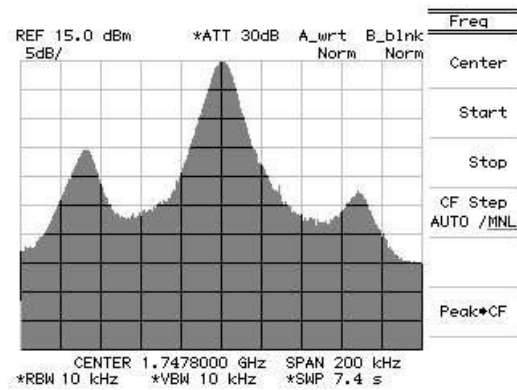
1)

Faulty spectrum – COBBA faulty, COBBA and CCONT broken soldering.
