Repairhints

3310

NHM-5

HDa 12

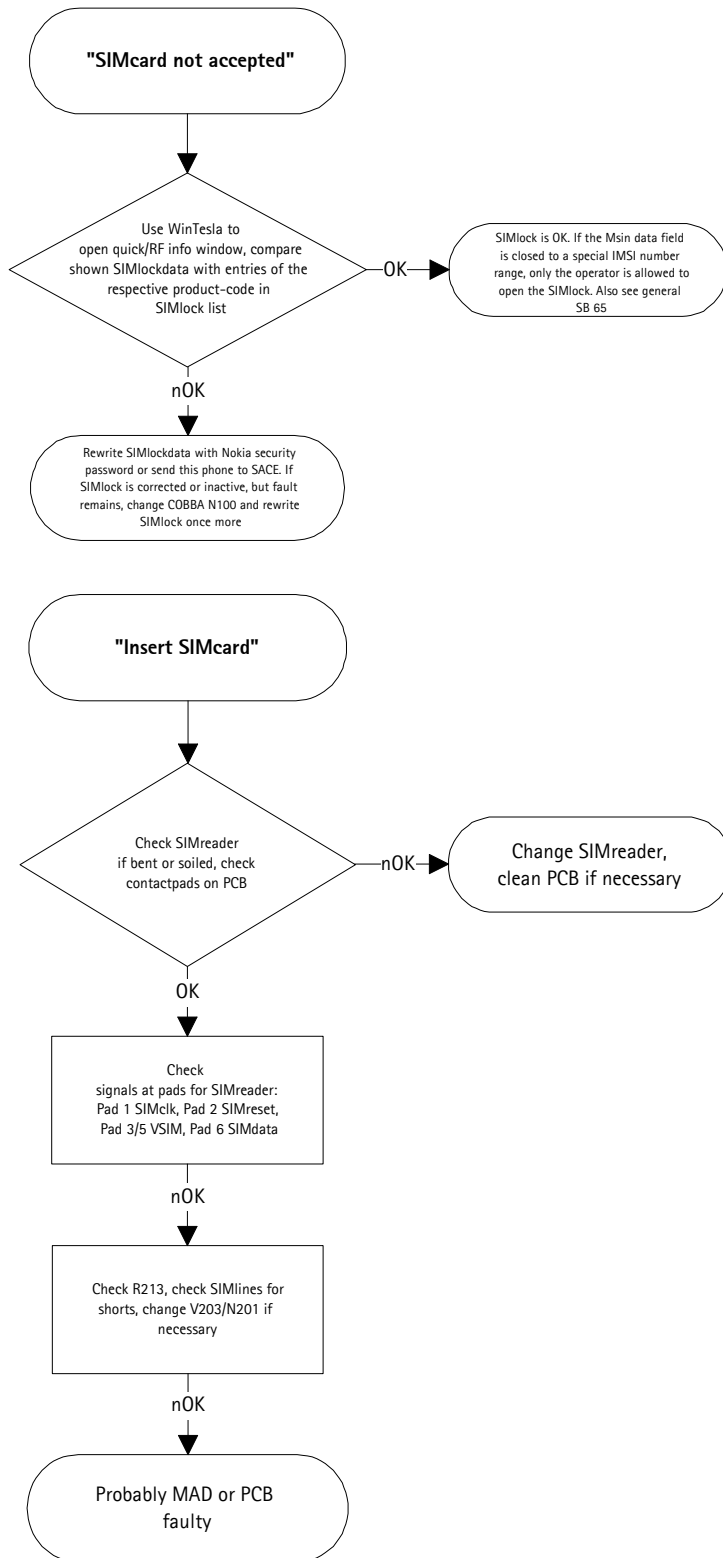
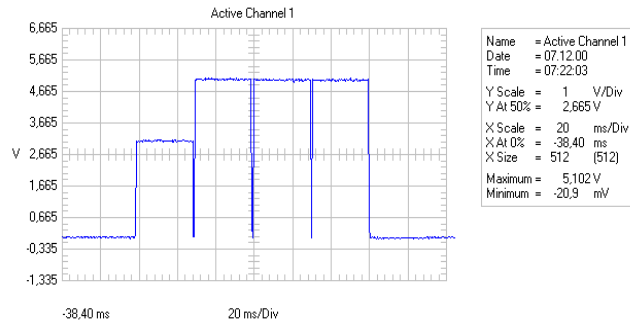
VSIM after switching on the phone without SIMcard. CCONT pulses up VSIM for four times, the first time the amplitude is 3 Volt, the next three times it is 5 Volt.
If the phone is switched on with SIMcard VSIM stays on the level with which the SIMcard will work, expected that SIMcard is not dirty or damaged.

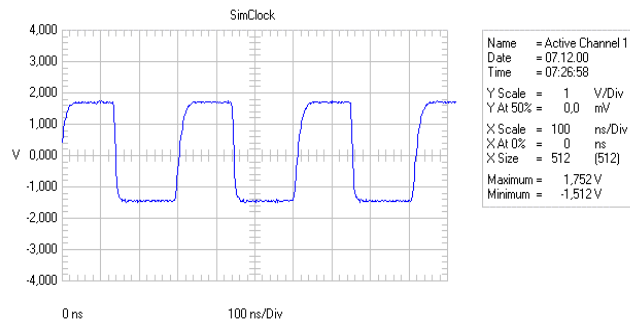
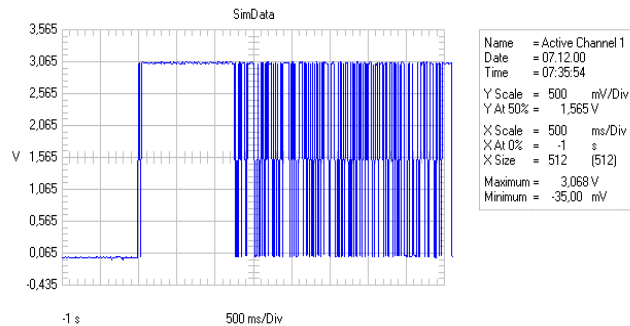
Note that SIMClock and SIMData are only present when SIMcard is active, for example when phone registers to network.

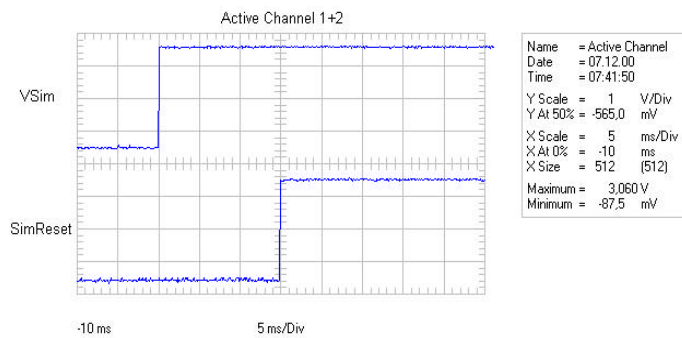
SIMReset is low-active, that means that the SIMcard will be reseted when SIMReset is 0 Volt.
This is the case after switching on the phone (diagram above). While VSIM is already high, SIMReset keeps low for a few milliseconds – in this time the card will be reseted.

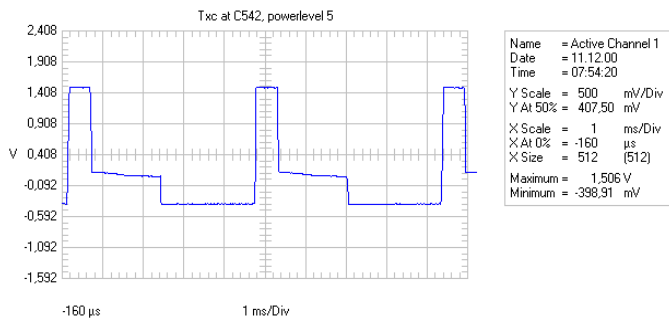
TXC measured at C542 (active unit TX, powerlevel 5)

The amplitude of TXC depends on the chosen powerlevel. It varies between 0.6Vpp on powerlevel 19 and 1.9Vpp on powerlevel 5.

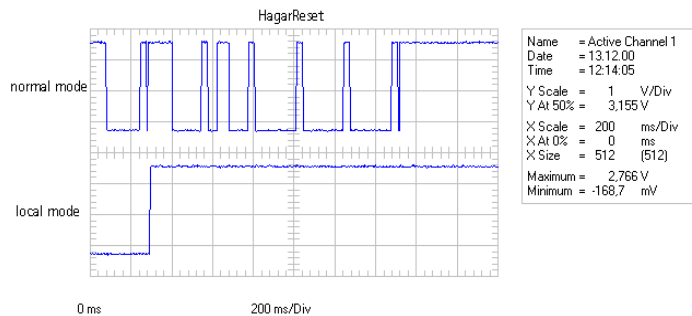
HAGARRESET
Measured at R516

While HAGAR Reset pulses from 0V to 2.8V in normal mode, it stays on 2.8V in local mode after being low for some milliseconds.

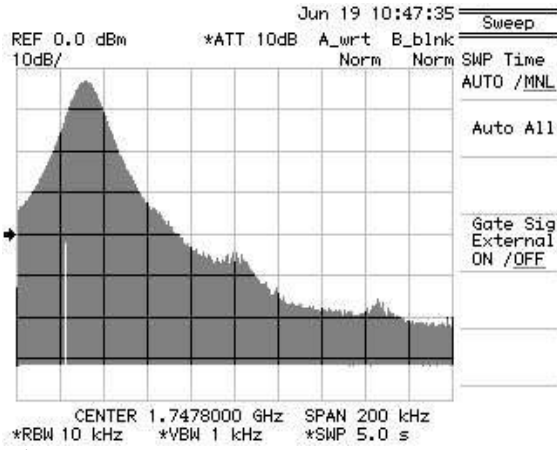
1) Normal spectrum

Faulty spectrum

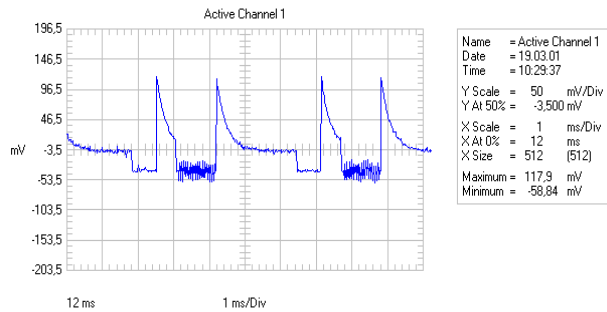
Check 26MHz reference oscillator at G502 pin 3, 1Vpp, frequency deviation < 100Hz
 Check 942.6MHz at both sides of L504
 Check Sdata at R300, Sclk/Sena at R301 and HAGARReset at C540, refer to diagrams in section TX-faults
 Check 67.708kHz at the four pads of C512 located towards G502 (burst mode, input level-65dBm)

If signal is not ok, check Vrxrf 2.8V at C500, also check Vchp 4.8V at C505 and frequency of G500 at T502 pin 3/4 (RX Ch.38: 3770.4MHz) or change HAGAR N500.

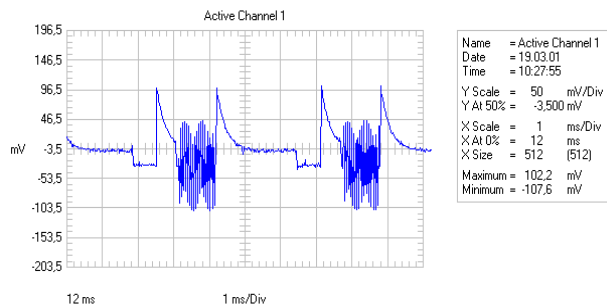
Check 67.708kHz at the four pads of C512 located towards N500 (burst mode, input level -65dBm)

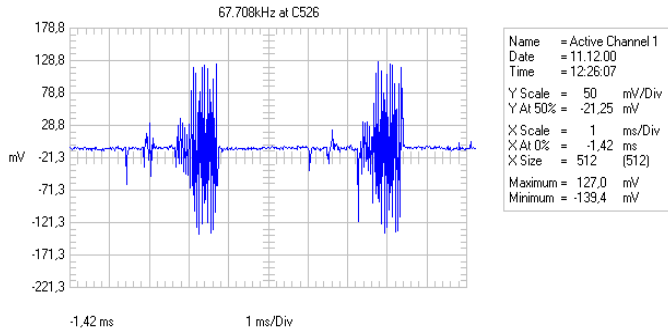
Check 67.708kHz at C526 (burst mode, input level -65dBm)
