HD947 GF7\_17 Vers.2

The purpose of this document is to provide some further service information for NOKIA 6150 phones.

# Doesn't switch on

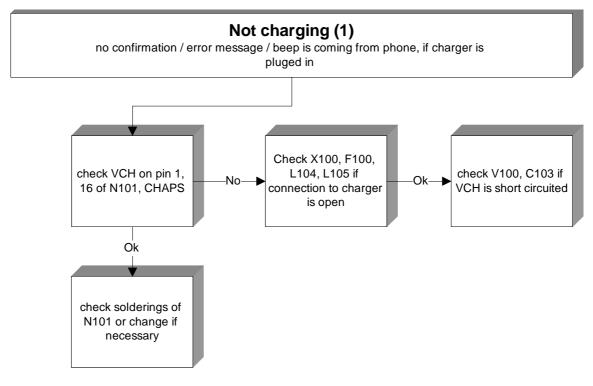
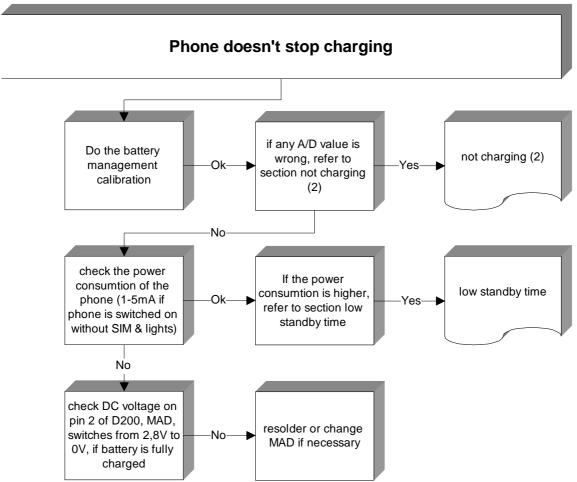
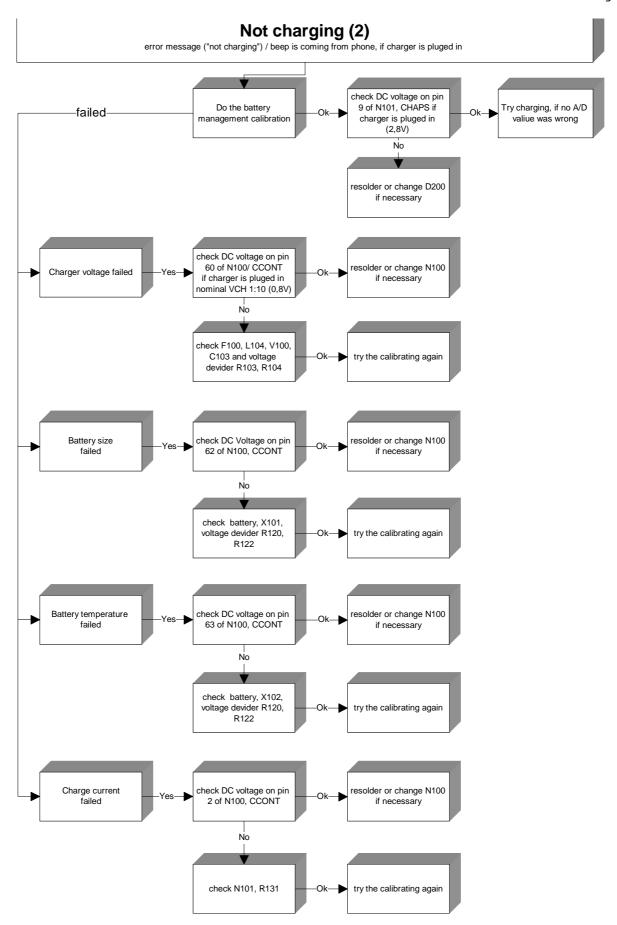
# Not charging

# F100 faulty

• Check resistance of F100 (0 $\Omega$ )

#### V100 faulty

• Check resistance of V100 (50K $\Omega$  in circuit)

#### L104 faulty Vcharge

• Check resistance of L104 (0 $\Omega$ )

#### L105 faulty Charge ground

• Check resistance of L105 (0 $\Omega$ )

#### C103 faulty short circuit on Vcharge

• Check resistance of C103 (50K $\Omega$  in circuit)

## N101 faulty/ poor soldering

- Check PWMOUT on Pin 7 (1 Hz standard charger / 32Hz fast charger)
- Check if CHARLIM on Pin 9 is 2.8V DC

## N100 faulty/ poor soldering

- Change if any A/D value is out of limit but the DC voltages are ok.
- If DC voltages are wrong, check corresponding voltage dividers
- Check PWMOUT on Pin 56 (1 Hz standard / 32 Hz fast)

- If charging stops to early
- If message "not charging appears on LCD"
- If any part in charging circuit has changed
- If any A/D value is out of limit, check the corresponding DC Voltages on CCONT

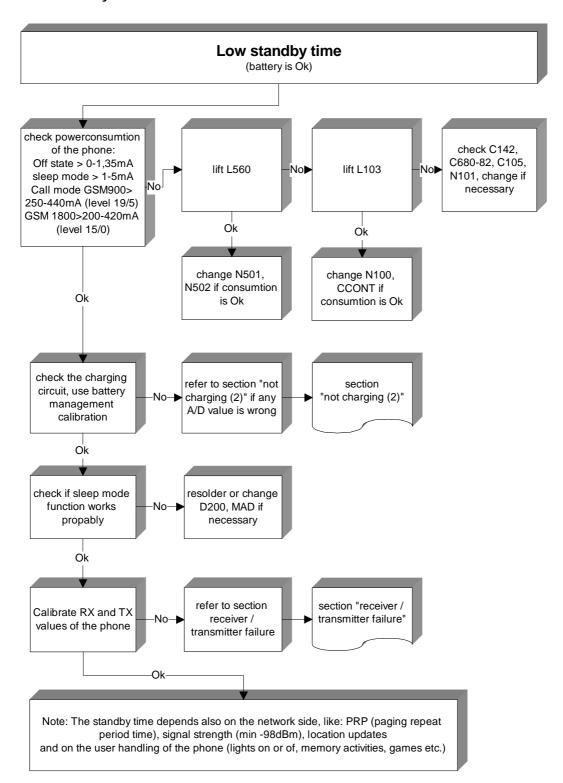
# Low Stand by time

N501 / N502 / N100 / N101 / D200 / Battery calibration - faulty

Check the current consumption in different operations mode

- Disconnect the PA's N501 / N501 lift L560 and check the current again
- Check if the current consumption comes from the first or second side of CCONT lift L103
- Check C105, C142 or N101
- Check soldering of the MAD
- Change MAD
- calibrate Battery value if charching stop to early or battery are to hot after charching (see also chapter "Not charging)

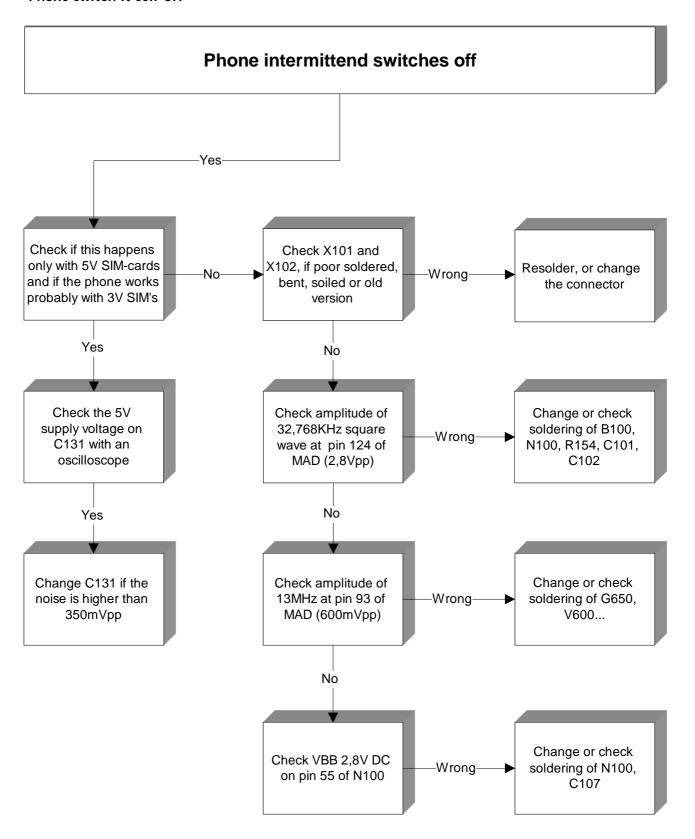
#### Phone switch it self off

## C131 10µF/10V

- Check that the handset work with 3V SIM-cards
- Check that the 5V voltage over the capacitor C131 are around 4,8V-5,2V with maximal 350mVpp noise overlap (look to the diagram below)

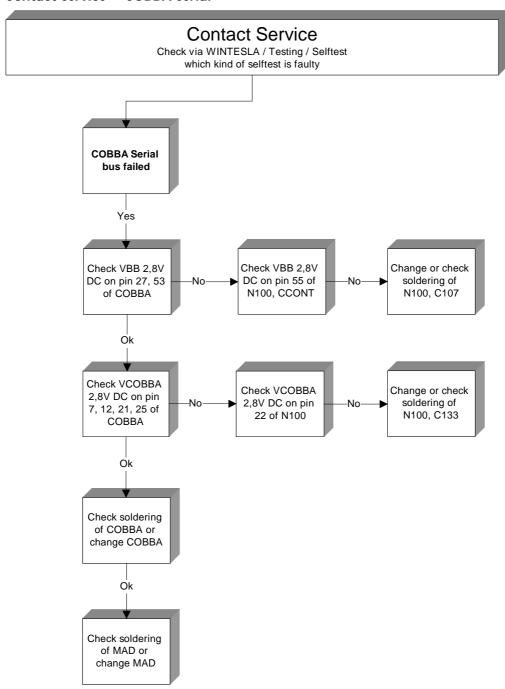
#### Contact service - COBBA serial

## N250 COBBA faulty / poor soldering

- Check VBB 2,8V DC on pin 27, 53 from COBBA
- Check VCOBBA 2,8V DC on pin 7,12,21,25, from COBBA
- Check COBBACKL 13MHz 3,2Vpp pin 45 from COBBA
- Resolder COBBA
- Internal error of COBBA

Note! Rewrite SIMLOCK and IMEI entries with use of the Nokia security SW (SSSW) and make a SW-update or send this phones to the SACE, if this procedure is not permitted to you

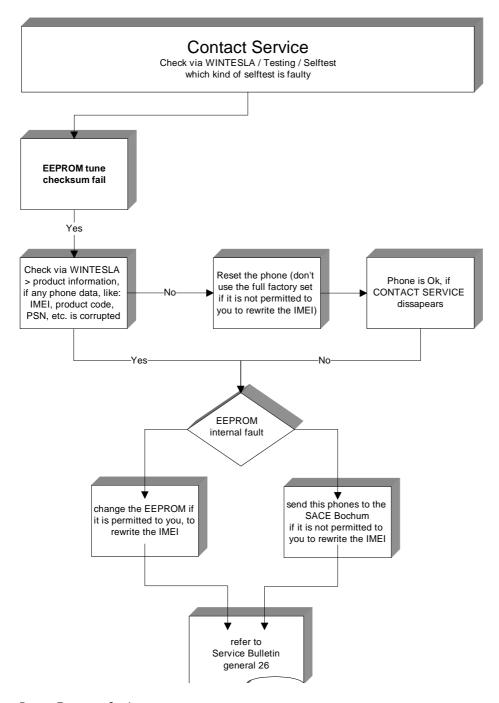
## Contact service – Eeprom tune checksum fail

#### D230 Eeprom faulty

- Check with wintesla if IMEI or product data are corrupt
- Don't use the "Full factory sett" with wintesla, otherwise the IMEI will be change to guestion marks
- Change the Eeprom if it's permitted for you and write all ID data (IMEI, product code...) back
- If you aren't allowed to change the Eeprom and the IMEI is missing, write a note with a little comment, and send it together with the phone to the SACE

Note! Rewrite SIMLOCK and IMEI entries with use of the Nokia security SW (SSSW) and make a SW-update or send this phones to the SACE, if this procedure is not permitted to you

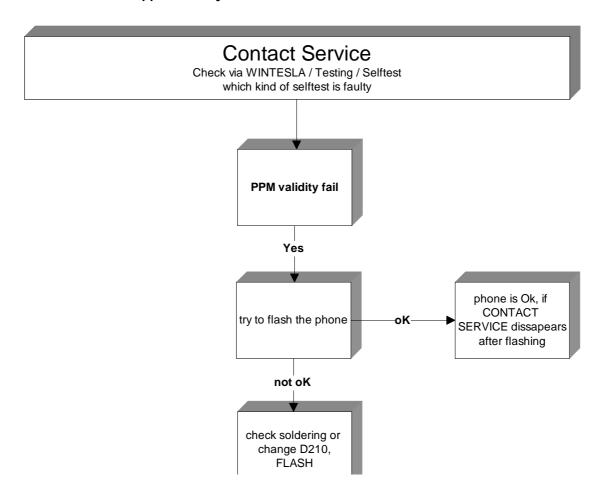
## Contact service - ppm validity

# SW / D210 Flash faulty / poor soldering

- Check if the fault disappear after update the handset
- Resolder D210 Flash
- Internal error of Flash

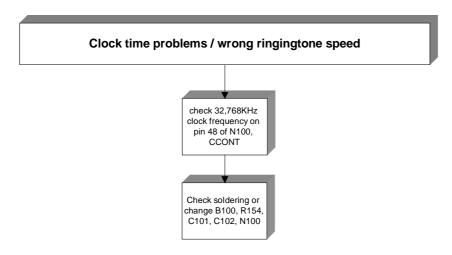
# Clock time or user settings problems

Clock time / Ringing tone is to fast or to slowly 32,786KHz Sleep oscillator

- Check that the sleepclk 32.768KHz square wave frequency on pin 48 CCONT isn't higher or lower
- Check the crystal B100, R154, C101, C102, N100

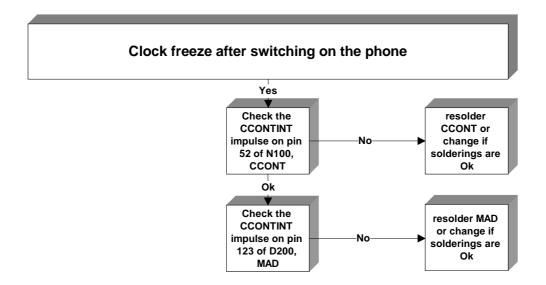
Clock will freeze after switch on

CCONTINT short circuit / break

- Check the CCONTINT impulse on pin 52 CCONT or pin 123 MAD (see the diagram below)
- Check pin 52 CCONT pin 123 MAD short circuit or break

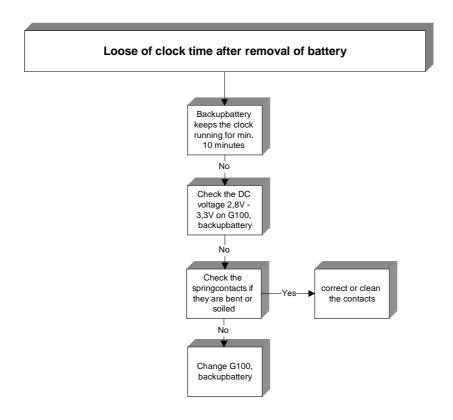
Loos the clock time if the battery is empty or removed for few minutes

G100 Back up battery faulty / disconnect

- Check the voltage 2,8V-3,3V over the back up battery connected to the PCB in the service modus
- Check the spring contacts
- Clean the back up battery contacts on the board

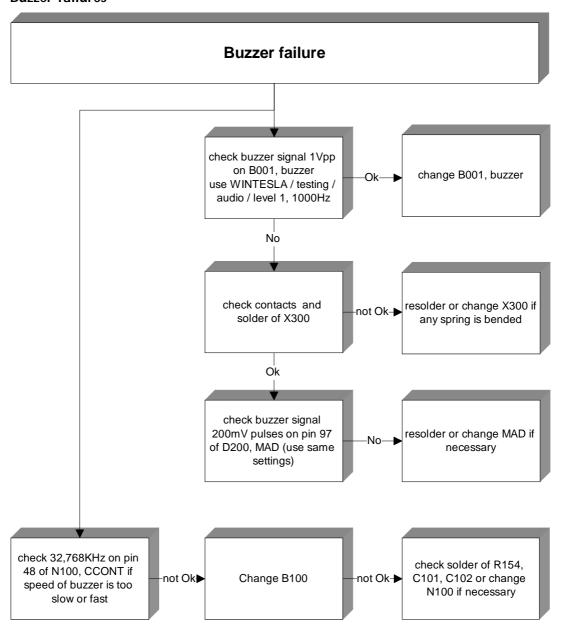
#### **Buzzer failures**

#### B001 / UI-module

- Check buzzer signal about 1Vpp pulses (use WINTESLA / testing / audio Level 1, 1000Hz)
- Change component if signal is ok

## X300, board to board connector

- Check soldering
- Check contact springs, change component if bent

#### D200, MAD

Check buzzer signal on Pin 97 (200mV pulses) use WINTESLA / testing / audio Level 1, 1000Hz

# B100, 32.768KHz crystal

- Change component if ringing tone speed is to low or high if a call comes in. If you pick a ringing tone from the menu, the speed is normal.
- In this case, also the clock is running wrong if the phone is switched off.

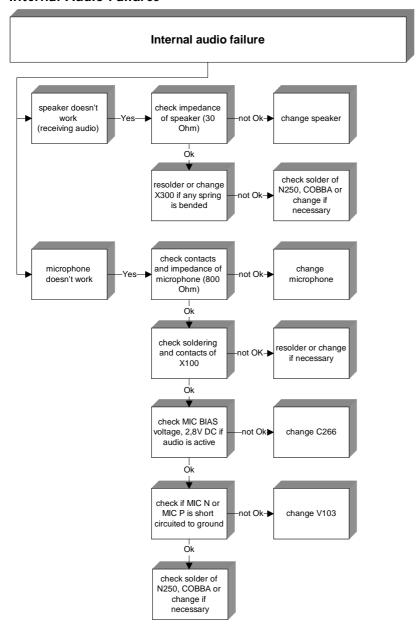
#### **Internal Audio Failures**

#### Speaker

No / quiet / distorted receiving audio signal

- Check the mechanic of speaker, contacts, membrane, soiling
- Check resistance of speaker (about  $30\Omega$ )

## Microphone

No / quiet / distorted transmitting audio signal

- Check contacts of microphone
- Check resistance of microphone (about  $800\Omega$ )

#### X300

- Check soldering
- Check contacts (change connector if bent)

#### X100

- Check microphone spring contacts
- Check soldering

#### V103

• Check resistance from MIC N or MIC P to ground (about 1K $\Omega$  and 2K $\Omega$ ) change component if resistance is 0 $\Omega$

#### C266

• Check MIC BIAS voltage 2.8V DC collector V 250 if audio is active (use WINTESLA / testing / audio)

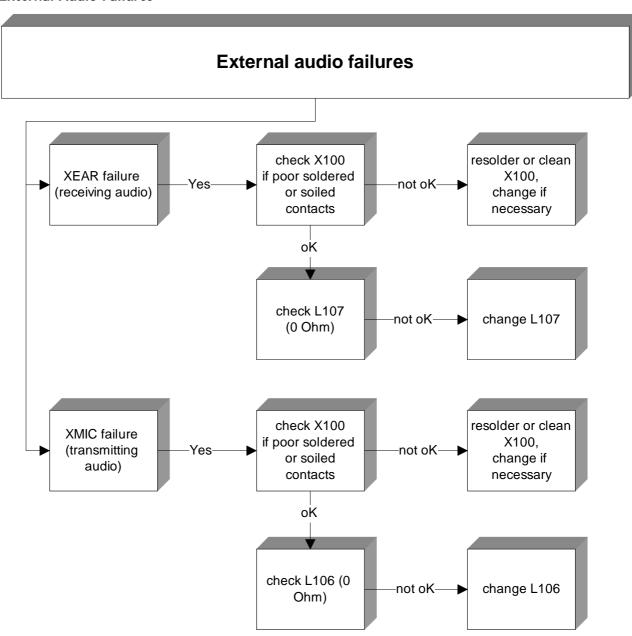
## **External Audio Failures**

#### L106

• Check resistance of coil (0 $\Omega$ ), if there is no XMIC

#### L107

• Check resistance of coil (0 $\Omega$ ), if there is no XEAR

## X100

- Check soldering
- Check contacts (soiling)

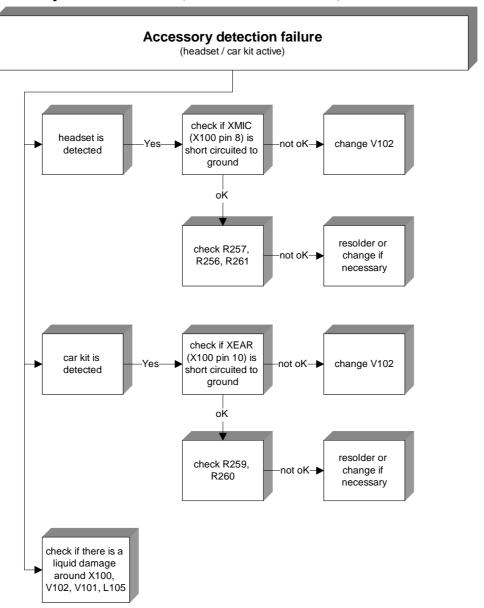
# Accessory detection failure (headset / car kit active)

#### V102

- Check the resistance of XMIC to ground if headset is detected
- Check the resistance of XEAR to ground if car kit is detected
- Change component if resistance is low

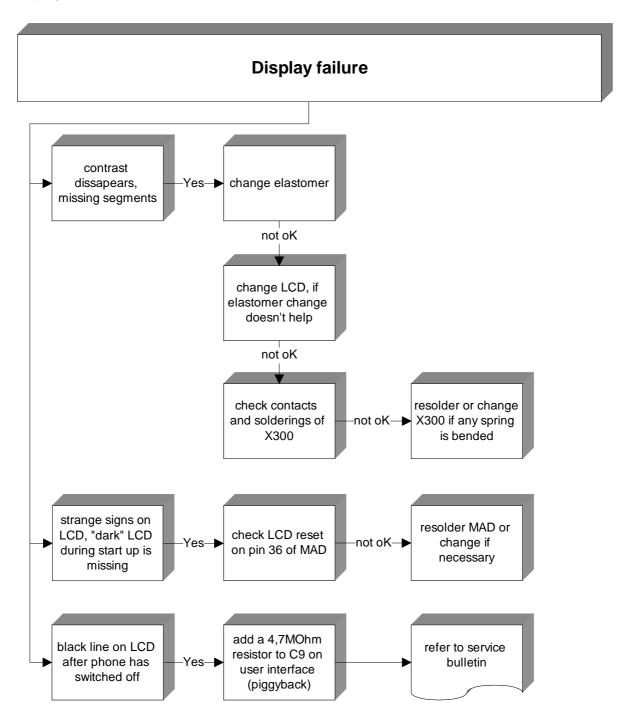
# **Display Failure**

#### Elastomer

Change Elastomer if contrast disappears, missing segments

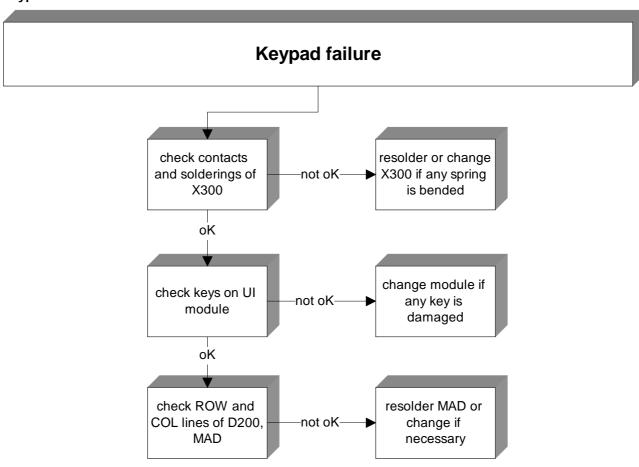
# Keypad failure

#### X300

- Check soldering
- Check contacts (change connector if bent)

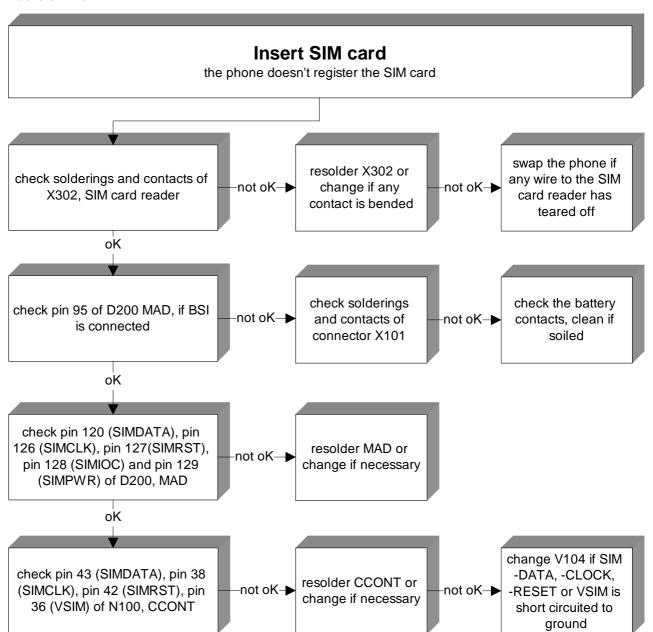
#### Insert SIM CARD

#### X302, SIM card reader

- Check soldering
- Check contacts (change connector if bent)

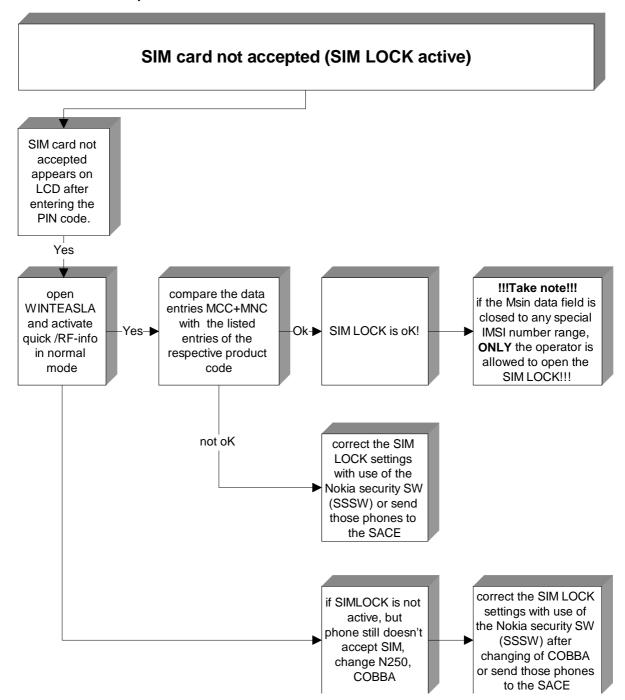
SIM card not accepted, SIM LOCK failure

- If message "SIM Card not accepted" appears on LCD after entering PIN code,
   a SIM LOCK is activated in this phone.
- Initialise phone into normal mode and activate Quick/ RF-info (WINTESLA) compare the SIM LOCK entries with the references from the operator

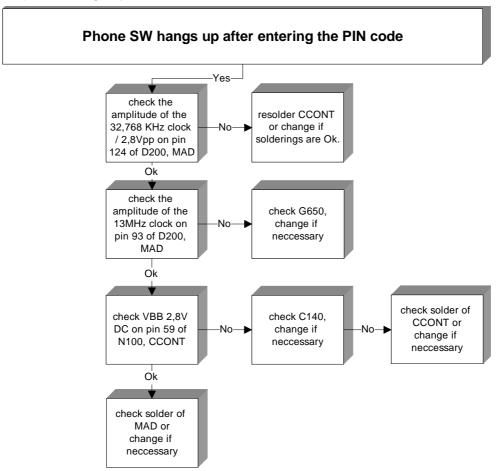
# The phone hangs up after insert the PIN-code

## D200 MAD faulty / poor soldering

- Check the amplitude of the 32,768KHz square wave on pin 124 (comes from CCONT pin 48)
- Check the amplitude of the 13MHz clock frequency pin 93 (from G650)
- Check VBB 2,8V DC
- Resolder MAD
- Internal error of MAD
