CONFIDENTIAL HDa-13/S 893 Introduction Date 2001-02-07 1 (29) Repairhints Version 1.0 Approved

# Repairhints

6210/6250 NPE-3/NHM-3 HDa13/S 893

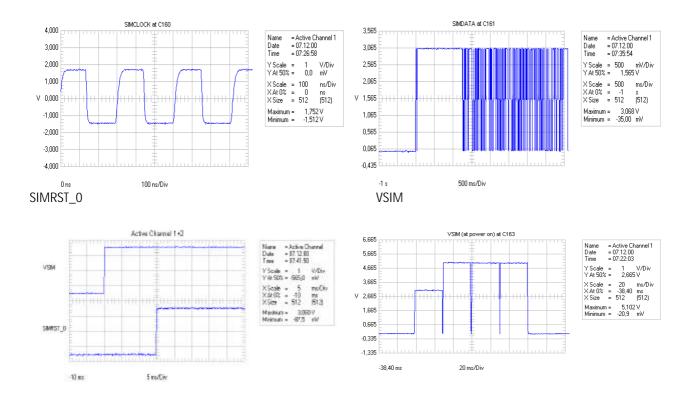
# SIMcard Signals

Check resistance of SIMlines to GND - change V160, C163, C164 if necessary, probably broken solderings under CCONT N102 Change CCONT N102 and run energy management calibration, if fault persists - probably MAD D301 or PCB faulty.

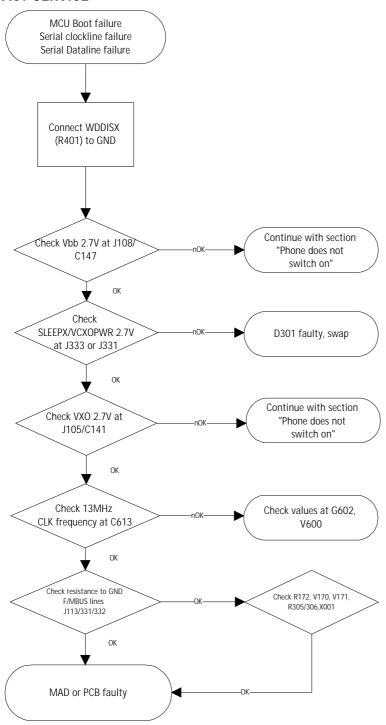
# **CONTACT SERVICE**

This fault means that the phone software is able to run and thus the watchdog of CCONT N102 can be served. Selftest functions run when power is switched on and program is executed from FLASH If any selftest fails, - "CONTACT SERVICE" appears in Display.

Possible failures:

#### MCU ROM Checksum failed:

# **CCONT Interface failed:**

Probably broken solderings under CCONT N102

#### DSP Alive failed

In most of all DSP alive selftest failures MAD D301 is faulty, which is not changeable.

Try to flash the phone. If not ok after flashing – change FLASH D311 if you are authorized to rewrite IMEI and SIMlock data, if failure persists after changing D311, MAD D301 defect which is not changeable.
