Repairhints

Service-Level 3 & 4

6310

NPE-4

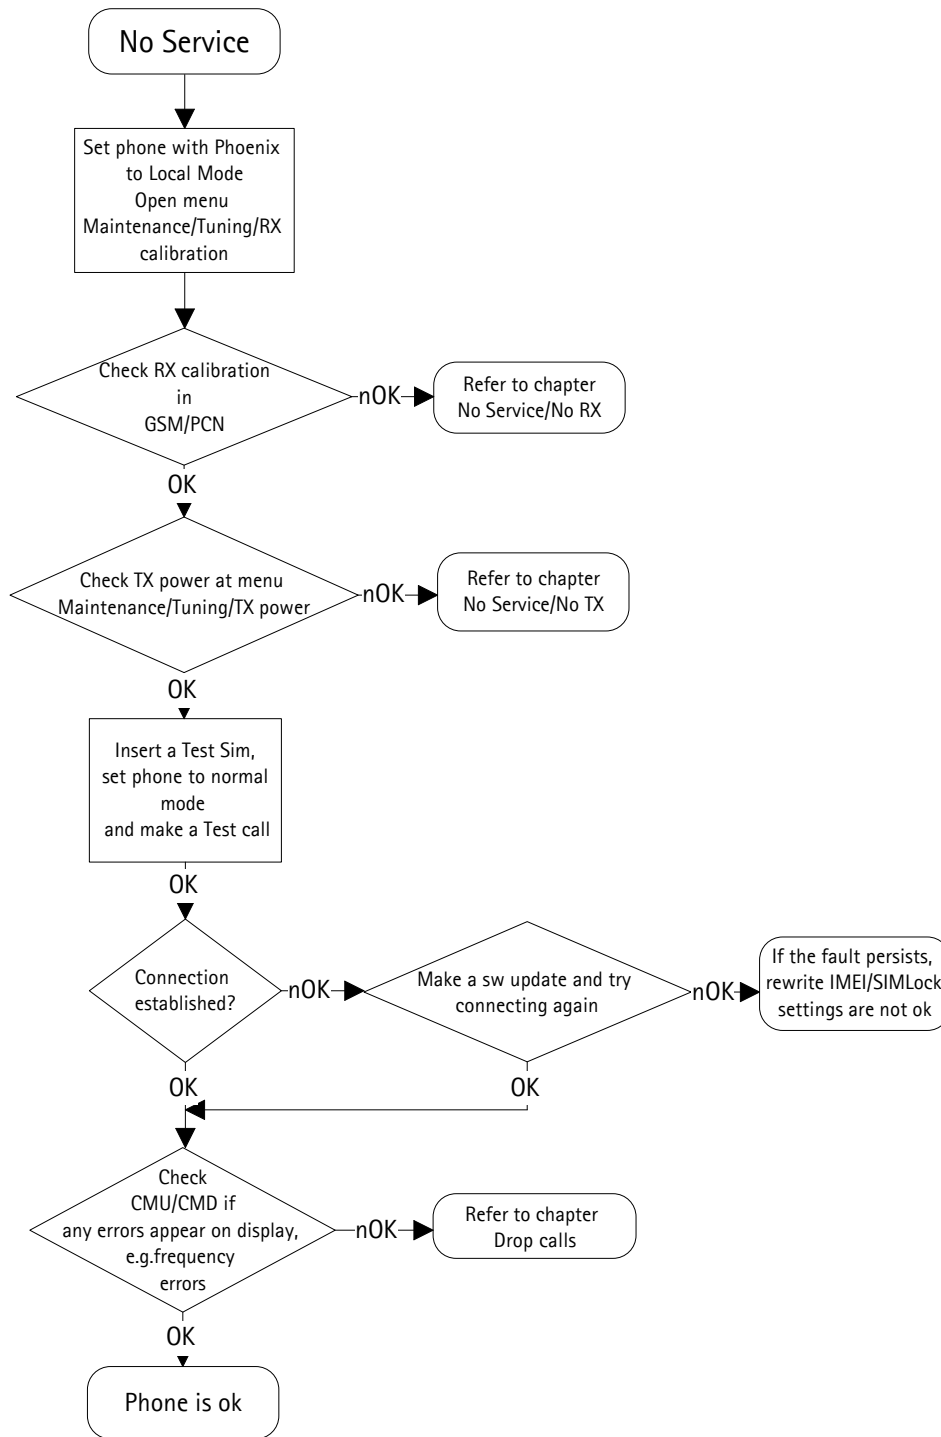
Flowchart – No service

No Service ® no RSSI

Set the RF generator to GSM 942.4 MHz at channel 37, RF level -55 dBm and also the phone to same frequency and channel.
Check RX I/Q signals at C721, C722 (See picture below)
Always measure in burst mode (with an oscilloscope in DC mode).

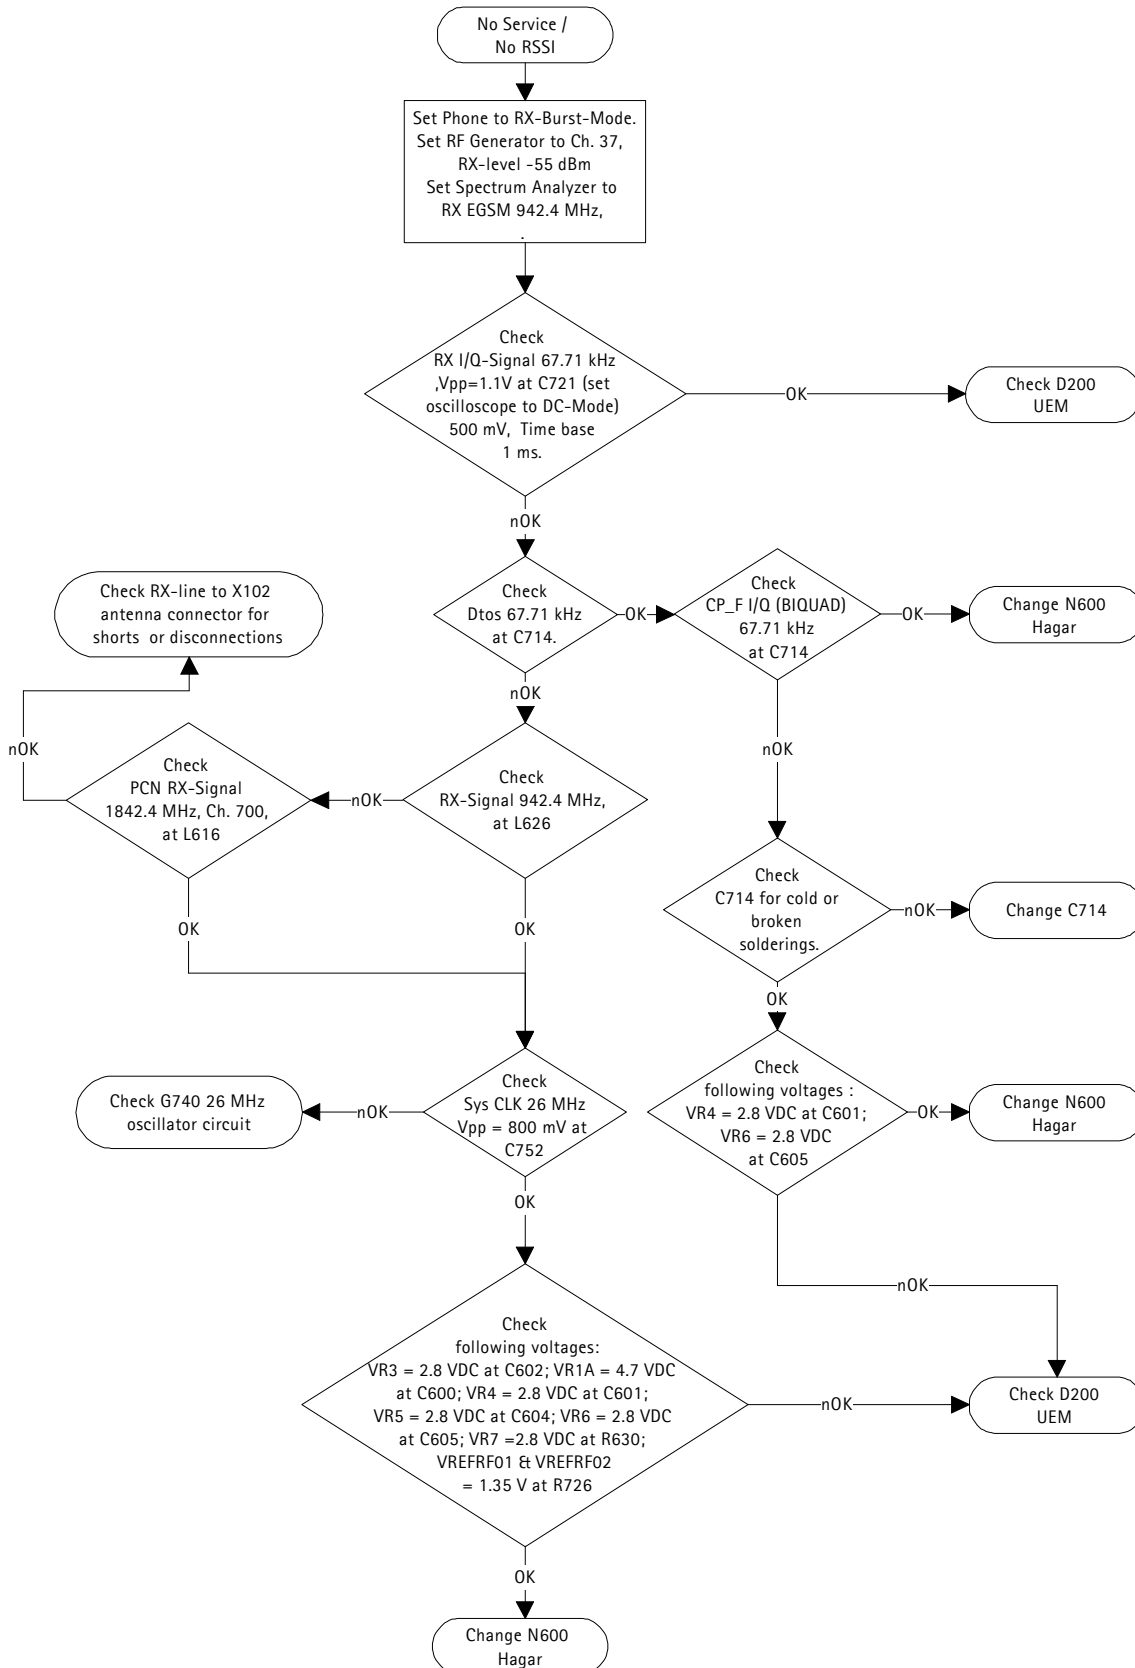
Flowchart - No service ® no RX

If one of the upper described voltages is not ok, check UEM D200.
If all voltages are ok, change N600 Hagar.

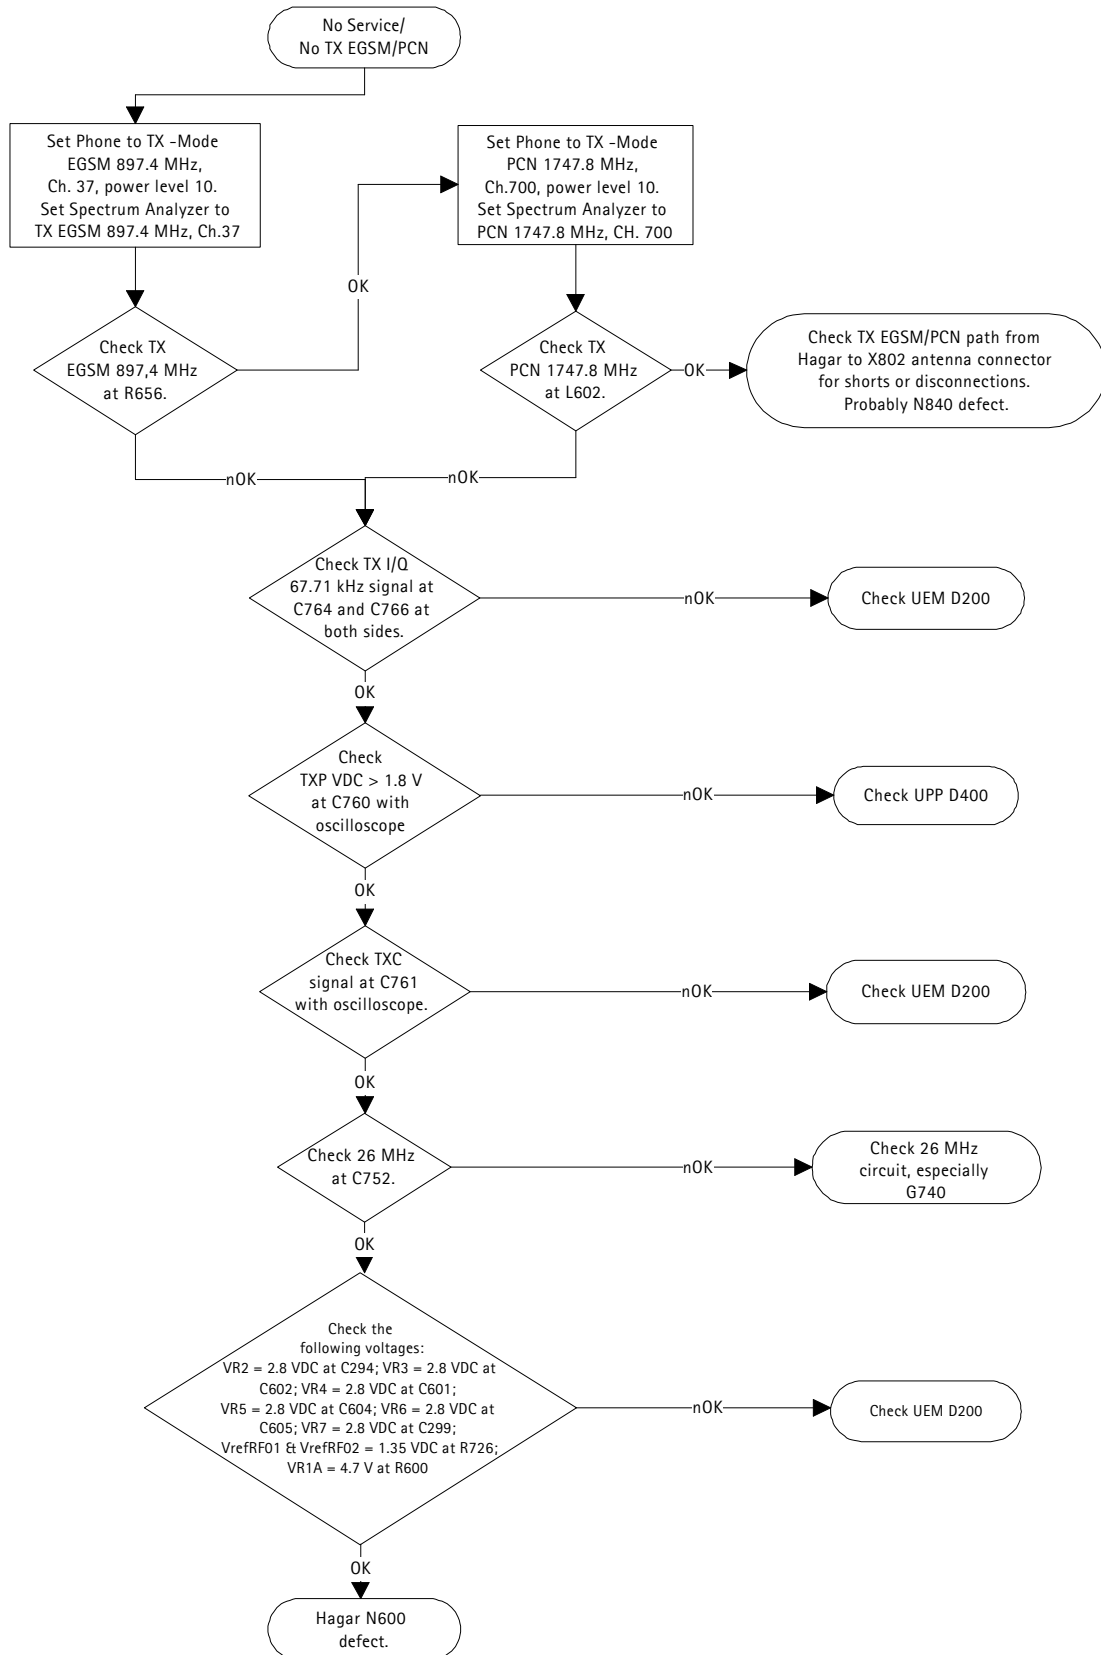
Flowchart - No service ® no TX

If all voltages are ok, change Hagar N600.
