Repairhints

7110

NSE-5

HD 945

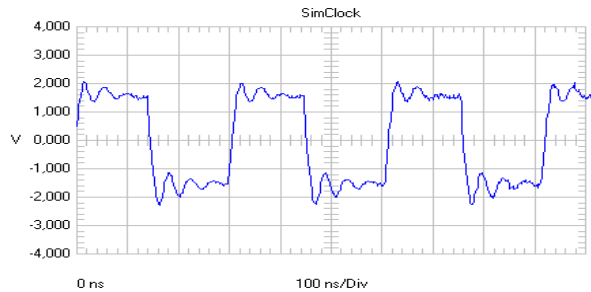
Name	= Active Channel 1
Date	= 28.08.00
Time	= 12:02:43
Y Scale	= 1 V/Div
Y At 50%	= 0,0 mV
X Scale	= 100 ns/Div
X At 0%	= 0 ns
X Size	= 512 (512)
Maximum	= 2,075 V
Minimum	= -2,281 V

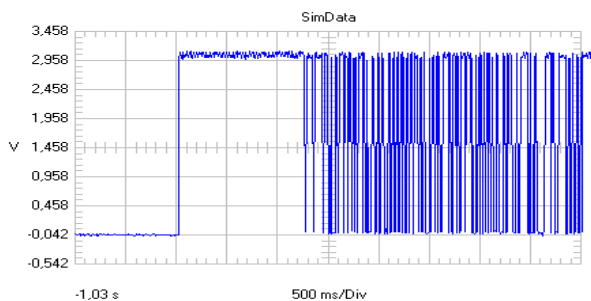
Name	= Active Channel 1
Date	= 25.08.00
Time	= 10:40:07
Y Scale	= 500 mV/Div
Y At 50%	= 1,458 V
X Scale	= 500 ms/Div
X At 0%	= -1,03 s
X Size	= 512 (512)
Maximum	= 3,120 V
Minimum	= -60,05 mV

Note that SIMClock and SIMData are only present when SIMcard is active, for example when phone registers to network.

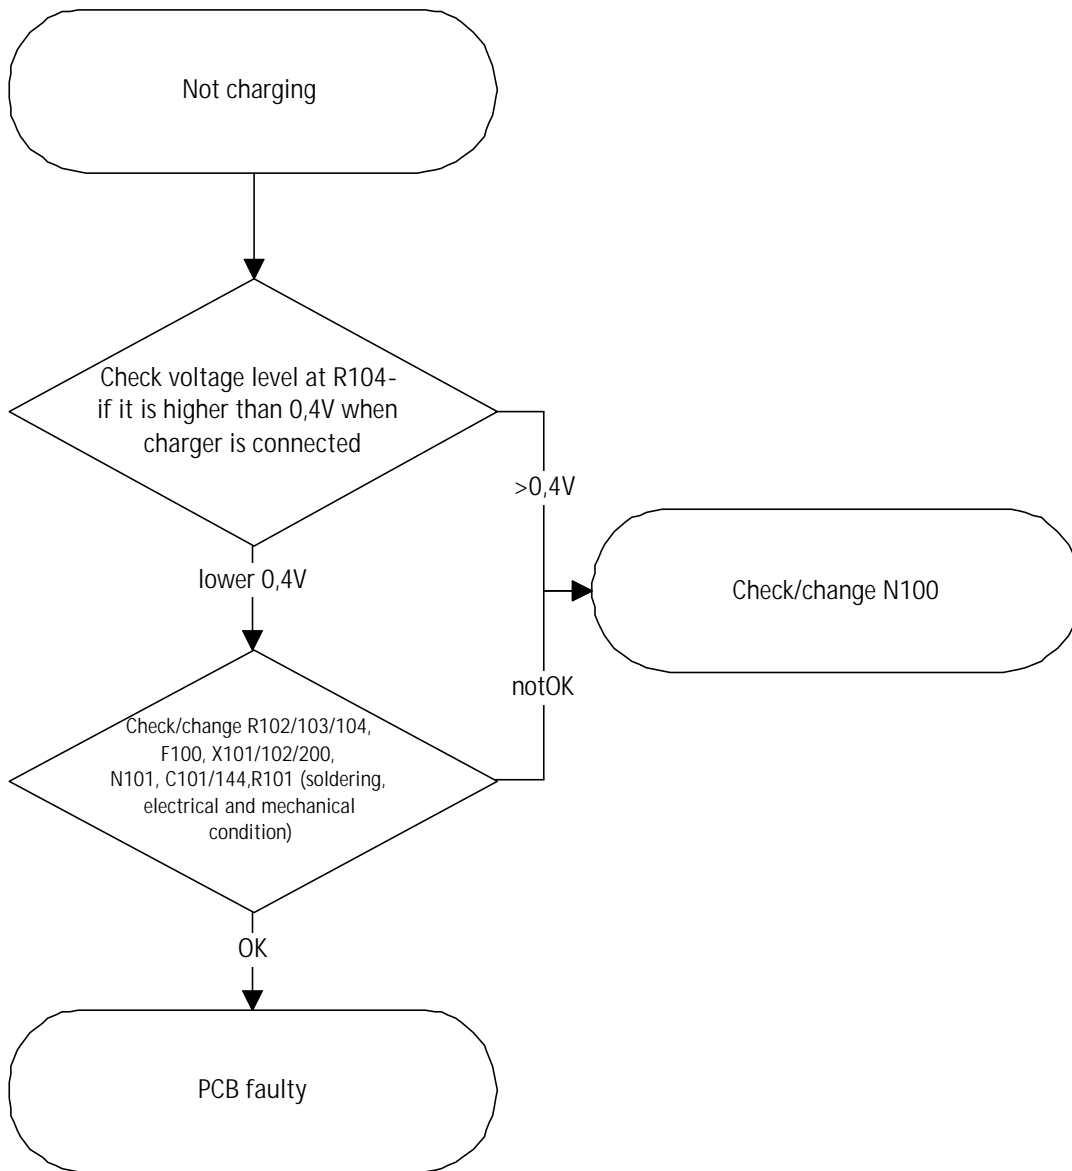
NOT CHARGING (NOTHING HAPPENS IF CHARGER IS CONNECTED)

First of all : Always Check the mechanical condition of all connectors and connections

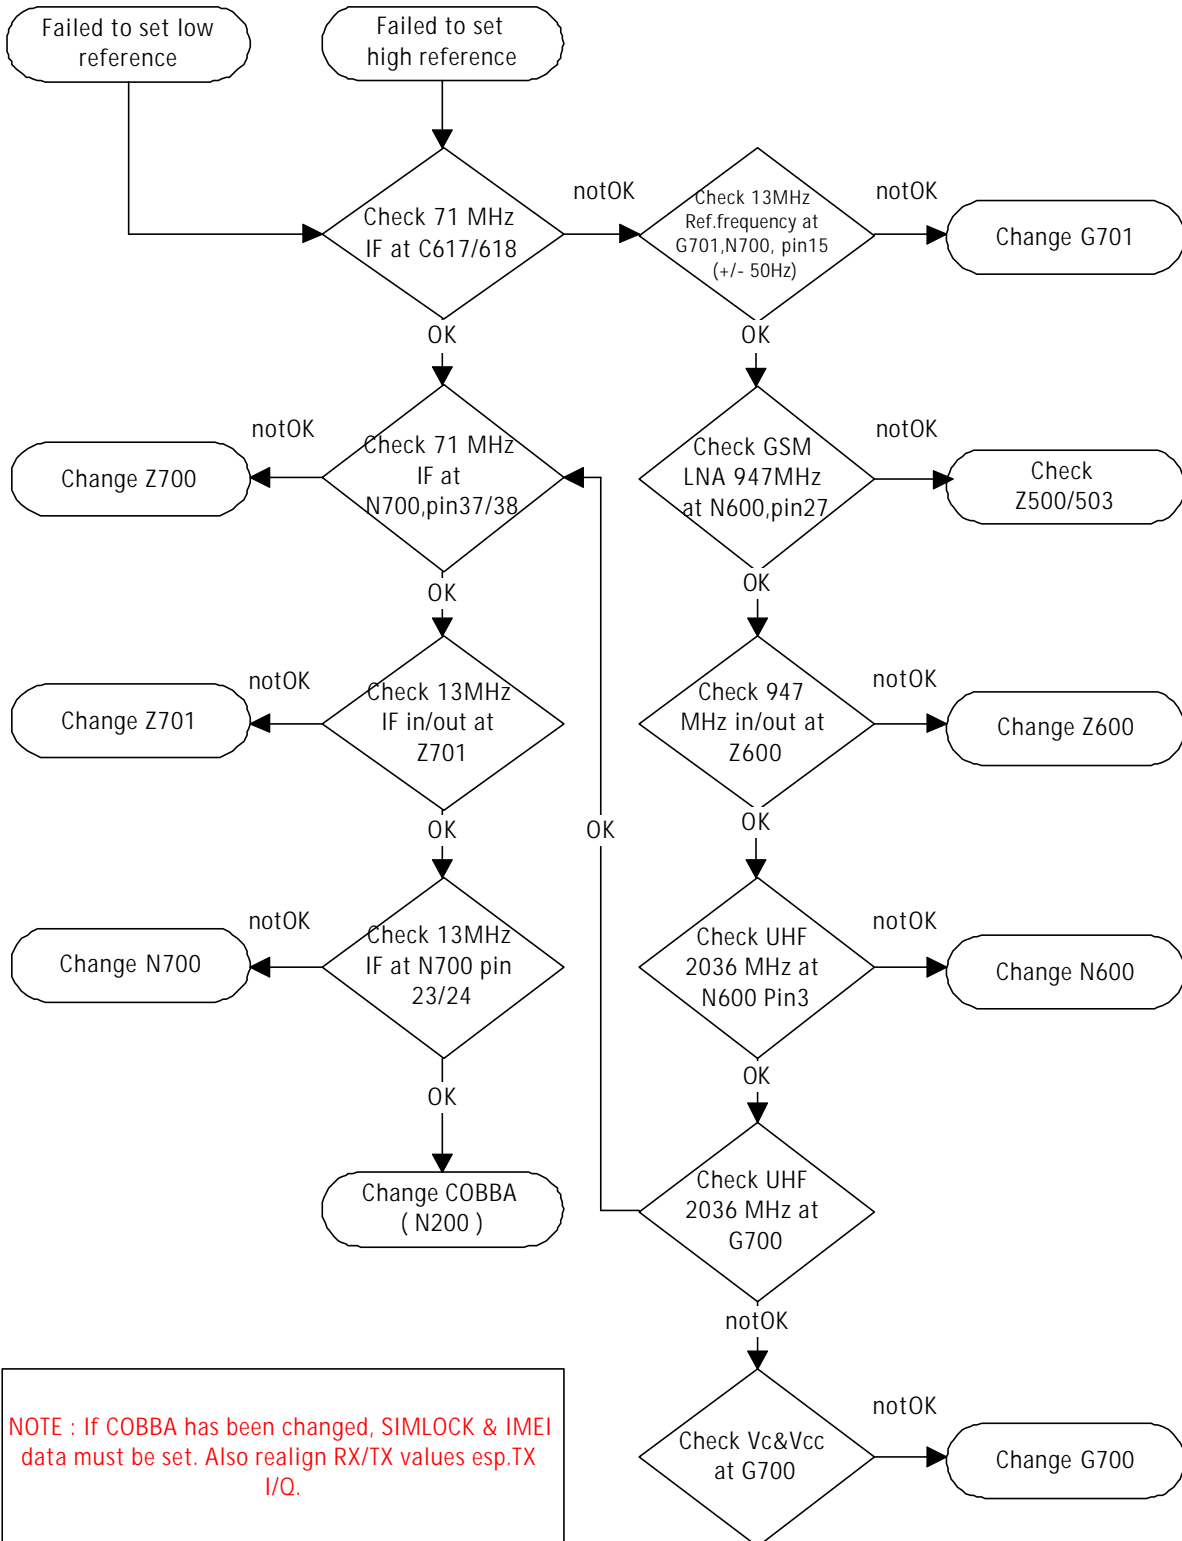
NO SERVICE GSM 900 - First Check spectrum if it is only a RX failure , see spectrum charts.
REF: GSM 900: Ch60 (947 MHz) / GSM 1800: Ch700 (1842,8 MHz).

WINTESLA TUNING RX CALIBRATIONS

NOTE : If COBBA has been changed, SIMLOCK & IMEI data must be set. Also realign RX/TX values esp.TX I/Q.

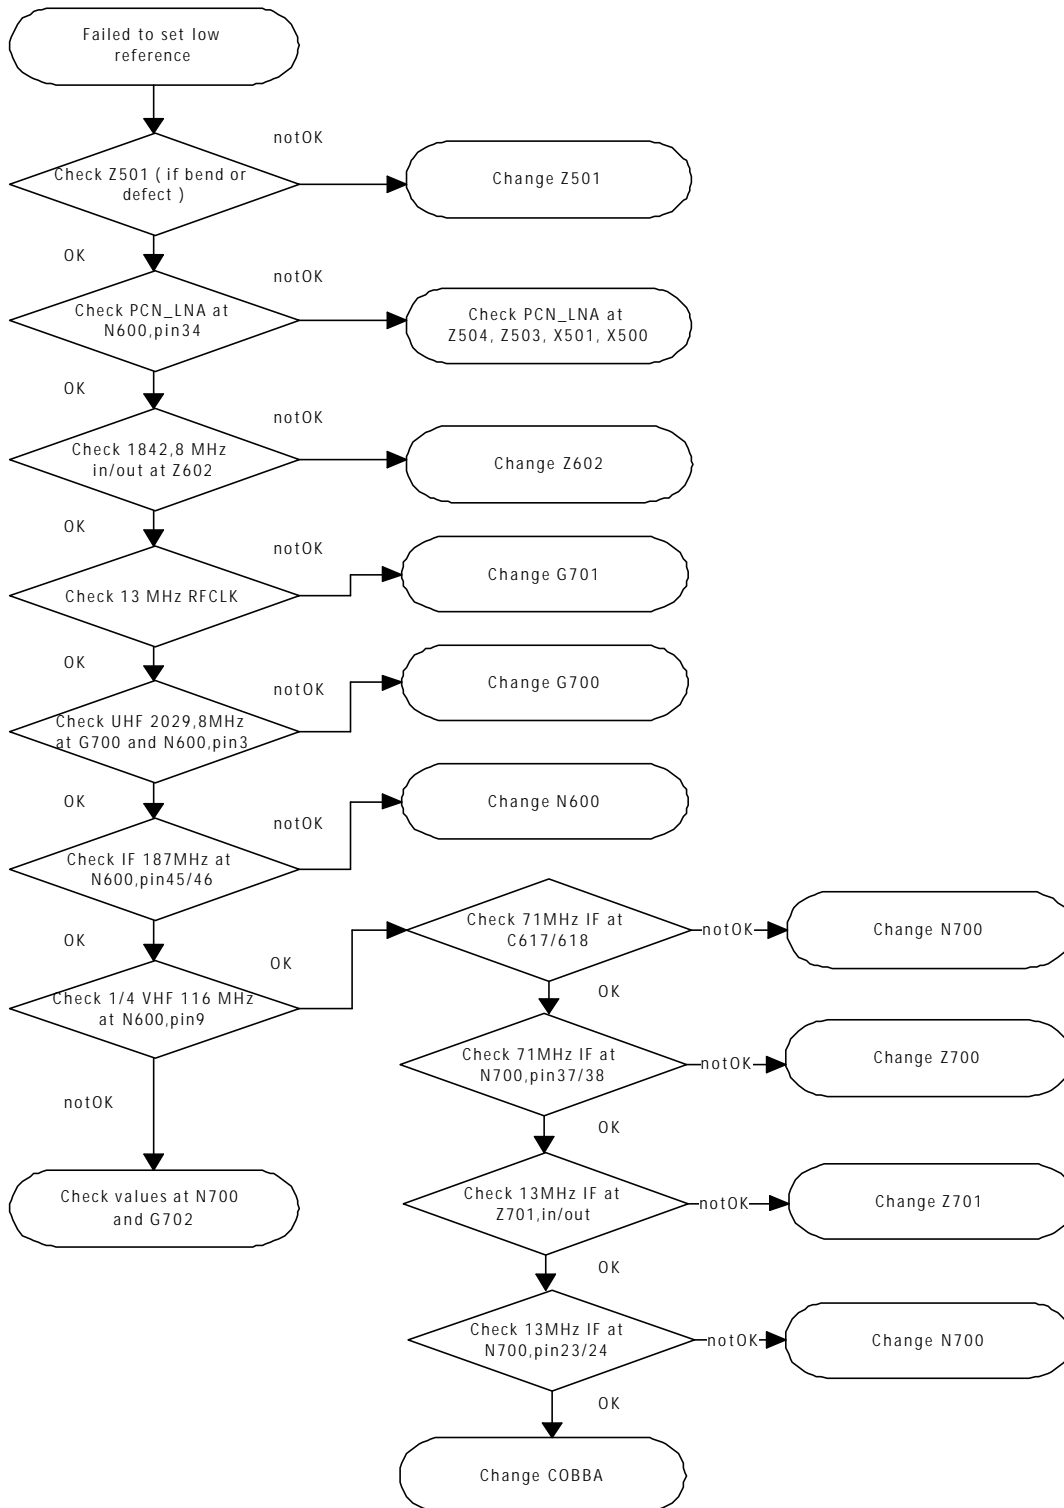
NO SERVICE GSM 1800 First Check spectrum if it is only a RX failure. See spectrum charts.

WINTESLA TUNING RX CALIBRATIONS

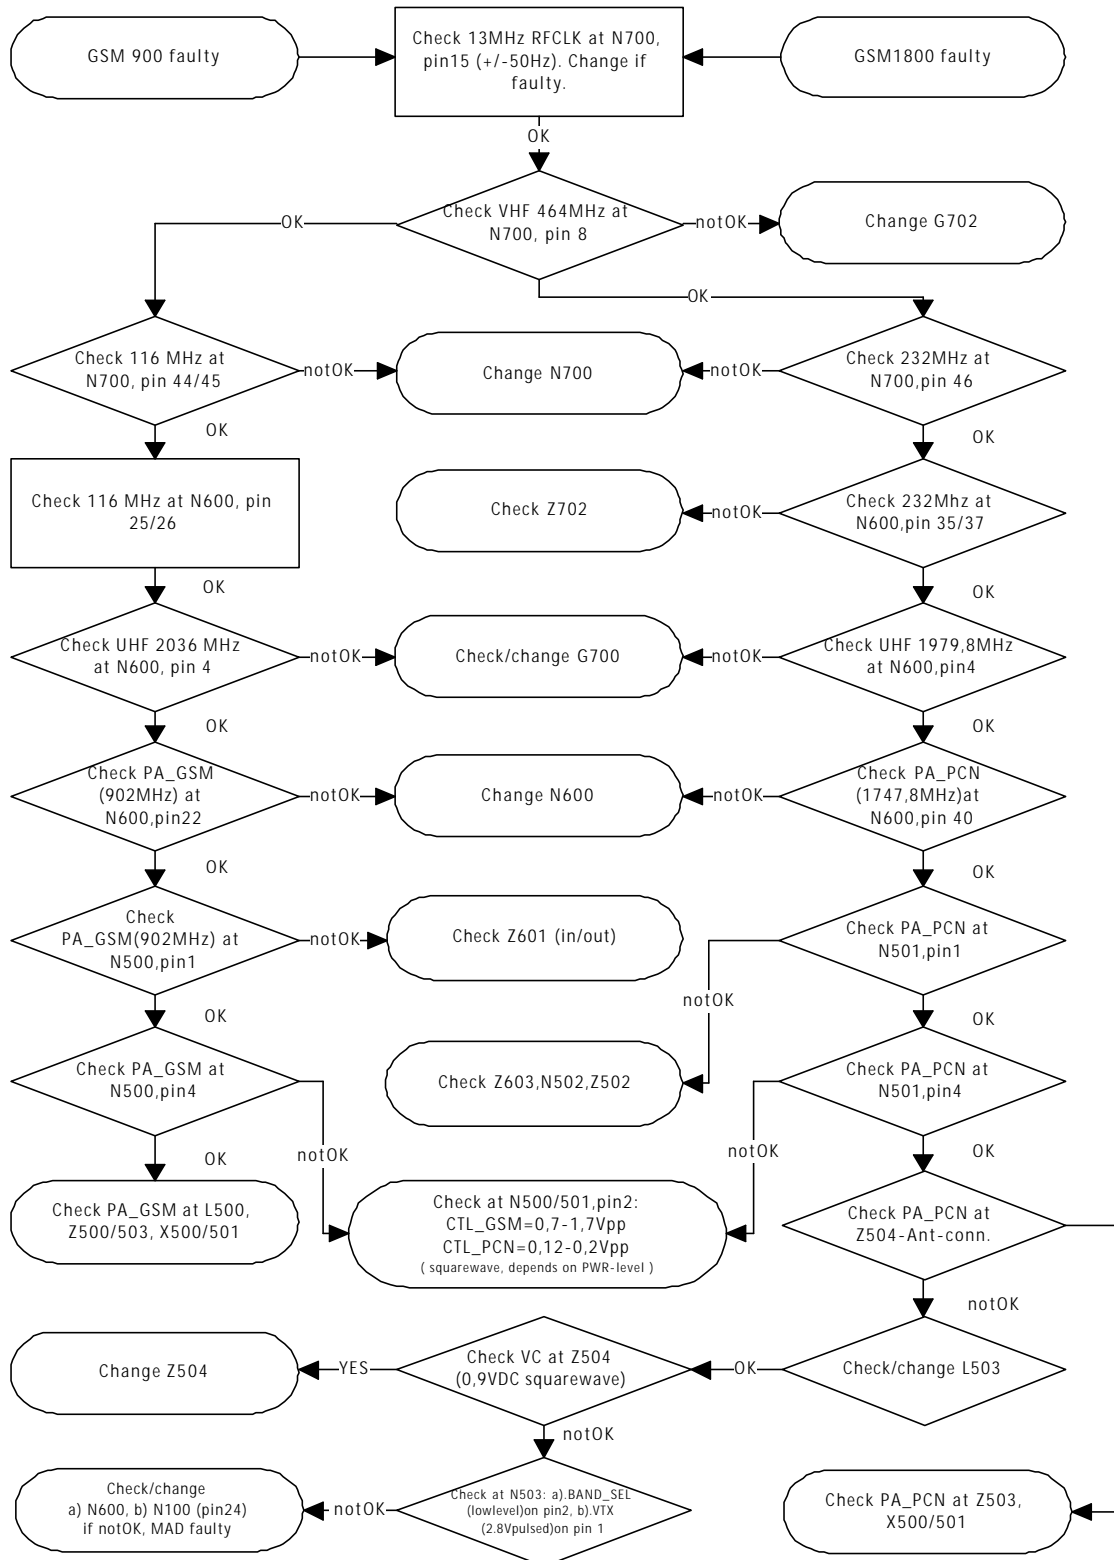
TX FAILURE

2. TX - POWER FAULTS**3. TX FAULT AT GSM 900****REFERENCE IS : CH 60 / 902 MHZ**

Check 13 MHz Reference Freq. output at G701 (and VC / AFC Pins) --- If not ok – change G701.
Check 13 MHz Reference Freq. at N700 / Pin 15 --- If not ok – change N700.
Check VHF Oscillator Freq. 464 MHz at N700 / Pin 8 --- If not ok,
check values at G 702 (VC / VCC) --- change Oscillator if necessary.
Check 116 MHz at N700 / Pin 44,45 --- If not ok – change N700.
Check 116 MHz at N600 / Pin 25,26.
Check UHF Oscillator Freq. 2036 MHz at N600 / Pin 4 --- If not ok – change G700.
Check PA_GSM 902 MHz at N600 / Pin 22 --- If not ok – change N600.
Check PA_GSM 902 MHz at N500 / Pin 1 --- If not ok – check / change Z601 in & out (if possible).
Check PA_GSM 902 MHz at N500 / Pin 4 --- If not ok,
check CTL_GSM at N500 / Pin 2 => 0,7 – 1,7 Vpp squarewave / depends on Powerlevel.
If this happens --- change N500.
Check PA_GSM 902 MHz at L500 in & out (or if bend) --- If not ok – change L500.
Check PA_GSM 902 MHz at Z503 (input) --- If not ok – change Z500 after lifting case.
