Repair-Hints

8210/8850

NSM-2/3

HD 914/916

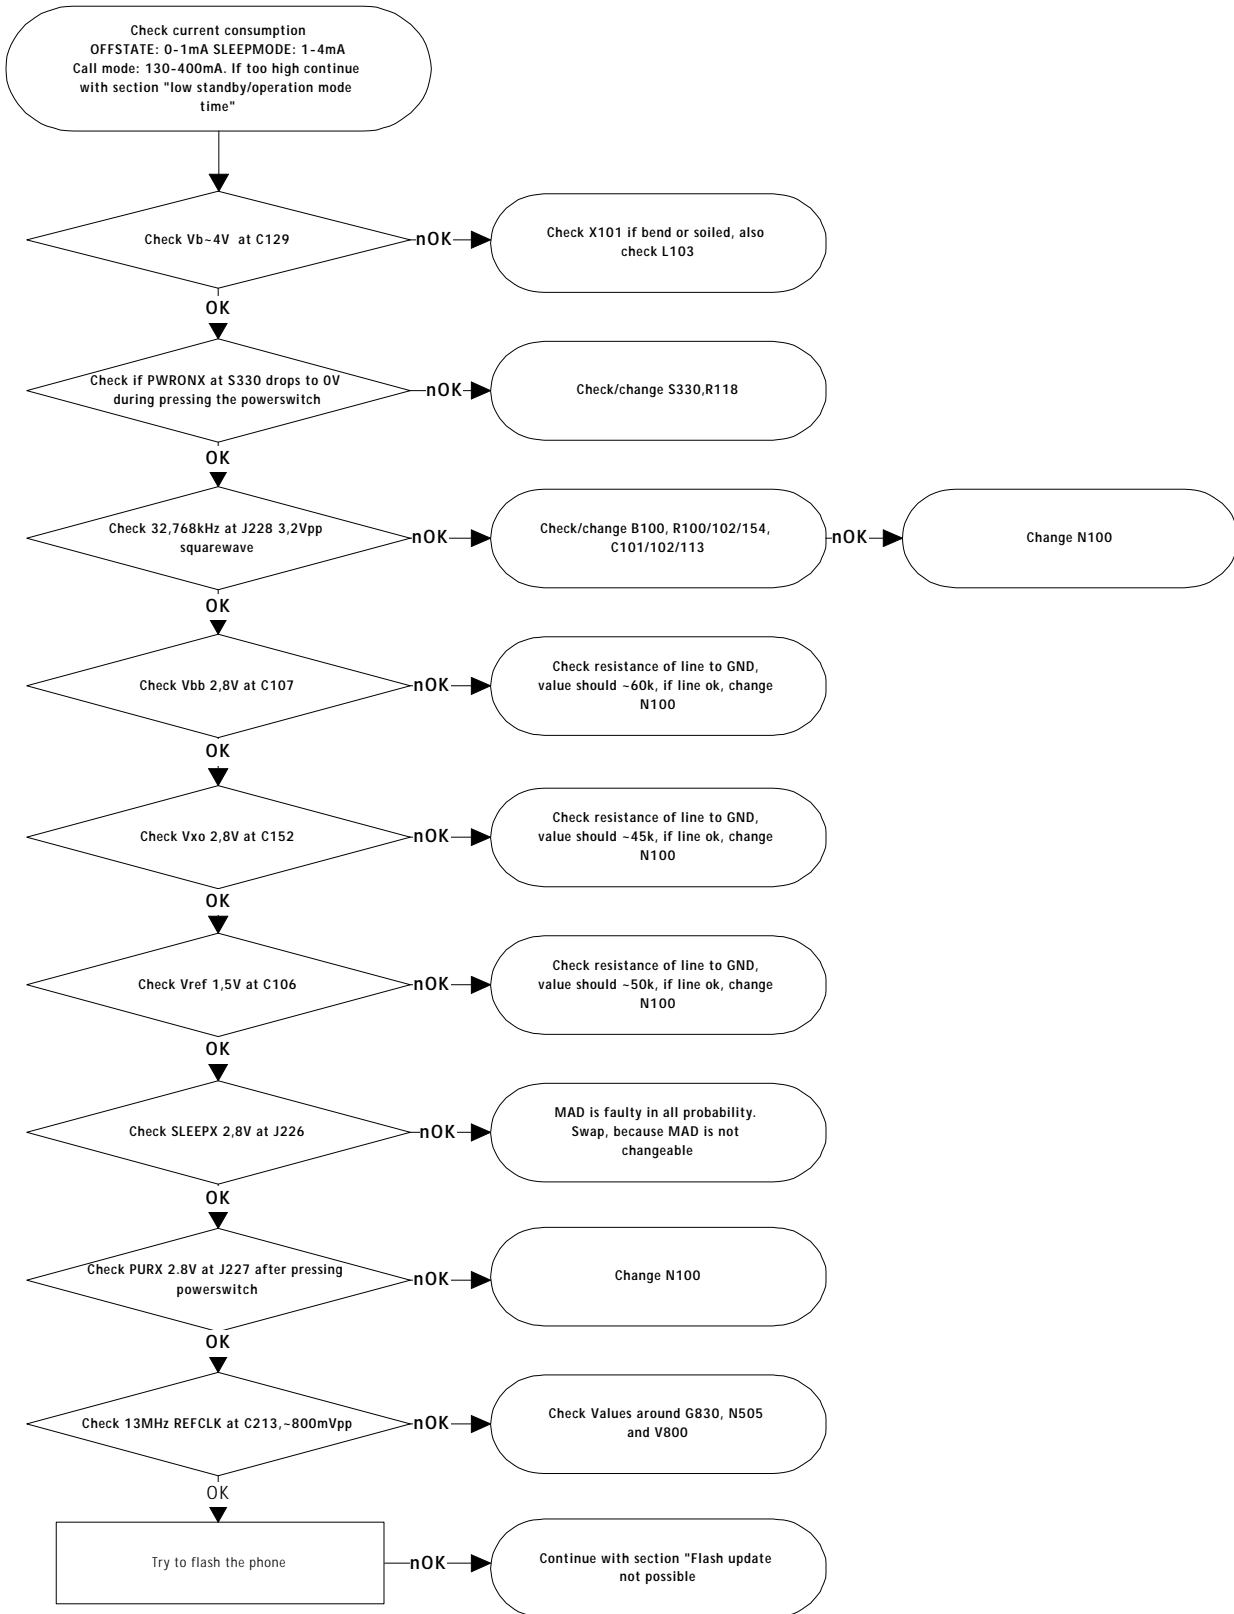
PHONE DOES NOT SWITCH ON

Battery connector

Check if bent or soiled.

Power on/off switch S330 faulty

Check that PWRONX at S330 decreases to 0V during pressing the powerswitch.

B100

Check voltage at B100, both 1.6V DC.

Check 32.768kHz sinewave at C102, 700mVpp.

G830 Reference oscillator faulty

Check Vcc 2.7V at C831 and Vcon (varies between 0.3V and 2.3V) at C832.

N100 CCONT faulty

Probably broken solderings under CCONT N100. Replace CCONT with μ BGA rework machine.

Clean pads of connector on PCB if soiled.

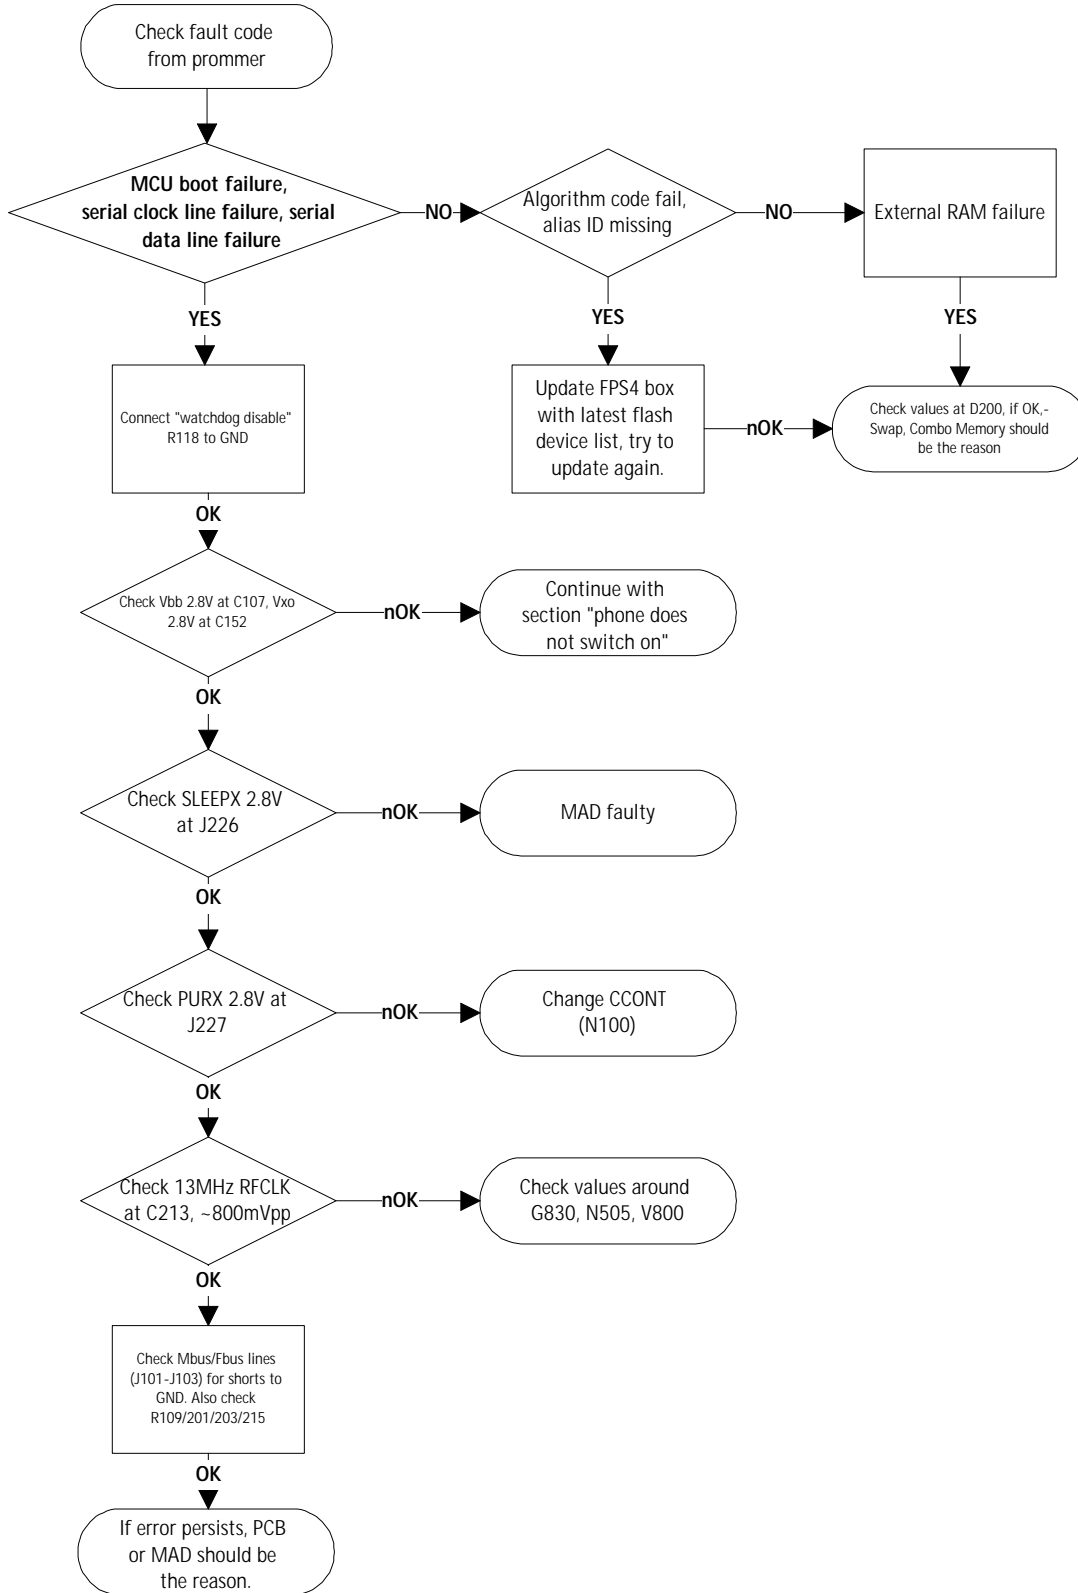
FLASH UPDATE NOT POSSIBLE

Mbus / Fbus lines faulty

Check that there's no short at J101- J103 to GND, resistance of lines should be between 60kOhm and 220kOhm.

If "algorithm code / alias ID missing from prommer box" appears while flashing, make sure that your FPS4 box is updated with the latest flash device list.

If "contact service" appears while flashing, change C205 from 1 μ F to 2.2 μ F (Code 2610203) to stabilize flash programming voltage.

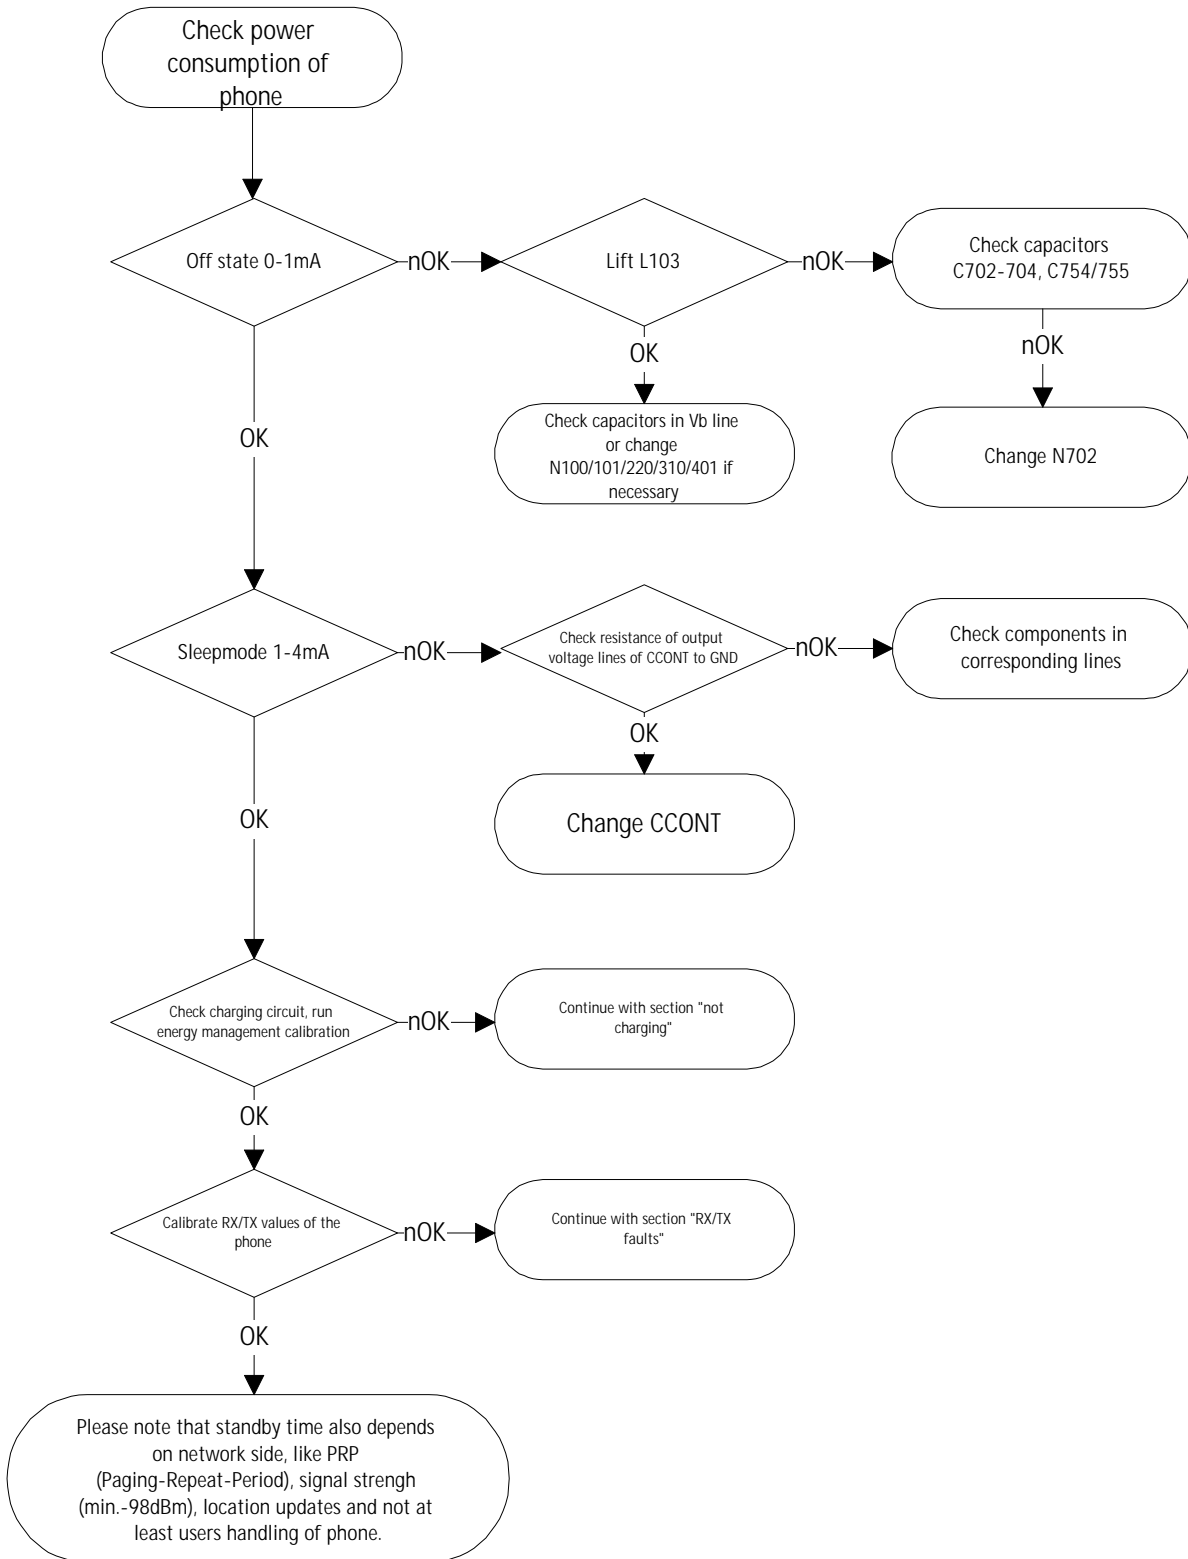
Low standby / operation mode time

Check the current consumption in different operation modes:

Funktion mode	Minimum current in mA	Maximum current in mA
Off state	0	1
Sleep mode	1	4
Call mode GSM 900	140	400
Call mode GSM 1800	130	370

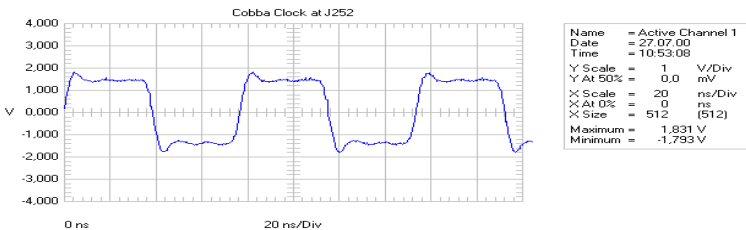
COBBA parallel/serial failed

Check Vbb 2.8V at C201 and VCOBBA 2.8V at C248.
Check COBBAC1k at J252.

Probably broken solderings under COBBA (N250) – replace COBBA. If fault remains, MAD or PCB faulty.
Note: IMEIdata and SIMlock must be rewritten after COBBA- change, also retune RF-values.

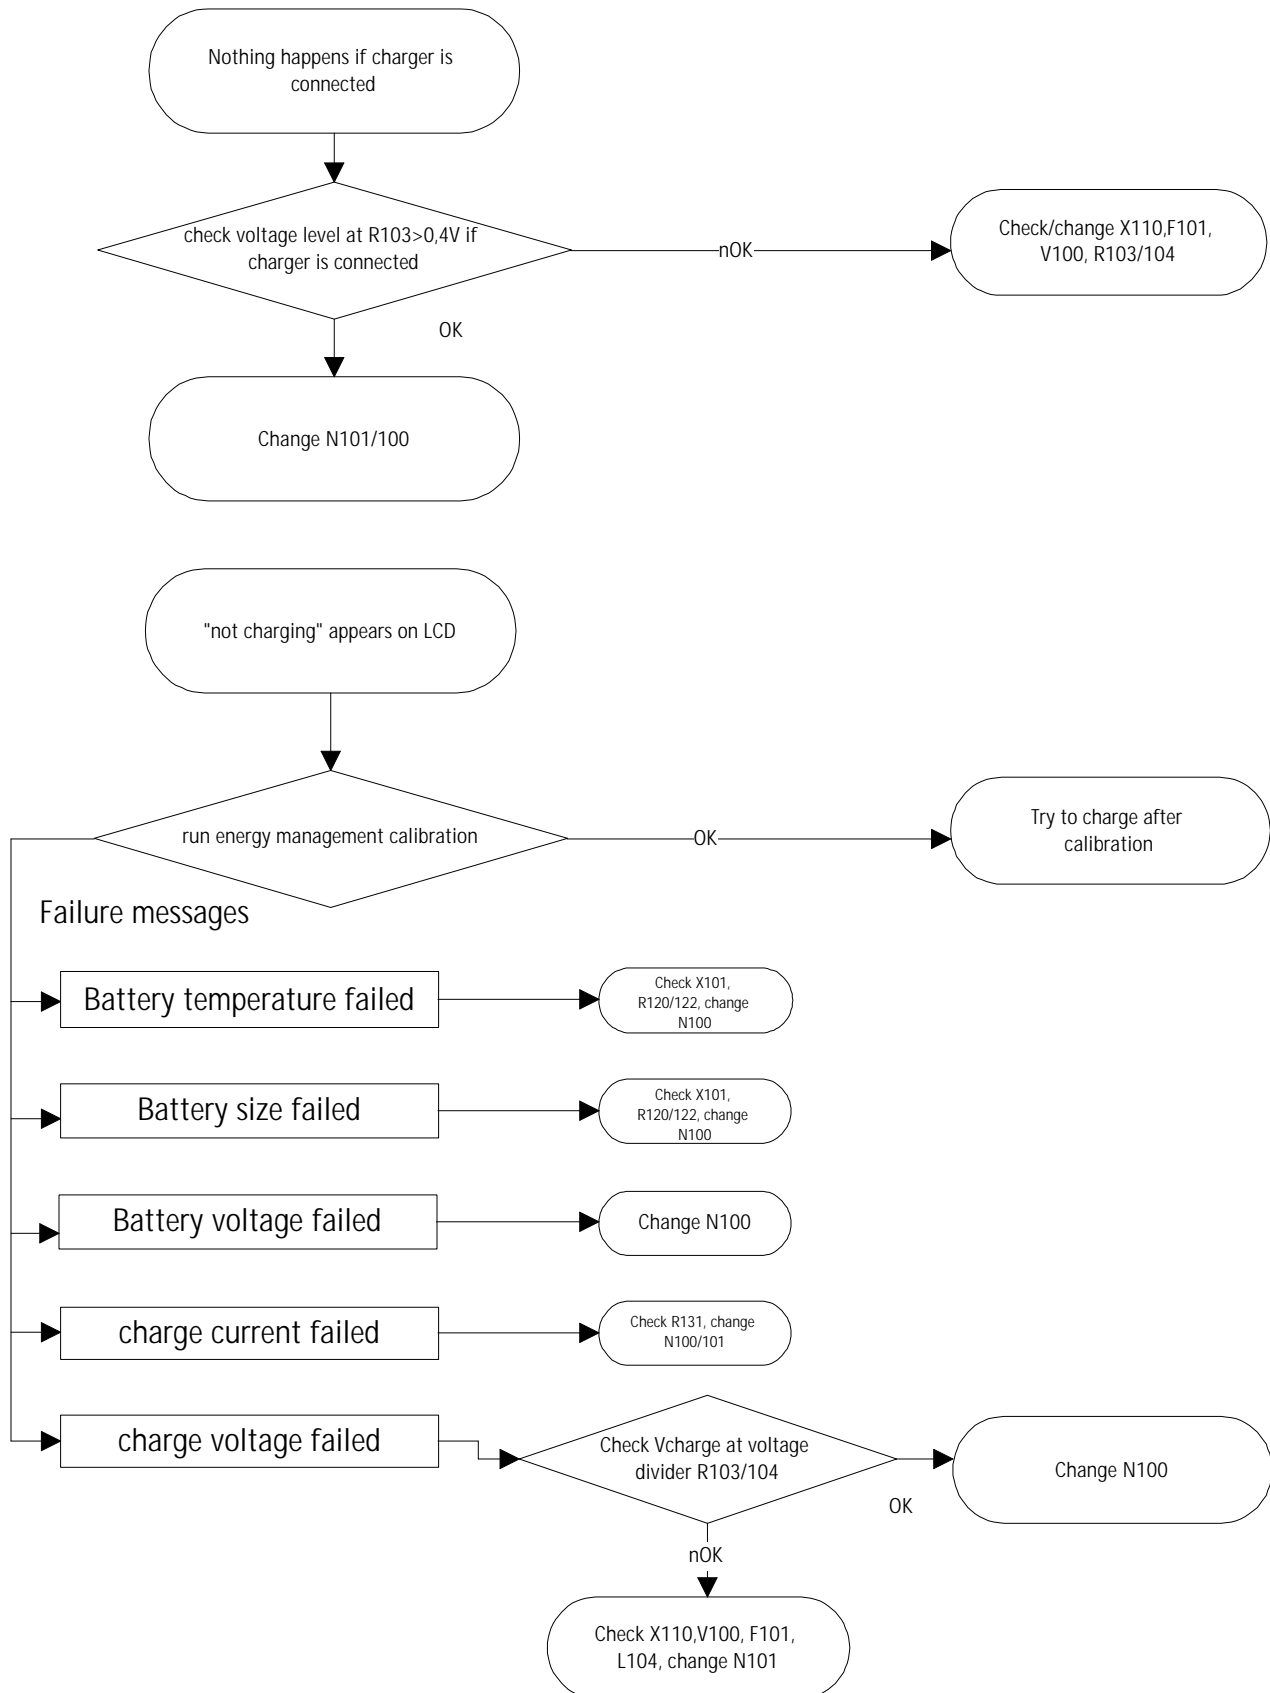
Not charging

X110 DC/HS connector, X101 battery connector

Check mechanical appearance of connectors, make sure that pads for connectors on PCB are clean.

Run calibration if charging stops too early, if message "not charging" appears on LCD or any part in the charging circuit has been replaced.

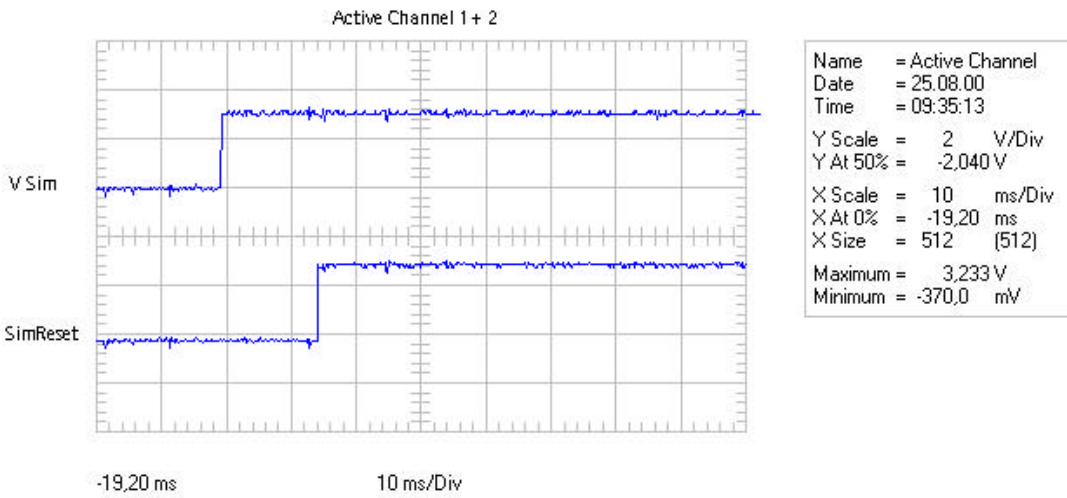
SIMReset is low-active, that means that the SIMcard will be reseted when SIMReset is 0 Volt. This is the case after switching on the phone (diagram above). While Vsim is already high, SIMReset keeps low for a few milliseconds – in this time the card will be reseted.

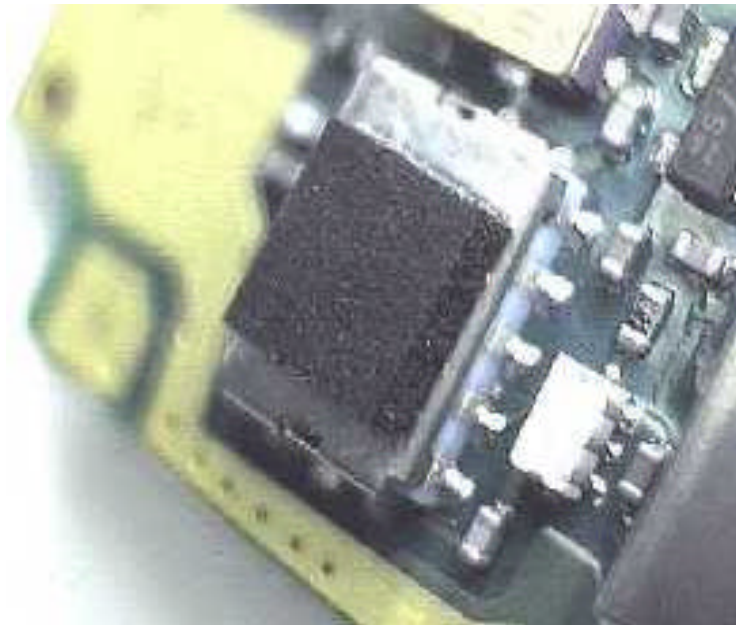
If all values are ok but still there´s no or too low TX power signal at J600 (Antenna pad), check solderings of Z670.

If it is necessary to change Z670, don't forget to replace foam on sparepart. (NSM-2 only, see also Service Bulletin 22).

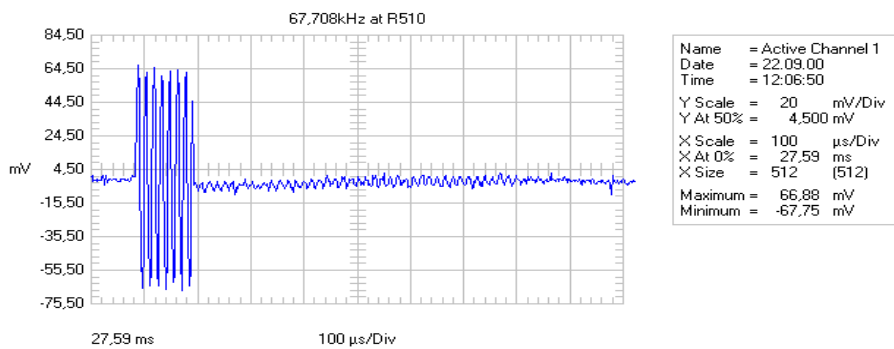
Check 67,708kHz at R510 (burst mode, input level -65dBm).

If signal is not ok at R510, check C510- C513 for shorts to GND, check resistance of R510 (4 * 100R) or change HAGAR (N505).

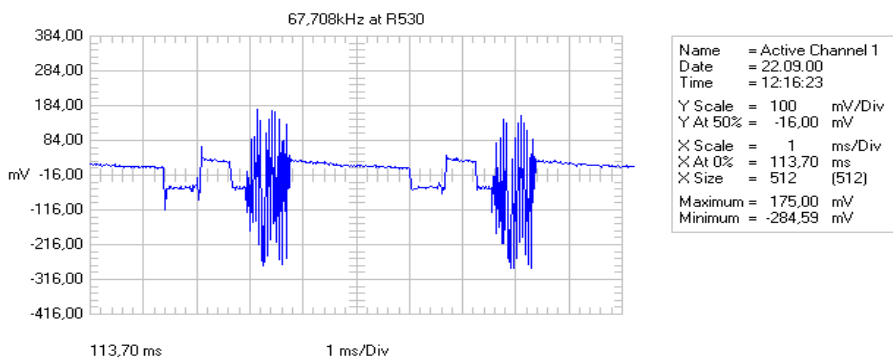
Check 67.708kHz at R530 (burst mode, input level -65dBm).

If signal is not ok at R530, check Vref 1,35V at C535, also check C530-C533 if broken or broken soldered, change HAGAR (N505) if necessary.
