Repairhints

8210/8850/

8890

NSM-2/3 & NSB-6

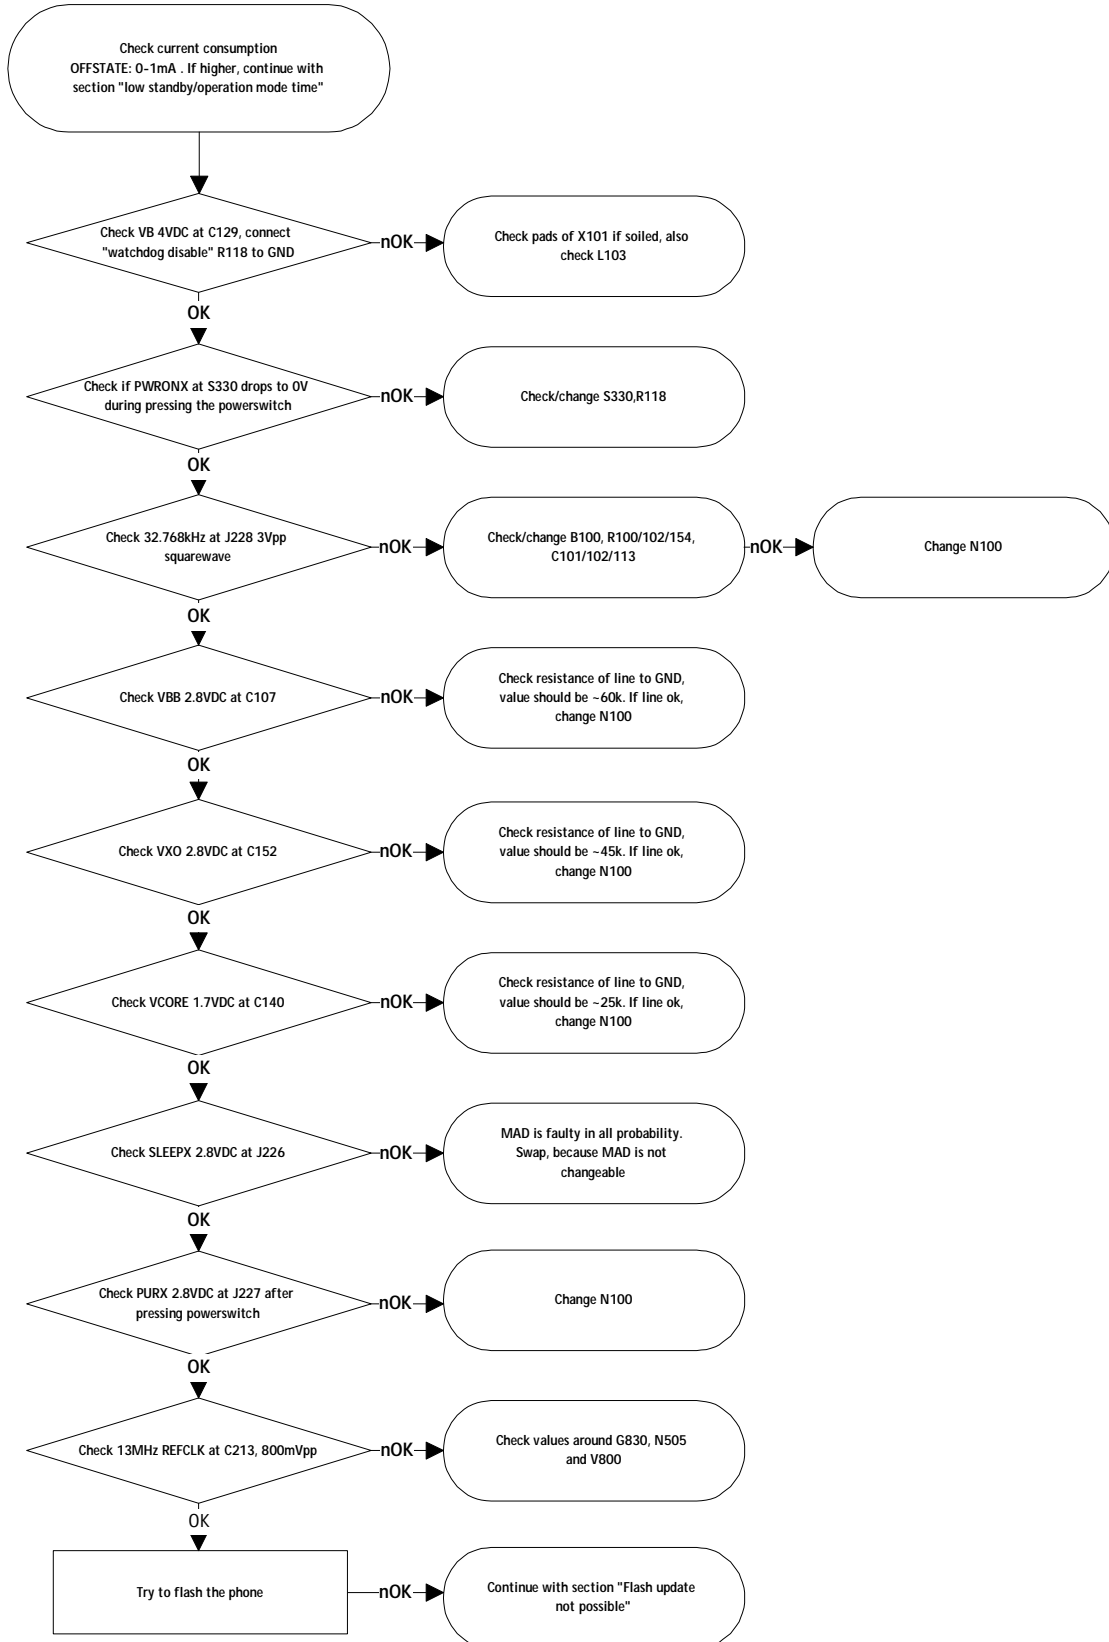
PHONE DOES NOT SWITCH ON

Phone does not switch on**Battery connector X101**

- Check if contact springs are bent, soiled or corroded.
- Clean pads of connector on PCB with an appropriate amount of IPA if necessary.

- Check sleepclock 32.768kHz squarewave at J228, 3Vpp.
If signal is not measurable, check if voltage at pads of B100 is 1.6V DC. If voltage is not ok, check R100/102/154 or change CCONT N100.
- If sleepclock-oscillator works but on an incorrect frequency, check C101 and C102 for defect or broken solderings. But in most cases the crystal B100 itself is responsible for this fault.

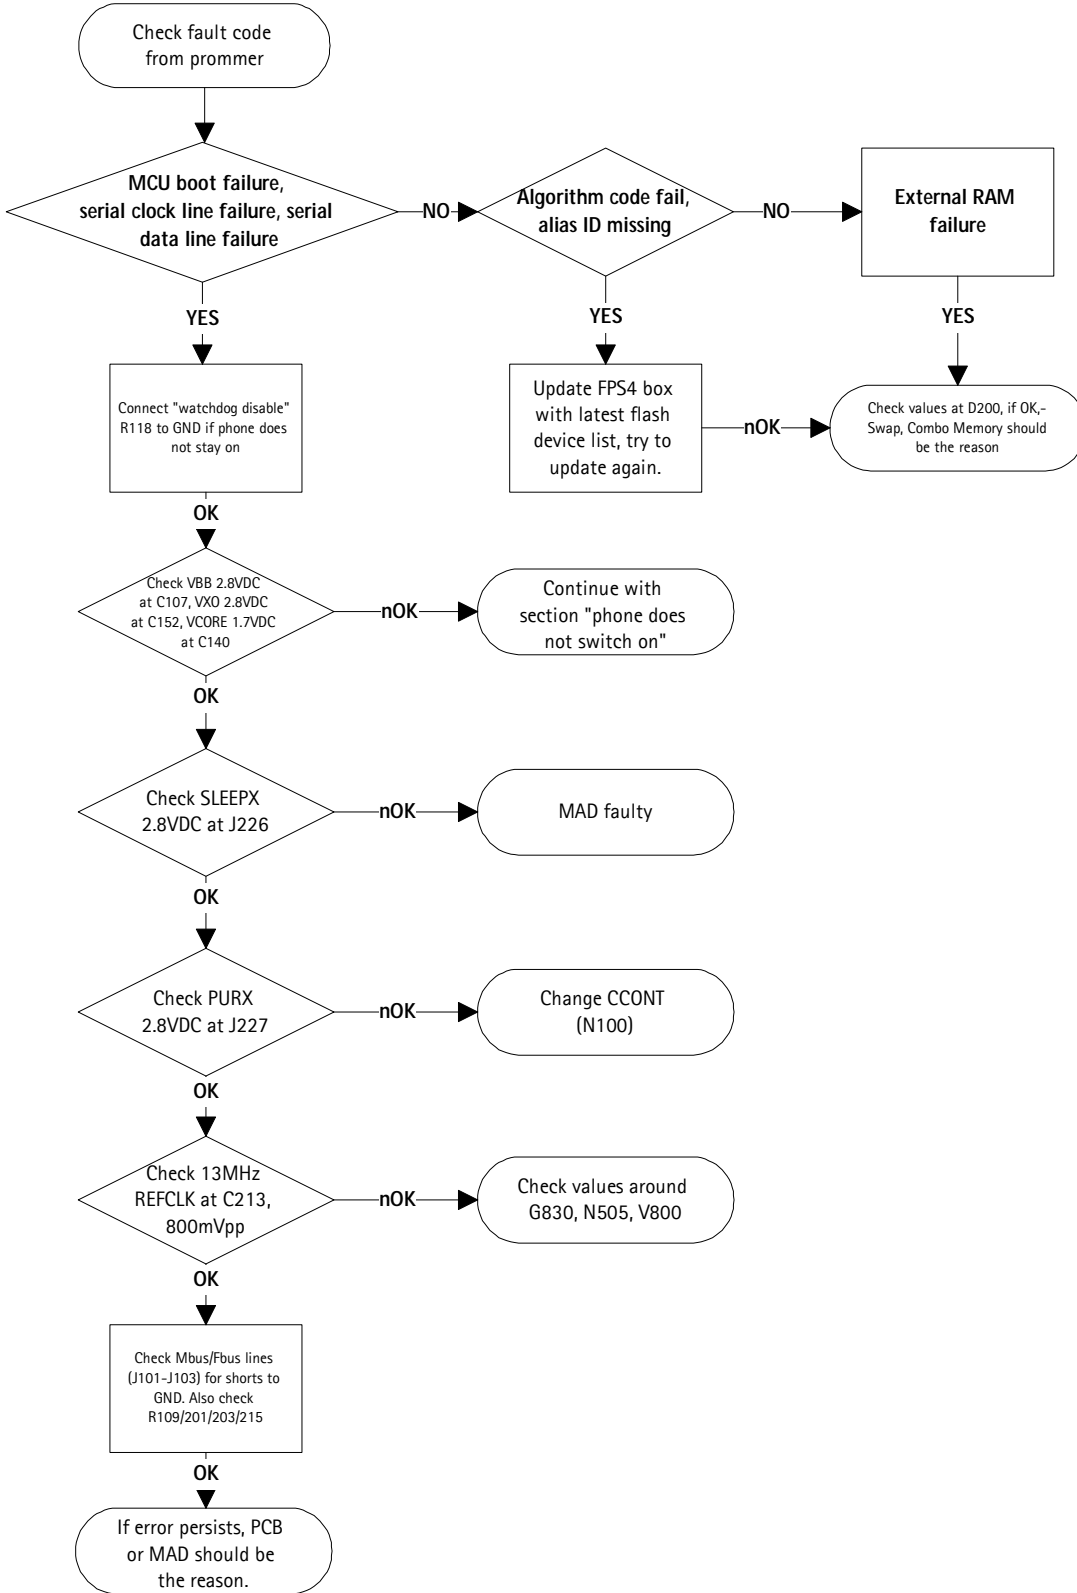
FLASH UPDATE NOT POSSIBLE

Flash update not possible**Failure message "MCU boot failure, serial clock-/dataline failure"**

If fault-code from prommer is one of the above mentioned and phone does not stay on, disable watchdog by connecting R118 to ground and try to update again. If fault remains, check the following:

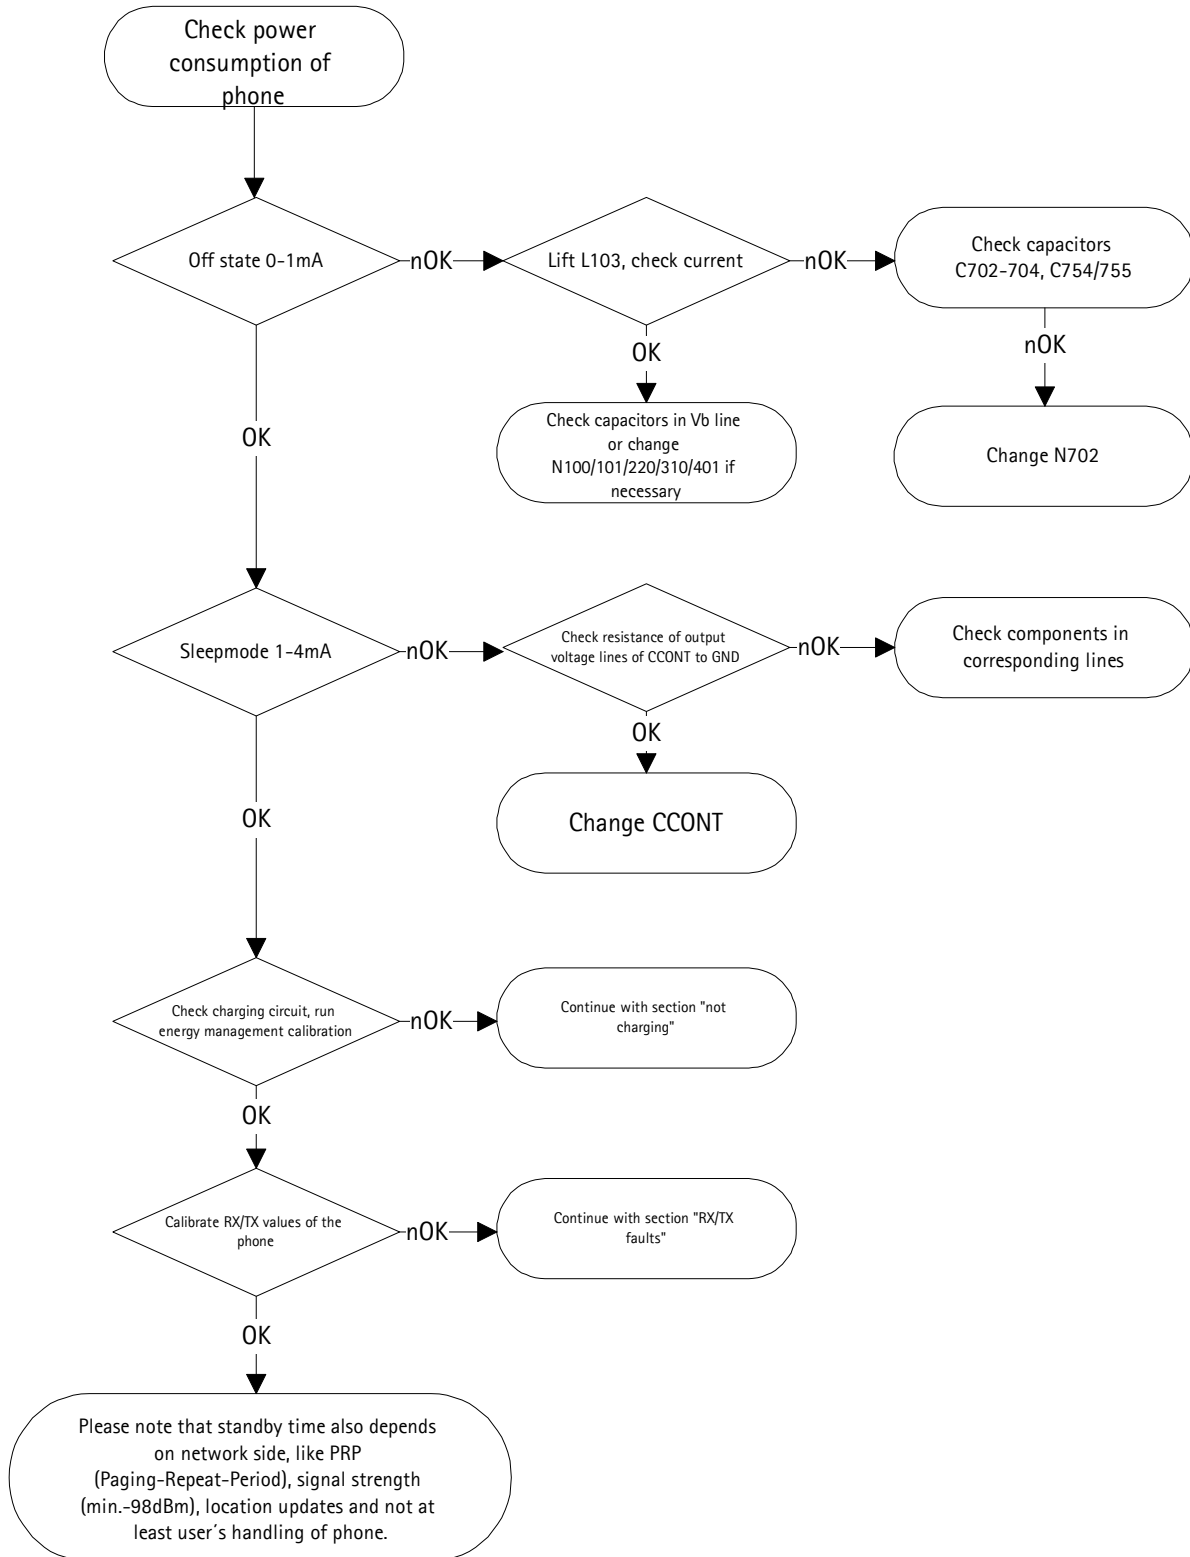
LOW STANDBY / OPERATION MODE TIME

Low standby / operation mode time

Check current consumption in different operation modes:

First to do in case of this fault is to lift L103 and check current consumption.
 If current still is too high, usually the power amplifier N702 is defect but it also is possible that one of the capacitors C702/703/704/754/755 is faulty – lift them one by one to find the fault.
 If current consumption is ok after removing L103, VB-line is faulty. It now is a bit difficult to find the reason for the fault, because both capacitors in VB-line (eg. C100/105/129/142/165...) or N100/101/220/310/401 can be responsible.
 Anyway you should begin with CCONT N100, which is the reason in most cases.

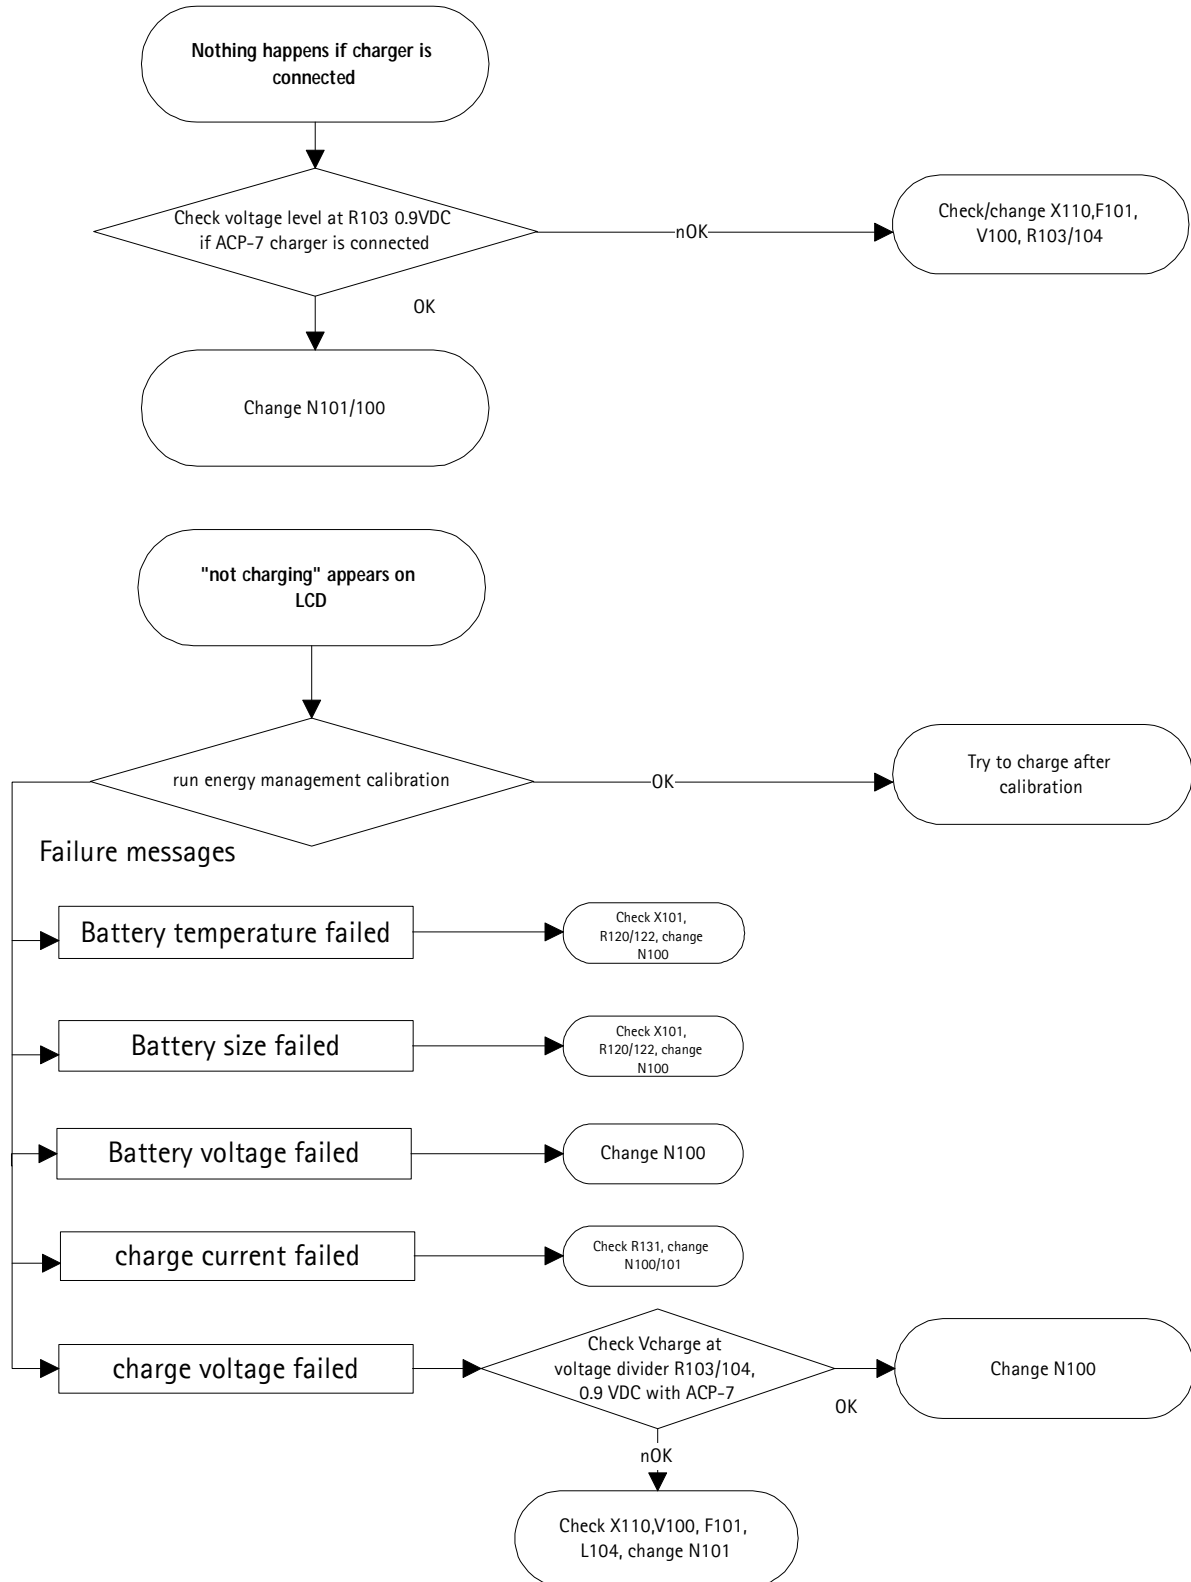
NOT CHARGING

Not charging

In case of any fault in the charging circuit: First run energy management calibration to define the fault!

- Check mechanical appearance of DC/HS-connector, especially check contact springs if bent, soiled or corroded.
- Check solderings and resistance of fuse F101 and coil L104.
- Check resistance of R103 (4.7k Ω) and R104 (47k Ω), also check that Vcharge-line has no short circuit to ground: resistance normally is 50k Ω . Check V100 and C103/114 if not ok.

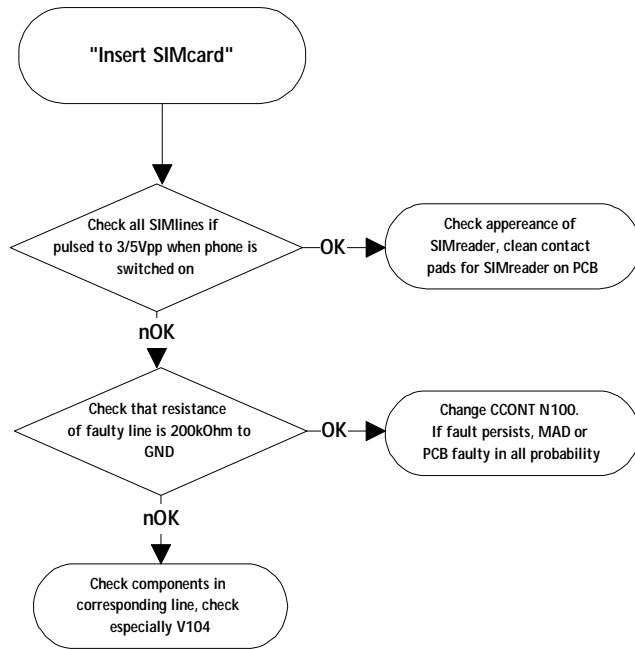
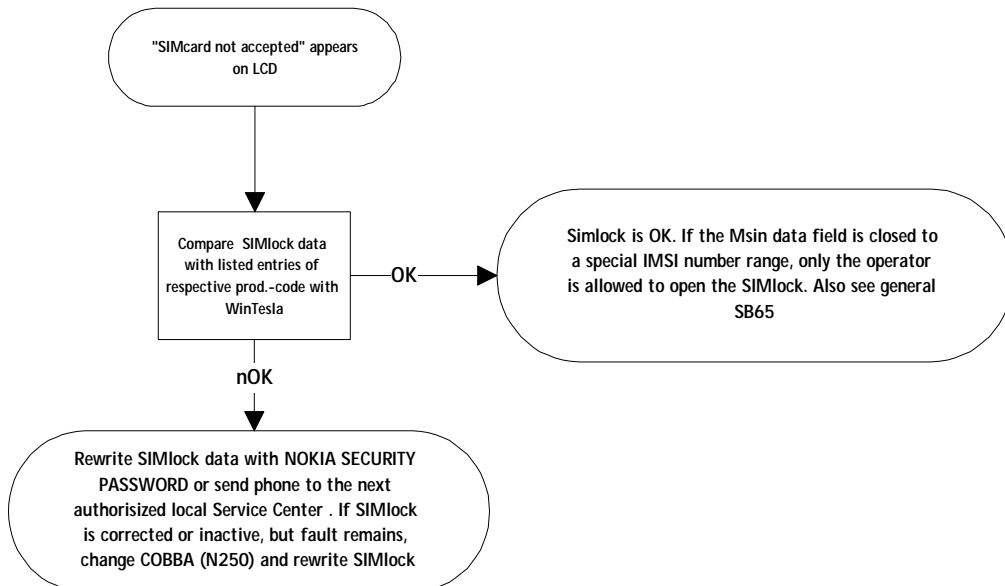
SIMCARD FAULTS

Display message “Insert SIMcard”

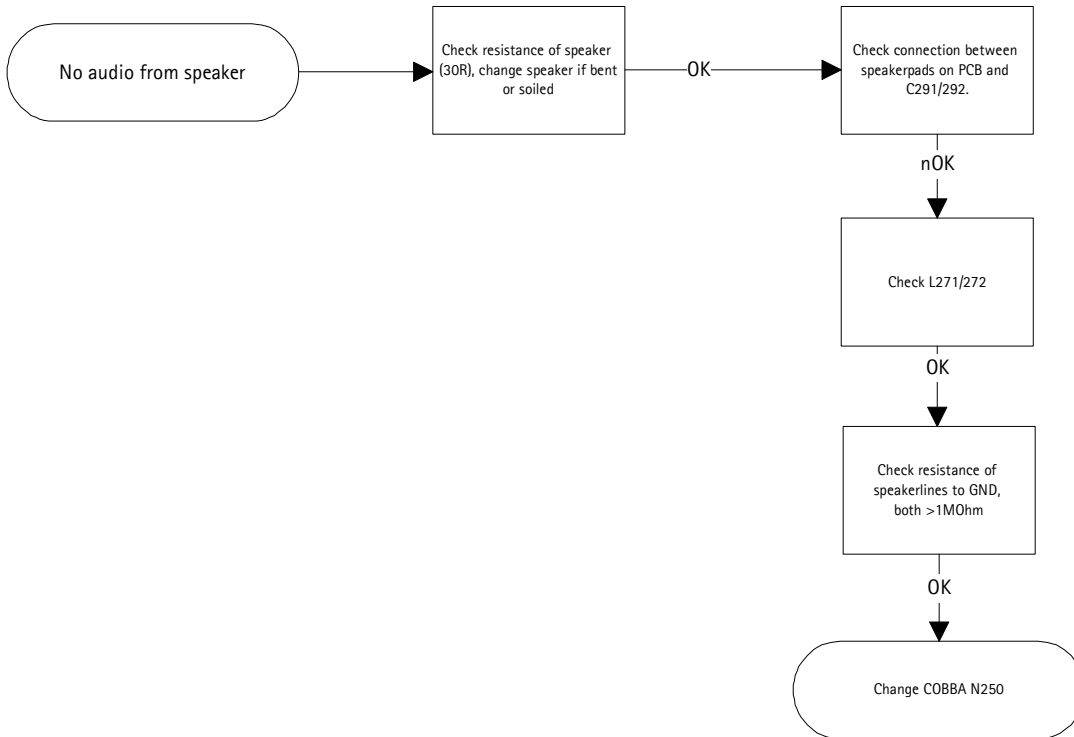
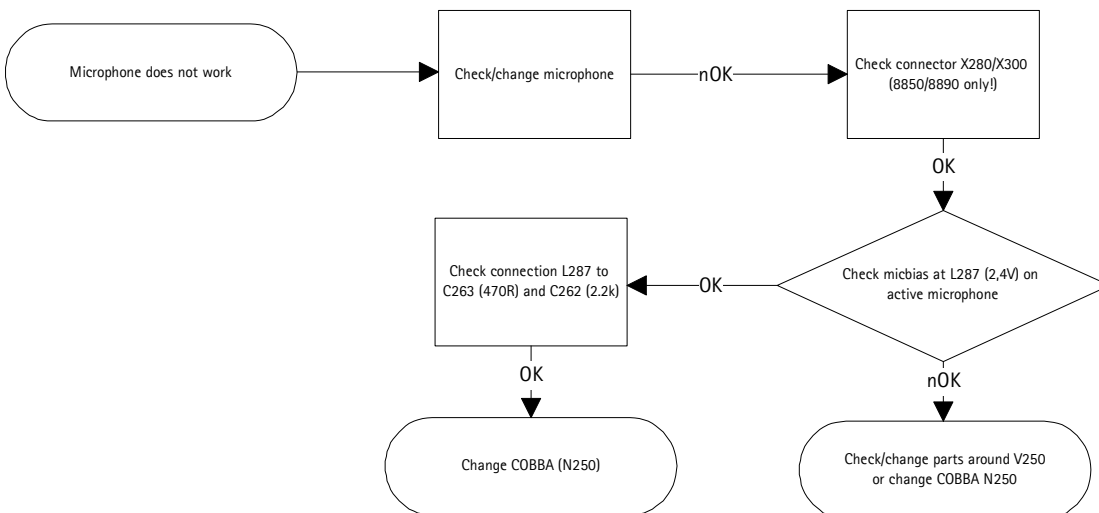
INTERNAL AUDIO FAULTS

In case of any internal audio-fault in your phone, first you should use WinTesla to define the fault to a single audio-line. If for example communication is possible without problems when using a headset but the internal audiolines do not work, activate audioloop between external input and internal output, so that you can hear the incoming signal from generator in the internal speaker. If this is not the case you concrete know that the internal speakerline is faulty. With this procedure you have the possibility to exactly define the defect line, what simplifies finding out the trouble.

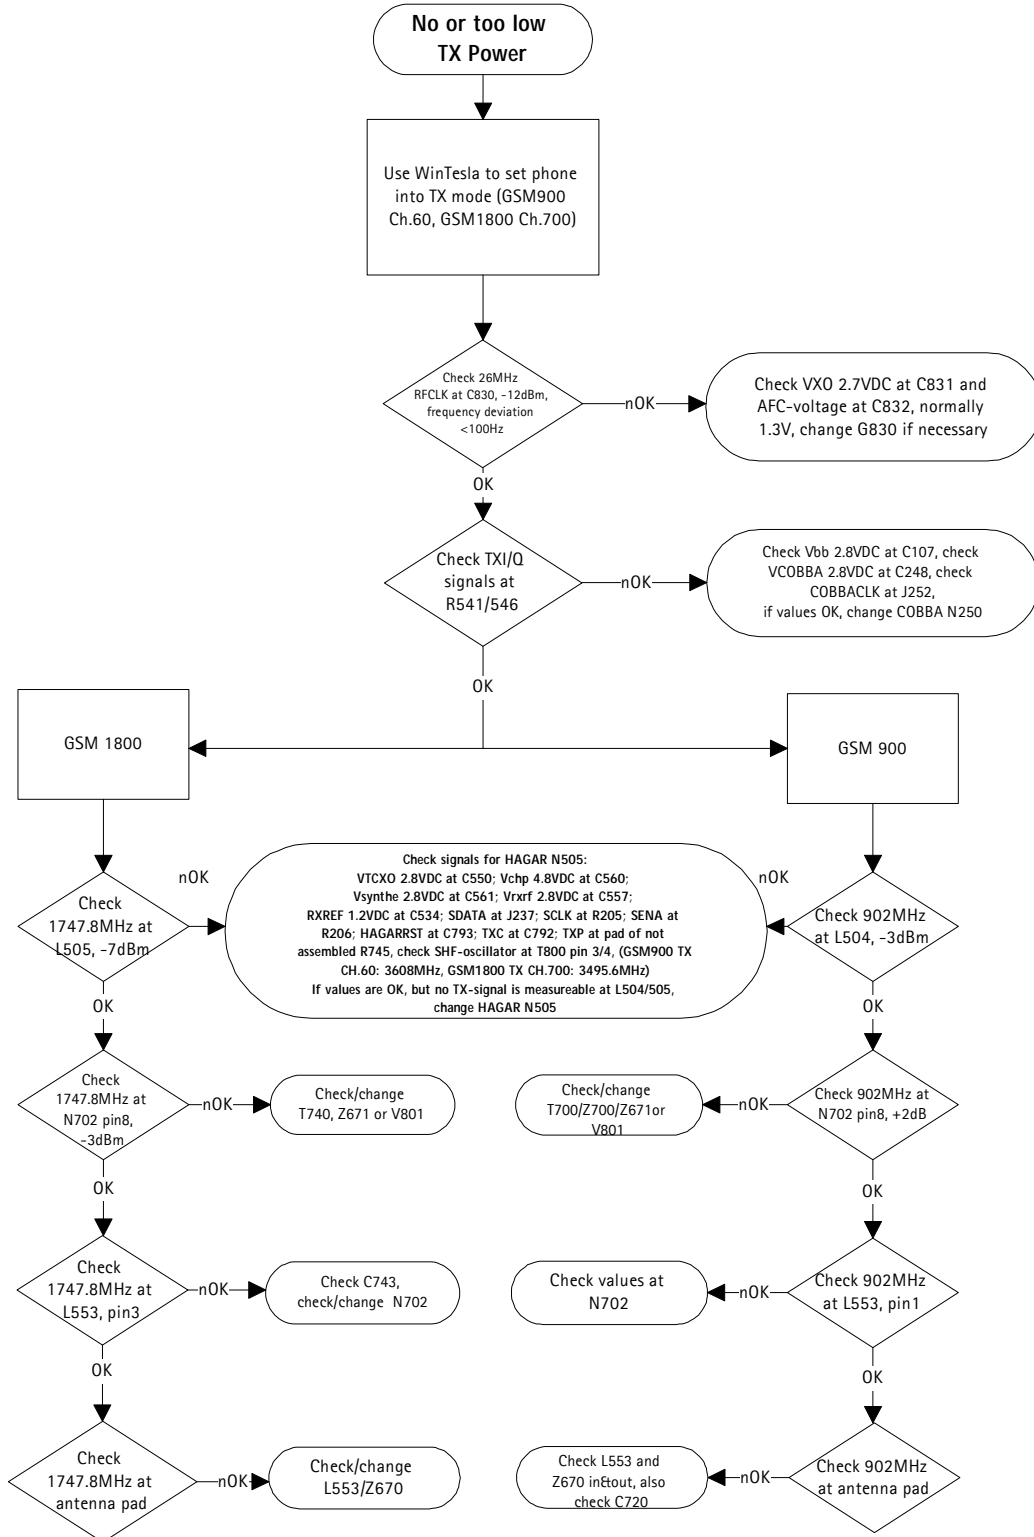
No or too low TX power GSM 900 (NSM-2/3)

Use WinTesla to set phone into following mode: Initialise/ Local mode/Testing/ RF Controls/ active unit TX, Ch.60

If signal is not ok, check VXO 2.7V DC at C831 and AFC-voltage at C832, which normally is 1.3VDC but may vary between 0.3V and 2.3V DC. If AFC-voltage is 0V, especially check R832 if torn off or defect.

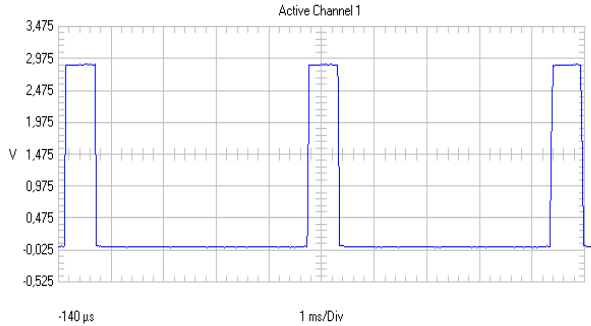
TXP 2.8Vpp measured at pad of not assembled R745, which is located between R791 and R541. You can check the signal at the pad located near by R744.

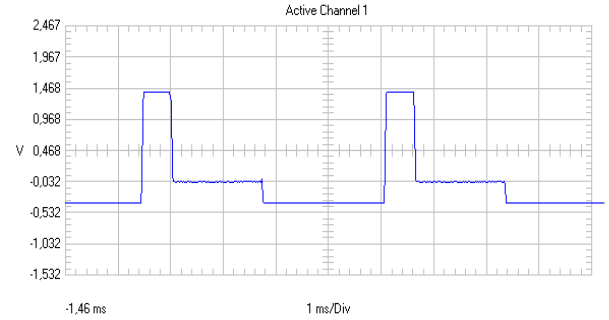
TXC measured at C792
 Note that the amplitude of TXC varies between 0.4Vpp - 1.8Vpp depending on TX-powerlevel.

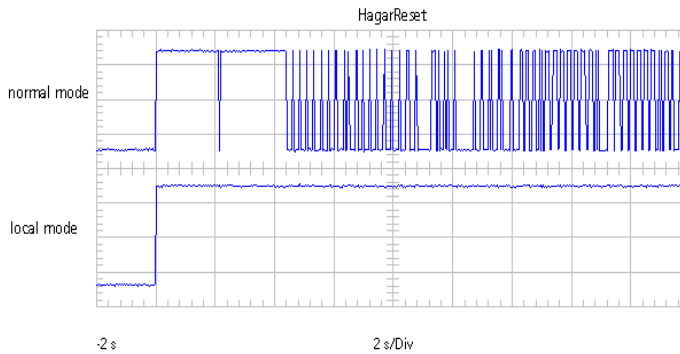
Also check HAGARReset at C793:

Remember that HAGARReset varies depending on the phone mode: while it is 2.8V DC in local mode, it changes between 0V and 2.8V in normal mode!

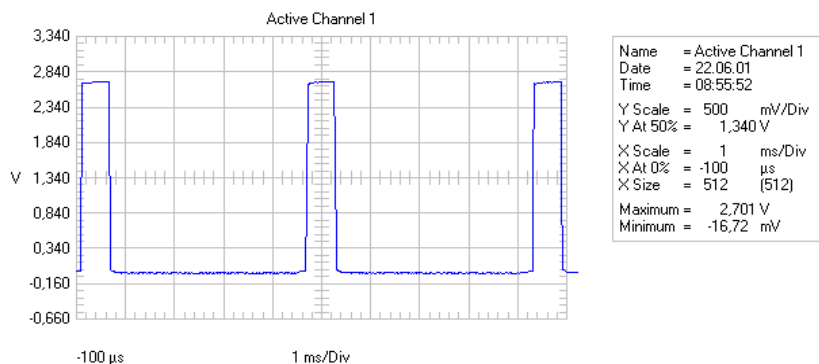
- check VBATT 4V DC at N702 pin 3 and 6
- check TXVGSM at N702 pin 2, $2.8\text{Vpp} / 217\text{Hz}$:

- Also check VAPC at N702 pin 7. Waveform is the same as it is for TXVGSM, but the amplitude of VAPC varies depending on the chosen TX-powerlevel: 1.2Vpp on power level 19 and 2Vpp on power level 5.

If the above mentioned conditions are fulfilled but amplitude of TX-spectrum at L553 pin 1 is too low, change the poweramplifier N702.

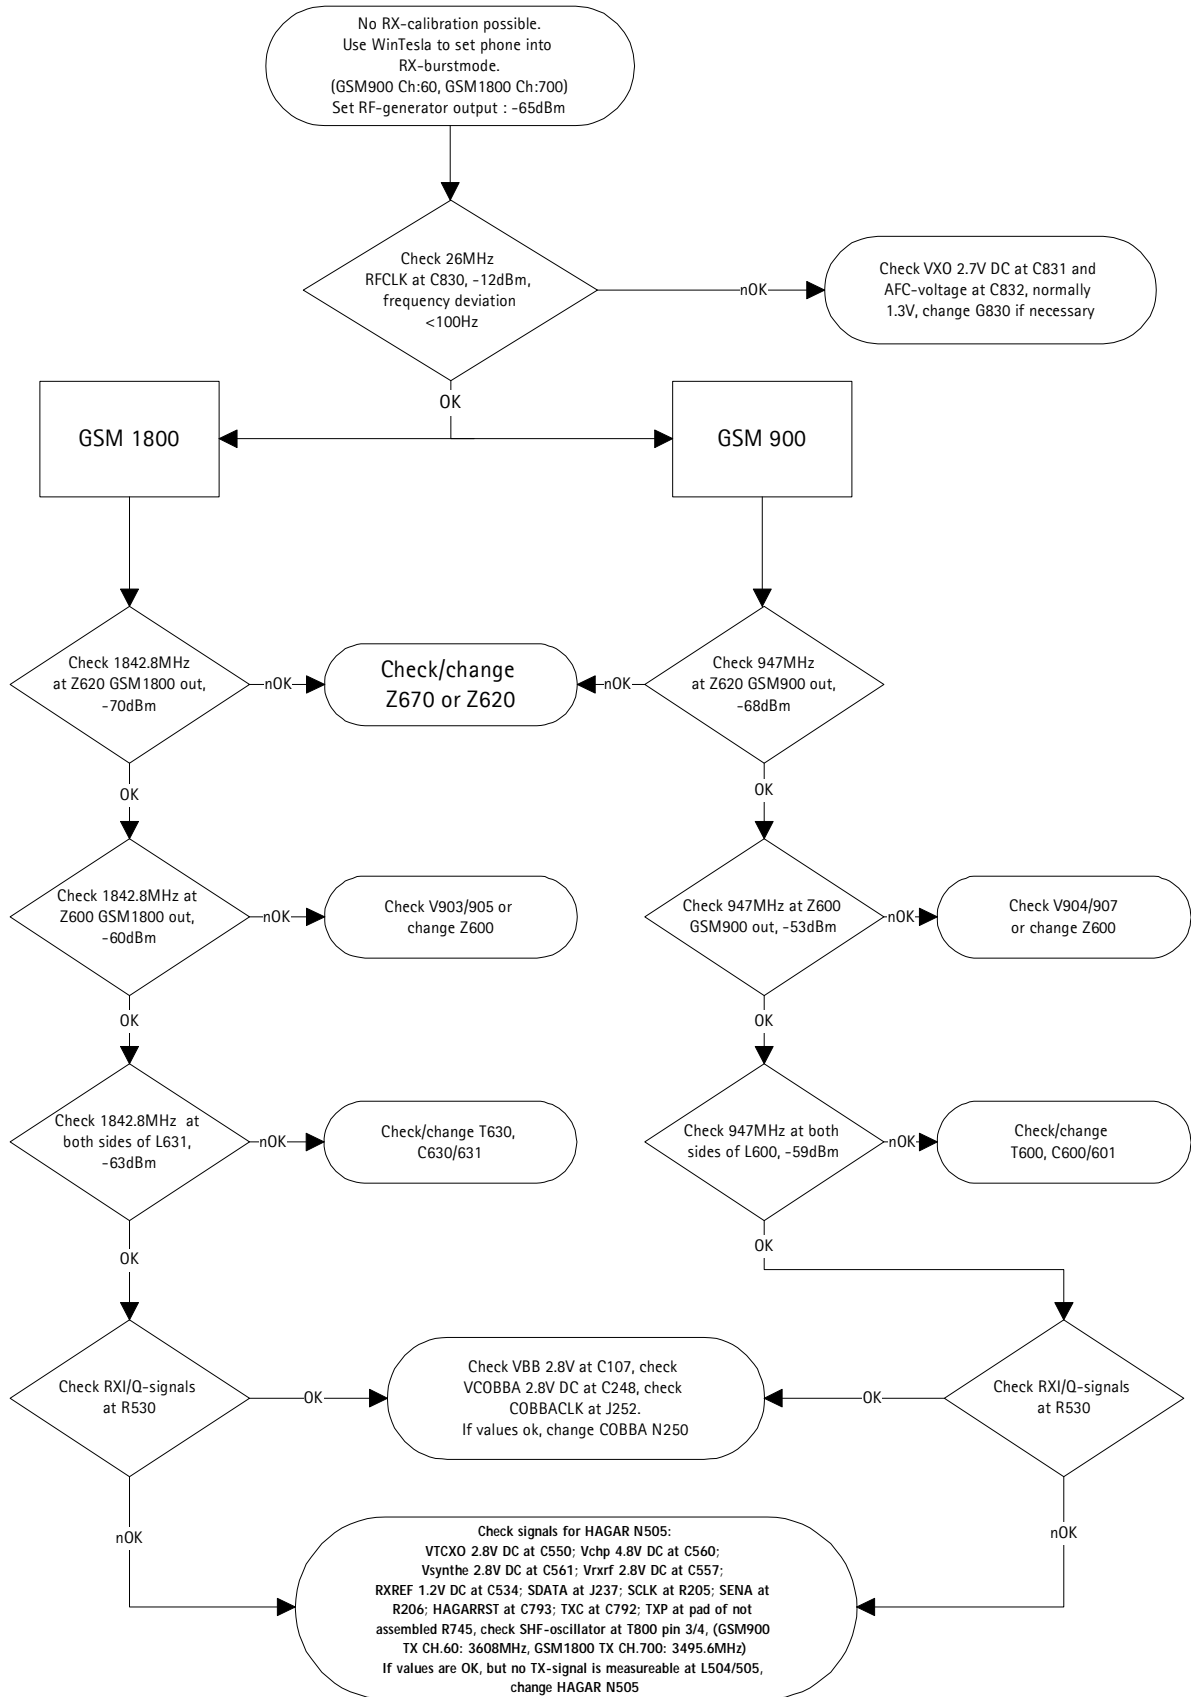
RX-calibration not possible

No RX-calibration GSM 900 possible (NSM-2/3 & NSB-6)

Use WinTesla to set phone in following mode: Initialise/Local mode/Testing/RF Controls/active unit RX Ch.60, burst mode. Set RF- generator to RF- level output of -65dBm.

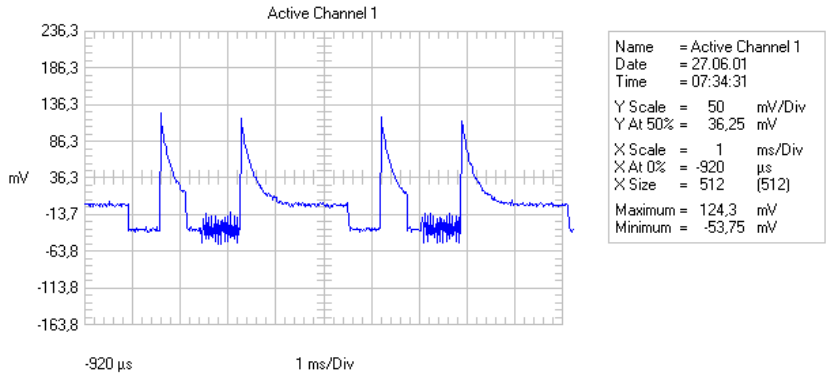
If 947MHz RX-signal at L600 is ok, check 67.708kHz at C522/523:

If this signal is not measurable, check voltages/signal which HAGAR needs to work as listed on next page:

If the above mentioned signals are ok but no 67.708kHz signal is measurable at C522/523, change HAGAR N505.

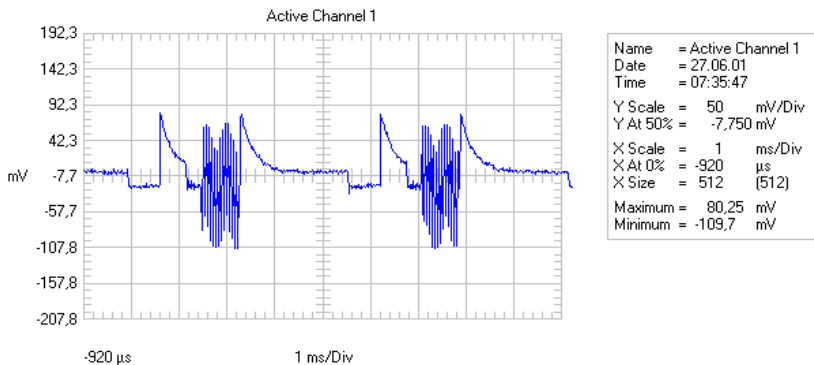
Check 67.708kHz at C520/521:

If no signal is measurable at C520/521, change HAGAR N505.

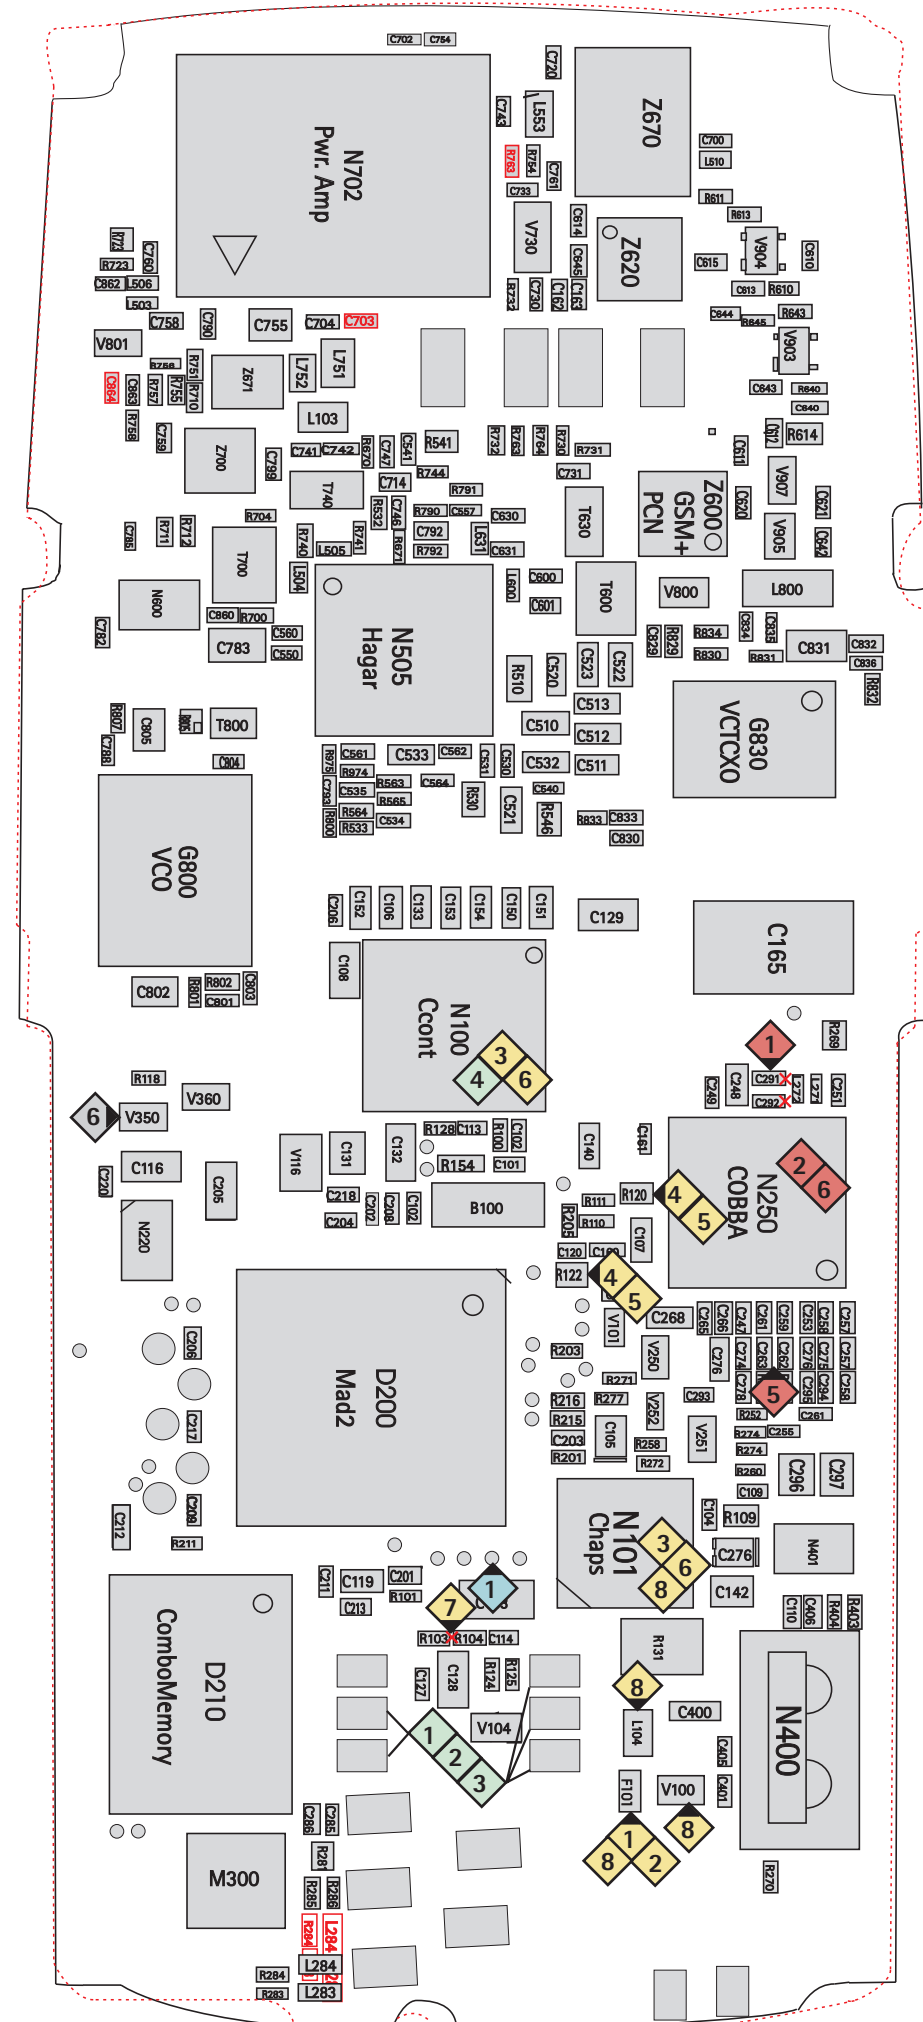
NO TX GSM900

1. Check 26MHz REFCLK at C830(700mVpp), frequency deviation <100Hz.
2. Check TXIQ signals at R541/546. If ok, go to 4.
3. Check VBB 2.8V DC at C107 and VCOBBA 2.8V DC at C248, check COBBACKL at J252, probably COBBA (N250) faulty or broken soldered.
