Repairhints

Communicator 9000/9000i RAE/K-1/4

The purpose of this document is to provide some further service information for NOKIA Communicator 9000/I. It contains a lot of collected tips and hints to find failures and repair solutions easily.

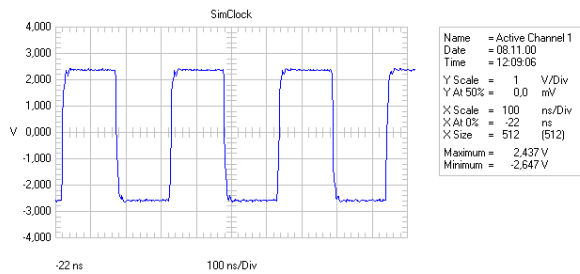
Note that SIMClock and SIMData are only present when SIMcard is active, for example when phone registers to network. Some SIMcards do not allow to switch off SIMClock but the clock-frequency can be reduced from 3.25MHz to 1.625MHz if SIMcard is not used.

SIMReset is low-active, that means that the Simcard will be reseted when SIMReset is 0 Volt. This is the case after switching on the phone. While VSIM is already high, SIMReset keeps low for a few milliseconds – in this time the card will be reseted.

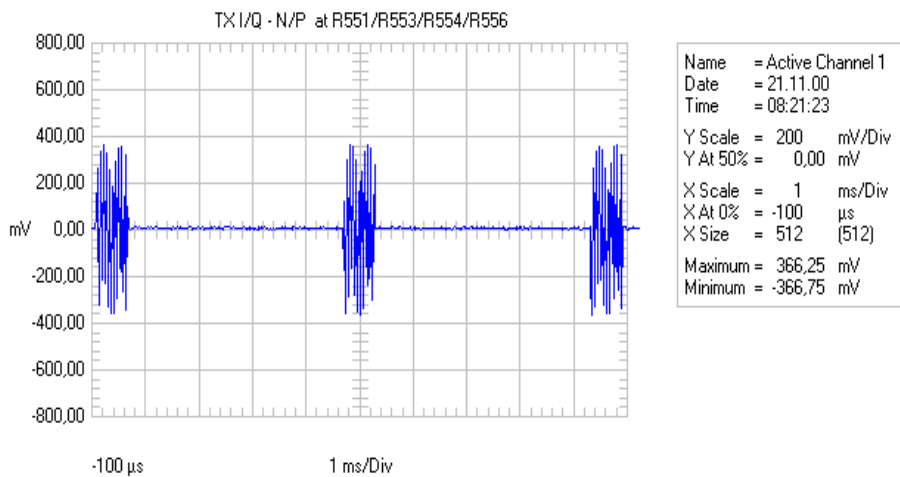
TXIN	:	400mVpp squarewave at R551
TXIP	:	400mVpp squarewave at R553
TXQP	:	400mVpp squarewave at R554
TXQN	:	400mVpp squarewave at R556

Check TXC (at R574) and TXP (at R571) signals to N551

- Check soldering / change N551 if necessary
- Check soldering / change E400 if necessary
