Repairhints

Communicator 9210 RAE-3

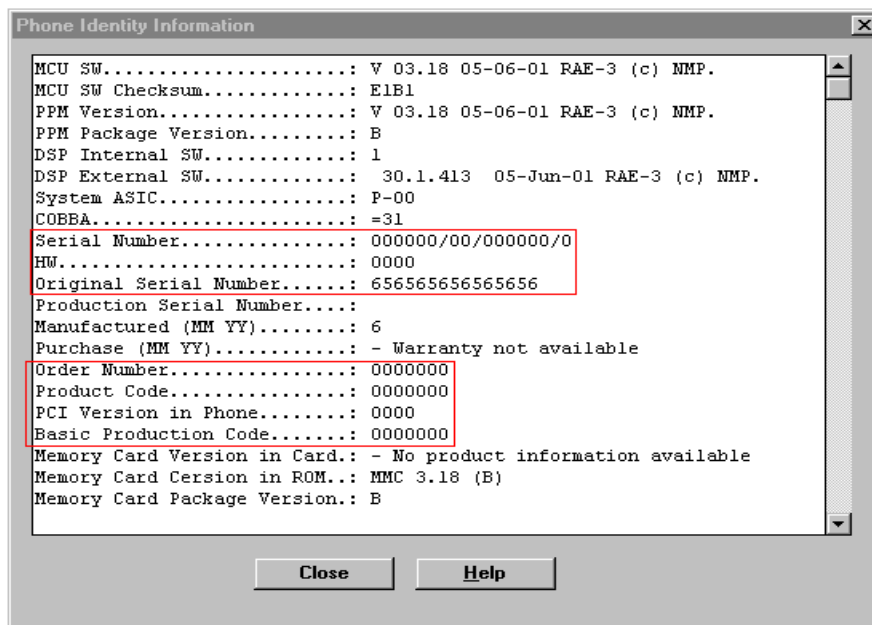
- Product Code and HW version not rewriteable
- IMEI 15*0 / Original Serial Number = 656565656565656
- Flashing Error message "Can't Set factory counter"
- Check which fault has happened using WinTesla menu Testing/ Selftest (e.g. MCU ROM Checksum).
- If one of the EEPROM faults occurred, open menu View/ Phone Information and take a look the marked values.(See picture)

Try to flash the communicator with SW 4.13 and promming option **Erase Only**. Also the memory card has to be updated. If the MMC is not updated some applications do not working well. (See SB-023)
For a faster MMC-image update it is a good solution to use ext. drive for MMC. (See SB-018)
For Erase Only it is necessary to use the dll version 04.00.00 and the modified RAE3.ini file. (See SB-025)

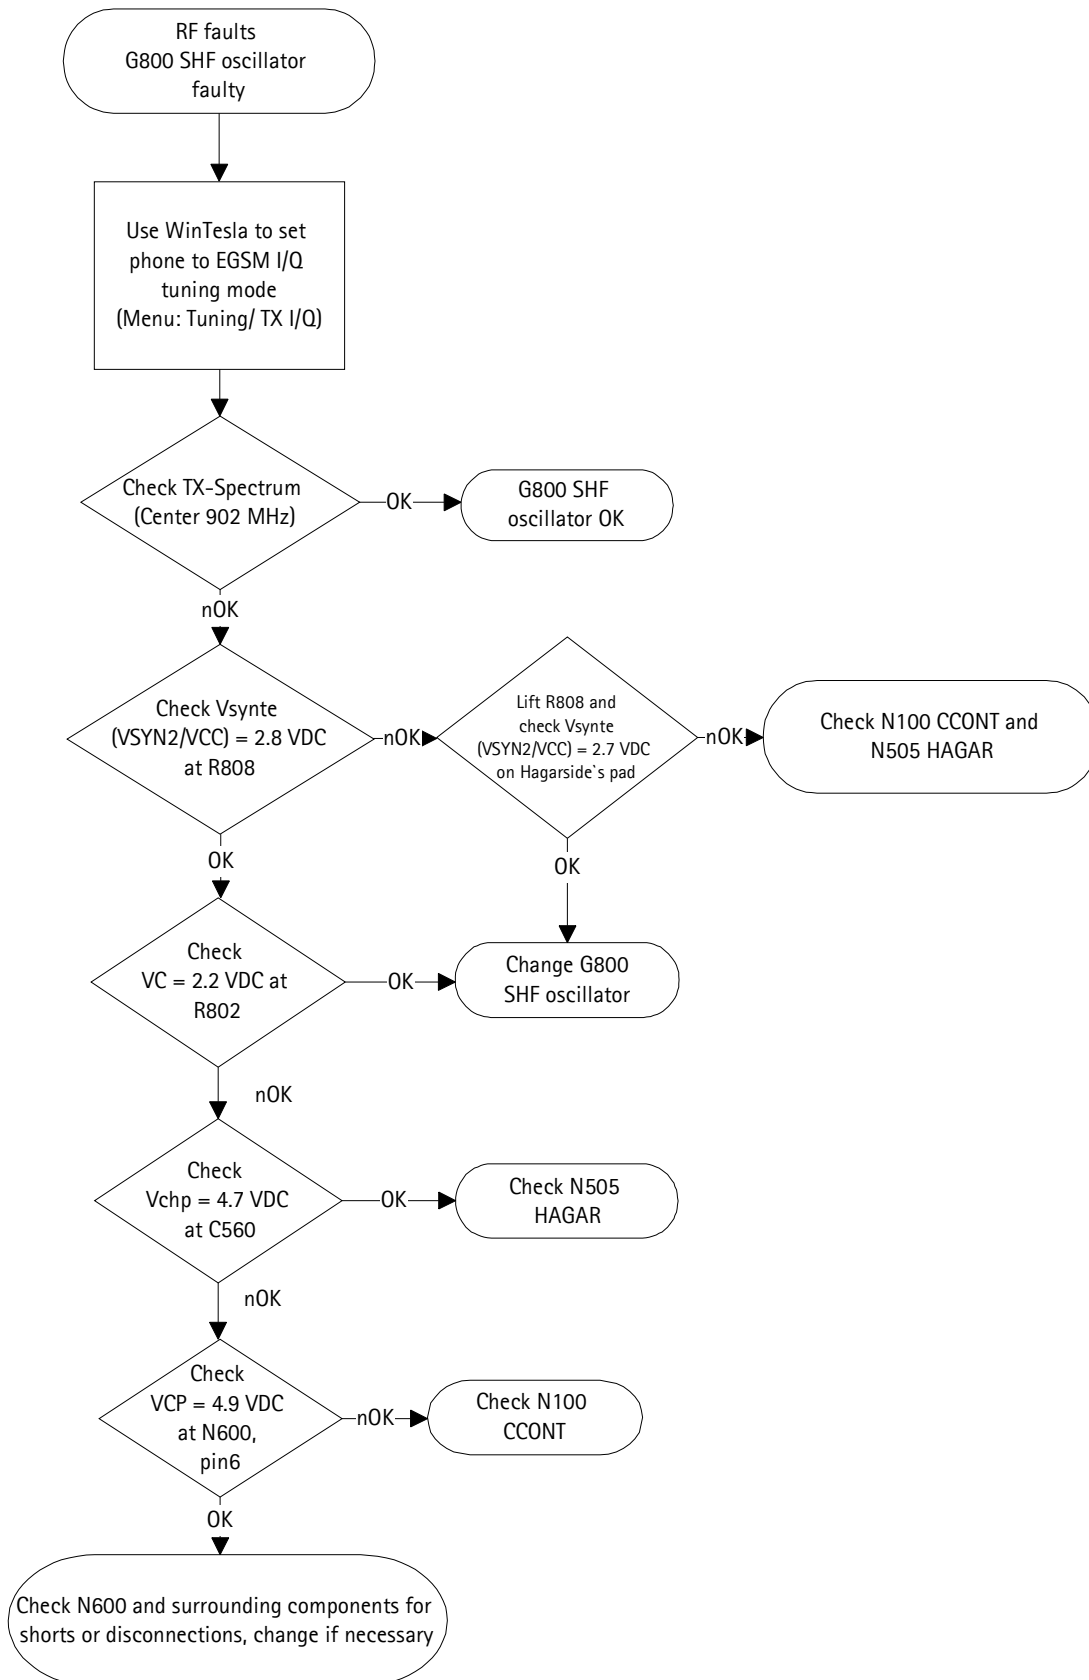
G800 SHF oscillator faulty

- If Picture 2 is appearing on spectrum analyser, check following voltages:
- Check Vsynte (VSYN_2/VCC) = 2.8 VDC at R808. If not ok, lift R808 and measure the voltage on the pad to HAGER's side. If Vsynte is ok, check G800 SHF oscillator and surrounding components for shorts or cold soldering and change or resolder the faulty ones.
- If Vsynte (VSYN_2/VCC) is not ok after lifting R808, check N100 CCONT.
- Check VC = 2.2 VDC at R802.
- Check Vchp = 4.7 VDC at C560. If not ok, check VCP = 4.9 VDC at N600 Pin 6. If not ok either, check N100 CCONT.
- If VCP is ok, check N600 voltage regulator and surrounding components for shorts or disconnections and change the faulty ones. If the surrounding components are ok, change G800 SHF oscillator.
- If VC is not ok, refer to N505 HAGAR faulty.

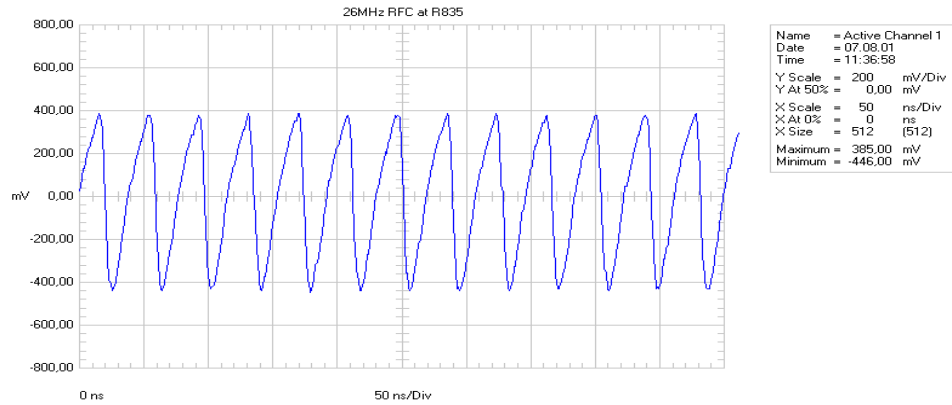
- Check VTCX0 (VX0) = 2.8 VDC at C553. If not ok, check N100 CCONT.
- Check 26MHz (Vpp = 800mV AC) at R835, frequency deviation ±100Hz (See picture below).
- If not ok, check G830 oscillator circuit.

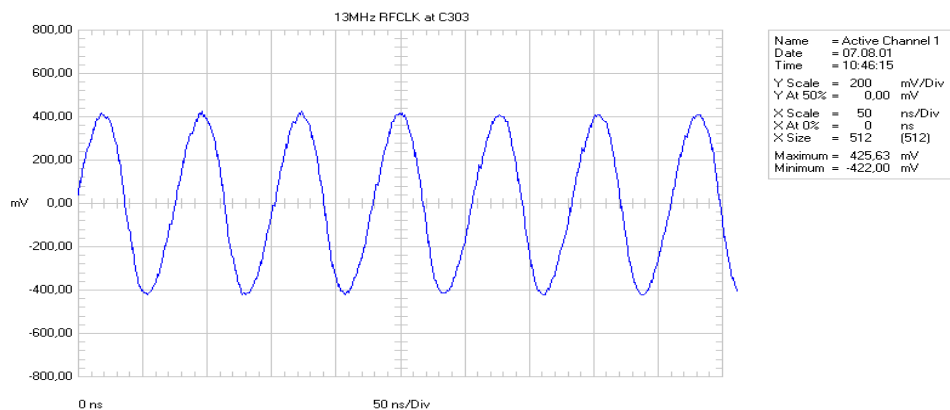
- Check RFC = 13MHz (Vpp = 800 mVAC) at L800, frequency deviation ±50Hz (See picture below)
- If not ok, check V800 and surrounding components for shorts or disconnections and change the faulty ones, otherwise probably N505 HAGAR circuit is faulty.

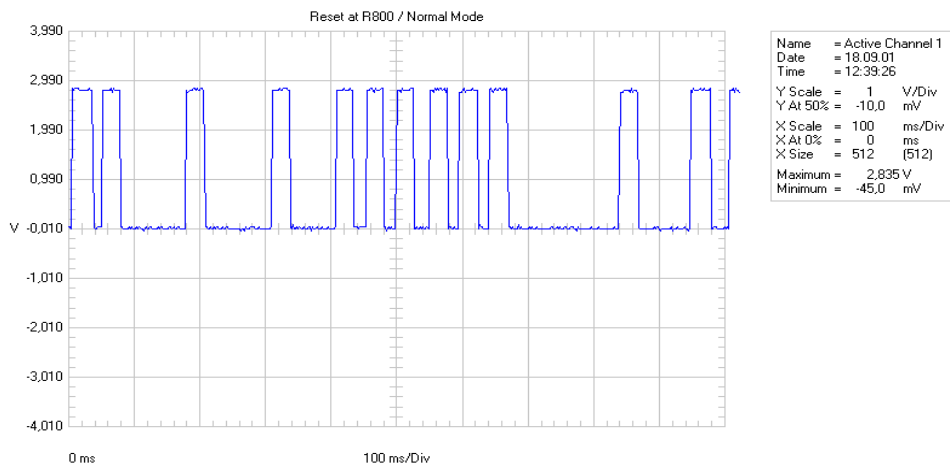
- Check Vsynte (VSYN_2) = 2.8 VDC at C561. If not ok, check N100 CCONT.
- Check VREF_2 = 1.5 VDC at R564. If not ok, check N100 CCONT.
- Check Vchp = 4.7 VDC at C560. If not ok, refer to G800 SHF oscillator faulty
- Check Vrxrf (VRX) = 2.8 VDC (RX active). If not ok, check N100 CCONT.
- Check Reset = 2.8 VDC (in Local Mode) and 2.8V pulse (in Normal Mode / one part (RX/TX) active) at R800 (See picture below)

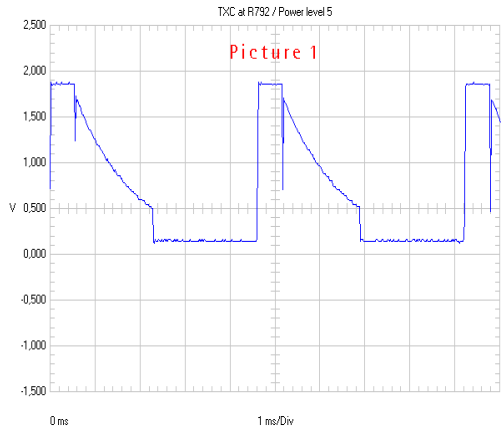
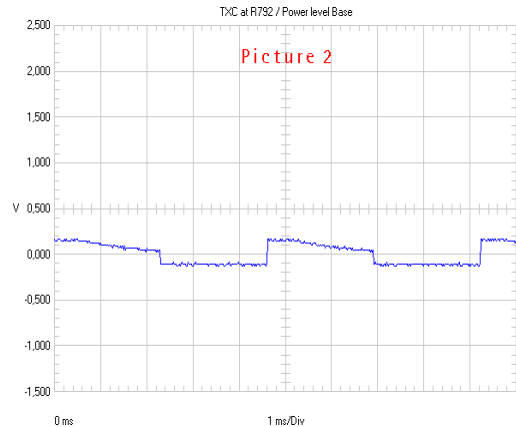
- Check Vmod (VTX) = 2.8V at R700. If not ok, check N100 CCONT.
- Check TXC (TX active) at power level 5 (picture 1) and at power level base (picture 2) at R792. If not ok, check N200 COBBA.

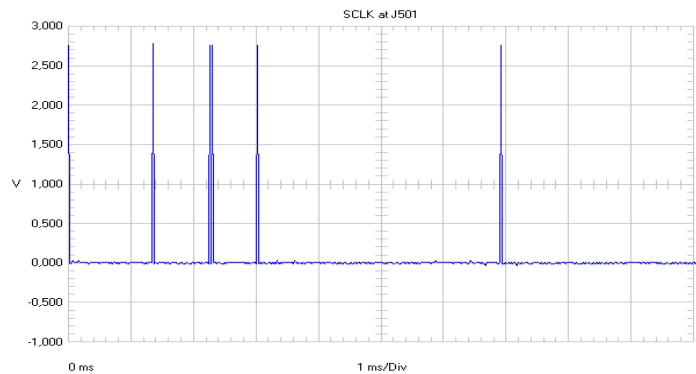
- Check SCLK at J501, SDATA at J500 and SENA at J502. (See picture below)
- If one or all three signals are not ok, probably the D300 MADLINDA is faulty.
