CCS Technical Documentation RH–17 Series Transceivers

# **Troubleshooting — Antennas**

This troubleshooting guide addresses potential failures that will affect the antenna performance of the RH-17 phone, and how to correct these failures.

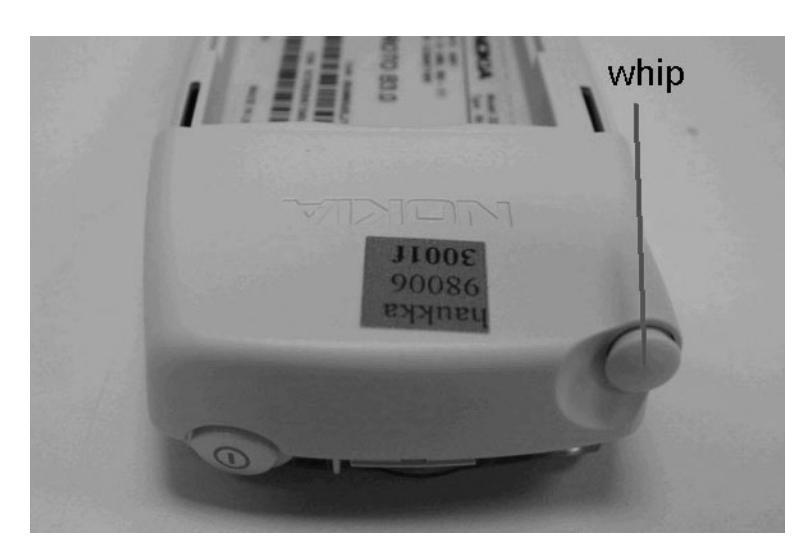
Figure 3: Back and Top of RH-17

Note in Figure 3 that when the whip antenna is properly installed, the cap "clicks" into the D-cover when the whip is fully retracted.
