**Nokia Customer Care
3155/3155i (RM-41), 3152 (RM-61)
Mobile Terminal**

Antenna Description and Troubleshooting

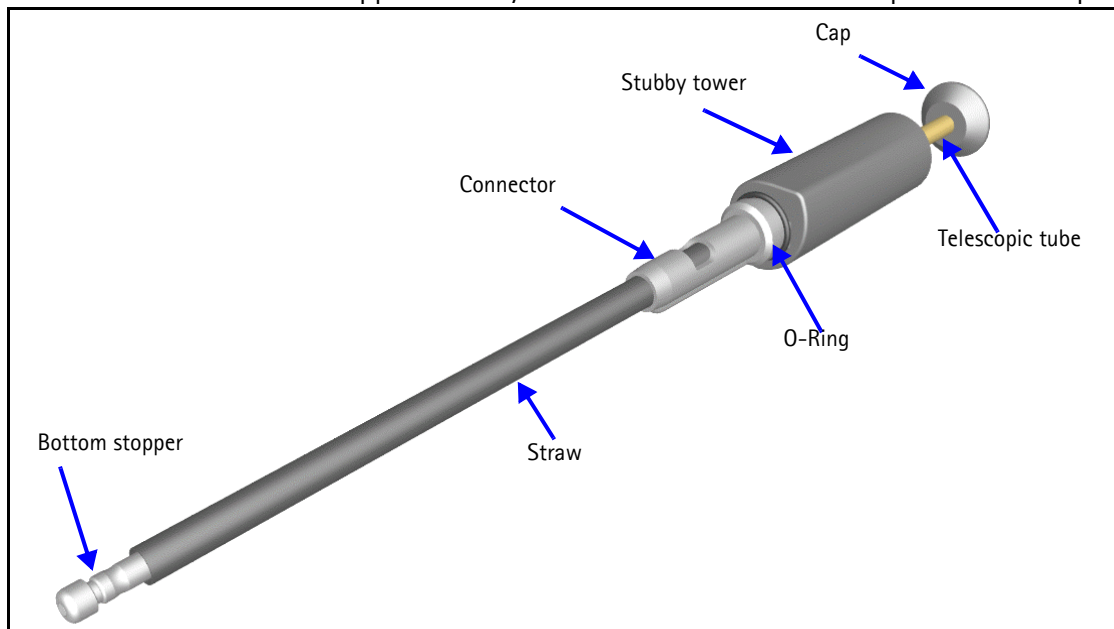
Figure 1: Whip antenna assembly

The whip antenna is shipped fully retracted with the telescopic section fully collapsed. The feed contact must appear at a 45-degree angle and must be free from damage, deformation, or unusual bending. The straw must be approximately 5.0mm from the end of the bottom stop.

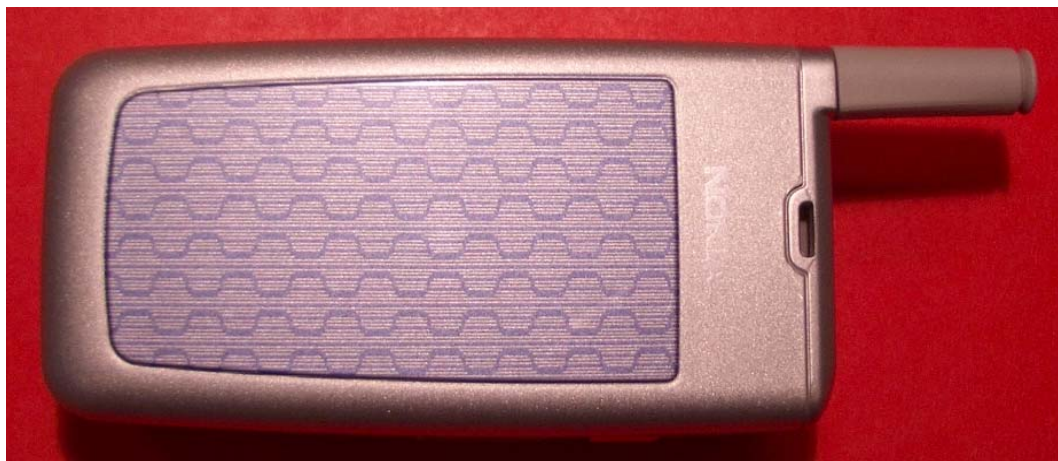
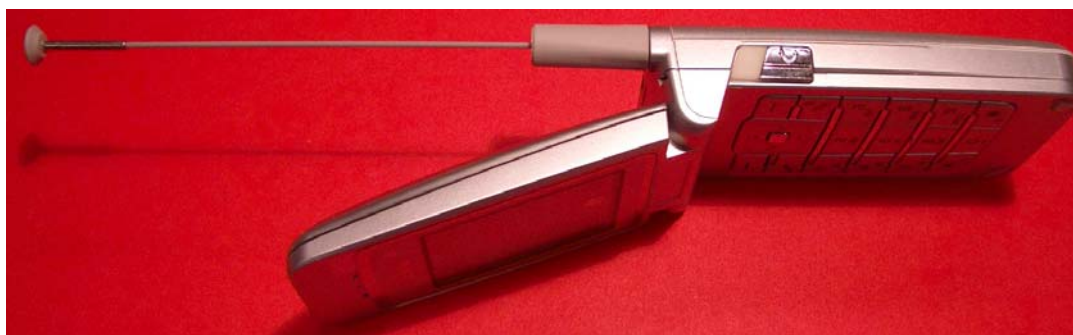
Figure 2: Whip retracted and whip extended

Note in [Figure 2](#) that when the whip is properly installed, the cap clicks into the antenna tower when the whip is fully retracted. When fully extended, the length from the end of antenna tower to the top of the cap must be around 118mm.
