# Repairhints

# 3310/3330

# NHM-5/6

The purpose of this document is to provide some further service information for NOKIA 3310 / 3330 phones.

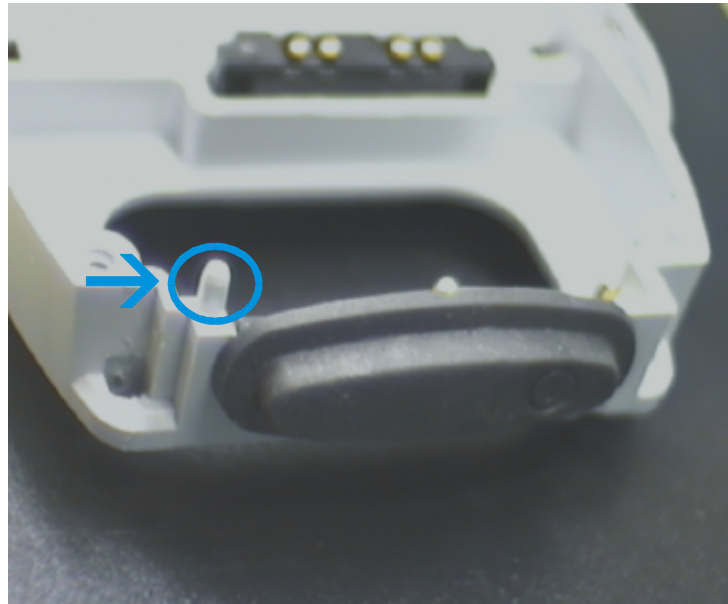
Figure 1-1

**Difficulties when removing B-Cover (SB13 / NHM-5)**

If customer criticizes bad removal of B-Cover cut away the guiding pin of the D-Cover (see Figure 1-1). After this procedure it is necessary to assemble the phone with a torque screwdriver prepared for **30Ncm!**

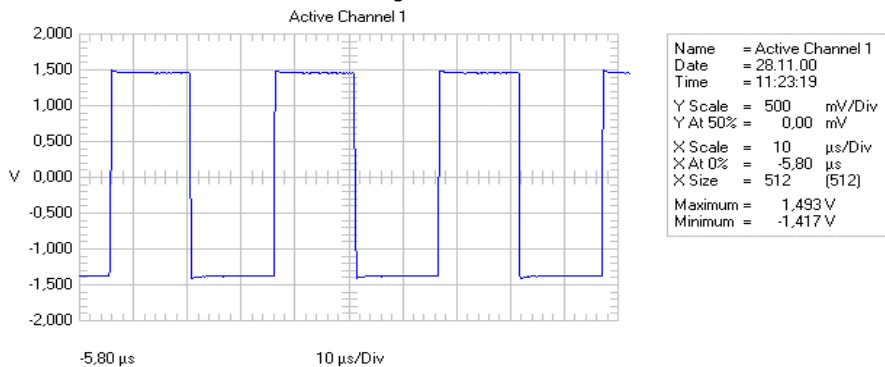
Figure 3-1

Check at C220 whether 32.768 kHz oscillator is working:

Amplitude of 32.768 kHz at C220 is 3 Vpp. If signal is not measurable check periphery of B200 like R211/212/214 and C229/230, change crystal B200 if necessary. If this does not solve the problem change CCONT N201. Remember to run energy management calibration after changing CCONT N201!

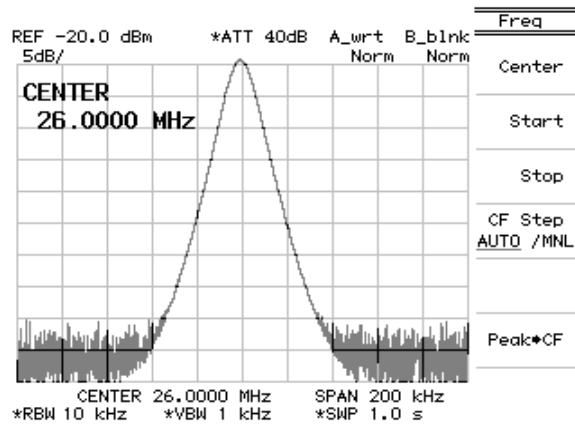
Figure 3-3

In case that the signal shown in figure 3-2 is not measurable, check voltages at reference oscillator G502: Check VCC 2.6 VDC at G502 pin 2, also check control voltage (AFC) at pin 1 which normally is 1.2 VDC. Note that control voltage may vary between 0.1 VDC and 2.3 VDC. Even without control voltage the oscillator must be able to work on a frequency around 26 MHz as shown in the Figure 3-3.  
If this is not the case you have to change G502.

26 MHz reference clock at the output of G502: Amplitude is around -10 dBm.

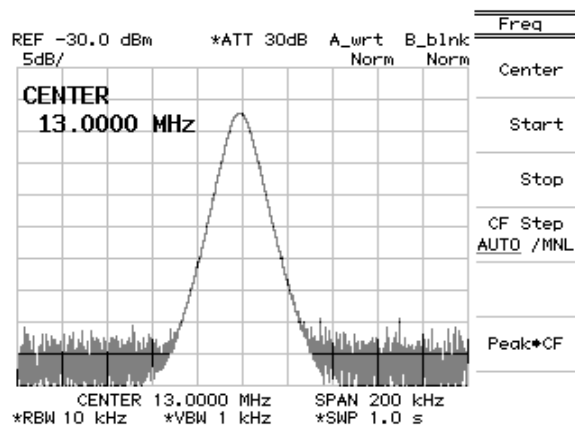
Figure 3-4

Amplitude of 13 MHz system clock at C559 is around -18 dBm.

If the signal shown above is not measurable, check VTCXO 2.7 VDC at C506/518. If both VTCXO and 26 MHz reference clock are ok but 13 MHz system clock at C559 is not measurable, you have to change Hagar N500. Remember to realign RX/TX-values after changing Hagar N500!

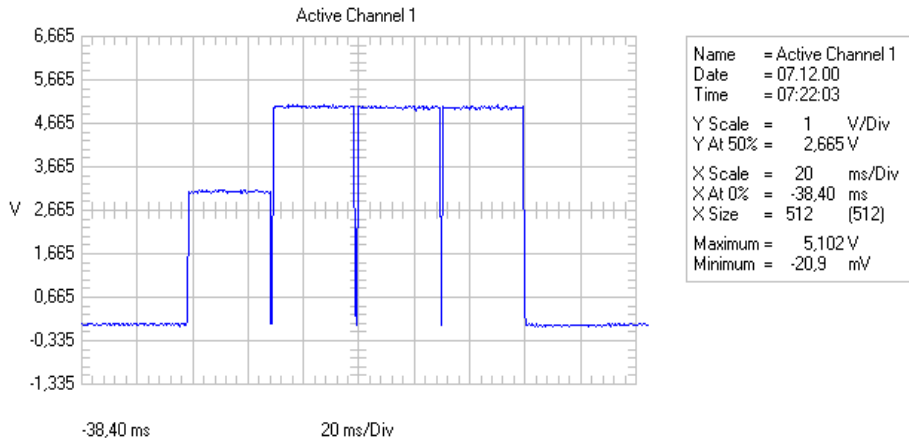
Figure 9-1

The easiest way to find out the reason for this fault is to check if every single SIMline is pulsed to the signal shown below after initializing the phone:

You can check this signal easily at the SIMreader's pogo-pins of the service-jig. The signal must be measurable at all pins except the ground pin.

If the above-mentioned signal is ok at all five pogo-pins, check mechanical appearance of SIMreader. Also check that contact-pads for SIMreader on PCB are clean.

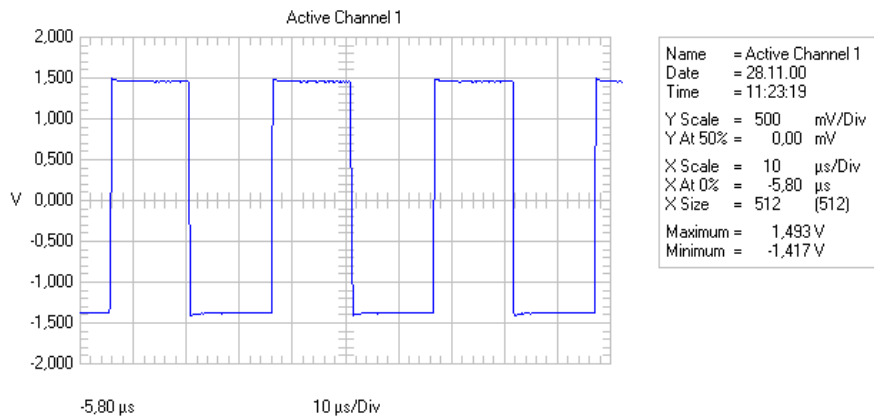
Figure 11-2

In case that clock time has to be corrected in short periods check amplitude and frequency of sleepclock-oscillator at C220.  
 (3 Vpp squarewave at 32.768 kHz).  
 If amplitude or frequency is not ok, change crystal B200.  
 If fault persists, check parts around B200 as R211/212/214 and C229/230.

32.768 kHz measured at pad of C220 located towards crystal B200.

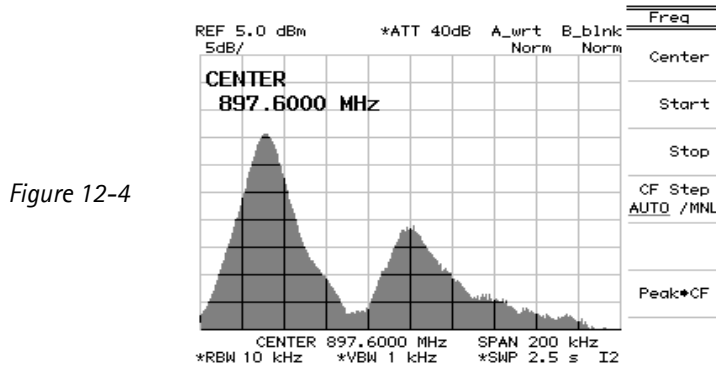
If TXIQ-signals at R541/548 are ok, check 897.6 MHz TX-spectrum at both sides of L514:

Amplitude of TX-spectrum at L514 is around 0 dBm. If this spectrum is not measurable, you have to check all signals, which HAGAR N500 needs to work:

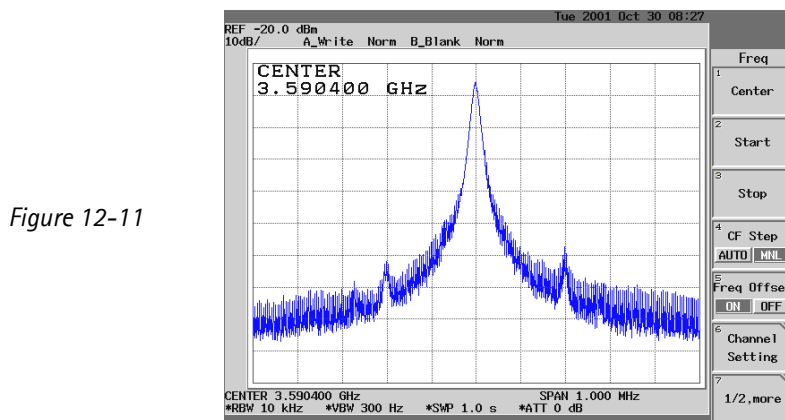
Figure 12-11

Also check signal of SHF-oscillator G500 at T502 pin 3/4:

If SHF-oscillator does not work on expected frequency, check that voltage at C522 is 2.7 VDC. Also check control voltage at C558, which varies between 1.2 V and 3.3 VDC. If control voltage is 4.8 VDC, the oscillator is faulty or the control loop is open.

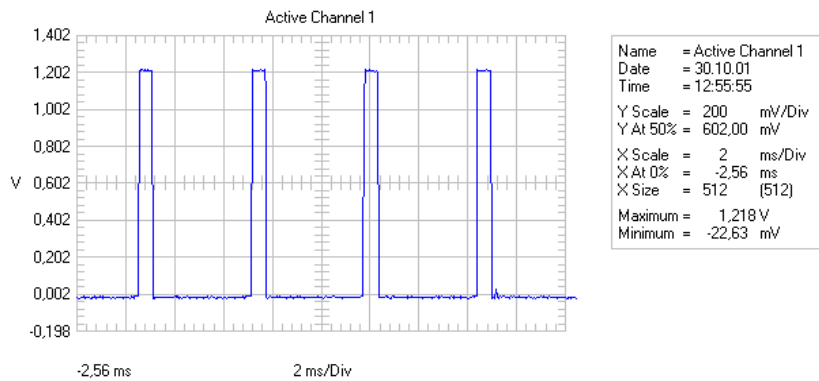
Figure 12-12

- Check VBATT 4 VDC at C570/572.
- Check Vapc at C565, which varies between 1.2 Vpp and 1.7 Vpp depending on TX-power level:

If these values are ok but amplitude of TX-spectrum at L515 pin 1 is too low, change the power amplifier N502.

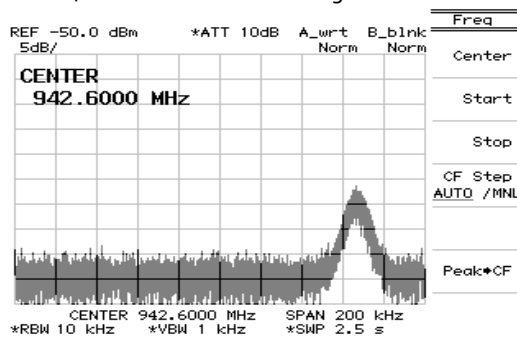
Figure 12-17

Amplitude of RX-signal at C545 is approximately -67 dBm.

If signal is not measurable or amplitude is too low, check solderings of C593 and C556. Ensure that attenuation of filter Z501 is not higher than 3.5 dBm. Especially check with microscope ceramic bottom plate of diplexer Z502 if broken in case of temporary receiver faults!

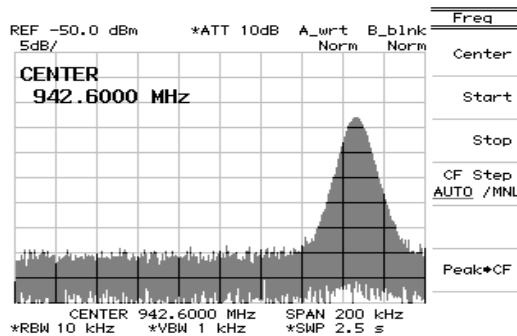
Figure 12-18

Amplitude is around -52 dBm. Check solderings of C537. Also ensure that LNA V501 works:

Check with an oscilloscope voltages at base (figure 12.19, 1.1 Vpp) and collector (figure 12.20, 2.6 Vpp) of V501, change V501 or N500 if necessary.

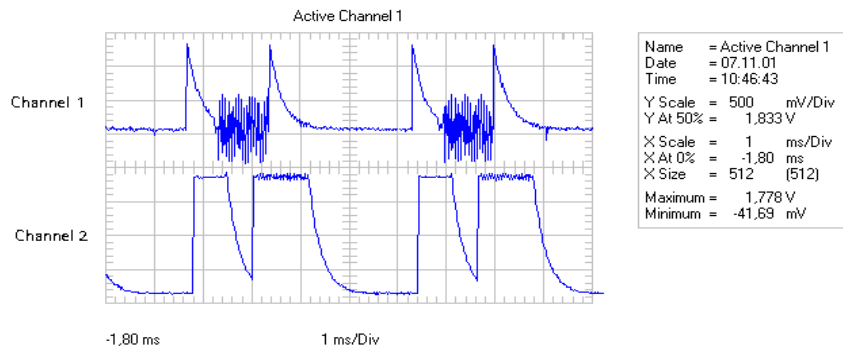
Figure 12-21

If 942.6 MHz RX-signal at L504 is ok, check 67.708 kHz at the four pads of C512 located towards N500:

Channel 1 only shows the AC-part of the signal while channel 2 shows the same signal on its DC-level.

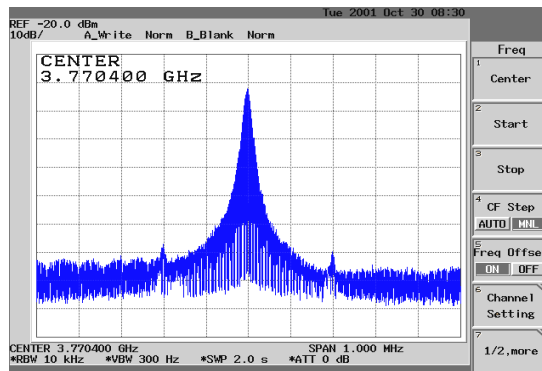
Figure 12-22

Furthermore check signal of SHF-oscillator at T502 pin 3/4, 3770.4 MHz:

If SHF-oscillator does not work on expected frequency, check that voltage at C522 is 2.6 VDC. Also check control voltage at C558, which varies between 1.2 V and 3.3 VDC. If control voltage is 4.8 VDC, the oscillator is faulty or the control loop is open.

In case that it is necessary to rework G500 unfortunately you have to remove the RF-shielding first.

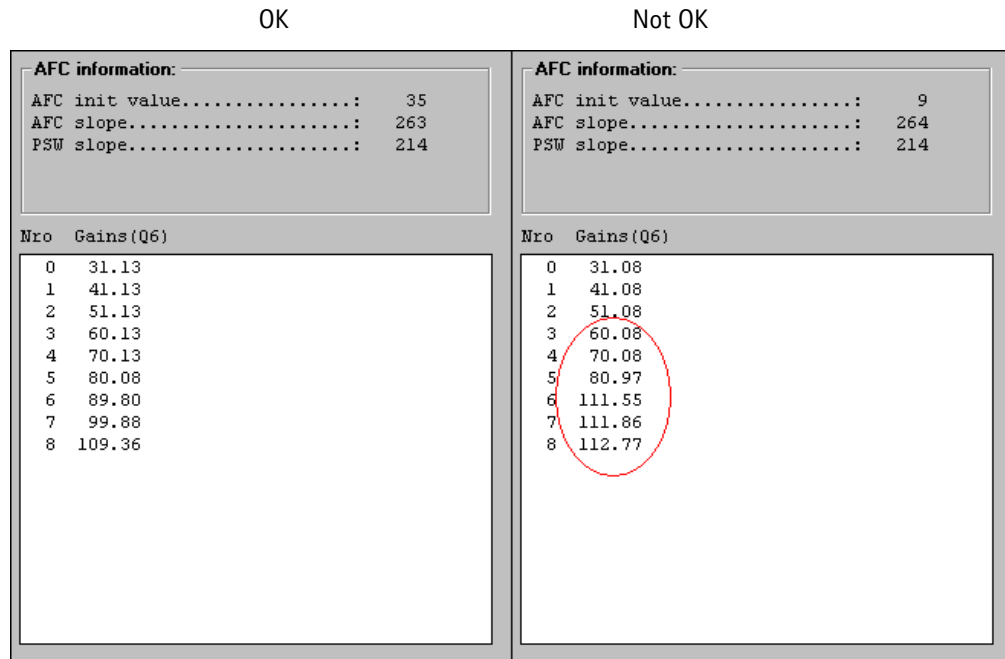
Figure 12-25

In case of this fault combined with an RX-calibration which works, but whose values are not ok (incorrect stepwidth as shown in figure 12-25), check signals at R500 and R504. The signals below were measured in RX-burstmode with an input level of -65 dB. Channel 1 shows the signals of a proper working phone while channel 2 shows the same signals of a phone in which C508 is faulty. R500 contains four resistors, so that you have to measure all four lines. It could happen that you will get the signal shown in channel 2 more than once. That means that more than one of the four capacitors in C508 are broken.

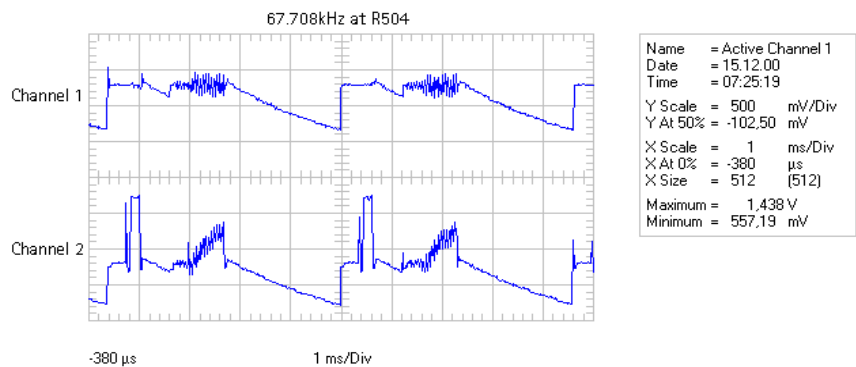
Figure 12-26

Signals measured at R504  
(RX burstmode, input level -65 dBm):

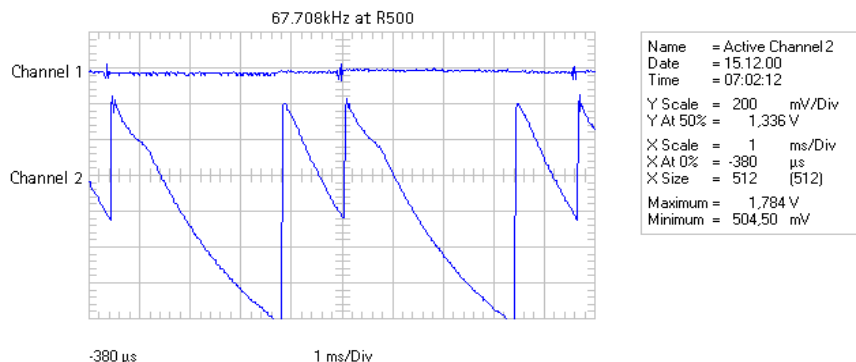
Figure 12-27

Signals measured at R500  
(RX burstmode, input level -65 dBm):
