Repairhints

8310

NHM-7

The purpose of this document is to provide some further service information for NOKIA 8310 phones.

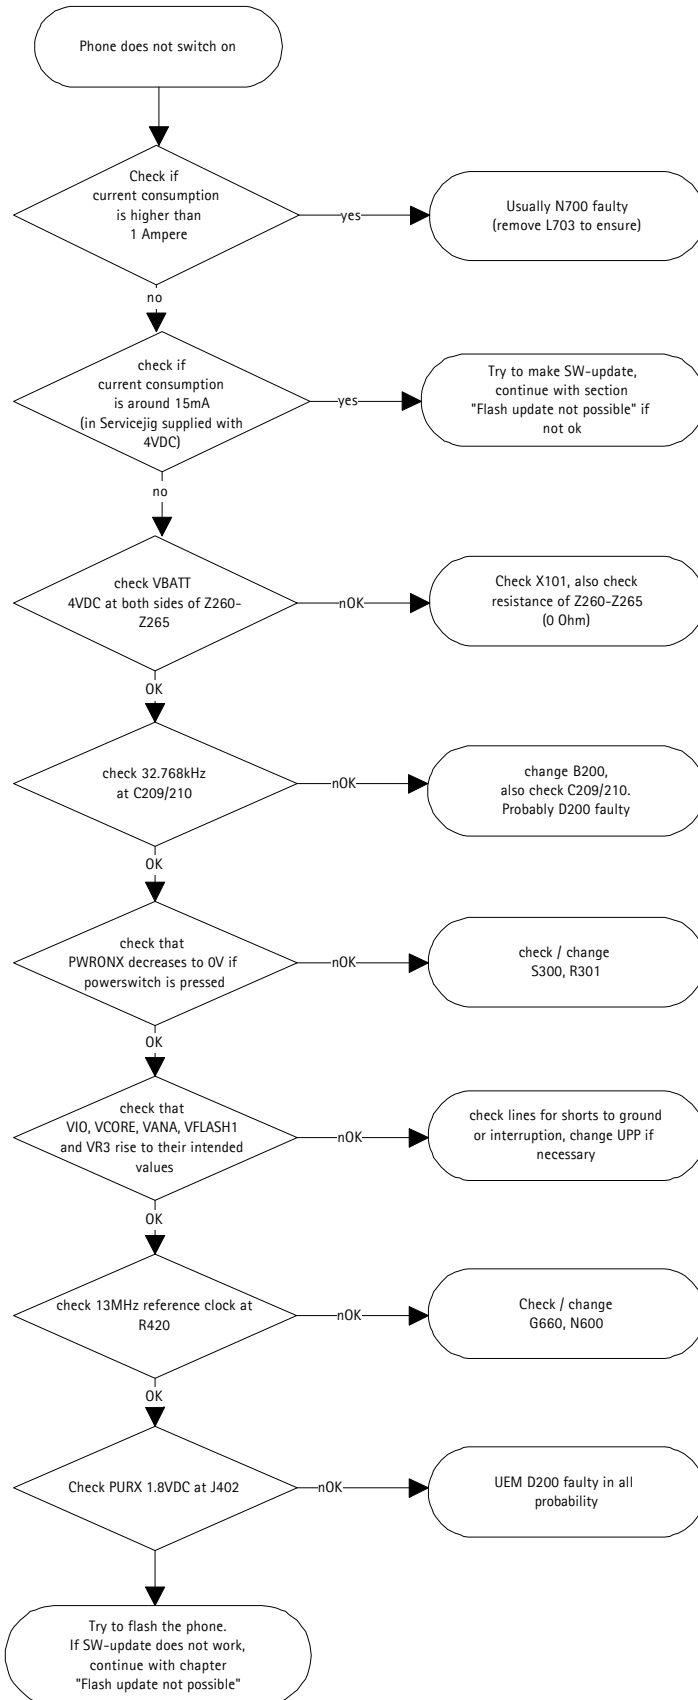
PHONE DOES NOT SWITCH ON**X101**

- check DC-voltages at C209 and C210, normally 0.5VDC. If voltages are not ok check C209/210 for shorts to ground. It also is possible that UEM D200 is defect.
- if DC-voltages are ok but no 32.768kHz signal is measurable at C209/210 change the crystal B200.
Note that this signal must be always measurable if battery voltage is higher than 3.1VDC, even if phone is switched off! In this case amplitude of 32.768kHz is a bit lower (700mVpp at C209, 550mVpp at C210).

- in case that phone does not switch on while current consumption stays on 15mA (in Service jig supplied with 4VDC) this indicates that Flash D450 probably is empty. Try to make SW-update. If any failuremessage appears during flashing, try SW-update a second time. It also can be necessary to change D450. Note that in this case you have to rewrite IMEI, Simlock data and Product code, furthermore you have to run all RX/TX-tunings and energy management calibration!

- check mechanical appearance of battery connector. Change part if it is bent, soiled or corroded.

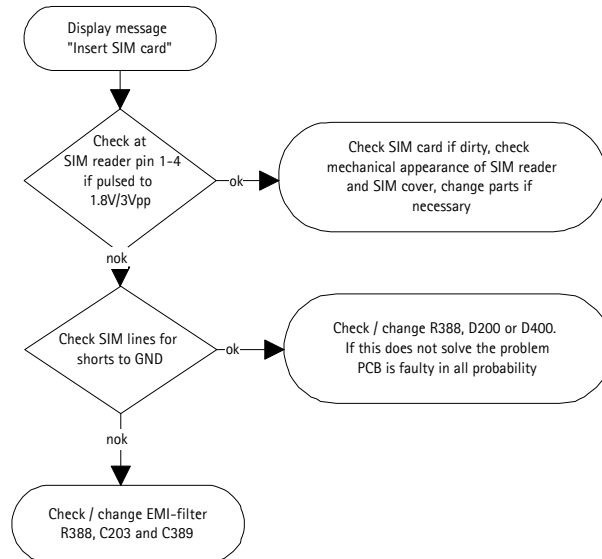
**X386**

In case that resistance of all lines is ok but fault persists, EMI-filter R388 may have internal interruption. Change part and retest the phone. It also is possible that UEM D200 or UPP D400 are responsible for this fault. Due to the missing possibility to rewrite phonedata after changing UEM D200 you should not change this part.

In case that phone messages "Insert SIM card" on LCD, first of all check mechanical appearance of SIM card reader X386. If contact springs are bent, soiled or corroded you have to change the sim reader.

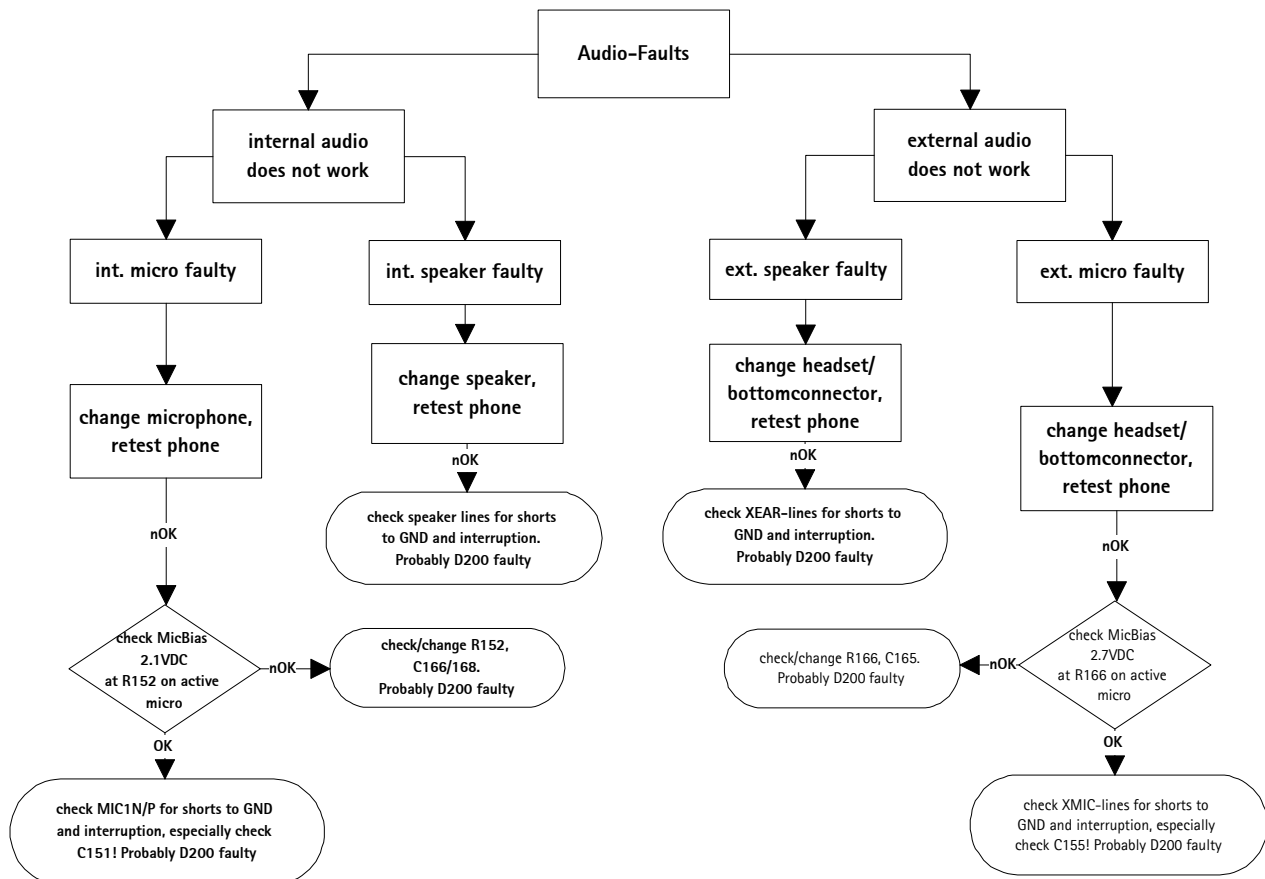
I009 bottomconnector

- check resistance of the double capacitors, which normally is > 20MΩ. Both parts have tendencies to leak and often are responsible for missing uplink audio (C151 in case of internal -, C155 in case of external audio faults).

- check mechanical appearance of bottomconnector I009 in case that internal microphone does not work, external audiopath seems to be interrupted or headset is not recognized. Retest phone with new connector in case of doubt. Also ensure that contact pads for connector on PCB are clean.

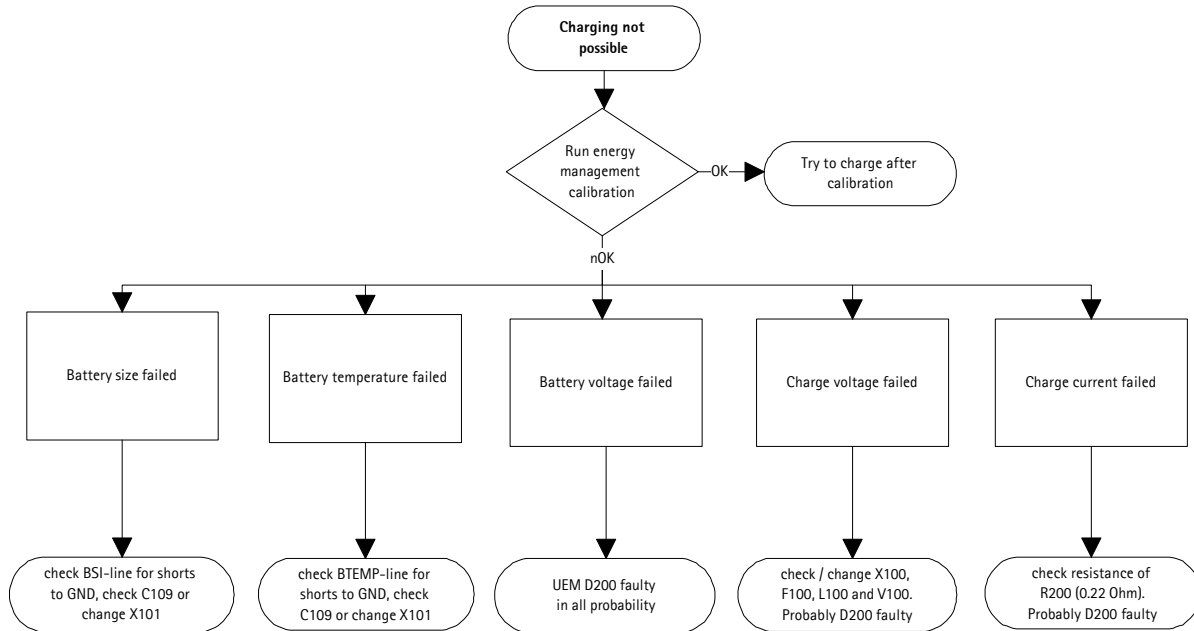
Also check whether charging is only from time to time not possible or if charging does not work permanently. In case that fault appears from time to time only, especially check spring contacts of bottom connector I009 and battery connector X101 if bent, soiled or corroded. Also make sure that contact pads for bottom connector on PCB are clean. If necessary clean PCB with an appropriate amount of alcohol. Do not use any scratching or rubbing tools!

- check that V100 does not cause a short circuit to ground. Resistance of VCHAR-line to ground normally is $\sim 2.8k\Omega$

First thing you should do in case that charging of battery is not possible is to run energy management calibration. Note that calibration only works with JBV-1. In Service jig it is not possible because of missing bottom connector I009.

- check mechanical appearance of battery connector and bottom connector, change parts if bent, soiled or corroded. also ensure that contact pads for bottom connector on PCB are clean.

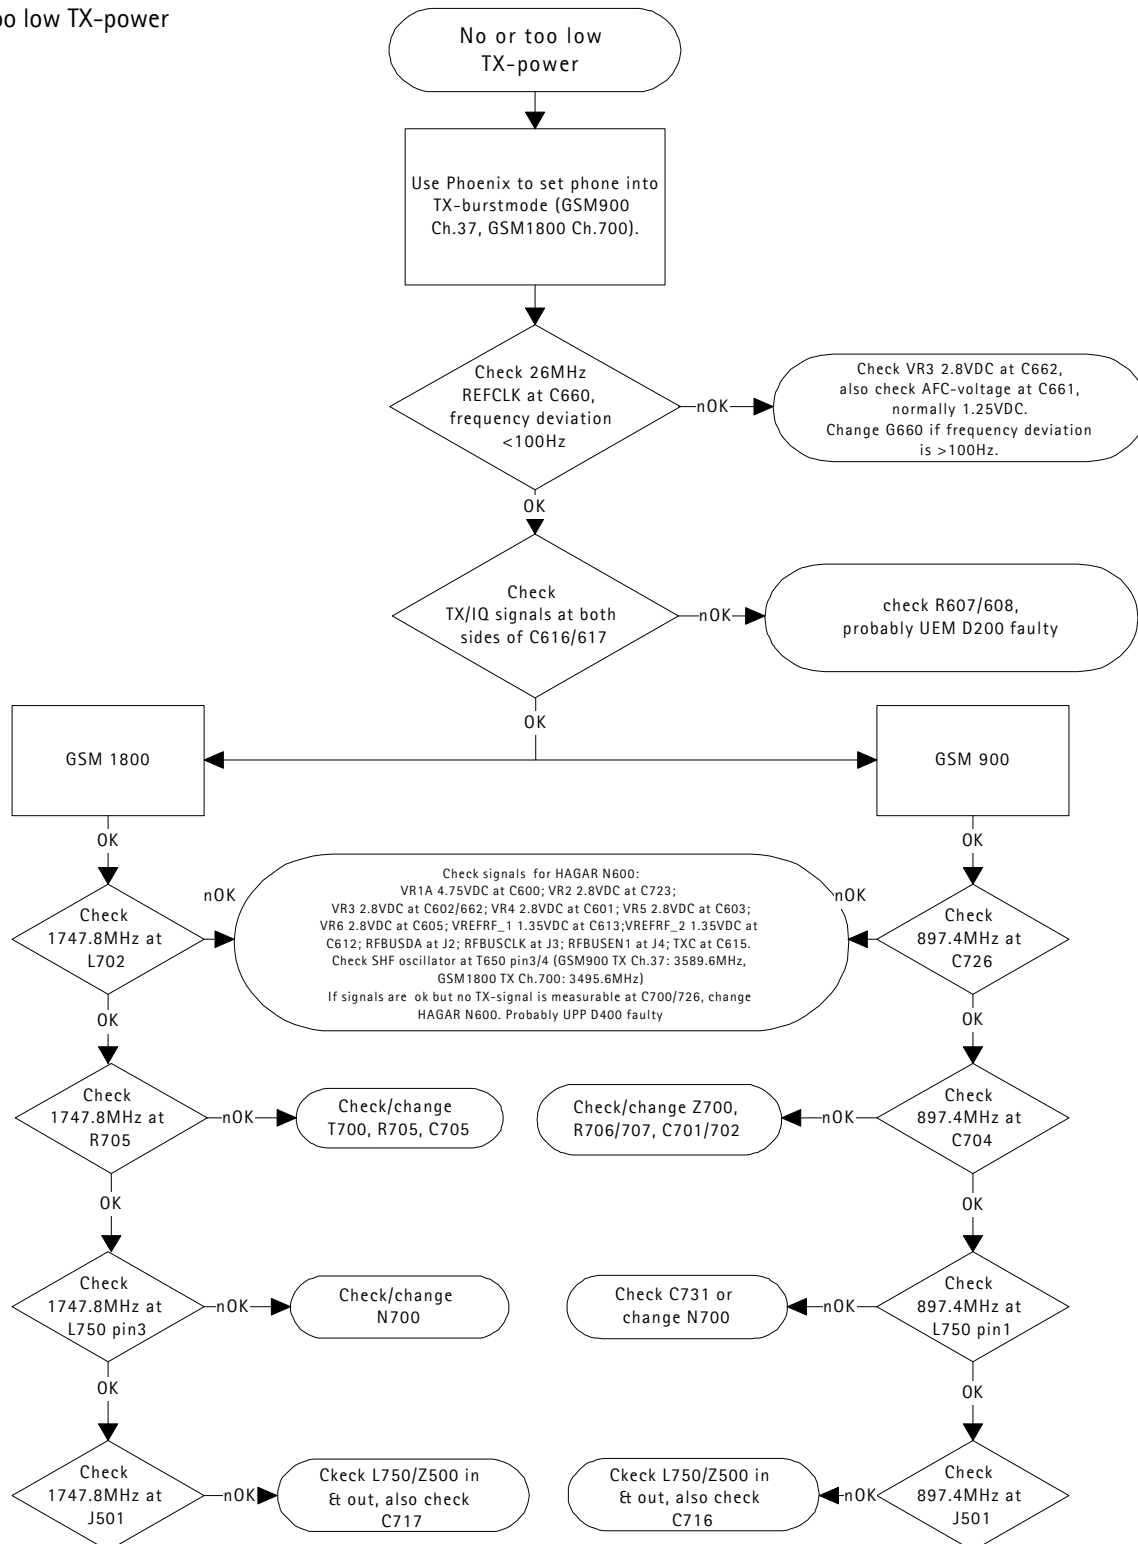
G660

If no signal is measurable at T650 check VR7 2.6VDC at C650. If OK, set span of your analyser to e.g. 250MHz to check if the oscillator works on any other frequency as on the supposed. If this is the case check control voltage at C652 which normally is 2.1VDC on channel 37. In case of noise on the control voltage especially check C653 (tendency to leak).
 If the oscillator does not work at all, change G650 and retest the phone.

If these signals are ok but no TX-signal is measurable at C726 (C700 in GSM1800), you have to change Hagar N600. Unfortunately TXP and Hagar reset, which also are necessary for a working Hagar are not checkable because of missing testpoints. Change UPP D400 in case of doubt and retest the phone.

- set phone with Phoenix on local mode
- check VR3 2.8VDC at C662. With only this voltage the oscillator must be able to work on a frequency of 26MHz, Otherwise you have to change G660. Check signal at C660:

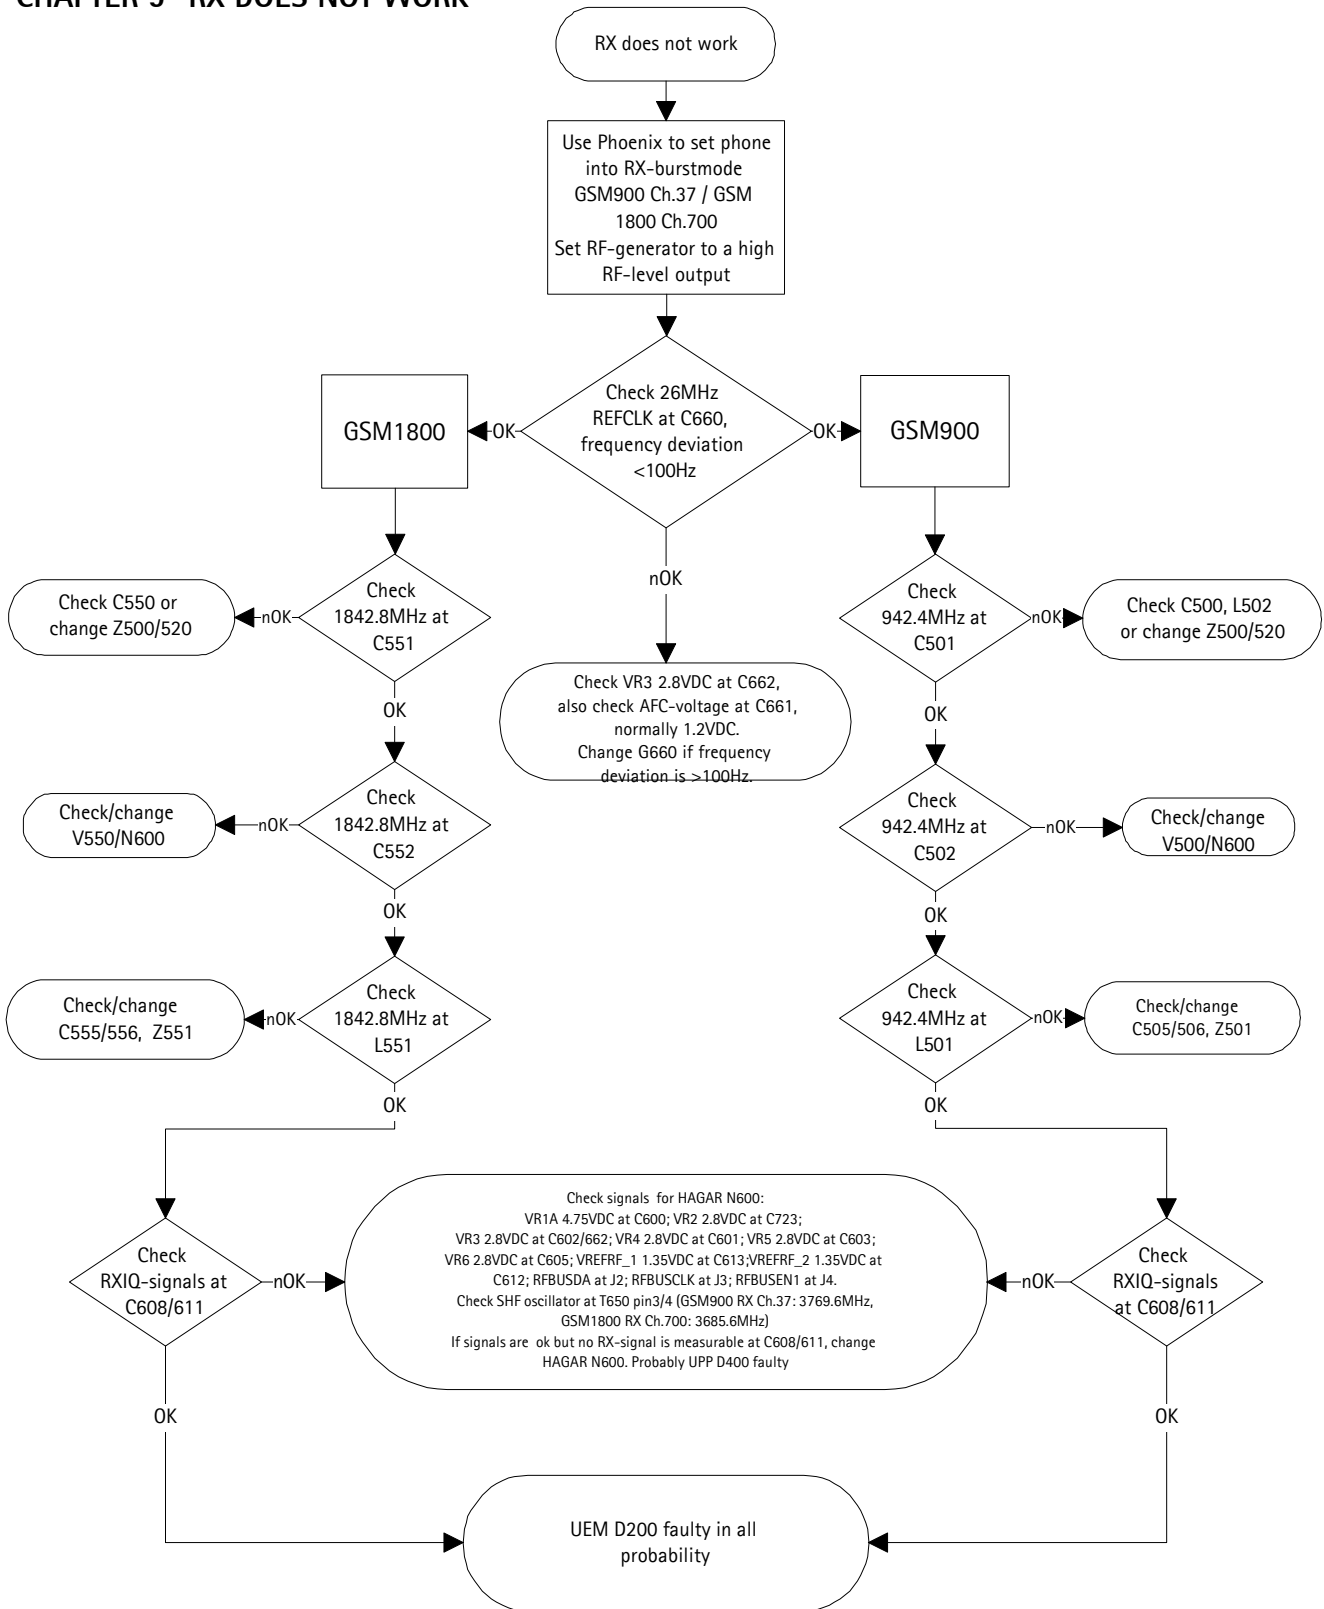
If no signal is measurable at T650 check VR7 2.6VDC at C650. If OK, set span of your analyser to e.g. 250MHz to check if the oscillator works on any other frequency as on the supposed. In case of that check control voltage at C652 which normally is 3VDC on channel 37. Especially check C653 (tendency to leak) in case of noise on the control voltage. In case that the oscillator does not work at all, change G650 and retest the phone.

- first thing to do as in case of TX-faults is to set phone with Phoenix to local mode, activate RX-burstmode Ch.37
- check VR3 2.8VDC at C662. With only this voltage the oscillator must be able to work on a frequency of 26MHz. Otherwise you have to change G660. Signal of G660 at C660 is shown on page 14. AFC-voltage at C661 normally is 1.25VDC, but may vary between 0.05VDC and 2.5VDC. If frequency deviation of G660 is >100Hz it is necessary to change the oscillator!
