Model: Model-J CF		Date: 4-Mar-02	No.: RG570001
Subject: Language Software History		Prepared by: H. Someya	
From: Technical Services Dept., GTS Division			
Classification:	<input type="checkbox"/> Troubleshooting	<input type="checkbox"/> Part information	<input type="checkbox"/> Action required
	<input type="checkbox"/> Mechanical	<input type="checkbox"/> Electrical	<input type="checkbox"/> Service manual revision
	<input type="checkbox"/> Paper path	<input type="checkbox"/> Transmit/receive	<input type="checkbox"/> Retrofit information
	<input checked="" type="checkbox"/> Other ()

Model: Model-J CF		Date: 15-Mar-02	No.: RG570002
Subject: Remarks at firmware update		Prepared by: T. Itoh	
From: Technical Services Dept., GTS Division			
Classification:	<input type="checkbox"/> Troubleshooting	<input type="checkbox"/> Part information	<input checked="" type="checkbox"/> Action required
	<input type="checkbox"/> Mechanical	<input type="checkbox"/> Electrical	<input type="checkbox"/> Service manual revision
	<input type="checkbox"/> Paper path	<input type="checkbox"/> Transmit/receive	<input type="checkbox"/> Retrofit information
	<input type="checkbox"/> Other ()

Model: Model-J CF		D

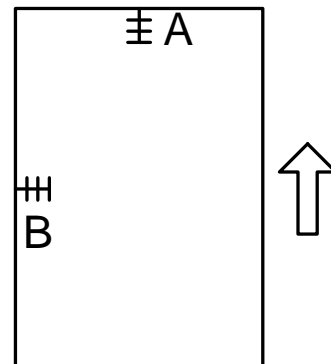
G570R908.WMF

A: Leading Edge Registration
B: Side-to-side Registration

1. Place the test chart on the exposure glass and make a copy from one of the feed stations.
2. Check the leading edge and side-to-side registration, and adjust them with the following SP modes if necessary.
Standard: $0 \pm 2\text{mm}$.

SP mode
Sub-scan	SP4-010
Main-scan	SP4-011

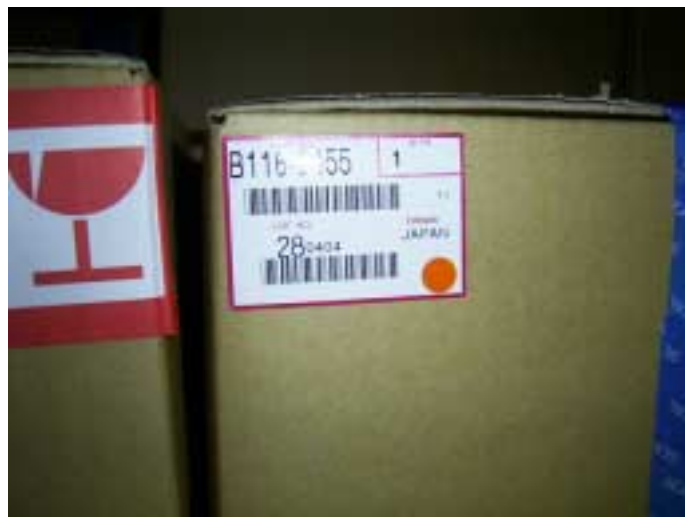
Step 7 on pg. 4 below, i.e. checking to make sure SP4-205 is at 70, is necessary due to a RAM data error with the retrofit lens block assemblies (#B1169455) discovered at the manufacturer's side. Specifically, one of the several special tools used by the manufacturer was defective, causing a limited amount of assembly RAMs to contain a value of 8 instead of the normal 70. Therefore, please ensure that this value is at 70 in Step 7 below, as dirty background in ADS mode may occur if this value is 8.

Please note that all boxes bearing the seal shown below contain lens block assemblies with the correct data (70).

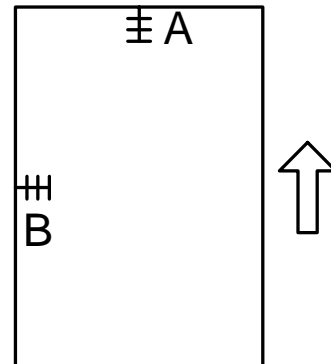
G570R908.WMF

A: Leading Edge Registration
B: Side-to-side Registration

1. Place the test chart on the exposure glass and make a copy from one of the feed stations.
2. Check the leading edge and side-to-side registration, and adjust them with the following SP modes if necessary.
Standard: $0 \pm 2\text{mm}$.

SP mode
Sub-scan	SP4-010
Main-scan	SP4-011
