SUBJECT: F400/F410 Dual Job Feeder separation belts
(manual correction)

FROM: Copier Technical Support Group

MODEL: F400/F410

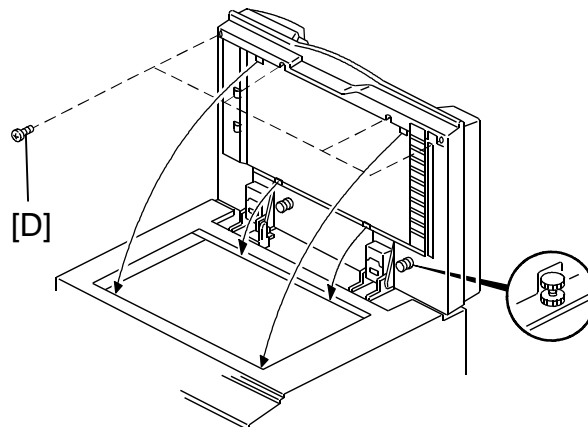
Page 27 of DJF 3rd line of upper NOTE and Illustration

- Incorrect
..... loosen four truss head screws [D], and tighten.

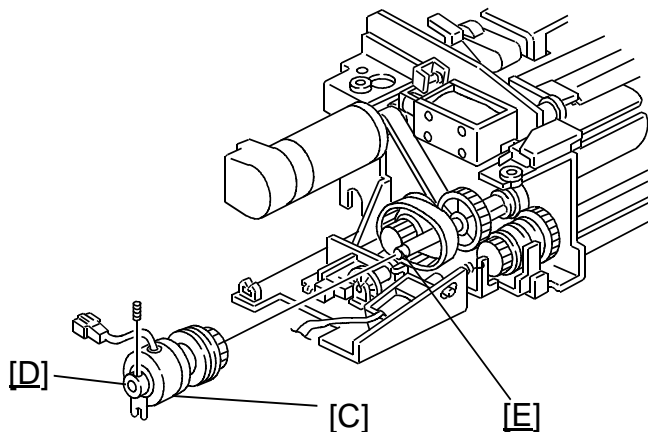
Page 43 of DJF Illustration

- Incorrect

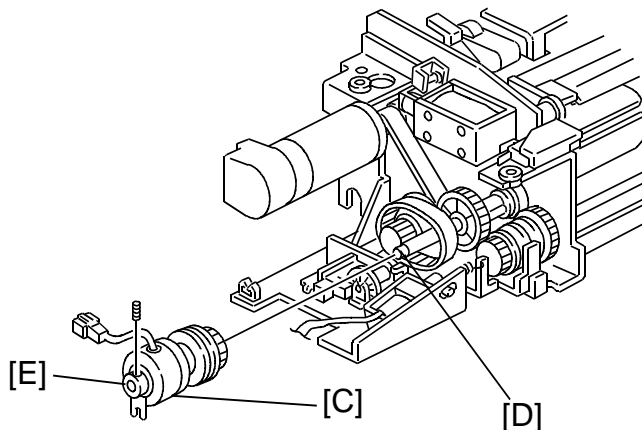
- Correct
