Model: Martini-C1	Date: 13-Sep-02	No.: RB064002
-------------------	-----------------	---------------

Subject: Jogger Fence Adjustment		Prepared by: Y.Urushihara	
From: 1st Tech. Support Sec. Service Support Dept.			
Classification:	<input type="checkbox"/> Troubleshooting	<input type="checkbox"/> Part information	<input type="checkbox"/> Action required
	<input type="checkbox"/> Mechanical	<input type="checkbox"/> Electrical	<input checked="" type="checkbox"/> Service manual revision
	<input type="checkbox"/> Paper path	<input type="checkbox"/> Transmit/receive	<input type="checkbox"/> Retrofit information
	<input type="checkbox"/> Other ()

Model: Martini-C1		Date: 4-Oct-02	No.: RB064005
Subject: Finisher screw detaches from slide rail bracket		Prepared by: K. Miura	
From: Technical Services sec. Service Planning Dept.			
Classification:	<input checked="" type="checkbox"/> Troubleshooting	<input type="checkbox"/> Part information	<input type="checkbox"/> Action required
	<input type="checkbox"/> Mechanical	<input type="checkbox"/> Electrical	<input type="checkbox"/> Service manual revision
	<input type="checkbox"/> Paper path	<input type="checkbox"/> Transmit/receive	<input type

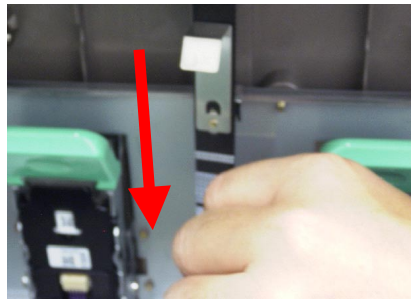
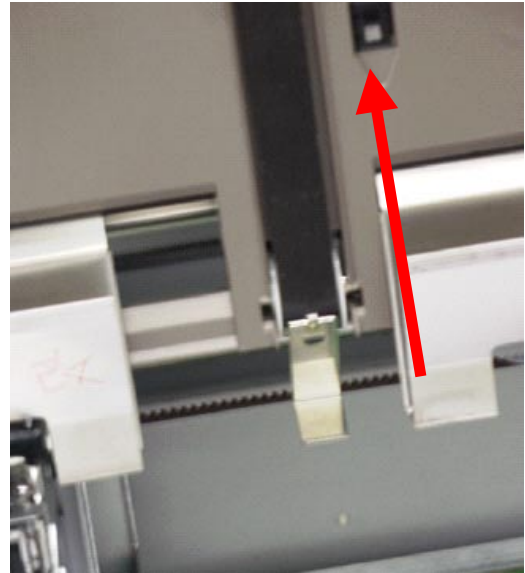
1. Move the belt hook down to the position shown in the photograph to the right by moving the stack feed out belt on the rear side of the unit by hand.

Important: Do not move the belt by the hook itself. Also, be sure to move the belt in the correct direction, shown by the arrow in the photograph below.

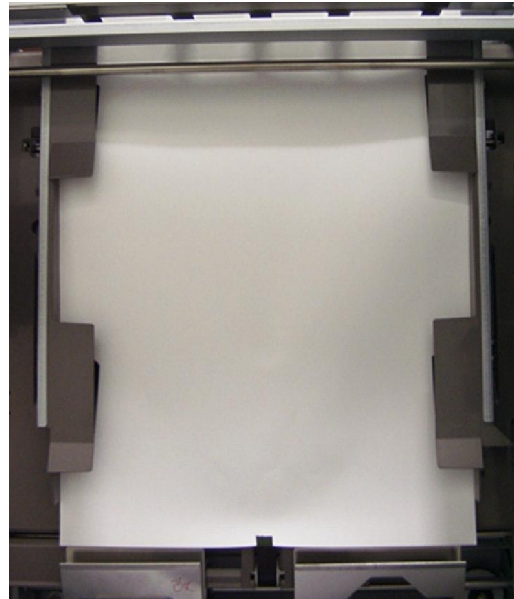
2. Insert the adjustment board (B4689003) between the jogger fences.

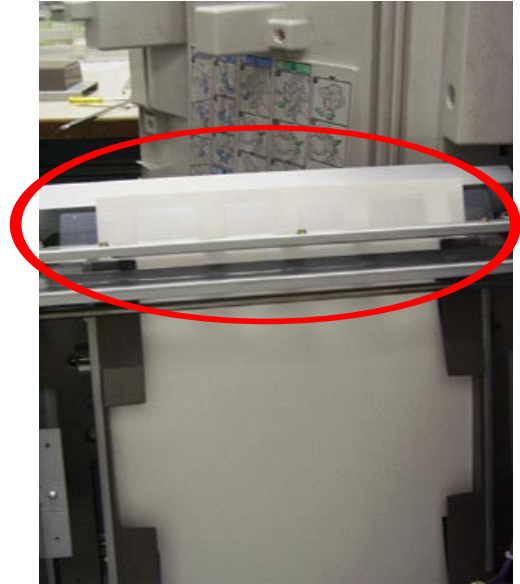
3. By manually moving the stack-feed out belt on the rear side of the unit, bring the adjustment board up until its edge is about at the top edge of the upper stay.

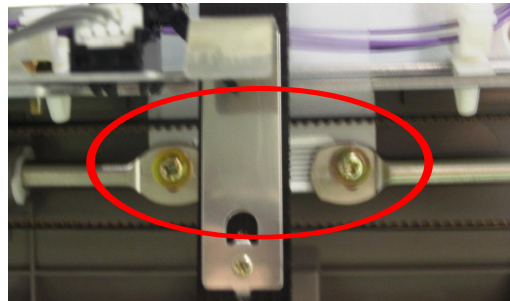
4. Loosen the 2 screws for the lower jogger shafts.

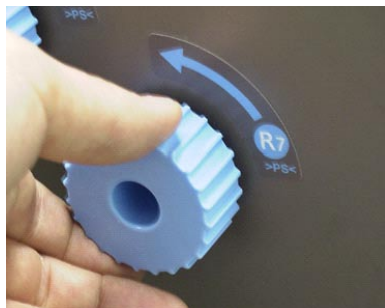
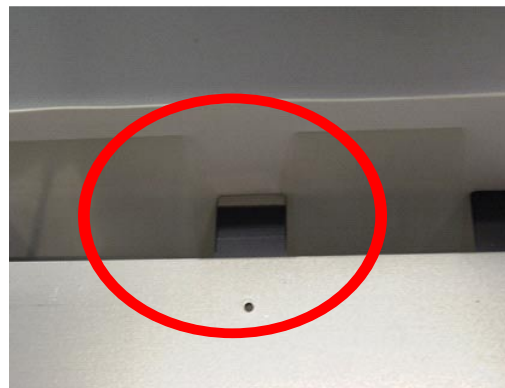
5. Rotate the R7 knob until the upper stay lightly contacts the adjustment board.

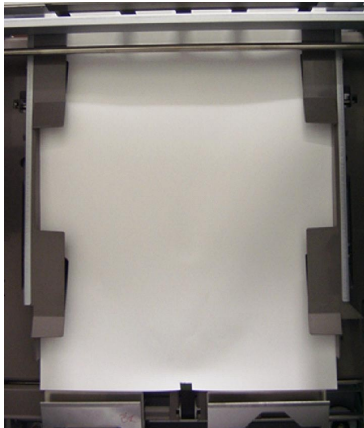
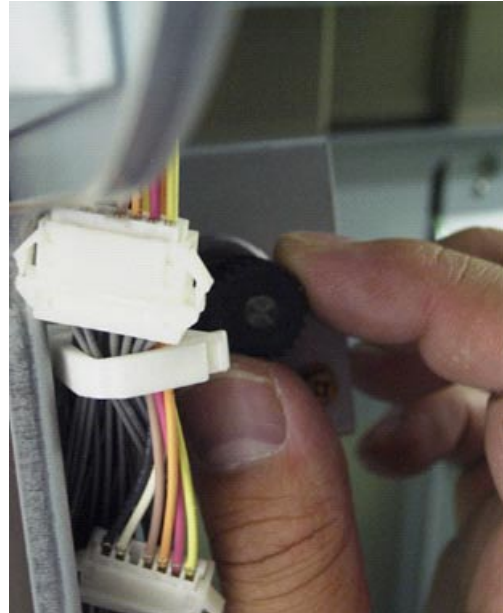
6. By turning the motor pulley (black knob), bring the fences together until they are roughly parallel to one another.

Note: At this point, the fences should not be tight against the board's edges.

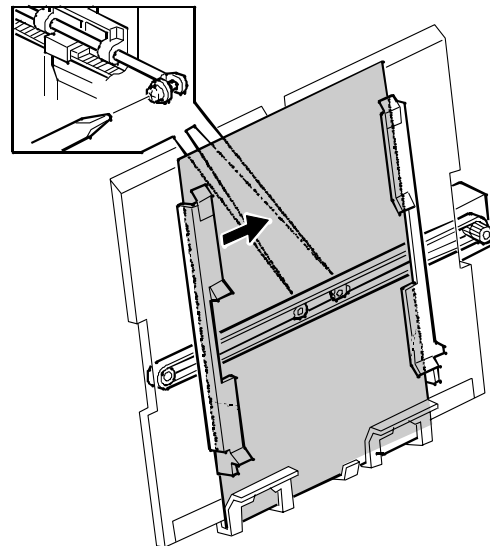
7. Bring the board flush against the rear jogger fence.

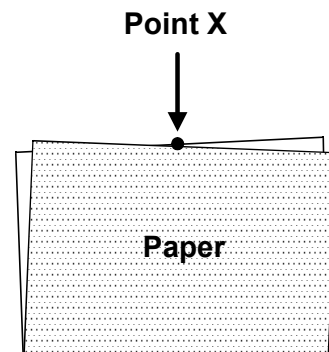
ADD2.WMF

15. Adjust the folding position using **SP6902** until the two edges intersect in the middle (point X). This will minimize vertical folding skew, i.e. bring the leading/trailing edges of the sheets closer together.

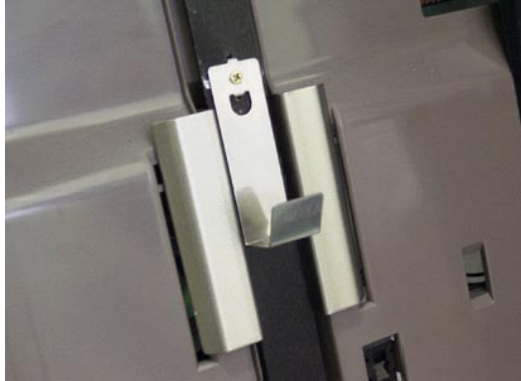
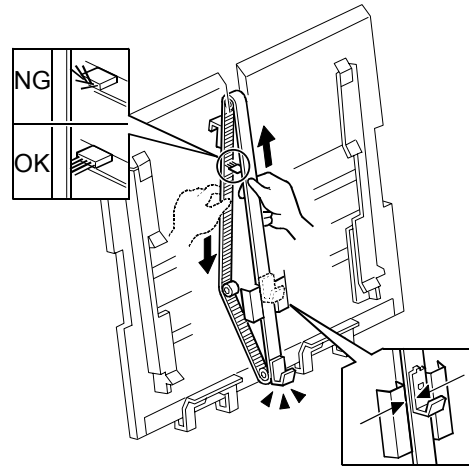
19. Bring the belt hook to the position shown in the photograph below then adjust the hook until it is parallel to the belt itself.

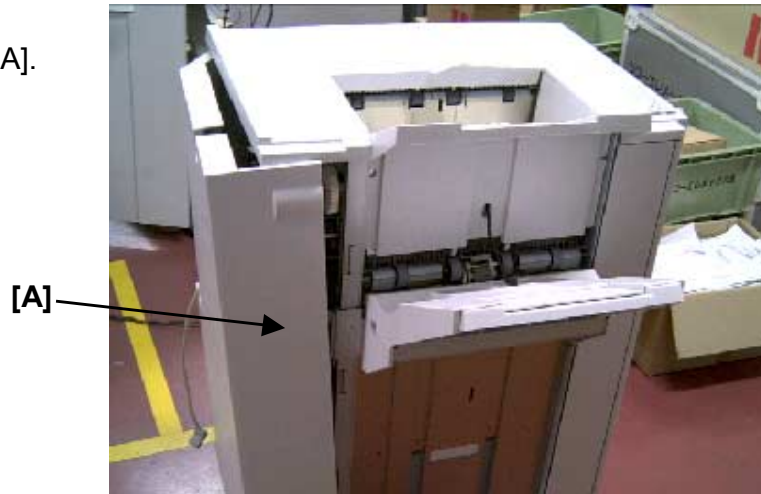
1. Remove the rear cover [A].

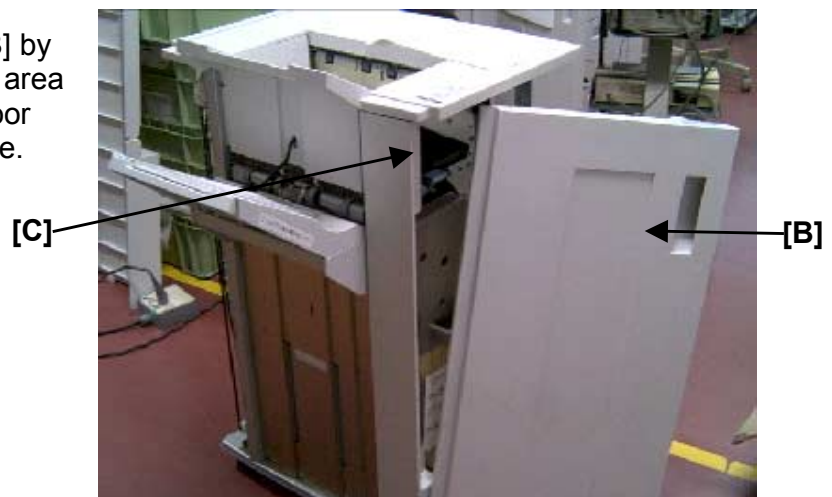
2. Remove the front door [B] by lifting up the upper hinge area [C], then removing the door shaft from its pivoting hole.

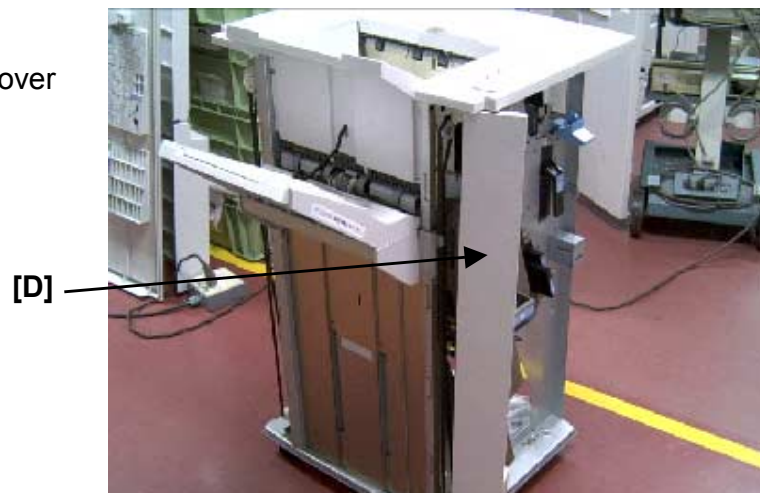
3. Remove the front right cover [D].

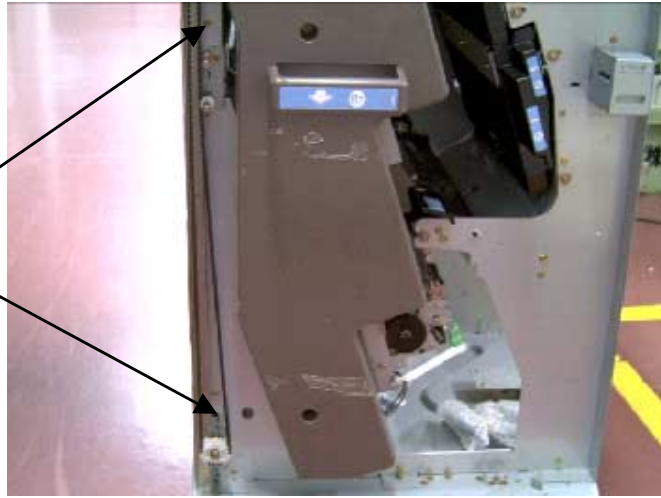
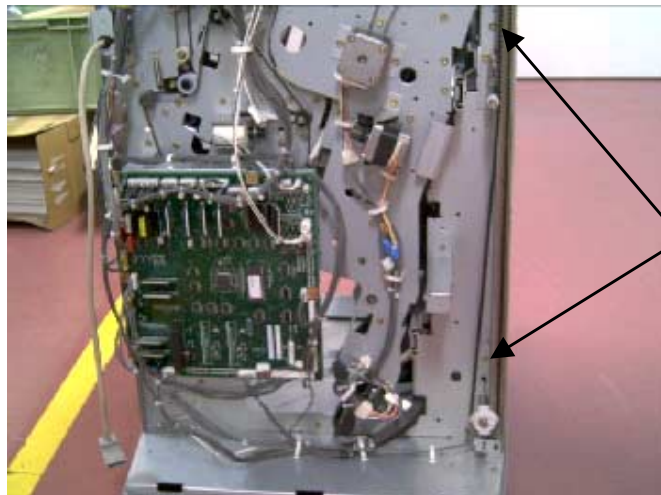
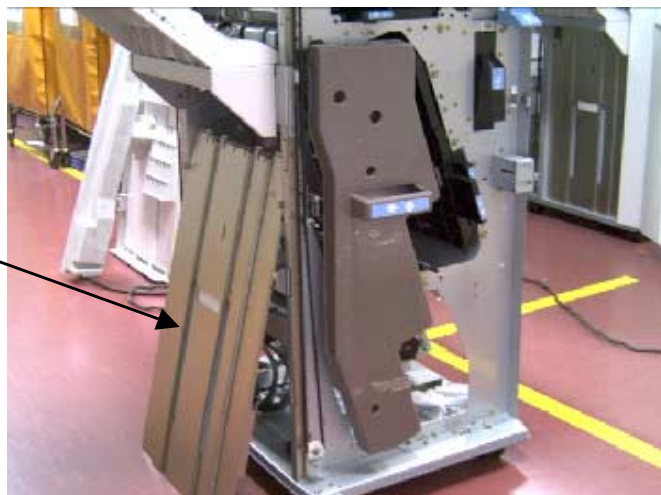
4. Remove the end fence [E] by first removing the 2 screws [F] on the front and rear plates (2 screws [G]), then pulling the lower portion of the fence outward to disconnect it from the machine.

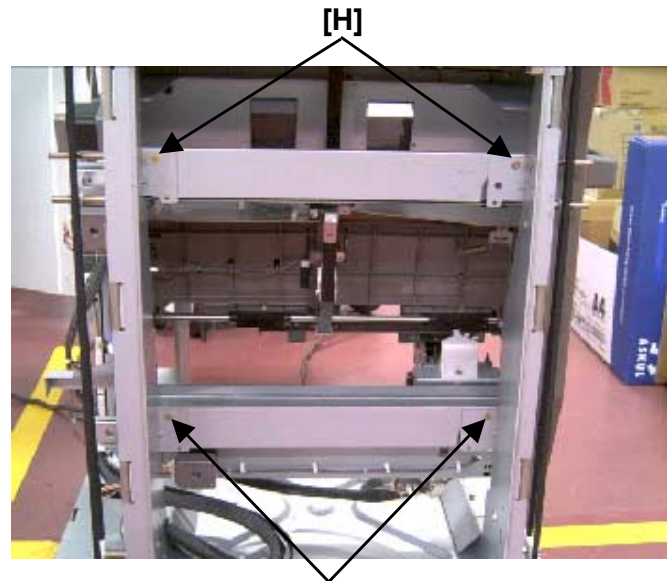
[I]: Do not remove

5. Remove the fixing screws [H] for the upper slide rail unit only.

NOTE: If the lower slide rail screws [I] are also removed here, the Stapler Unit will fall out.

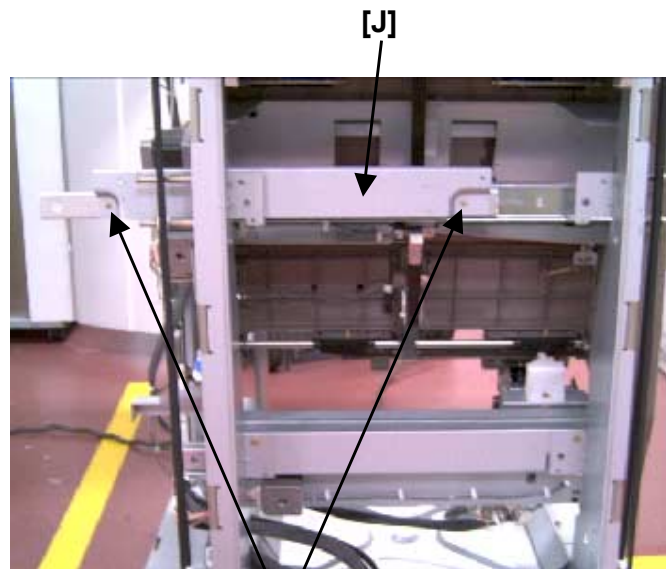
[K]

6. Slide the slide rail unit [J] toward the rear, then re-attach the fixing screws [K].

NOTE: Secure the screws slightly tighter than usual.

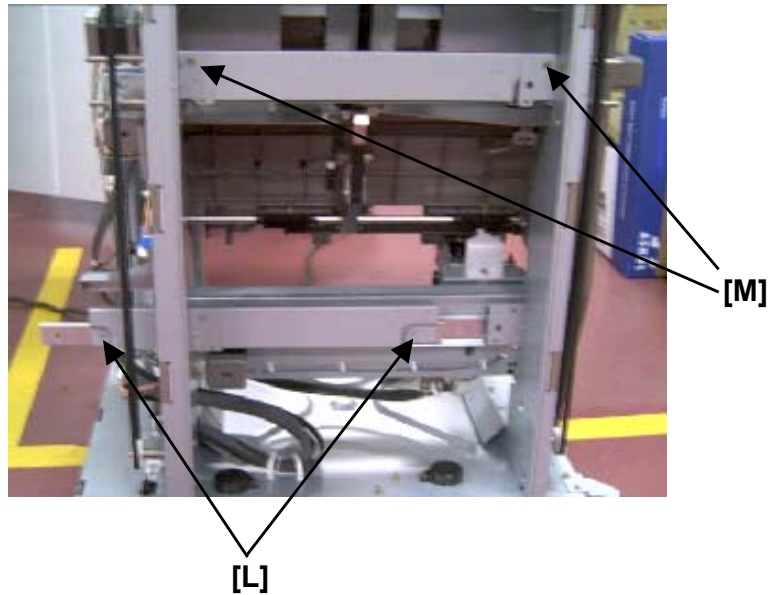
7. After making sure that the upper unit screws are tightened, remove the fixing screws [L] for the lower slide rail unit, slide the unit toward the rear, then reattach the screws [M].
NOTE: Secure the screws slightly tighter than usual.
