SUBJECT: MATT20 (A374) TROUBLESHOOTING GUIDE

FROM: Copier Technical Support Section

To aid the technician in troubleshooting matt20 misfeeds we are issuing this troubleshooting guide. If the guide is used properly it will resolve the majority of misfeeding problems the field is experiencing.

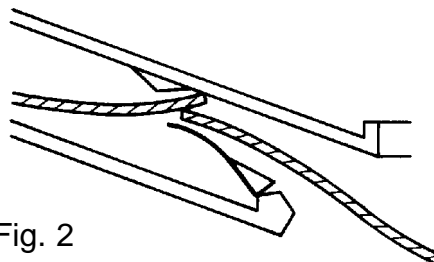
Fig. 2

When the paper slides back against the end fence, the trailing edge of the paper enters the gap between the guide mylar and the upper bin. Thus, the paper is stacked incorrectly in the bin, or in the worst case, the next sheet of paper jams or goes underneath the preceding paper (copies out of order) (see Fig. 2).

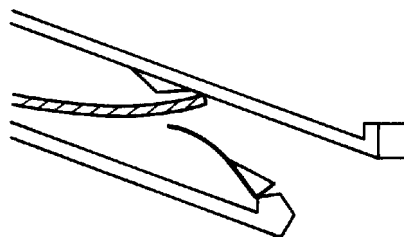
Fig. 5

However, if there is a gap which is big enough to allow the curled edge of paper to enter between the guide mylar and the upper bin (see Fig. 5) the above symptom may occur.

If the above symptom is observed in the field with the customer application, check which bin(s) have gap(s) which creates the problem. Follow the checking procedure described below to determine which bins should be replaced.

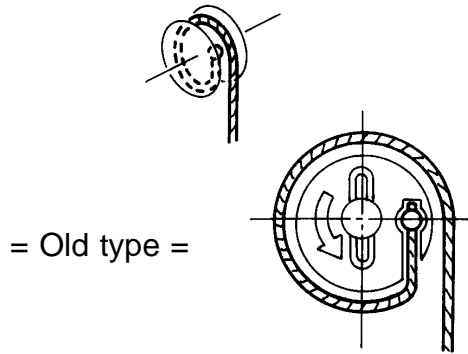
[Figure 3]

The bin lift wire may loosen on the wire pulley during transportation. When the wire pulley is driven from the home position under this condition, the wire may be wound up wrongly as shown in the figure 1. This will change the bin stop positions, resulting in paper jams.

For the old type:
Wind the wire once as shown and ----
Refer to the figures 3 and 5 in the next page.

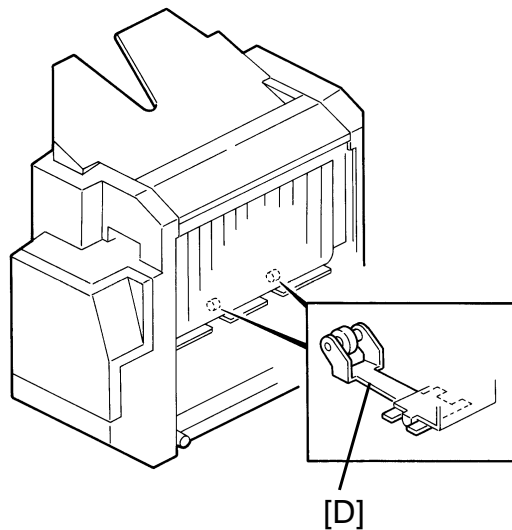
The technician bent the lower bin exit roller holder (spring plate) (P/N : A3742163) [D], trying to correct the normal paper skew when the paper exits into the bins. This reduces the paper transport ability causing bin jams.

Straighten the lower bin exit roller holders so they are flat and ensure that the paper comes out of the sorter with the correct angle.

NOTE: Once the holders are bent, it may be difficult to completely straighten the holders. In such a case, replace the entire lower bin exit rollers.

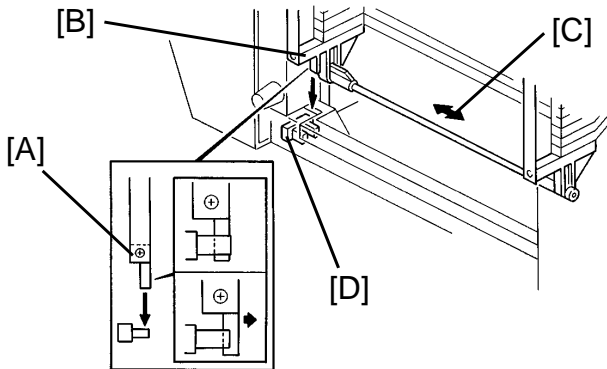
Due to gap between the projection [A] of the bin support block [B] and the side frame, the block can move in the arrow [C] direction. If the block moves away from the bin home position sensor [D] when the sensor should be actuated, the bin will not stop at the correct home position. In this case a paper jam occurs at the bin entrance.

From the march '93 production, the width of the interrupter [E] for the bin home position sensor has been increased from 4.5mm to 5.5mm to ensure sensor actuation.
