Model: Fresa		Date: 31-May-99	No.: RG024001
Subject: Service Manual		Prepared by: H. Someya	
From: Technical Service Dept., GTS Division			
Classification:	<input type="checkbox"/> Troubleshooting	<input type="checkbox"/> Part information	<input type="checkbox"/> Action required
	<input type="checkbox"/> Mechanical	<input type="checkbox"/> Electrical	<input type="checkbox"/> Service manual revision
	<input type="checkbox"/> Paper path	<input type="checkbox"/> Transmit/receive	<input type="checkbox"/> Retrofit information
	<input checked="" type="checkbox"/> Other ()

Although the Fresa engine service manual is based on the Fresa Win model, it may also be used for reference regarding the PS model as well. This is due to the fact that nearly all parts for the engine are identical, with a few exceptions such as the operation panel, some exterior parts and some decals.

Model: Fresa		Date: 31-Aug-99	No.: RG024003
Subject: Gradation Image Printing with PCL Printer		Prepared by: Y. Tamaoka	
From: Technical Service Dept., GTS Division			
Classification:	<input checked="" type="checkbox"/> Troubleshooting	<input type="checkbox"/> Part information	<input type="checkbox"/> Action required
	<

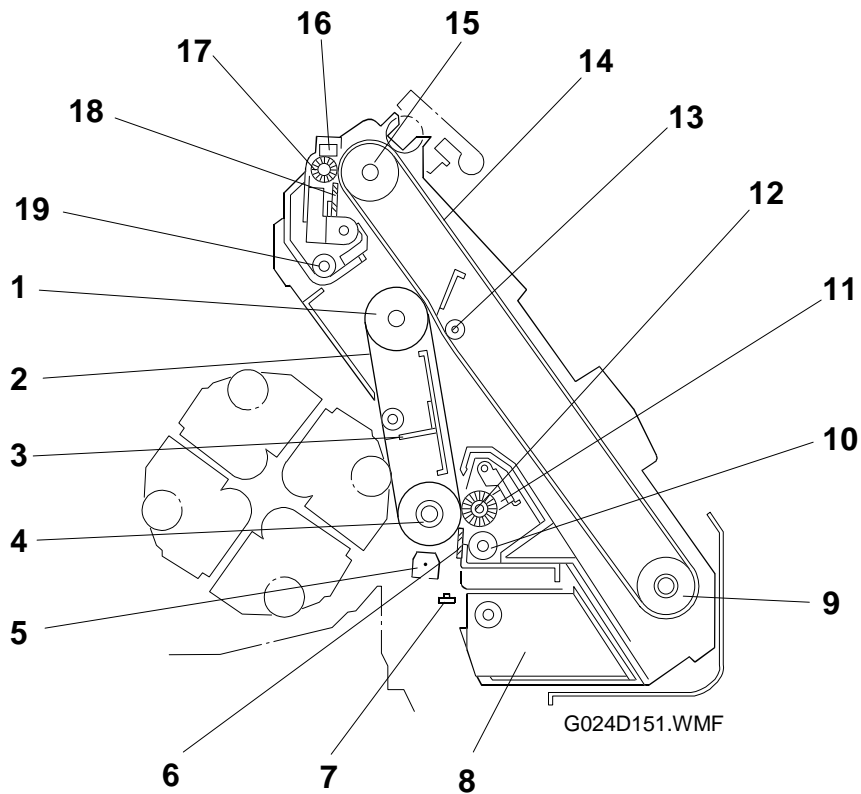
Page 2-6 PCU Overview

The callouts in the illustration below must be corrected.

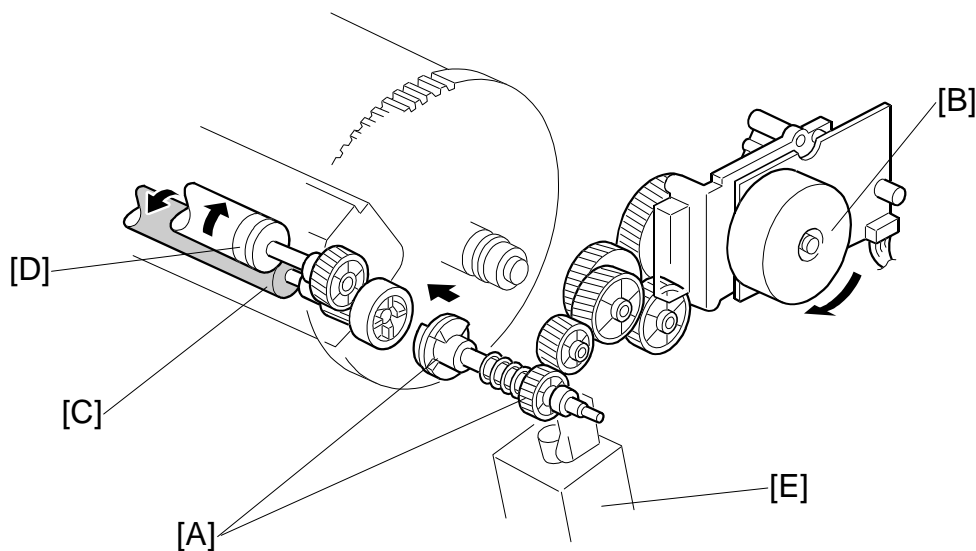
Page 2-32 Development Unit Drive

The callout [A] should be added to the gear.

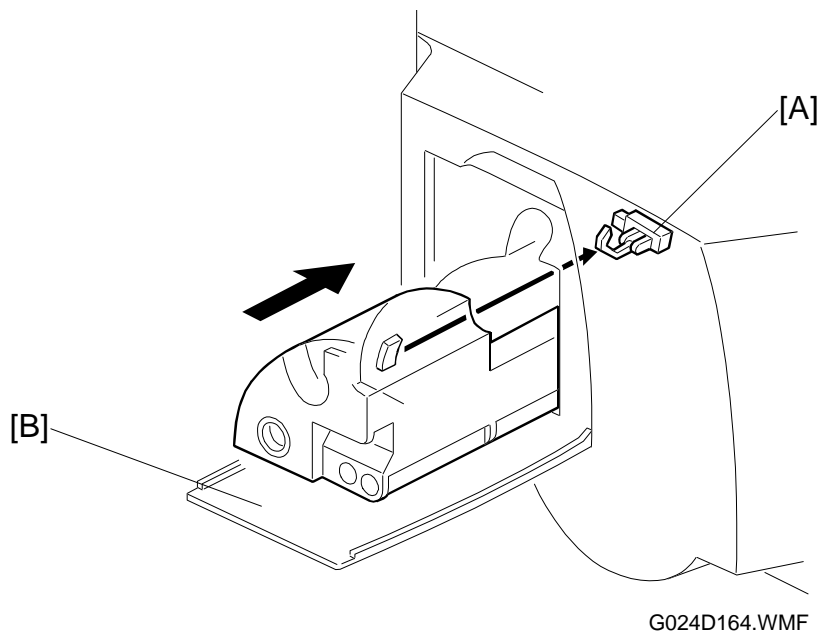
Page 2-36 DTM (Development Toner Magazine) Detection

Incorrect

Installing a toner bottle and closing the front cover [B] automatically initiates the recovery procedure, clearing the error.

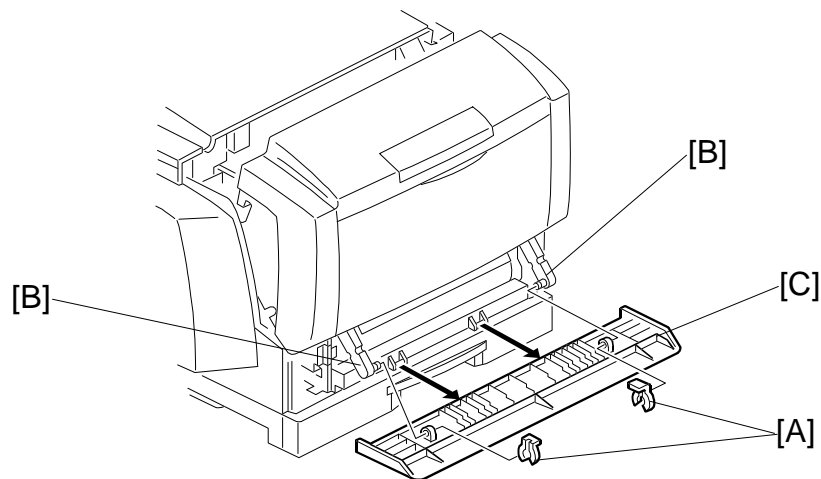
Page 6-3 Bottom Front Cover

A supplementary explanation should be added to the procedure below.

1. Open the front cover half way, and remove the two snap rings [A].
2. Carefully slide the hinge levers [B] out from the bottom front cover [C]. The levers are spring loaded.
3. Remove the bottom front cover.

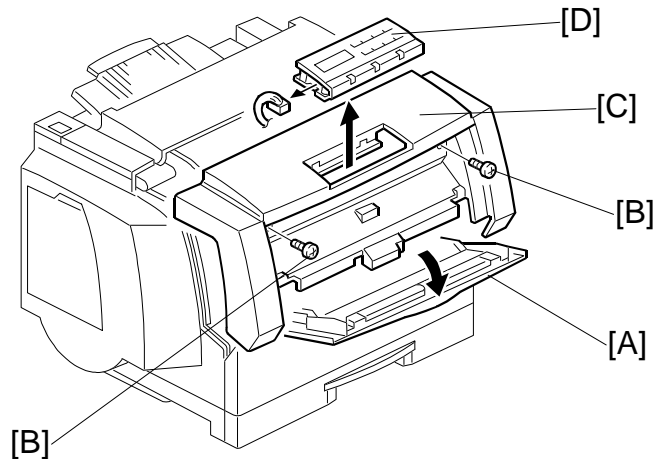
Page 6-3 Front Cover and Operation Panel

A supplementary explanation should be added to the procedure below.

1. Open the by-pass tray [A].
2. Remove the two screws [B] and carefully lift the front cover [C] from the printer.
3. Remove the operation panel [D] from the front cover (two hooks). Be sure to unplug the connector from the operation panel.

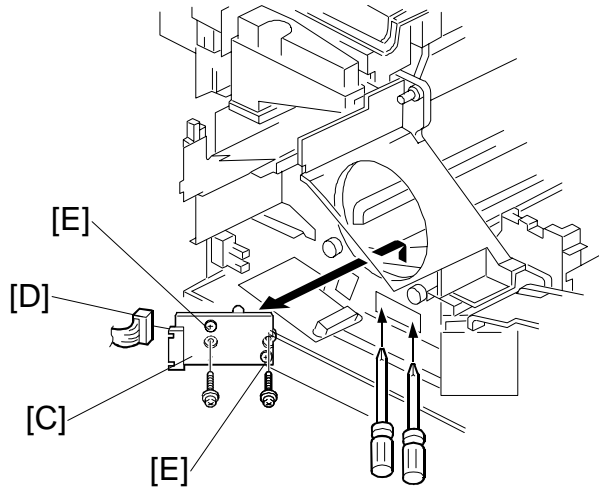
Page 6-18 LD Unit

The callouts of the illustration below must be corrected.

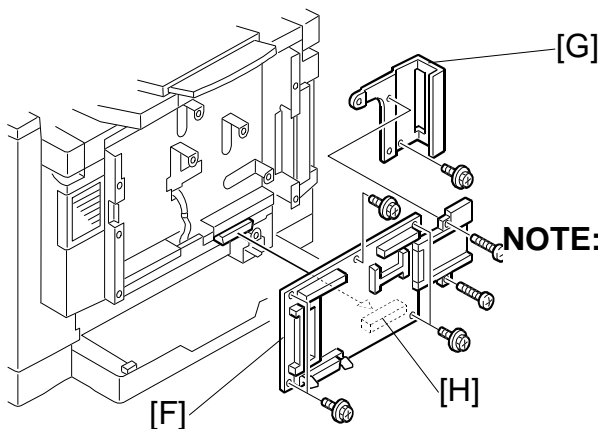
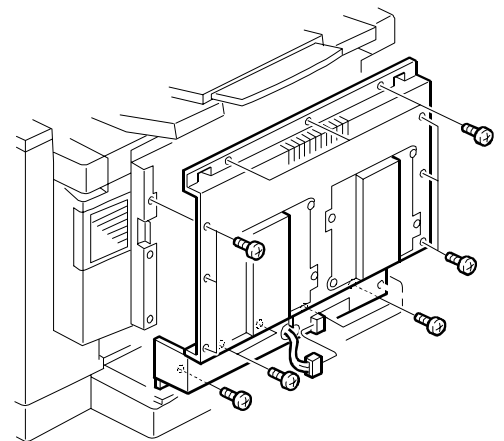
Page 6-35 Controller Board, Temperature/Humidity Sensor

The explanation in step 2 of the procedure and callout [H] should be corrected.

4. Remove the controller cover [E] (16 screws, including 2 screws around the parallel port).
5. Remove the controller board [F] with the bracket [G] attached to it (6 screws, 1 connector [H]).
6. Remove the bracket [G] and 2 screws from the controller board.

NOTE: To replace the controller boards, remove the NVRAM chip (IC23) on the old board, install it on the new board and finally install the new board itself. The NVRAM chip stores user settings and service records. These settings will be lost if the NVRAM chip is not transferred to the new board.

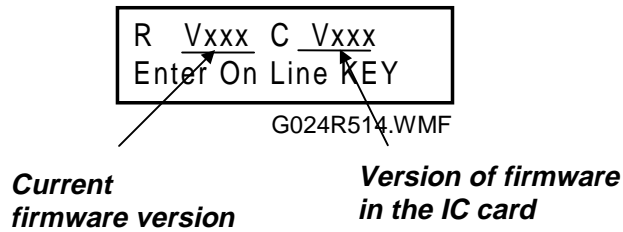
The explanation of the versions displayed during engine firmware updating (section 6.5.5) is switched around.

The version at the left side shows the current version and the other is the one in the IC card.
