Model: K-P1, A-C2, J-P1		Date: 03-Jul-01	No.: RB003008
Subject: Slow Printing from Macintosh		Prepared by: K. Misugi	
From: Technical Services Dept., GTS Division			
Classification:	<input checked="" type="checkbox"/> Troubleshooting	<input type="checkbox"/> Part information	<input type="checkbox"/> Action required
	<input type="checkbox"/> Mechanical	<input type="checkbox"/> Electrical	<input type="checkbox"/> Service manual revision
	<input type="checkbox"/> Paper path	<input type="checkbox"/> Transmit/receive	<input type="checkbox"/> Retrofit information
	<input type="checkbox"/> Other ()

Model: General (GW Models)		Date: 20-Dec-01	No.: RGene010
Subject: Series Print Mode		Prepared by: K. Misugi	
From: Technical Services Dept., GTS Division			
Classification:	<input checked="" type="checkbox"/> Troubleshooting	<input type="checkbox"/> Part information	<input type="checkbox"/> Action required
	<input type="checkbox"/> Mechanical	<input type="checkbox"/> Electrical	<input type="checkbox"/> Service manual revision
	<input type="checkbox"/> Paper path	<input type="checkbox"/> Transmit/receive	<input type="checkbox"/> Retrofit information
	<input type="checkbox"/> Other ()

Model: M

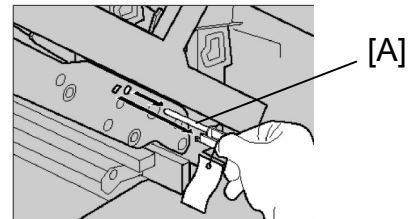
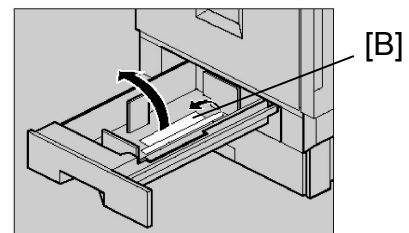
1. Remove the toner cartridges to prevent toner from flowing into the toner supply tube due to vibrations experienced during transport. This may cause the tube to be clogged with toner.
2. Put bubble wrap into the toner cartridge holder to shield the toner supply entrance. This prevents toner from flowing out to the toner cartridge holder.
3. Put the lock pin [A] (which comes with the machine) in the transfer belt unit.
4. Make sure there is no paper left in the paper trays and fix down the bottom plates with a sheet of paper and tape [B].
5. Empty out the waste toner bottle and attach securing tape to prevent the bottle from coming out.
6. Attach shipping tape to the covers and doors as shown, or shrink-wrap the machine tightly.

NOTE: 1. If pre-installing machines for some test prints at a service depot, please use a jig oil supply unit, and not the oil supply unit enclosed as an accessory.

This is because the toner supply system uses a touch-and-release mechanism, which can cause the unit to move freely up and down during transport if shipping the mainframe with the oil supply unit installed.

This in turn may damage the white holder on the fusing unit. However if simply moving the machine from floor to floor, the oil supply unit can be left installed.

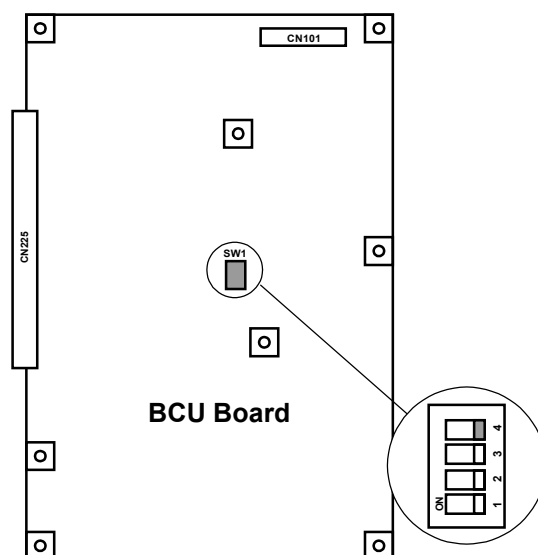
1. If the switch is mistakenly turned **OFF** in machines that have a clutch, a paper jam will occur near the fusing unit entrance. This occurs since the machine cannot drive the clutch.
2. Similarly, if the switch is mistakenly turned **ON** in machines that do not have the new clutch, fusing problems will occur. This will cause the machine to detect that a clutch has been installed. The machine will then release the "Clutch Off" signal to stop the drive to the fusing components, whenever they are not needed. Upon doing this, the PM counters for the fusing unit and oil supply unit will not count up, even though the parts are actually moving (as the clutch is not there to stop them). As a result, the message for the End of the PM period will come too late, overstressing these parts.

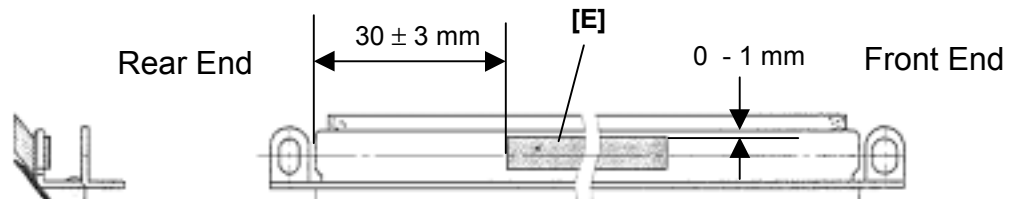
8. Clean the cushion attachment areas on the surfaces of the metal plates with alcohol.
9. Mark a line 30 ± 3mm from the rear edge of the brush.
10. Place the brush onto a few sheets of clean paper and attach the cushion [E] onto the metal plate of each brush, aligning the edge of the cushion with the edge of the brush.

NOTE: When attaching the cushions, be careful not to push down on the brush too strongly. This is because doing so can damage the Mylar and/or flatten out the brush fibers, which can prevent contact between the fibers and transfer belt and lead to vertical white lines.

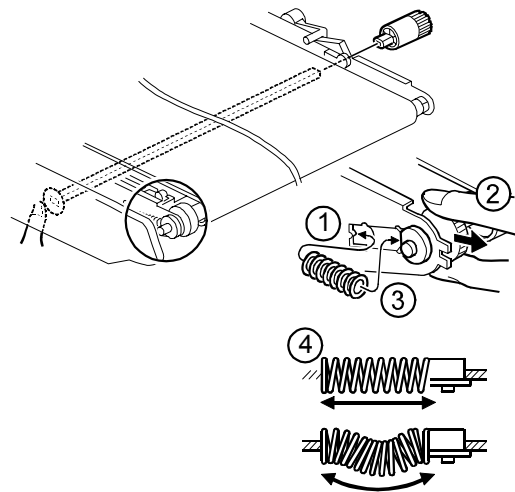
Tension springs:

1. Set the left end of the spring onto the projection.
2. Pull the transfer belt roller to the right.
3. Set the right end of the spring on the bushing.
4. Check that the spring is straight.

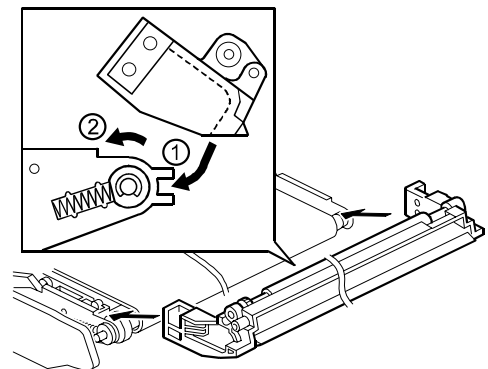
Transfer entrance guide:

1. Set the transfer entrance guide into position.
2. []
3. Screw the transfer entrance guide into the position.

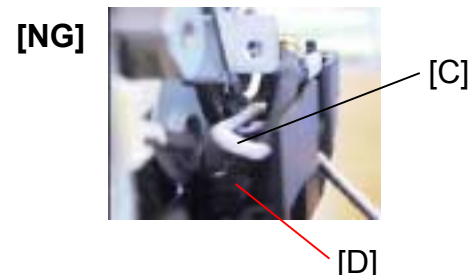
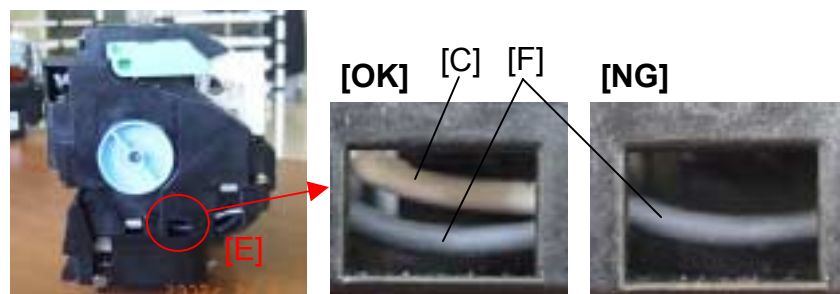
1. This positioning is essential. If the cable is above the projection, the C-ring of the heating roller may contact the cable and damage the protective sleeve. In the worst case, this could lead to an electrical short circuit.
2. If the white cable has been properly led, you will be able to see both it [C] and the gray cable [F] through the window [E] in the fusing unit cover.

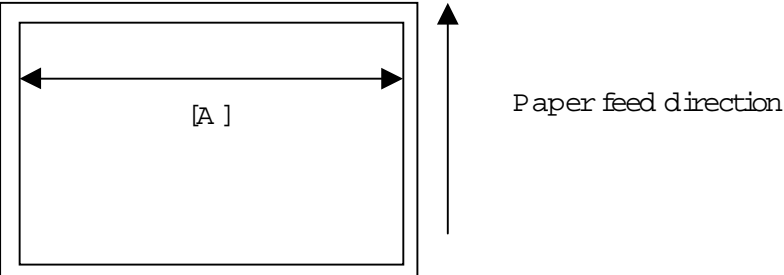
(2)	Measure distance [A] (along the main scan direction) and check to see if it is within the adjustment standard. - Main scan magnification adjustment standard [B]: Inch: 10.84" +/- 0.03" Metric: 293 mm +/- 0.9 mm <div style="text-align: center;">

</div> <ul style="list-style-type: none"> If [A] is not within adjustment standards: <ol style="list-style-type: none"> Calculate value [C]: Metric: $[C] = ([B] - [A]) \times 1200 / 25.4$ Inch: $[C] = ([B] - [A]) \times 1200$ If $[A] < [B]$, input: [current value in SP2-103-55 or 59] - [C] If $[A] > [B]$, input: [current value in SP2-103-55 or 59] + [C] <p>Example: SP2-103-55 If [A] is 1 mm (0.04") shorter than [B]: → $[C] = 1 \text{ mm} \times 1200 / 25.4 = 47.2 = 47$ (rounded off to nearest whole number). → If the current setting is 140, input $140 - 47 = 93$.</p>

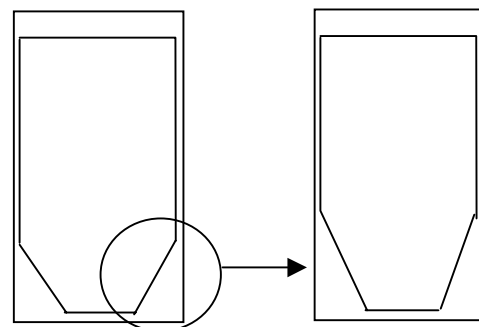
2. Black toner cartridge

Modification	Cut-in
Strips of Mylar have been attached to the inner package to prevent the package from bending or becoming dented. Note: Applied to all toner colors.	August, '01
The shape of the black toner package has been changed to create a steeper slope in the area circled in the illustration, allowing the toner to flow more easily. Note: Applied only to Black toner, since this change would reduce the package capacity too much for the color toners.	April, '02

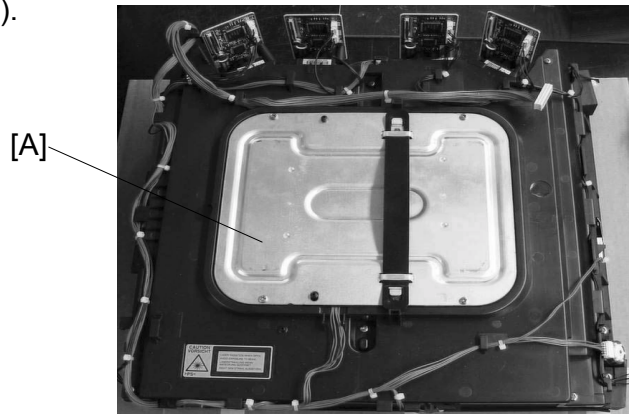
1. Open the upper cover [A] (4 screws).

Caution: If the sponge is not removed, the polygon mirror motor can be damaged and/or the printer may not function correctly.

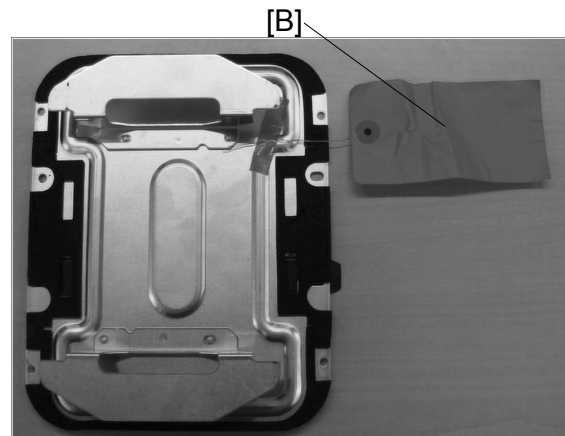
2. Remove the red tag [B] (tape).

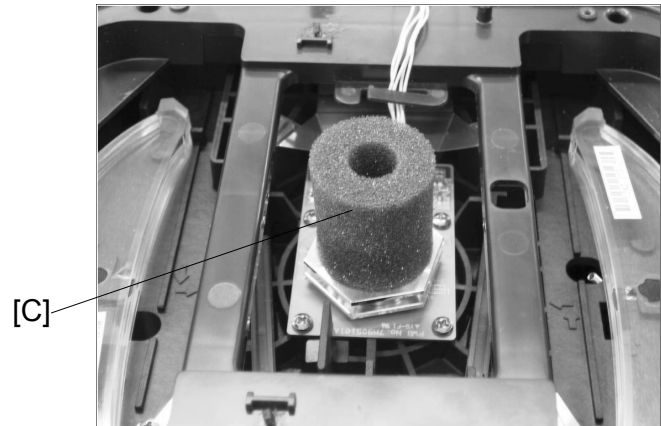
3. Remove the sponge [C].

Note 1: Be sure not to touch any of the mirror or lens surfaces.

Note 2: Be sure that dust does not get into the unit.
