Model: Adonis-P		Date: 31-Oct-99	No.: RG035001
Subject: Service Manual Corrections		Prepared by: K. Takagi	
From: Technical Service Dept., GTS Division			
Classification:	<input type="checkbox"/> Troubleshooting	<input type="checkbox"/> Part information	<input type="checkbox"/> Action required
	<input type="checkbox"/> Mechanical	<input type="checkbox"/> Electrical	<input checked="" type="checkbox"/> Service manual revision
	<input type="checkbox"/> Paper path	<input type="checkbox"/> Transmit/receive	<input type="checkbox"/> Retrofit information
	<input type="checkbox"/> Other ( )

Please make the following corrections in your Adonis-P service manual.

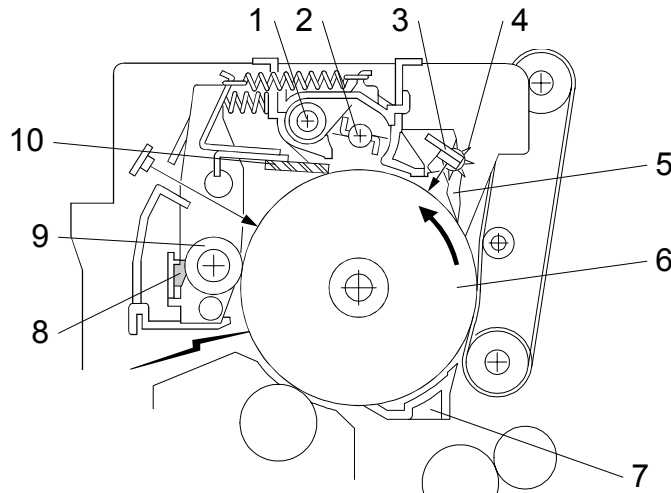
- **PHOTOCONDUCTOR UNIT (Page 2-16)**

There were incorrect callout numbers for the overview illustration. Correct the illustration as follows:

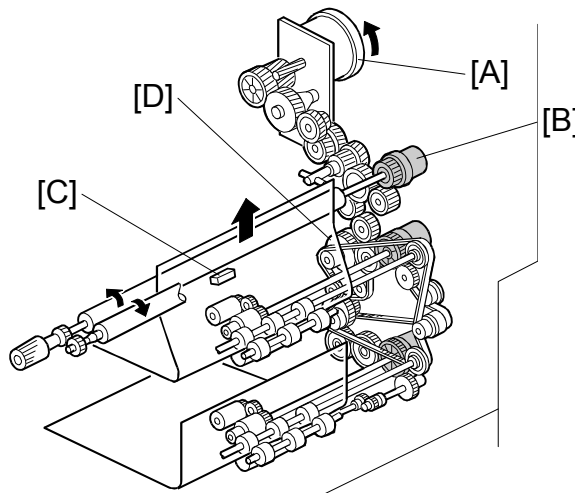
- **PAPER REGISTRATION (Page 2-44)**

There was a missing callout and an incorrect callout in the illustration. Correct the illustration as follows:

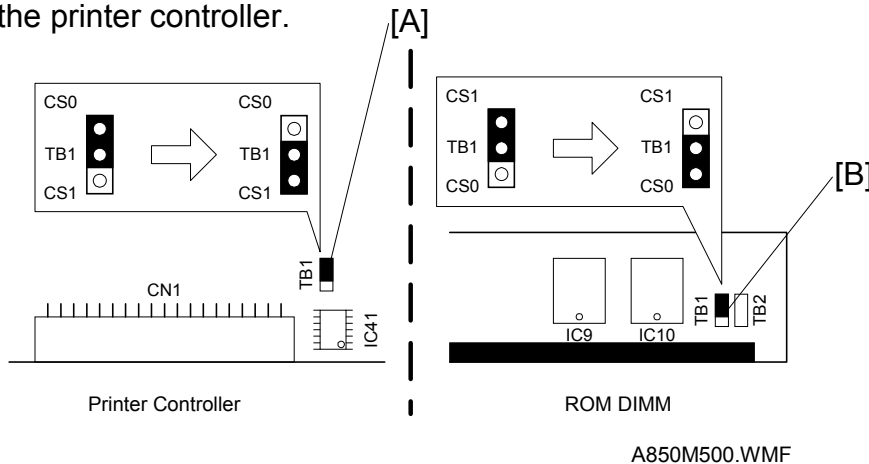
When downloading of the controller firmware is not successful from either the flash memory card or PC (and the printer controller does not start up), any attempts after that to download from the card or PC will not be possible. In addition, it will not be possible to return the machine to operating condition.

However, the firmware can be downloaded from the ROM DIMM as follows.

1. Remove the printer controller.

2. Change the position of the TB1 jumper [A] on the controller from CS0 to CS1.
  3. Change the position of the TB1 jumper [B] on the ROM DIMM that contains the controller firmware from CS1 to CS0.
  4. Install the ROM DIMM on the controller.
- CAUTION:** Make sure to install the correct ROM DIMM in the PS SIMM connector.
