Model: General (GW Models)		Date: 20-Dec-01	No.: RGene010
Subject: Series Print Mode		Prepared by: K. Misugi	
From: Technical Services Dept., GTS Division			
Classification:	<input checked="" type="checkbox"/> Troubleshooting	<input type="checkbox"/> Part information	<input type="checkbox"/> Action required
	<input type="checkbox"/> Mechanical	<input type="checkbox"/> Electrical	<input type="checkbox"/> Service manual revision
	<input type="checkbox"/> Paper path	<input type="checkbox"/> Transmit/receive	<input type="checkbox"/> Retrofit information
	<input type="checkbox"/> Other (      )

Model: Model U-P1		Date: 20-Dec-02	No.: RG071001
Subject: Image Skew		Prepared by: H.K.	
From: Technical Services sec. Service Planning Dept.			
Classification:	<input checked="" type="checkbox"/> Troubleshooting	<input type="checkbox"/> Part information	<input type="checkbox"/> Action required
	<input type="checkbox"/> Mechanical	<input type="checkbox"/> Electrical	<input type="checkbox"/> Service manual revision
	<input type="checkbox"/> Paper path	<input type="checkbox"/> Transmit/receive	<input type="checkbox"/> Retrofit information
	<input type="checkbox"/> Other (      )

Model: Model U-P1

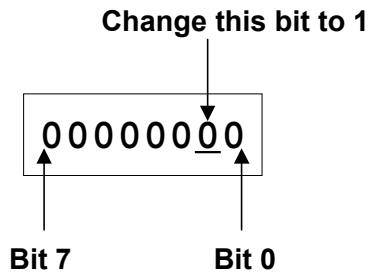
Enter the printer controller service mode, access the bit switch settings display, then change bit 1 of bit switch 2 to "1."

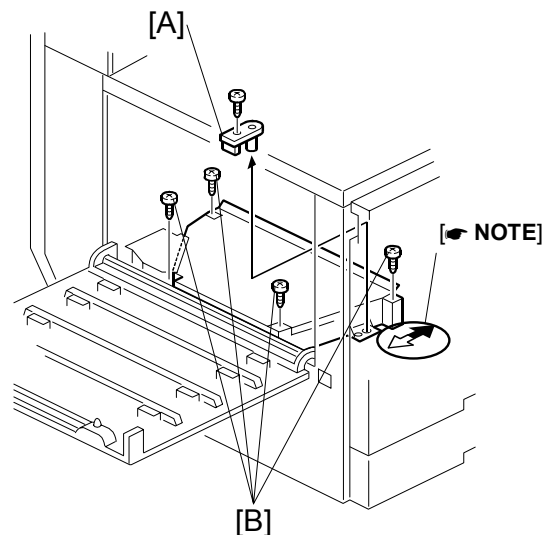
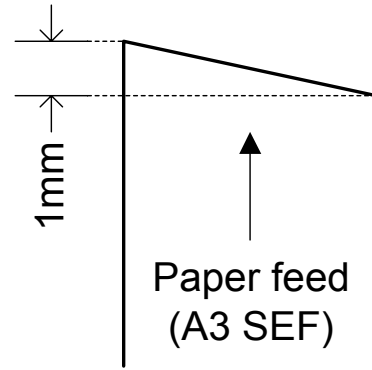
**Action 3 (parallelogram image of trimming pattern)**

**NOTE:** When the image skews as shown on the right, move the unit 1 mm in the direction of the black arrow as shown in the diagram **above and to the right**.

Adjust the position of the laser optics-housing unit as described in the Service Manual, pg. 3-11 to 3-14.

1. Positioning pin [A] (🔩 x 1)
2. Loosen 🔩 (x 4) [B].
3. Adjust the position of the laser optics housing unit (👉 Adjustment).
4. Fasten 🔩 (x 4) [B].

**NOTE:** After changing the position of the laser optics housing unit, do not reinstall the positioning pin. Keep the pin in a safe place.

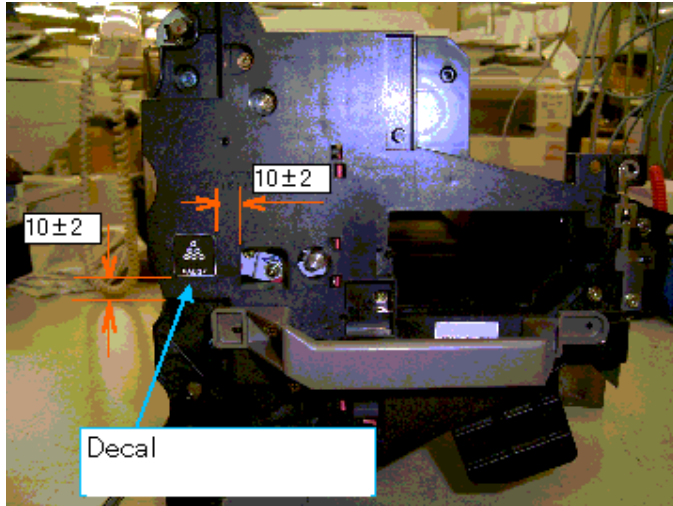
**New PCU**

The new PCU unit has a seal as shown on the front side of the PCU.

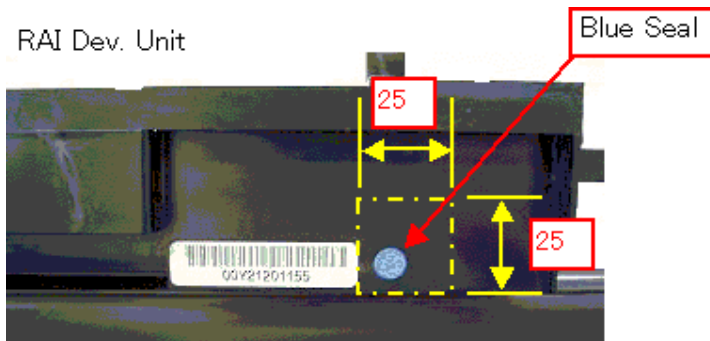
RAI Dev. Unit

- The new development unit from 2004 February production has a blue seal on the left side of the development unit.

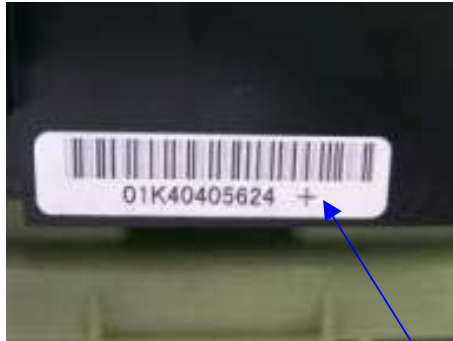
"+" Mark

The new development unit from 2004 June production has a "+" mark on the lot number decal as shown below.
