Model: General RTB	Date: 4-Feb-03	No.: RGene013b
--------------------	----------------	----------------

Subject: Service remarks at installation		Prepared by: T. Itoh	
From: Technical Service Sec. Service Planning Dept.			
Classification:	<input type="checkbox"/> Troubleshooting	<input type="checkbox"/> Part information	<input type="checkbox"/> Action required
	<input type="checkbox"/> Mechanical	<input type="checkbox"/> Electrical	<input type="checkbox"/> Service manual revision
	<input type="checkbox"/> Paper path	<input type="checkbox"/> Transmit/receive	<input type="checkbox"/> Retrofit information
	<input checked="" type="checkbox"/> Other (Specification change)

Model: Model J-P2		Date: 2-Apr-03	No.: RG080001
Subject: Service Manual Revision		Prepared by: H.Taguchi	
From: 1st Tech. Support Sec. Service Support Dept.			
Classification:	<input type="checkbox"/> Troubleshooting	<input type="checkbox"/> Part information	<input type="checkbox"/> Action required
	<input type="checkbox"/> Mechanical	<input type="checkbox"/> Electrical	<input checked="" type="checkbox"/> Service manual revision
	<input type="checkbox"/> Paper path	<input type="checkbox"/> Transmit/receive	<input typ

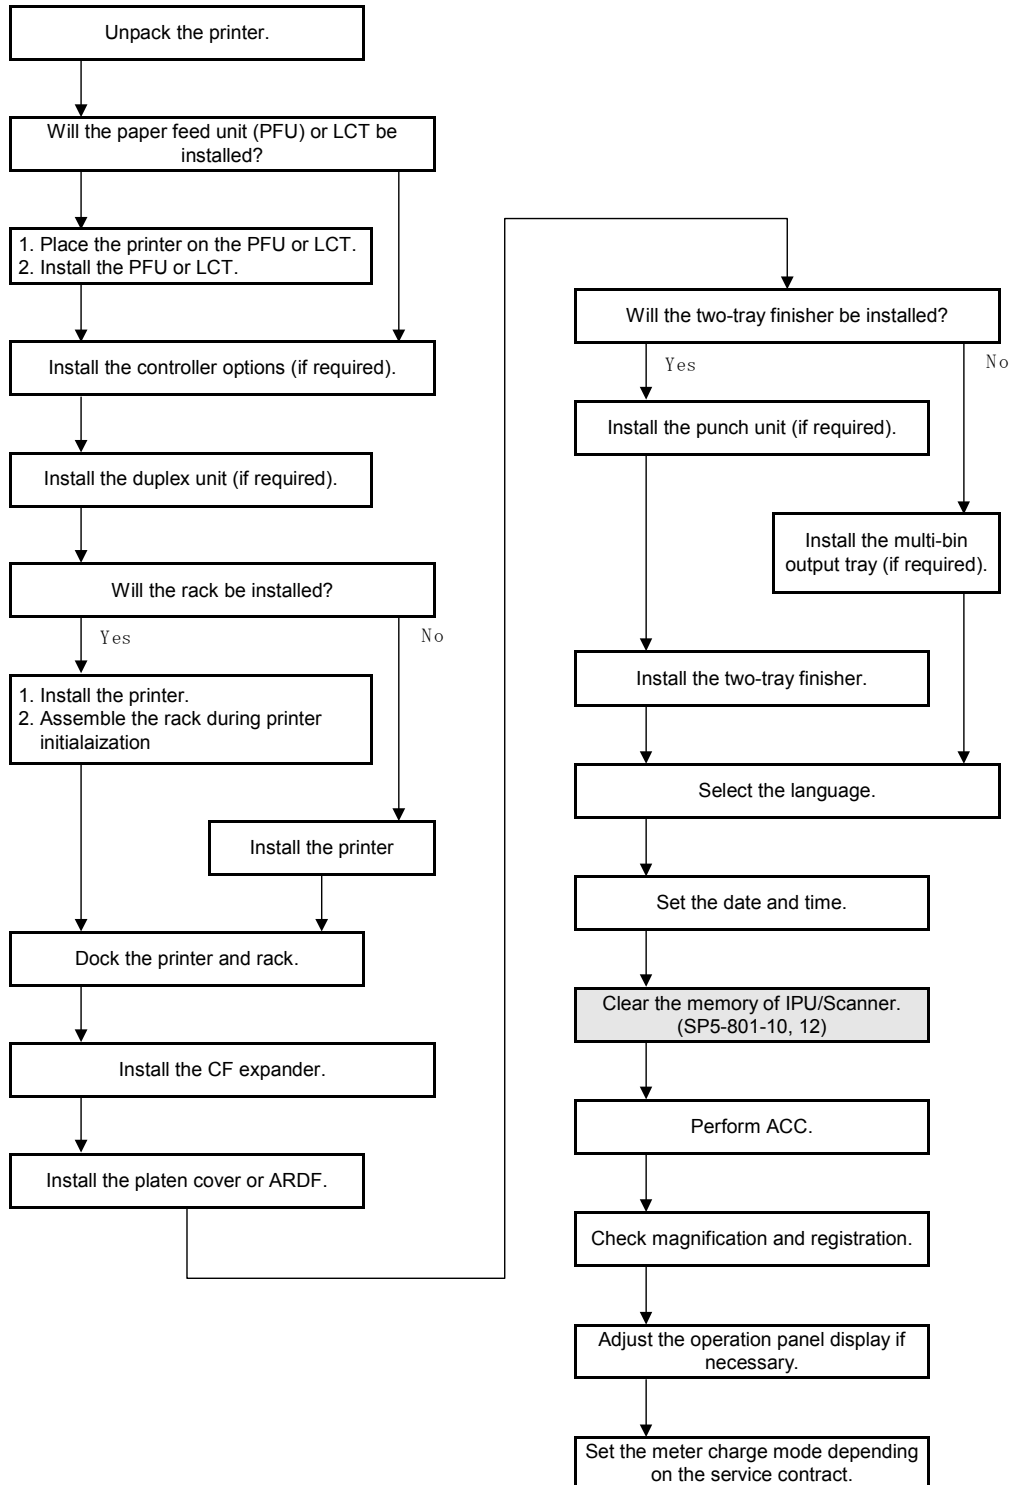
Page 1-7

Contents revised: The following bold word was deleted from the flowchart illustration.

Clear the memory of IPU/**Netfile**/Scanner (SP-5-801-10,12) ].

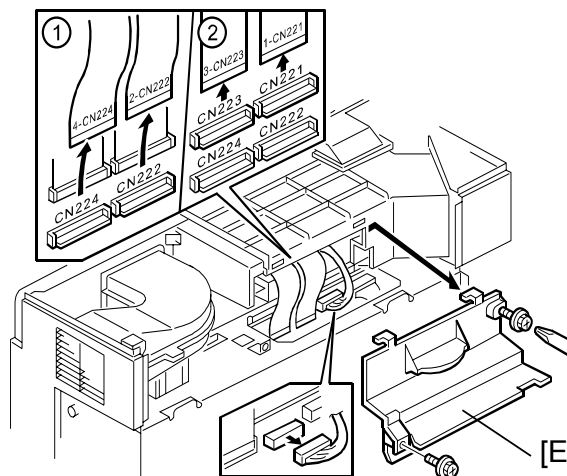
Page 3-10

- A screw has been added and the shape of the connector cover has been changed as follows.

- Step 12 revised as follows:

12. Connector cover [E] (Screw x 2)

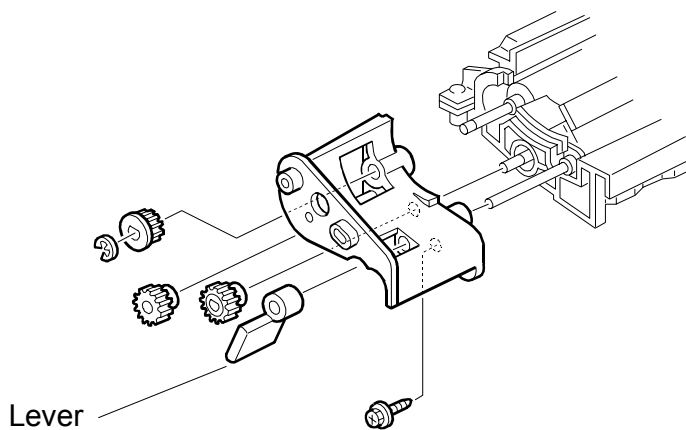
Page 3-23

- The screw which stops the lever has been deleted, and the shape of the lever has been changed as follows.

- Step 4 deleted.

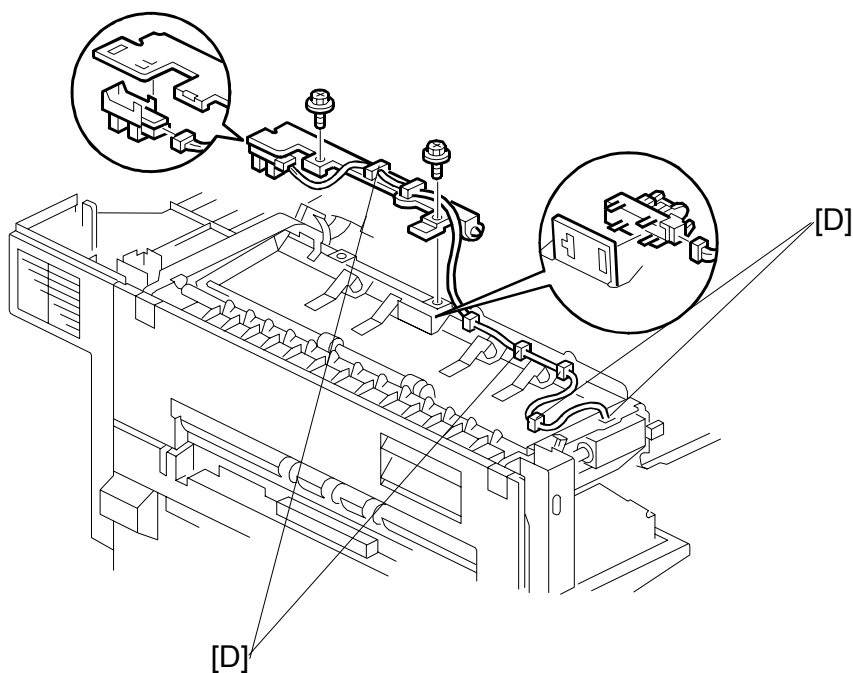
Page 3-42

- Four clamps [D] have been added, and the attachment of the harness has been changed as follows. The clamp at the right-hand end is not visible in the drawing.

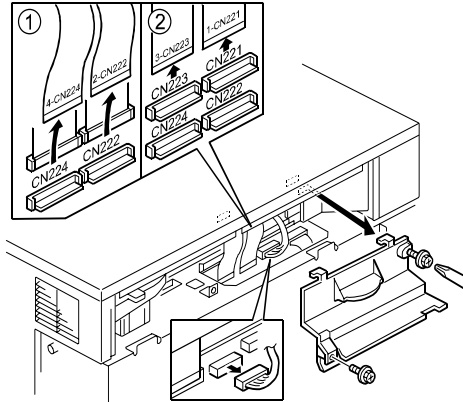
**Page 3-43**

- A screw has been added, and the shape of the connector cover has been changed as follows.

- Step 4 revised.

4. Connector cover [E] (Screw x 2)

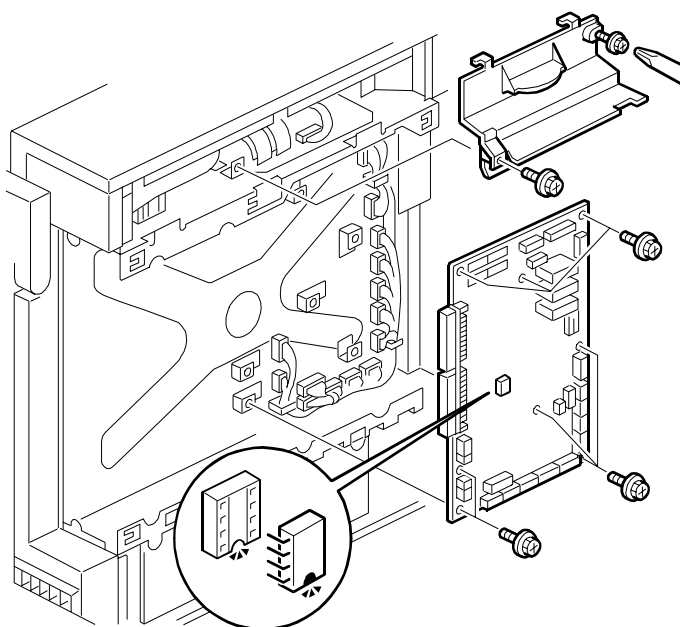
**Page 3-45**

- A screw has been added and the shape of the connector cover has been changed as follows.

- Step 6 revised.

6. Connector cover [E] (Screw x 2)

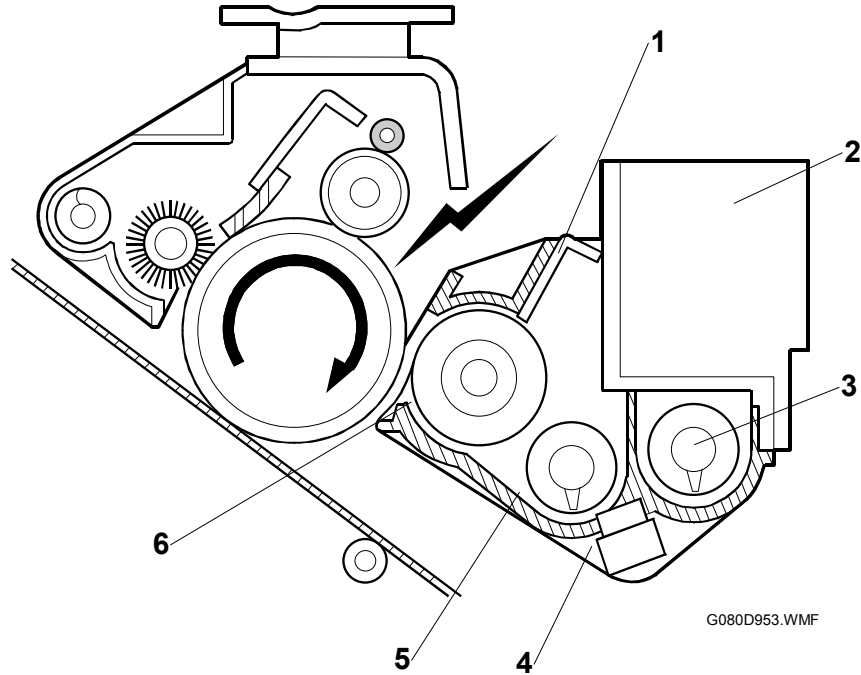
- Illustration revised to show correct parts:

1.Doctor blade

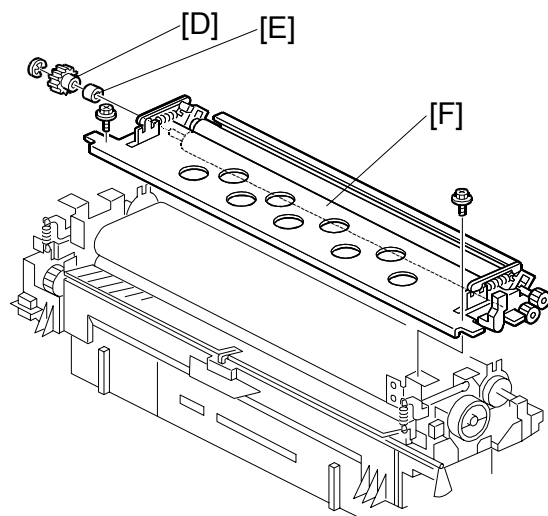
Controller → IPU (through) → Controller (**straight through**) → BCU**Page 3-32**Illustration revised to show the gear and collar:

- Steps 4, 5 revised as follows:

4. Gear [D] and Collar [E] (retaining ring x 1).
5. Cleaning unit [F] (screw x 2).
