Model: Model J-P3		Date: 14-May-04	No.: RG106001
Subject: The menu key cannot be used		Prepared by: H.Taguchi	
From: 1st Tech. Support Sec. Service Support Dept.			
Classification:	<input checked="" type="checkbox"/> Troubleshooting	<input type="checkbox"/> Part information	<input type="checkbox"/> Action required
	<input type="checkbox"/> Mechanical	<input type="checkbox"/> Electrical	<input type="checkbox"/> Service manual revision
	<input type="checkbox"/> Paper path	<input type="checkbox"/> Transmit/receive	<input type="checkbox"/> Retrofit information
	<input type="checkbox"/> Other ()

Model: Model J-P3		Date: 20-May-04	No.: RG106003
Subject: Vertical black lines		Prepared by: H.Taguchi	
From: 1st Tech. Support Sec. Service Support Dept.			
Classification:	<input checked="" type="checkbox"/> Troubleshooting	<input type="checkbox"/> Part information	<input type="checkbox"/> Action required
	<input type="checkbox"/> Mechanical	<input type="checkbox"/> Electrical	<input type="checkbox"/> Service manual revision
	<input type="checkbox"/> Paper path	<input type="checkbox"/> Transmit/receive	<input type="checkbox"/> Retrofit information
	<input type="checkbox"/> Other ()

Model: Mo

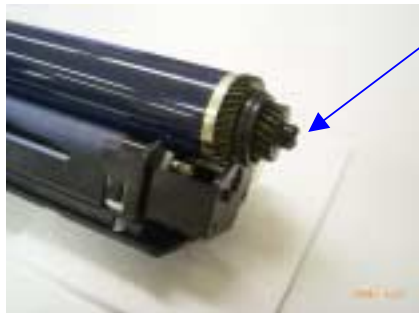
Slide the drum until this outer gear clears the PCU frame, as shown.

3. Hold the drum at both ends as shown, then slide it in the direction of the arrow until the outer gear has cleared the PCU frame (see the next photo).

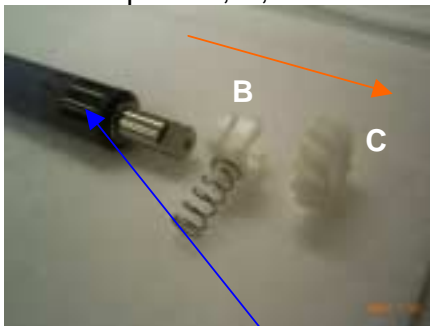
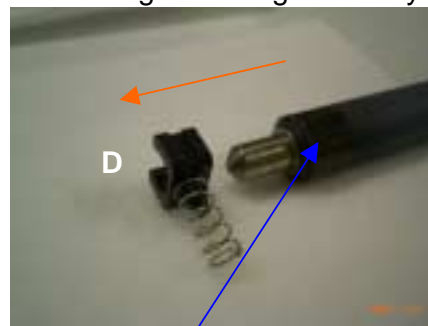
Tape-covered areas.
Do not remove this tape.

9. Remove parts B, C, and D as shown while holding the charge roller by its taped edges.

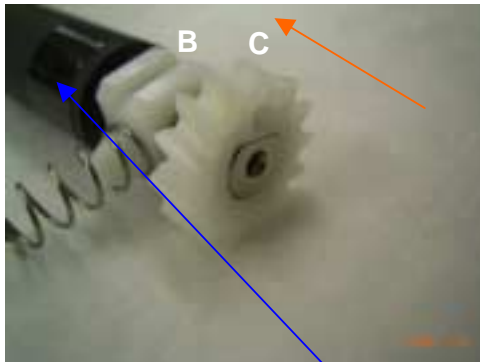
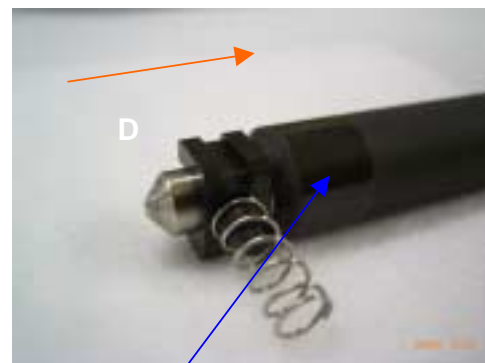
Tape-covered areas.
Do not remove this tape.

12. Attach parts B, C, and D while holding the charge roller by its tape-covered areas.

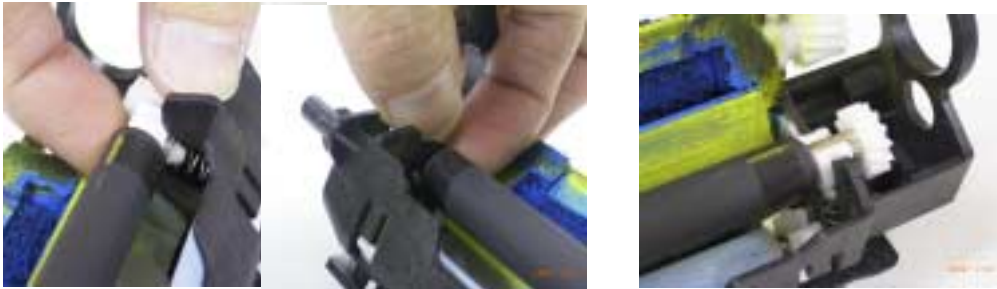
- Make sure to attach the charge roller as shown below, i.e. parts B and D should both fit into their respective guide ribs on the unit frame.
- Make sure that: 1) the spring is properly aligned (straight; not bent), 2) the gears on both sides are attached properly to the shaft, and 3) the charge roller cleaner is properly secured in its bushings at both ends.

13. Reattach the charge roller to the PCU frame (see the notes on the next page).

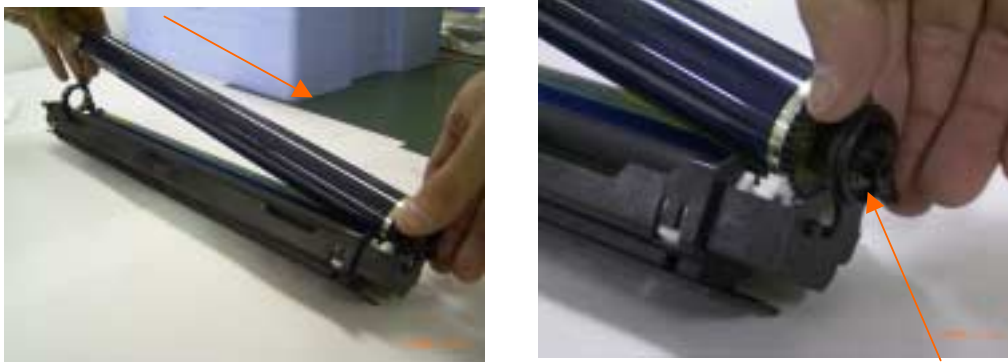
Set the drum gear in the frame hole.

14. Holding the drum by both ends as shown, reattach the gear-end first by sliding the drum in the direction shown and then mounting the gear in the frame hole.

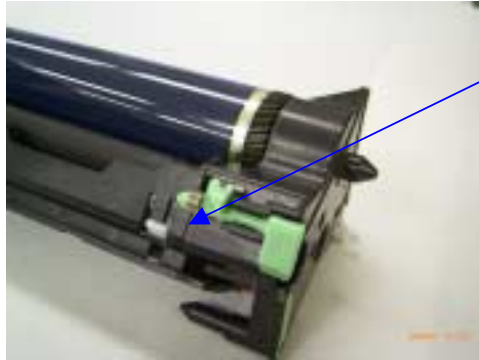
Make sure there is no gap between the cover and frame.

16. Reattach the front cover (2 screws).

- When reattaching the front cover, make sure there is no gap between the cover and frame.

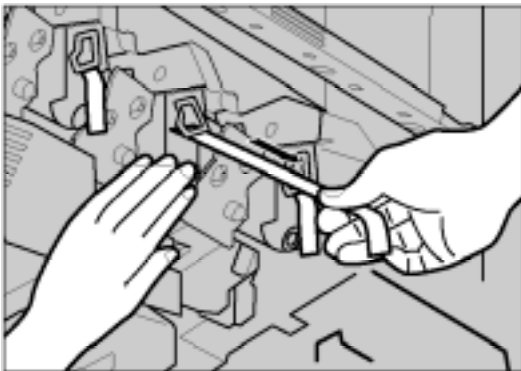
- The unit is not installed correctly at the factory
- A new unit is not installed correctly in the field at developer replacement

4. While you hold the development unit with one hand, pull out the tape gently as shown.
