Model: GF10		Date: 15-Dec-98	No: 1
Subject: Part number for the main motor		Prepared by: K.Takagi	
From: GTSS Field Information Dept.			
Classification:	<input type="checkbox"/> Troubleshooting	<input type="checkbox"/> Part information	<input type="checkbox"/> Action required
	<input type="checkbox"/> Mechanical	<input type="checkbox"/> Electrical	<input type="checkbox"/> Service manual revision
	<input type="checkbox"/> Paper path	<input type="checkbox"/> Transmit/receive	<input type="checkbox"/> Retrofit information
	<input type="checkbox"/> Other ()

Model: G Series, Schmidt Series		Date: 30-Jun-99	No.: RFMLU009
Subject: Vertical gray band		Prepared by: Y. Okunishi	
From: Technical Service Dept., GTS Division			
Classification:	<input checked="" type="checkbox"/> Troubleshooting	<input type="checkbox"/> Part information	<input type="checkbox"/> Action required
	<input type="checkbox"/> Mechanical	<input type="checkbox"/> Electrical	<input type="checkbox"/> Service manual revision
	<input type="checkbox"/> Paper path	<input type="checkbox"/> Transmit/receive	<input type="checkbox"/> Retrofit information
	<input type="checkbox"/> Other ()

Model: GF-10		Date: 15-Jul-99	No.: RG0250

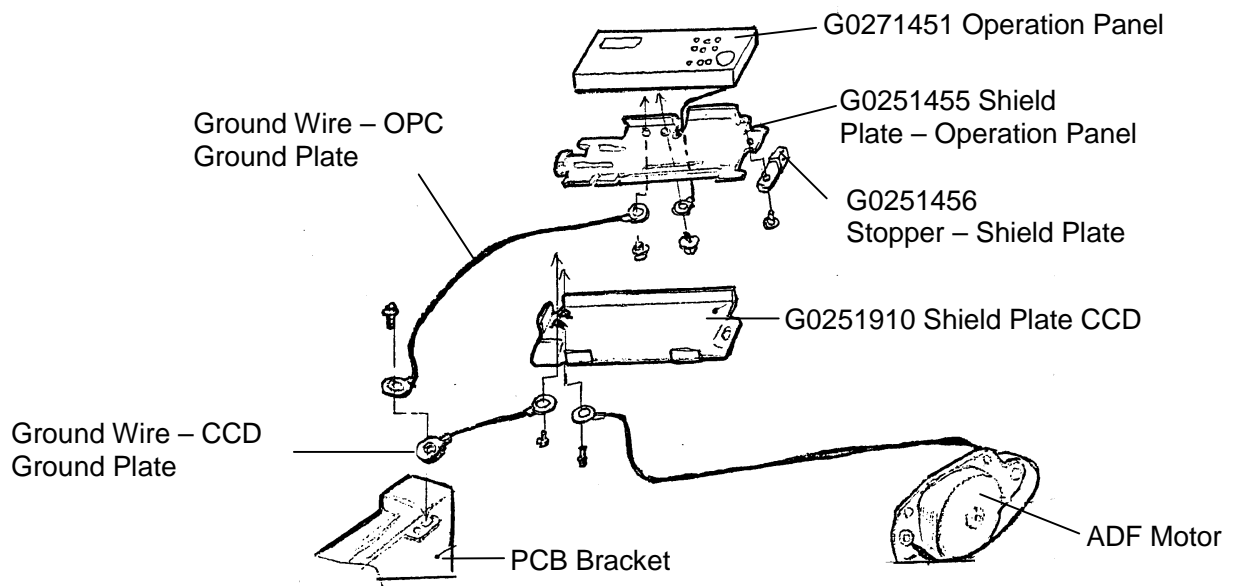
For reference: Assembly of ground wires

1. Attach the ground wire of the operation panel to the base of the scanner unit with one screw.
2. Push the loose wire into the gap between the base and lower cover (of the scanner unit).

1. Attach the ground wire of the operation panel to the operation panel bracket.
2. Push the loose wire into the opening in the bracket.
