<b>Model:</b> PRIPORT PEARL		<b>Date:</b> 31-Dec-98	<b>No:</b> 01
<b>Subject:</b> Pressure Cylinder Maintenance Cycle		<b>Prepared by:</b> H. Kokubo,

<b>Model:</b> PRIPORT PEARL		<b>Date:</b> 31-Dec-98	<b>No:</b> 02
<b>Subject:</b> Master Feed Jams or Cutter Errors		<b>Prepared by:</b> H. Kokubo, Priport Service Planning Section	
<b>Classification:</b>	<input checked="" type="checkbox"/> Troubleshooting	<input checked="" type="checkbox"/> Part information	<input type="checkbox"/> Action required
	<input type="checkbox"/> Mechanical	<input type="checkbox"/> Electrical	<input type="checkbox"/> Service manual revision
	<input type="checkbox"/> Paper path	<input type="checkbox"/> Transmit/receive	<input type="checkbox"/> Retrofit information
	<input type="checkbox"/> Other (      )		
<b>Model Name:</b> PEARL: Ricoh JP5000, Gestetner 5450, RexRotary 1560, nashuatec CP450, SVN 3350DNP

<b>Model:</b> PRIPORT PEARL		<b>Date:</b> 15-Sep-99	<b>No:</b> R-C229-4
<b>Subject:</b> Auxiliary Firmware Update Method - Flash memory card for updating firmware -		<b>Prepared by:</b> H. Kokubo, Priport Service Planning Section	
<b>Classification:</b>	<input type="checkbox"/> Troubleshooting	<input chec

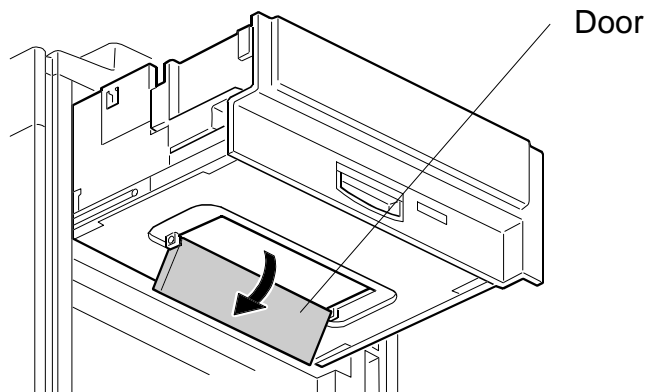
Due to heavy static electricity, the master is not guided into the buffer fans. This problem is especially likely when the master roll has almost run out and the diameter of the roll has become narrow.

1. First, slide out the master making unit and check if there is no master pieces in the buffer duct by opening the small door in the bottom of the unit.

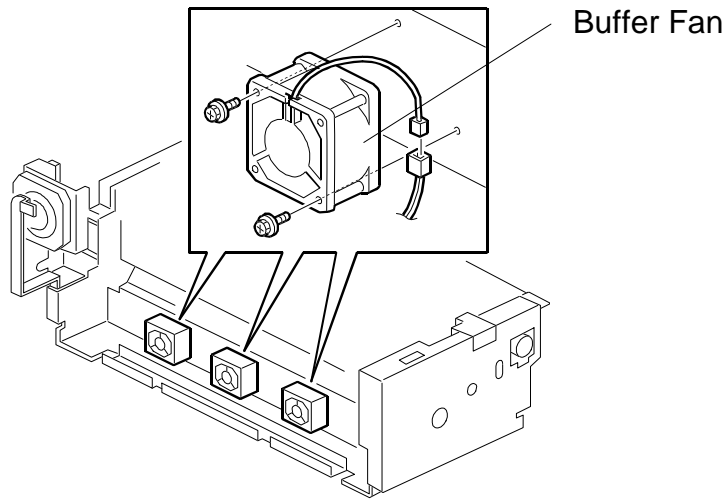
A tiny piece of master can cause the problem. Remove the three fans by loosening the screws, and check if there are anypieces of master.

2. Remove the exterior cover of the unit, and check if any master pieces are caught in the buffer fans.

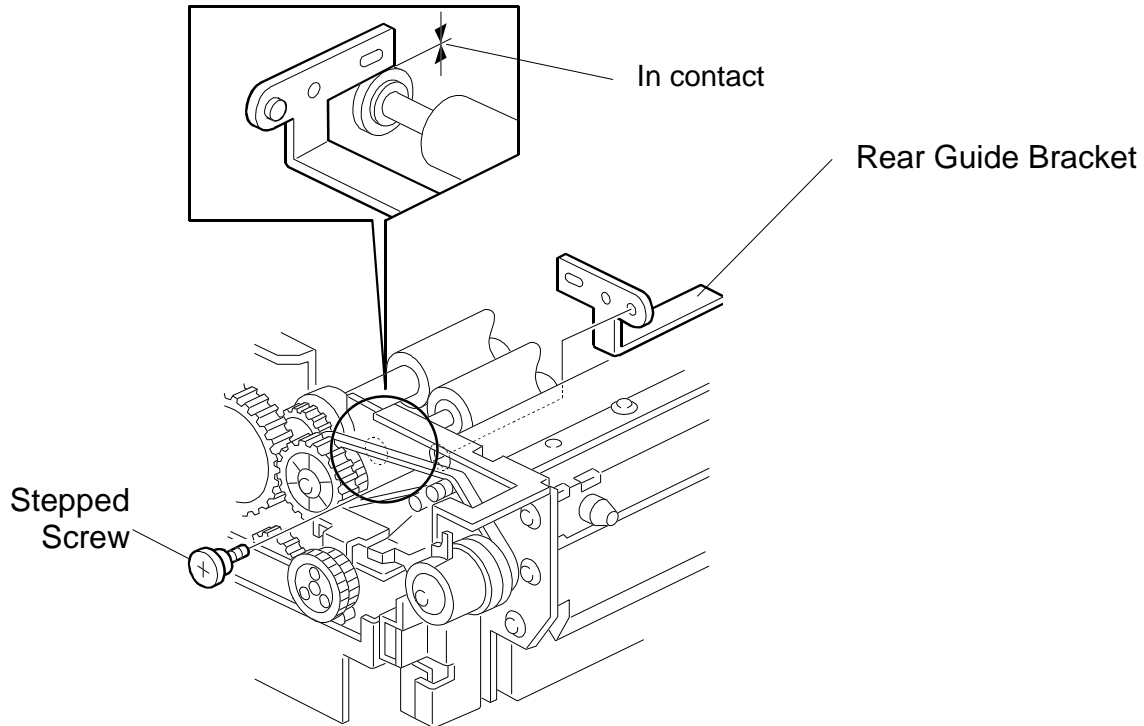
**CAUTION:** 1) The two brackets are different. Make sure to install them in the correct positions by referring to the diagrams above.  
 2) Make sure that both brackets are in contact with the flanges of the ball bearings at each end of the roller. (See diagram.)

3. Install the rear guide bracket (in the non-operation side of the unit) using the stepped screw, as shown above.

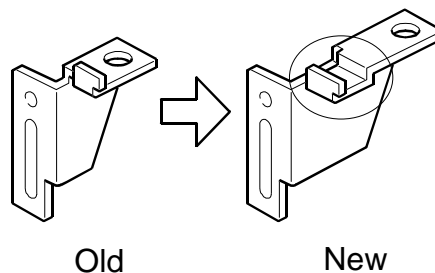
#### - The new bracket shape -

The new brackets were also applied from May 1999 production. The shapes of the old and new brackets differ as shown below. Therefore, you can identify whether the old or new type is installed in the machine.

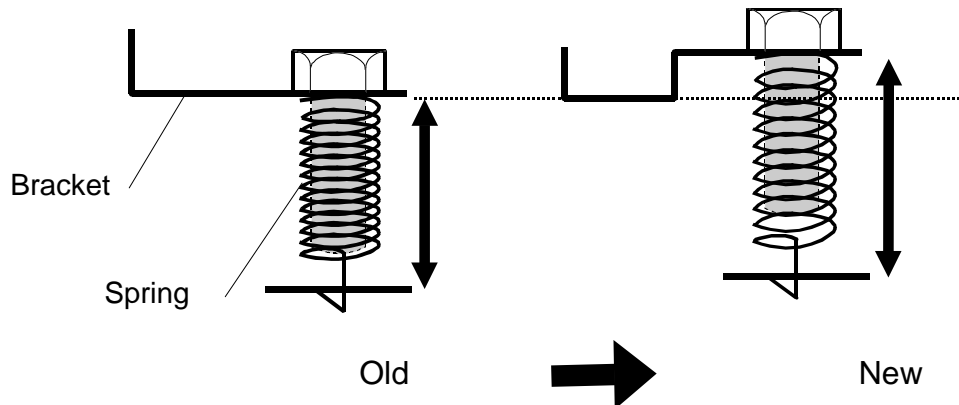
**NOTE:** The configuration of the old and new spring brackets has been changed as shown below. The new brackets can stretch the printing pressure spring more than before.

If you do not replace the spring brackets with the new type, set the adjustment value to 0 mm, which means to fully tighten the bolts.

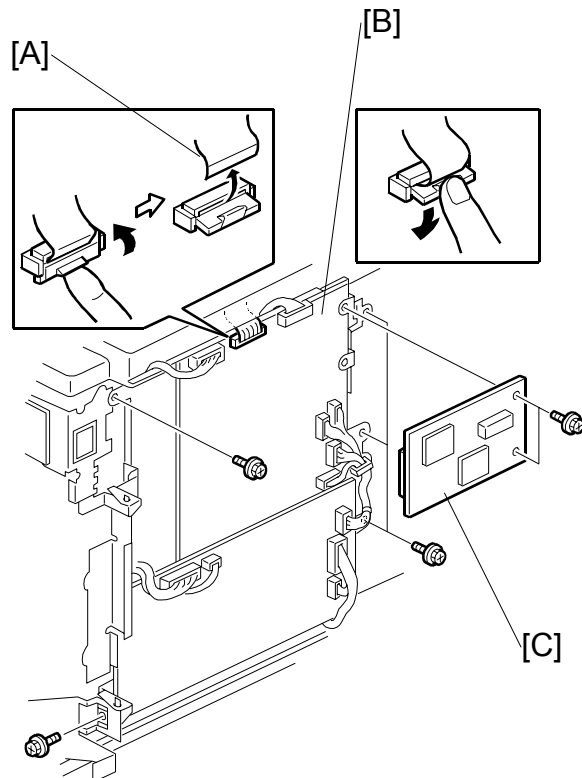
At the factory it was found that the grease applied to the sector gear shaft (in the master clamber drive unit) was insufficient. After investigating the production units, we found that this problem occurred from the December 1999 production of these machines.

If the sector gear shaft [A] wasn't greased or was insufficiently greased, the surface of the shaft [A] will gradually wear down, as the sector gear plate [B] and sensor actuator bracket [C] rotate along the shaft each time a new master is made.

If the shaft wears down (frictional wear), the sector gear plate [B] and/or sensor actuator bracket [C] will not work smoothly. This will cause the master clamber motor to lock or cause master clamping errors.

1. Turn off the main switch and disconnect the power plug.
2. Remove the rear cover.
3. Remove the flat cable [A], and open the MPU [B].  
**NOTE:** If the memory board [C] is installed, also remove it.
4. Remove screws and swing out the PSU (not shown).

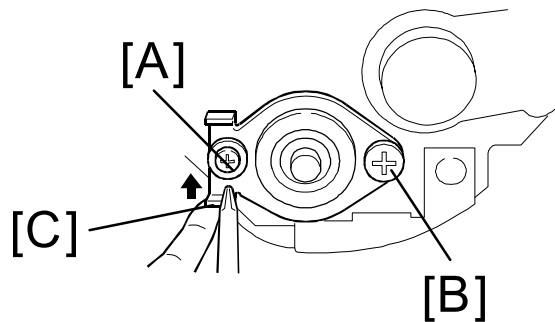
View from operator side

Producing over 2,000 prints with the same master causes an ink buildup to occur [A] between the inner surface of the drum metal screen [B] and the drum idling roller [C], after which the buildup is transferred to the area of the ink pump motor [D].

1. Install the new parts, then tighten screw [B] (A2596239) and leave screw [A] (09513006Z) loose.
2. Move the lip [C] of the bearing holder up all the way as shown, then tighten screw [A].

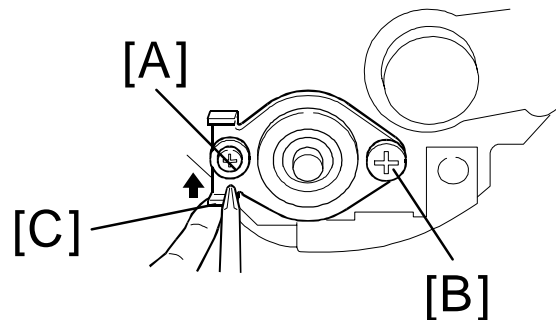
View from operator side

Producing over 2,000 prints with the same master causes an ink buildup [A] to occur between the inner surface of the drum metal screen [B] and the drum idling roller [C], after which the buildup is transferred to the area of the ink pump motor [D].

1. Remove the drum unit from the machine.
2. Remove the cloth and metal screens from the drum unit.
3. Wipe off the ink around the ink roller and the doctor roller.
4. Install the new parts, then tighten screw [B] (A2596239) and leave screw [A] (09513006Z) loose.
5. Move the lip [C] of the bearing holder up all the way as shown, then tighten screw [A].

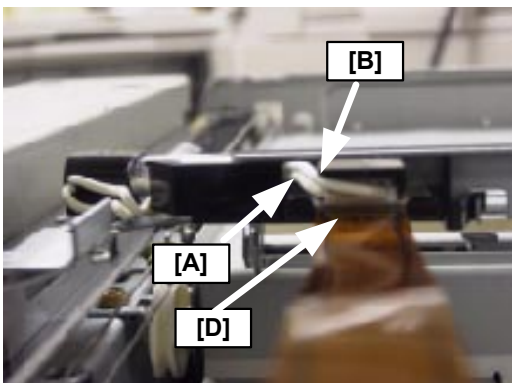
**Fig. 1: Correct**

**Correct (Fig. 1):** Wire [A] is led under wire [B], and they are not touching the flexible cable.

6. Push the pick [C] to the left to the remove the Harness Guide [E] for the flexible cable.
7. Put wire [A] and wire [B] in the same position as "Figure 1: Correct."

- Make sure wire [B] is **over** wire [A].
  - Make sure wire [A] and wire [B] are not too loose.
8. Re-attach the Harness Guide [E].
  - Put the left part of the pick [F] into the square hole [G], and then re-attach the pick [C].

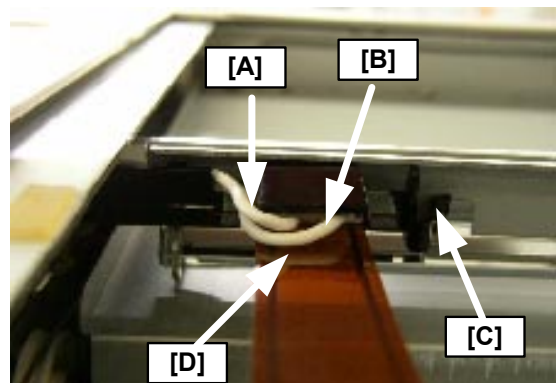
**Fig. 2: Incorrect**

**Incorrect (Fig. 2):** Wire [B] is led under wire [A], and one of them is touching the flexible cable.

- If the wires are like "Fig. 2: Incorrect", go to step 3.
3. Turn off the main switch.
4. Remove the exposure glass.
5. Check the flexible cable [D].
  - If you see any damage to the outside of the flexible cable, replace it.

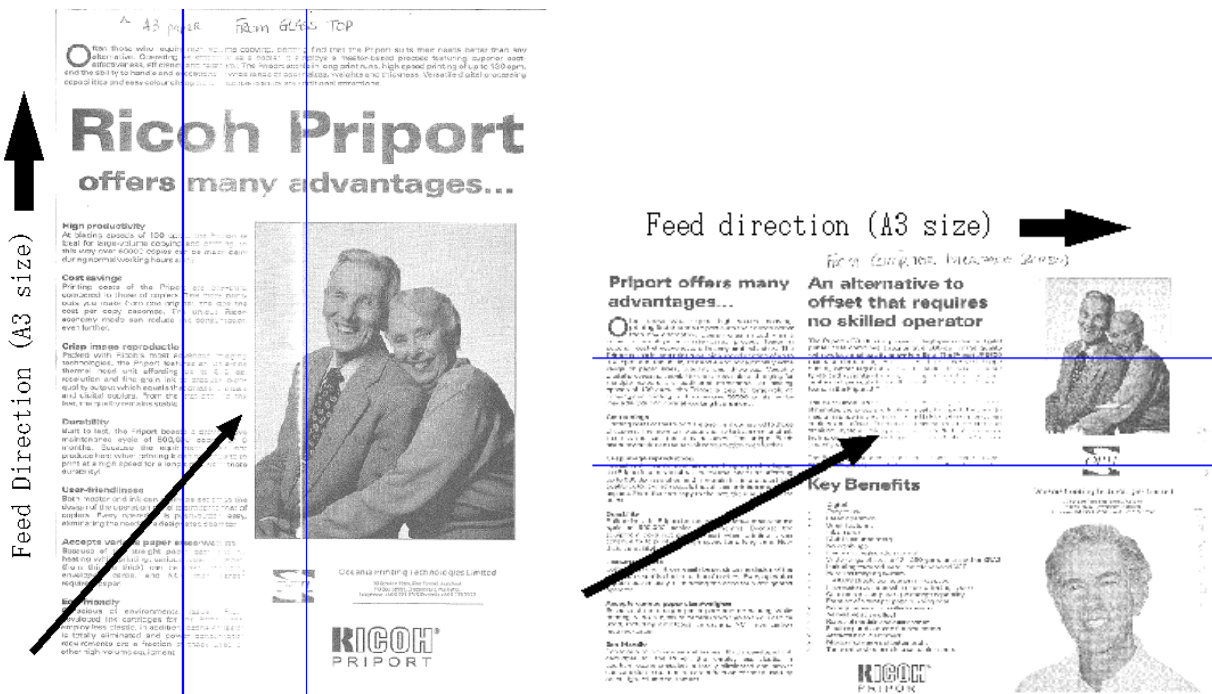
An area of the image (73mm wide) has low image density or white banding.
