SUBJECT: Ink Cartridge "O" Ring and Rubber Pad

FROM: Copier Technical Support Section

VT2100/2130/2150

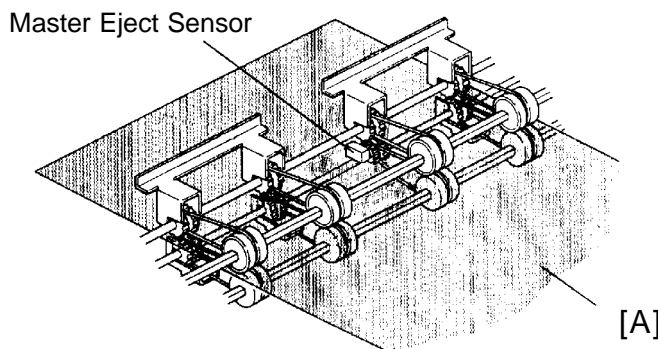
Note: If the sensor surface stains, the voltage may go over 1.7V

To ensure that the master eject sensor functions, perform the following adjustment procedure.

1. Clean the sensor surface with cloth dampened with alcohol.
2. Make a master with the blank original.
 - a. Set the blank original and make about 20 prints.
 - b. Stop printing and remove the master from the drum.
3. Insert the above master [A] between the upper and the lower eject rollers with the master film side up as shown.
4. Confirm that the voltage between TP104 and GND line (CN103-5) on the main PCB is $3.5V \pm 0.5V$
5. If it is not, adjust it by turning VR104 on the main PCB.

Note: Adjust the voltage under the condition that the master is stretched.

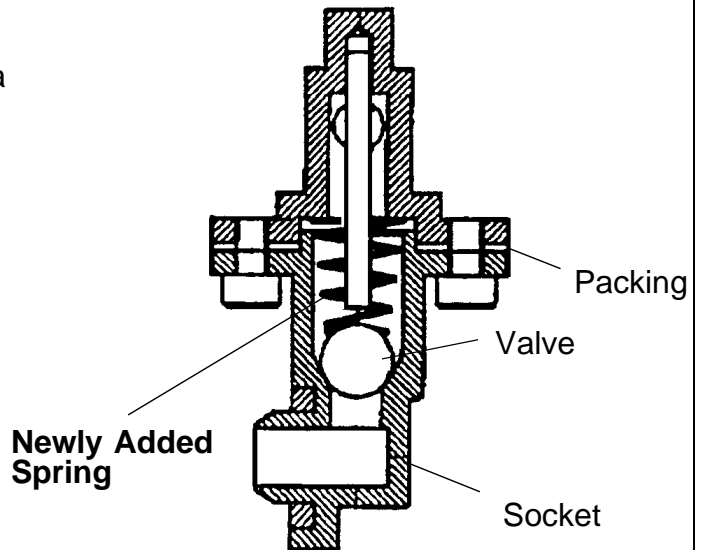
Cross-section of the Bottom Part of the Ink Pump

There are three types of ink pump. They are the NA/NB type that can hold the 1000 cc ink cartridge, the N type that can hold the 600 cc ink cartridge only, and the N810 type that is for the N810 and N810-II only. See the following table for the applicable models.

For the field machines, you can install the spring after removing the socket (with two screws). (It takes longer to replace the whole pump assembly.)

CAUTION: When you remove the socket, ink will leak. Be sure to place absorbant material to prevent the floor from becoming dirty with ink.

NOTE: 1. There is a packing between the socket and housing (see the illustration on the previous page). If it is damaged, you may have to replace the packing at the same time. (Normally, this is not required.) The part number is:

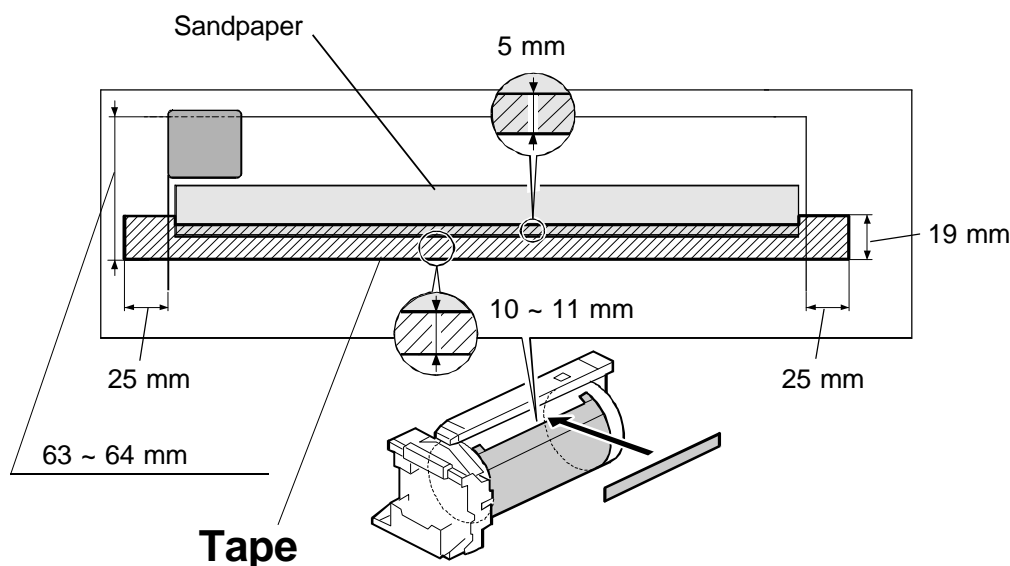
Due to the rough edges of the paper, the master wrapped around the drum becomes damaged.

Normally, even if the master is damaged, there is no ink around the area beneath the master where the paper leading edge contacts (there are no holes in the metal screen). However, after a long printing run, ink leaks onto this area and is transferred to the paper through the damaged part of the master.

3. Cover the leading edge part of the cloth screen on the drum with tape, so that ink does not leak even when the master is damaged.

- Cut the tape where it covers the sandpaper as shown. (The indicated area must be left as shown to hold the tape on the screen firmly.) Be careful not to damage the cloth screen surface.
- Cut both edges of the tape as indicated.
- Even if the sandpaper is not used on the cloth screen (the old type cloth screen), install tape at the same position by measuring the distance from the edge of the cloth screen to the lower edge of the tape (between 63 and 64 mm).
- Since the specification of the leading edge blank margin for the N915/935/955 models is 10 mm (5 mm for the other models), it is permissible to install the tape 5 mm lower than the position indicated above.

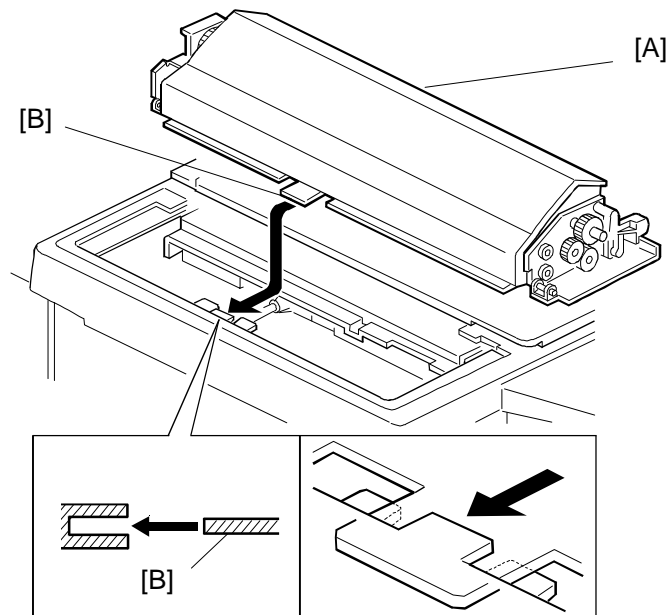
NOTE: If you do not follow the above instruction and the tab rides over the scanner unit frame, the ADF unit leans toward the right. There are guides [C], which are to guide both ends of the carriage, beneath the right end of the ADF (see the illustration above). Thus, these guides are just slightly lowered.

As a result, the carriage tends to be caught by the edge of the guides [C] while the carriage moves toward the original scanning position for the ADF mode. Even if the carriage is stopped on the way to the original scanning position, the master making process will happen as in the normal manner. However, as the original is not scanned properly, images will not be reproduced on the master, resulting in blank (or black) copies.

1. When you install the ADF unit [A] on the scanner unit, make sure to insert the tab [B] as shown above.

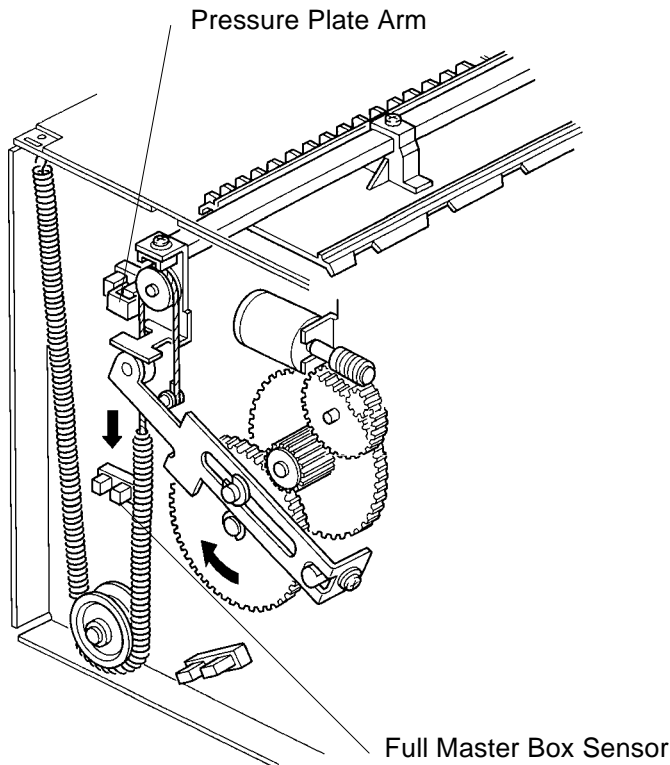
The new part has a narrower actuation plate as shown below. This means that the full master condition will be detected earlier than before.

If **SOLUTION 1** is not good enough, install the new part on the operation side of the master eject unit (see below).

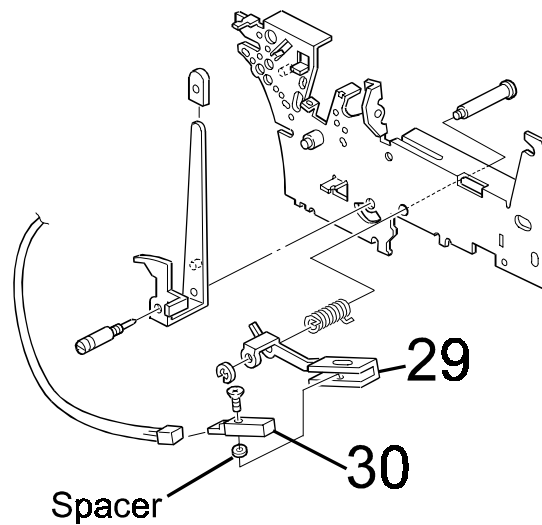
The machine continues to rotate the Master Roll even after the actual end condition is reached, stripping the roll paper off the roll. The very edge of the roll paper with the adhesive then causes a jam when it sticks to the Master Feed Rollers.

Change the sensor, or adjust the sensor's position as shown on the next page.
An output check for the Master End Sensor has been added from July 2001 production.

1. Unplug the power cord and slide the Scanner Unit to the left as seen from the operation panel side.
2. Lift the release lever and remove the Master Roll.
3. Raise the sensor position by installing a 0.2 mm-thick spacer as shown above (08072071). If this spacer has no effect, install one more 0.2 mm spacer or remove the first one and use a 0.4 mm spacer (07010030Z).
